U.S. Department  
of Transportation

National Highway  
Traffic Safety  
Administration

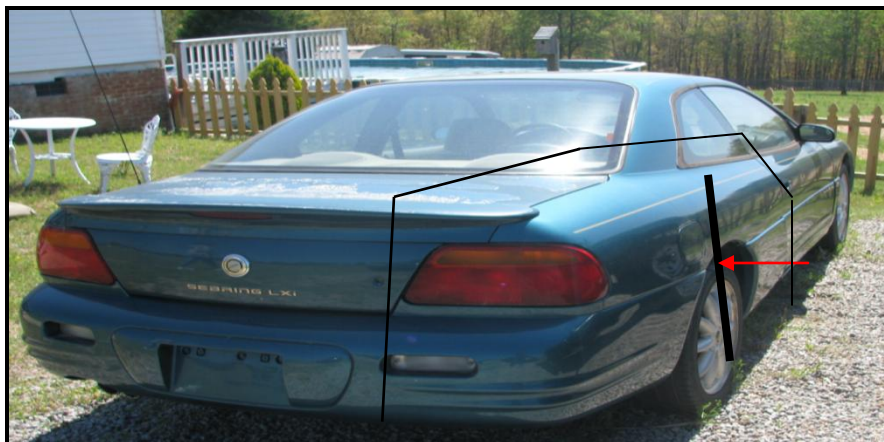
Both right and left rear tires are wearing in the inside due to several possible reasons. (1) Covington failed to re-align the uni-body frame as stated in the repair estimate. (2) The lower suspension cross-member is damaged and with either or both rear right and left struts, along with other rear suspension parts. (3) Or all the above.

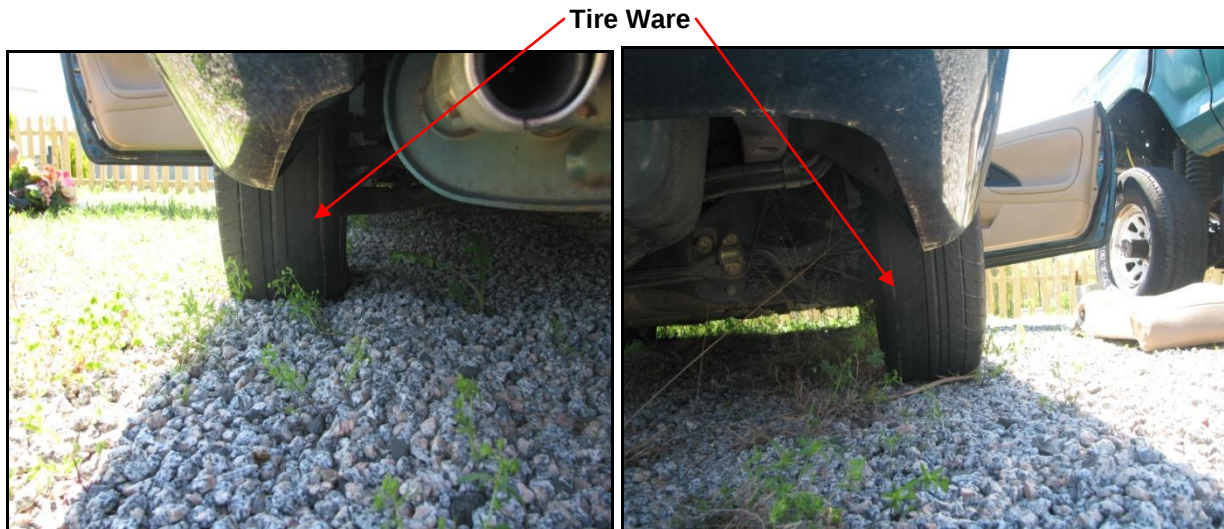
2. **Cost and application of anti-corrosion material(s) generally just stated as “corrosion protection” on estimate.** Anti-corrosion protection consists of more than one type of material used and should be itemized as a separate item. **Anti-corrosion materials are:**

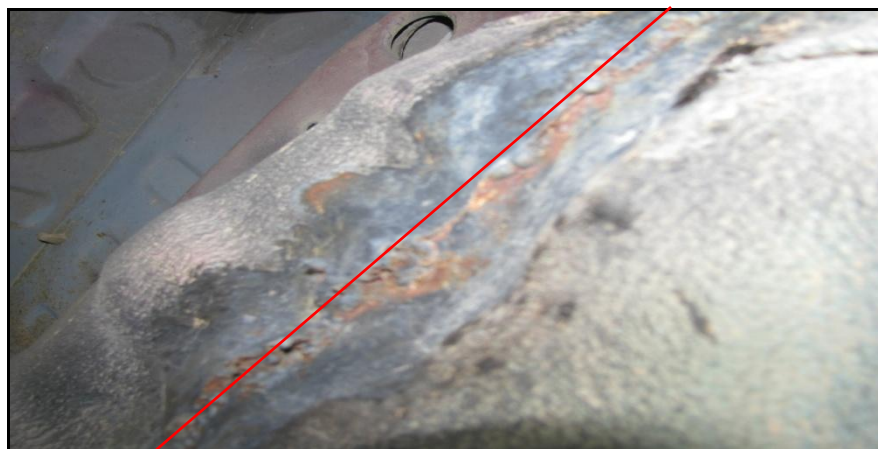
3. **Welded panel adjacent panel repairs.** The welds need to be smooth by grinding for the refinishing process to take place. In the photo below are indicated by a red lines **is one small example of the welds not smooth-out of the floor pan of you Sebring.**

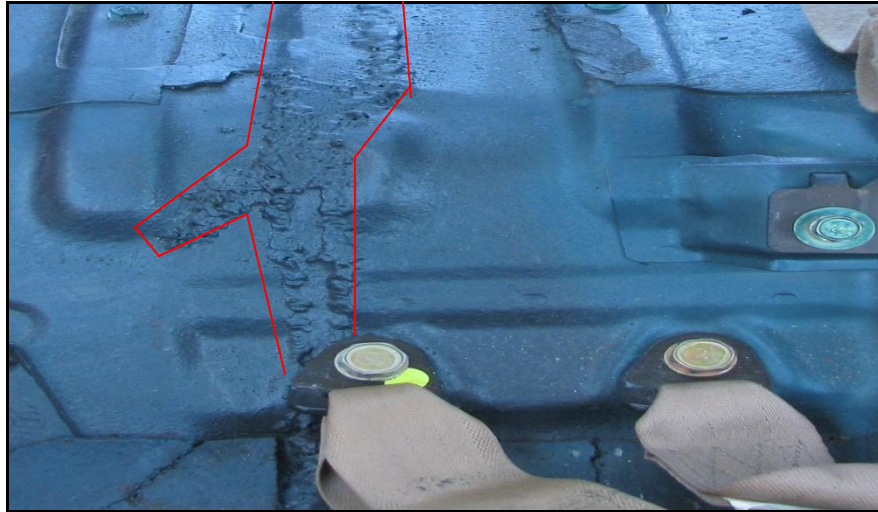
4. **Cost and application of seam sealers.** Seam sealers are used to prevent moisture and corrosion causing contaminants from entering into the areas where parts are joined together by welding. In the photo below is **one small example of seam sealer needing to be applied.** The red lines indicate where the floor-pan was installed needing seam sealer applied to prevent any moisture from entering between the original floor pan and the replacement floor pan.

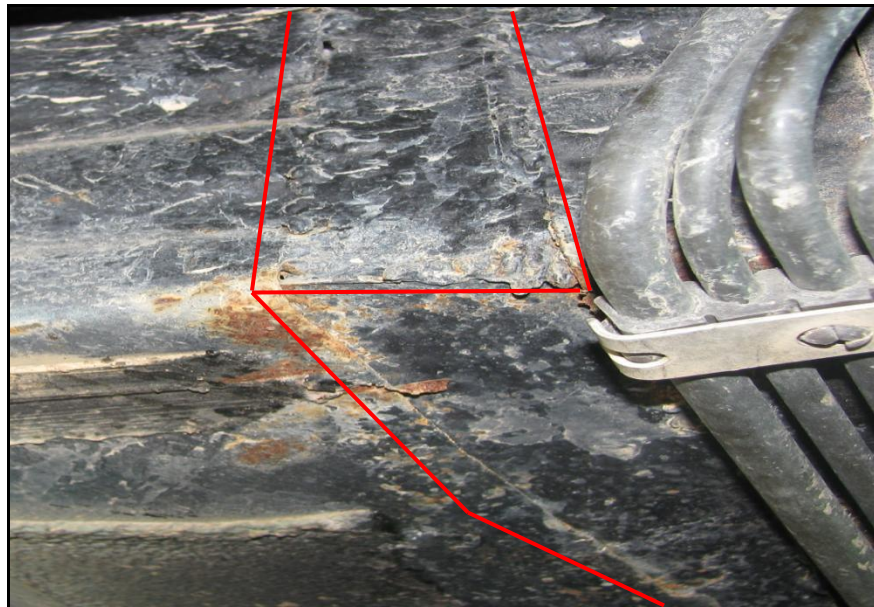
6. **Color tint and spray out test panel to achieve color match.** Many vehicle manufactures use many different paint products as do body shops. A color test panel should be used to assure a quality paint match.
7. **Mask for priming of body panels after body repairs.**
8. **Blend onto adjacent body panel to assure color match.** Blending into the next adjacent panel is actually needed to assure paint match to the trunk lid, roof and right door.

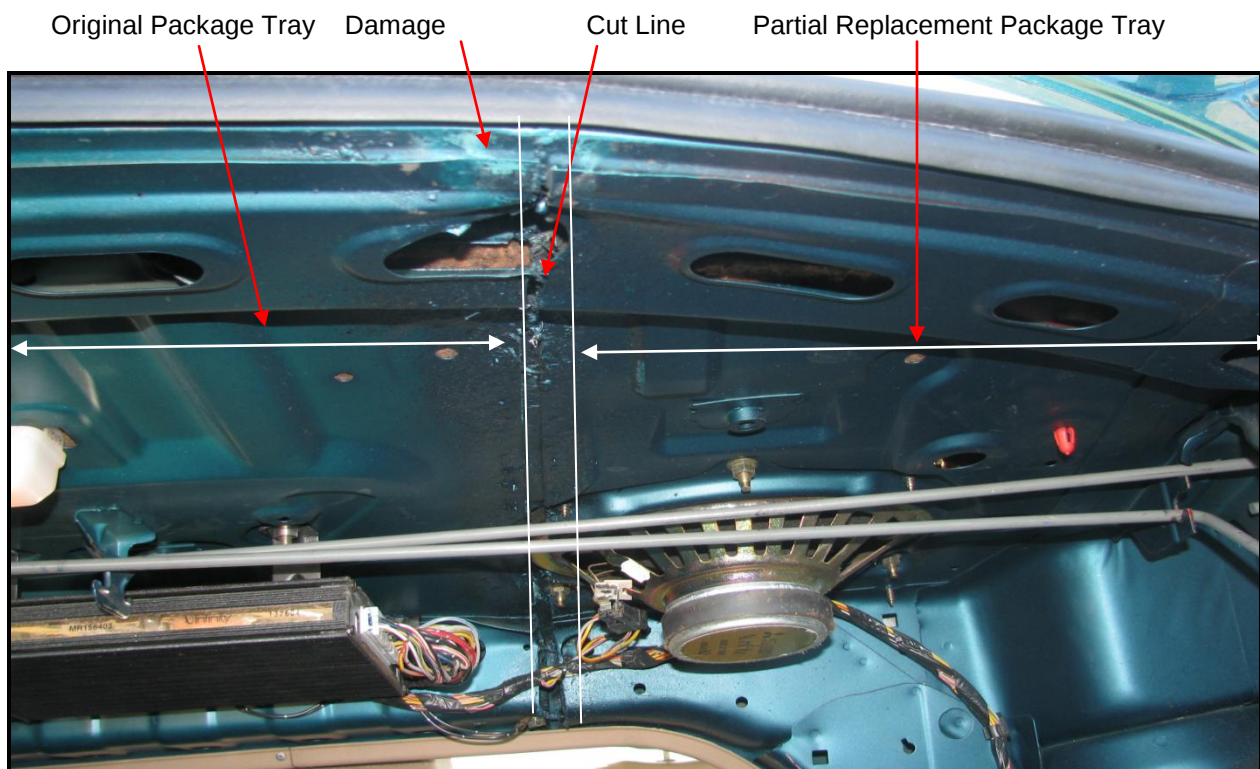
The rear passenger seats and trunk trim panels were removed, to inspect the repairs made and to photograph. The following photos are of the rear-body panel, trunk floor-pan, rear passenger seat floor-pan section and the floor-pan in front of the rear passenger seat. The rear-body panel and floor-pans are in need of **full replacement**. The floor-pans and rear-body panel are to be replaced as a whole part and/or replace in accordance to Chrysler's repair replacement guidelines and Farm Bureau is aware of this. In between the two red vertical lines was the cut area made by Covington's. The floor-pan and rear-body panel **IS NOT restored to a former place, position, or condition and IS NOT like kind and quality.**

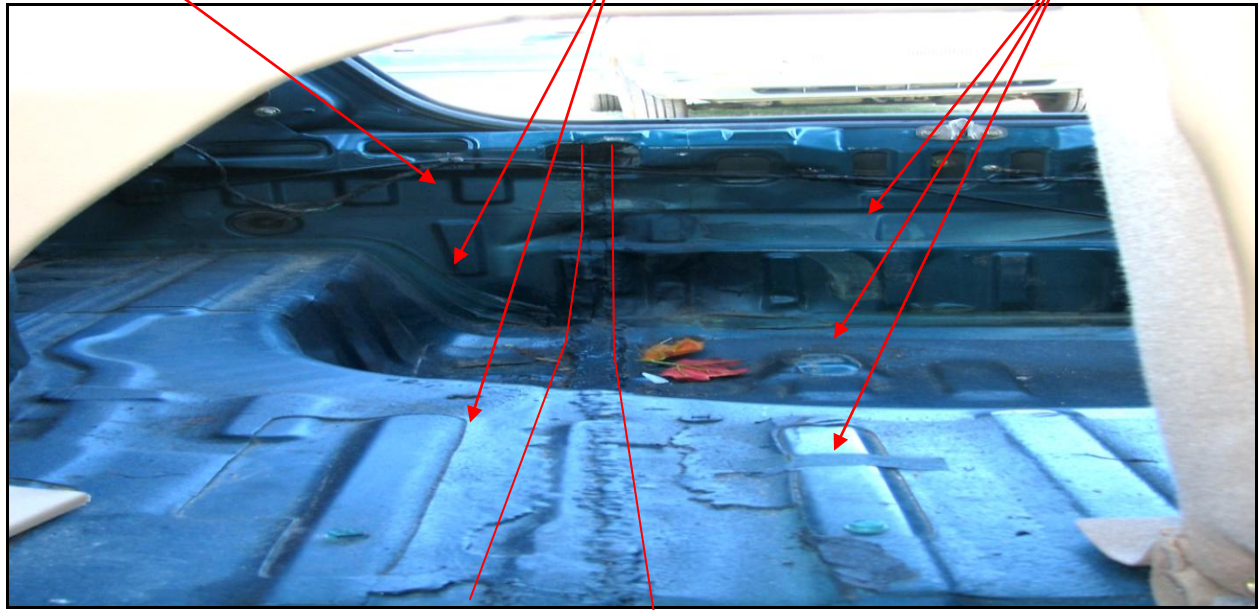
The photo below shows the replacement floor-pan under the rear passenger seat was in the area of the seat belt.

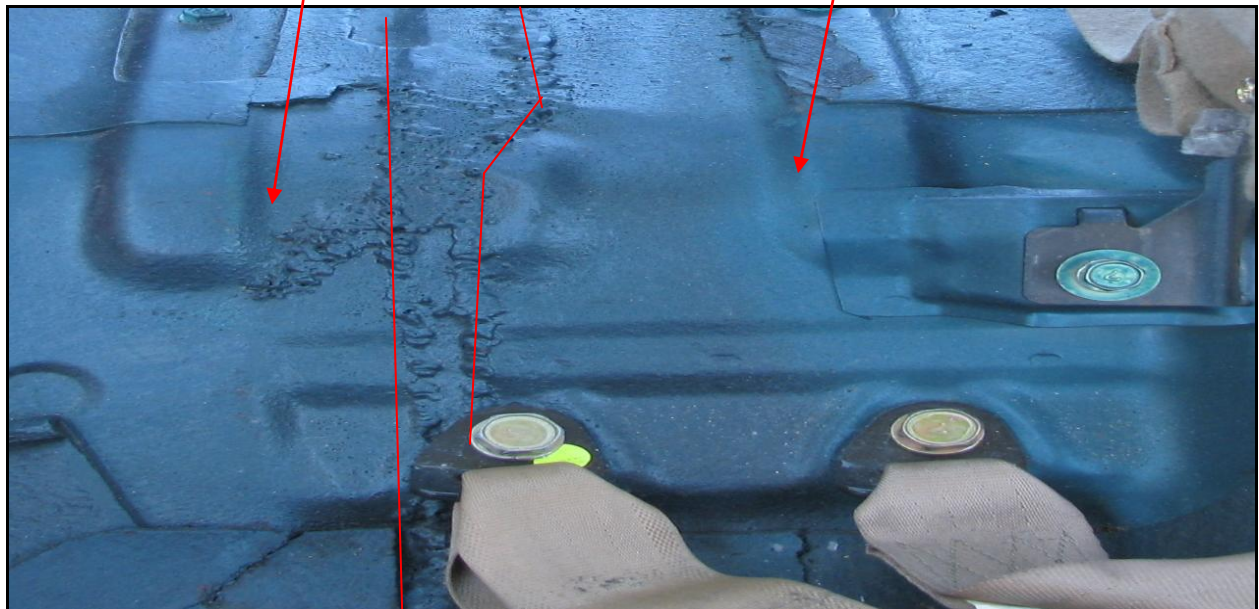
Covington's Body Shop continued the cut for removal and installation of the floor-pan just above the fuel tank. The red arrow is point to fuel tank wiring harness leading to the fuel tank that is directly underneath the cut area.

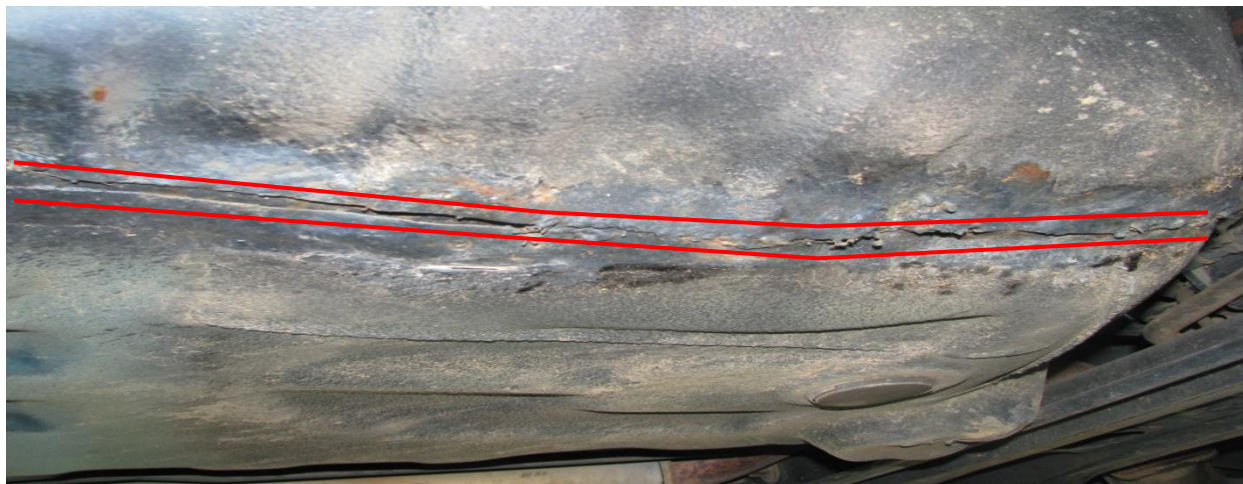
### Covington's Repair Estimate
