January 16, 2013

## ServiceNews

October 2002

## Install the IMRC Valve Correctly: '02-'03 RSX

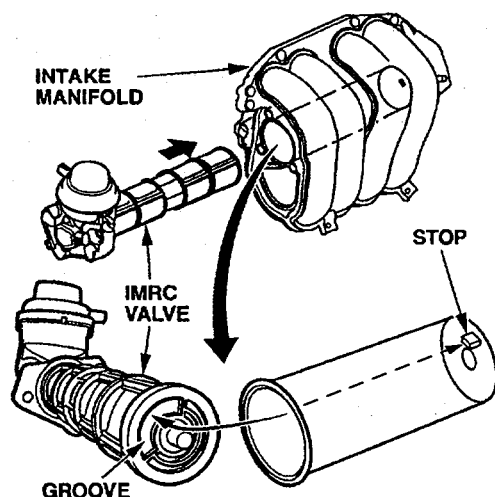
If you have a '02-'03 RSX with DTC P1077 [intake manifold runner control (IMRC) system malfunction (low rpm)] set, the IMRC valve (IMRC actuator assembly) was probably misinstalled. For a correct installation, make sure the stop in the intake manifold fits into the groove on the end of the actuator assembly.
