EA02-025

ATTACHMENT G

We have been informed that you are the insurance carrier for [REDACTED]. Our investigation of the vehicle fire and resulting loss have determined that this loss was caused by a defective cruise control deactivation switch installed on a 1993 Lincoln Continental owned by our insured.

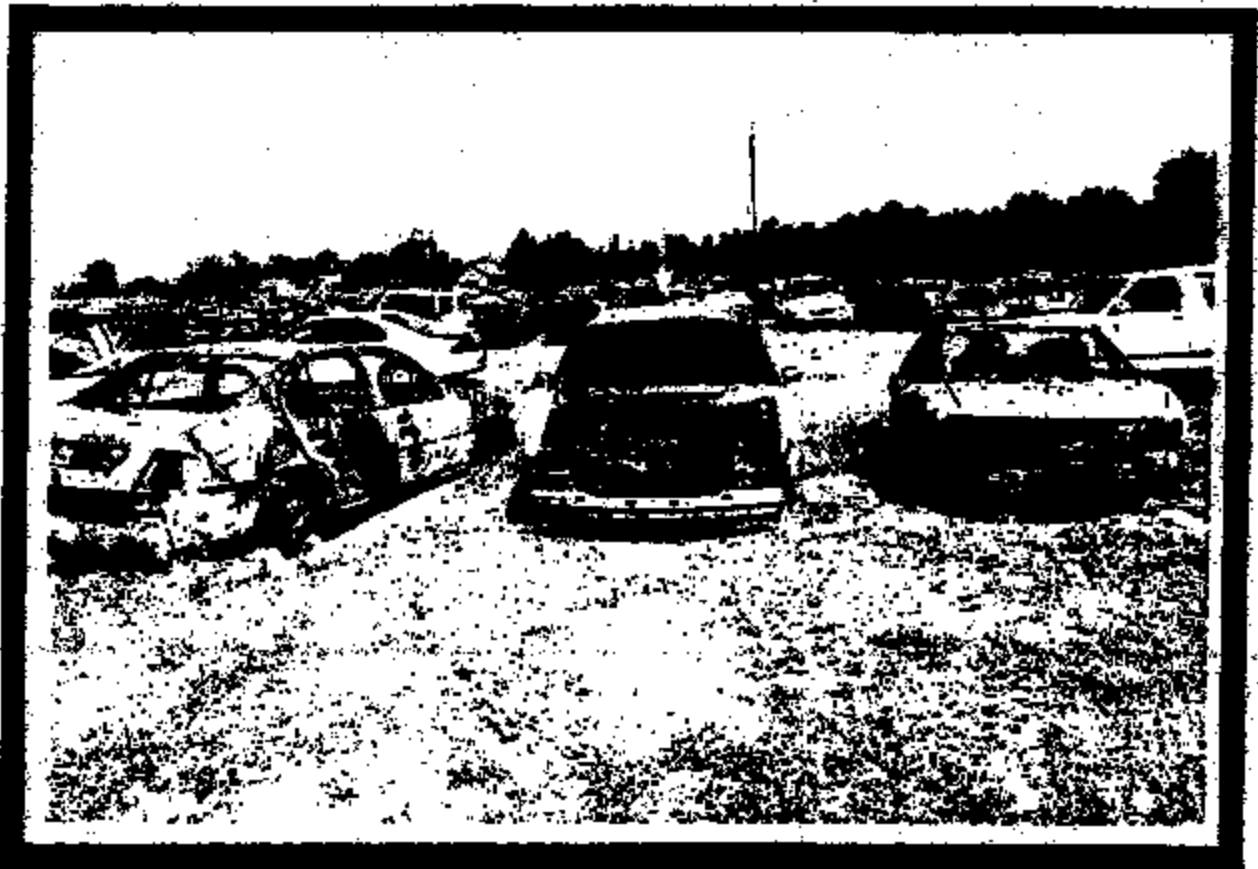
Photograph: #1

3.1 Pursuant to a request from [REDACTED] the above mentioned vehicle was inspected while it was situated on a parking stall at Sadleco Salvage Disposal in Lexington, SC (Photo #1). Proceeding in a clockwise direction from the front of the vehicle the exterior surfaces were photographed to document the condition of the vehicle at the time of our investigation (Photo #2, #3, #4, #5). It is our understanding that the vehicle was parked and unattended for approximately 1½ hours at which time the fire was discovered. It is also our understanding that the vehicle was parked at the insured's work place adjacent to two other parked vehicles, which also sustained fire damage. A portion of the vehicle identification number was recorded from a label on the driver's side lower windshield opening and the balance of the identification number was recorded from a label on the driver's side front door (Photo #6, #7). The fire spread from the engine compartment into the interior. The fire damaged the front seats in both positions (Photo #8) and concluded in the rear seat area, where the fire melted the upper layer of upholstery.
