FORD 8/5/03

LETTER TO ODI

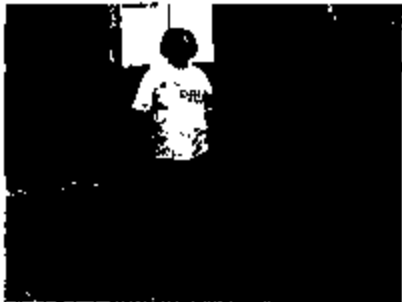
Figure 2 Burnete Matto, Service Manager

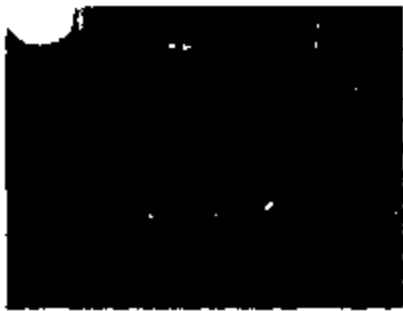
Figure 3 Isaac, Drivability Technician

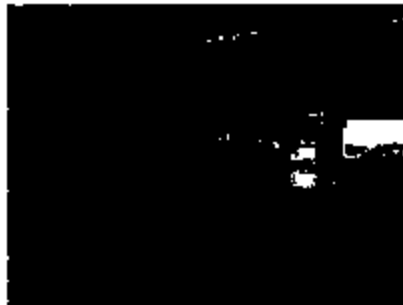
Figure 5 Service area, alternate view

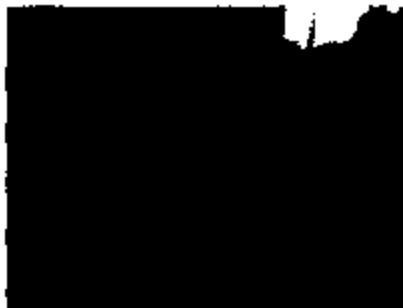
Figure 15 A second stud walked out, but the case did not break. The witness marks are pliers on the threads.

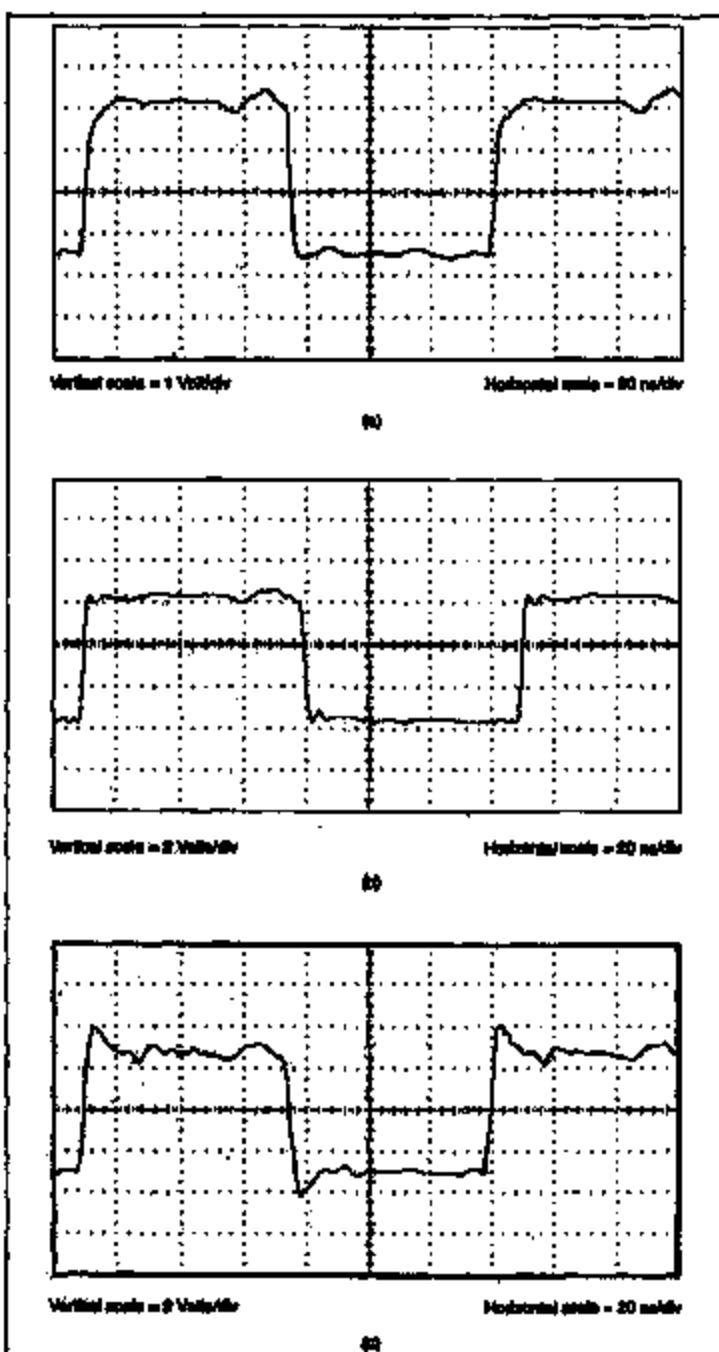
2. (a) HCB40 output into 50 ohms; (b) HCB40 output into 1800 ohms; (c) HCB40 output as viewed by two high Z passive probes.

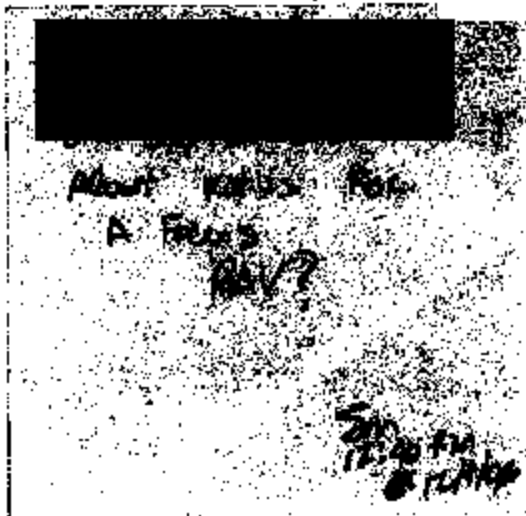
Maurer, James (J.B.)

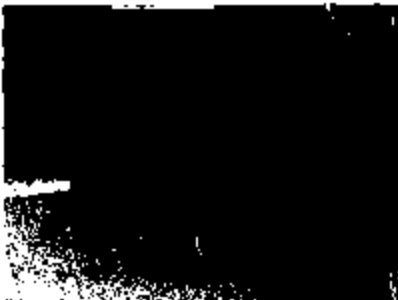
Figure 2 Burnete Matto, Service Manager

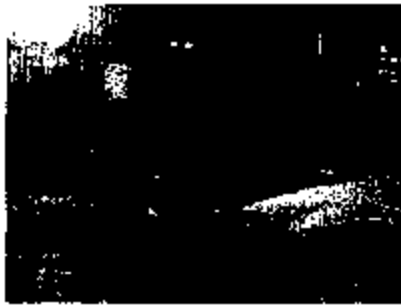
Figure 3 Isaac, Drivesability Technician

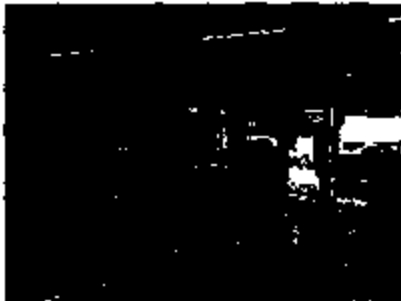
Figure 5 Service area, alternate view

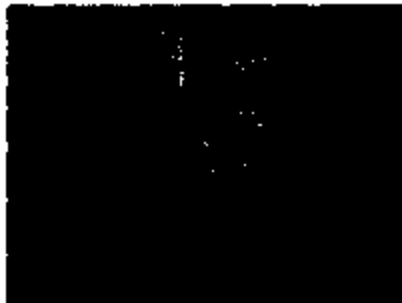
Figure 9 Blister on the MAF sensor's Case

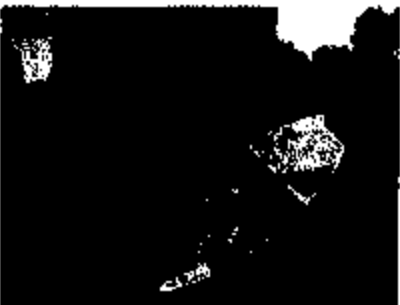
Figure 15 A second stud walked out, but the case did not break. The witness marks are pillars on the threads.

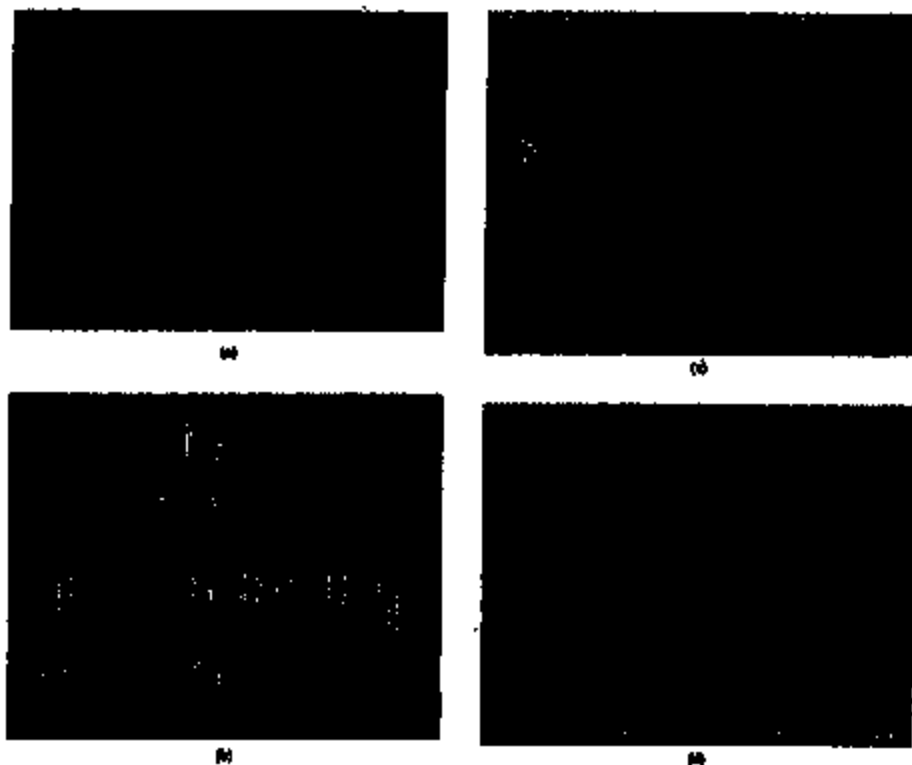
Fig. 1(a, b, c and d).

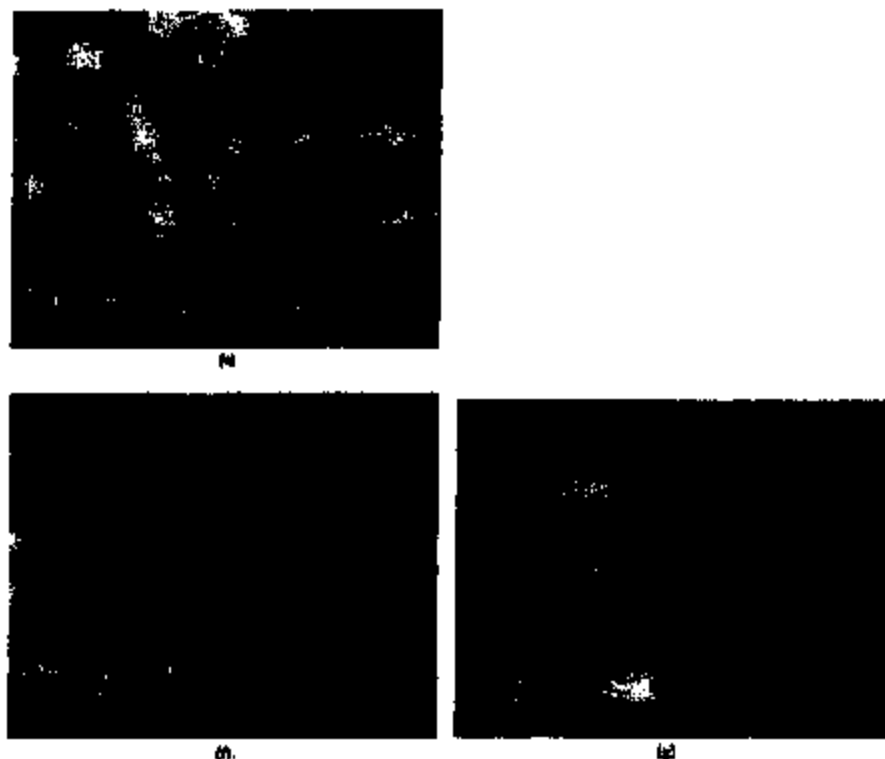
Fig. 1. SEM micrographs following a time sequence showing the damage of an interconnect under electromigration: (a) initial configuration; (b)-(d) 328 h; (c) 904 h; (d) 1171 h.

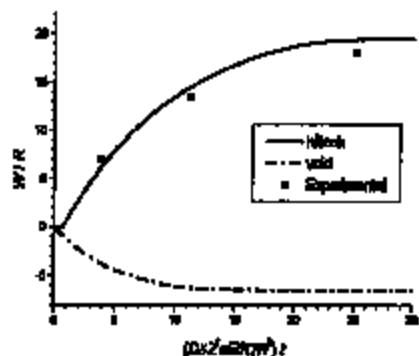
Fig. 9. Protruding height and the sinking depth vs the normalized time, $J_0 = 2.34(J_c)$.

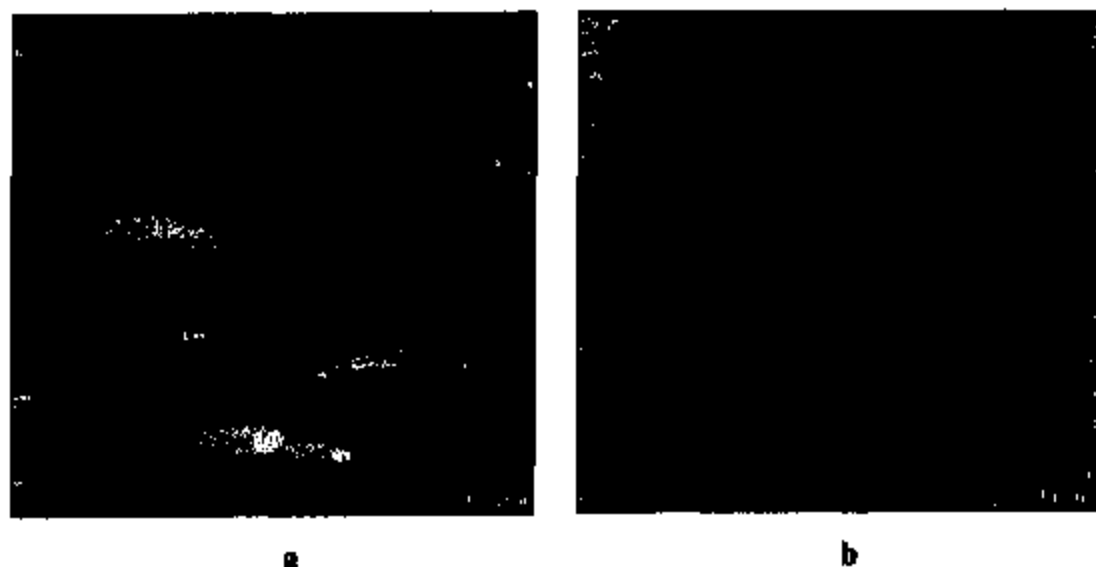
Fig. 1. Metallization surface examined by SEM after annealing (450°C, 30 min): (a) magnetron sputtered Al layer 1 μm thick; (b) similar layer of Al:Si:Cu alloy.

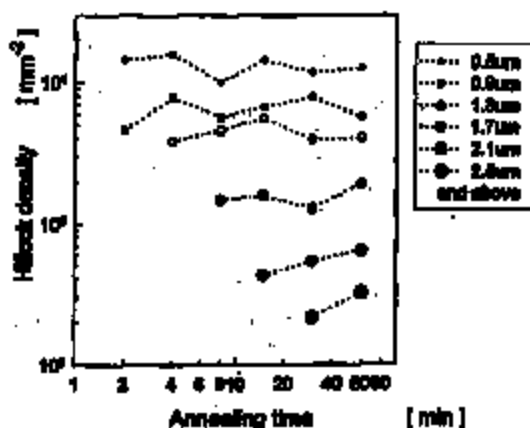
Fig. 2. Surface density of hillocks as a function of annealing time at a temperature of 400°C in N_2 for sputter-deposited Al layer of $0.7 \mu\text{m}$ thickness.

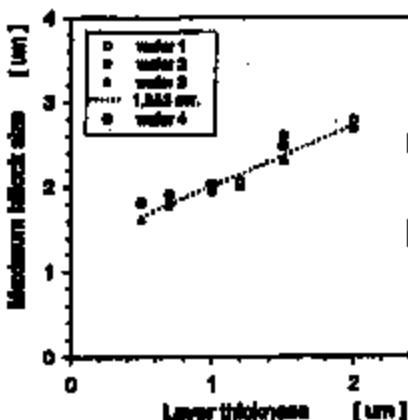
Fig. 4. Maximum hillock size versus Al layer thickness after furnace annealing at a temperature of 400°C for 8 min in N_2 (samples 1, 2 and 3). Sample no. 4 was annealed at 450°C for 5 min.

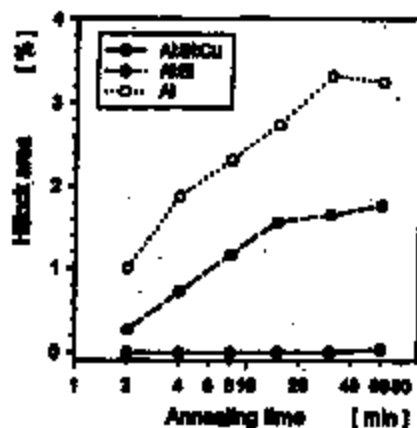
Fig. 5. Total area of hillocks normalized to the sample area as a function of annealing time at a temperature of 400°C in N_2 atmosphere for 1 μm thick Al and Al-based metallization layers.

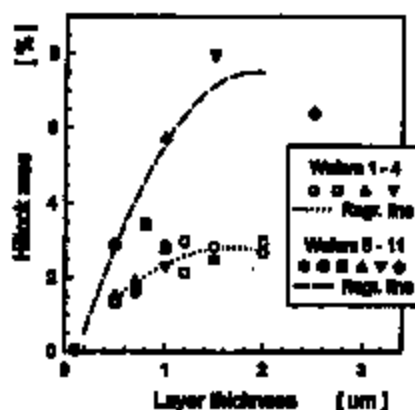
Fig. 6. Total area of hillocks normalized to the sample area versus Al layer thickness. Samples 1–4 were annealed at a temperature of 400°C for 8 min; samples 5–11 at 'standard' conditions (450°C, 30 min).

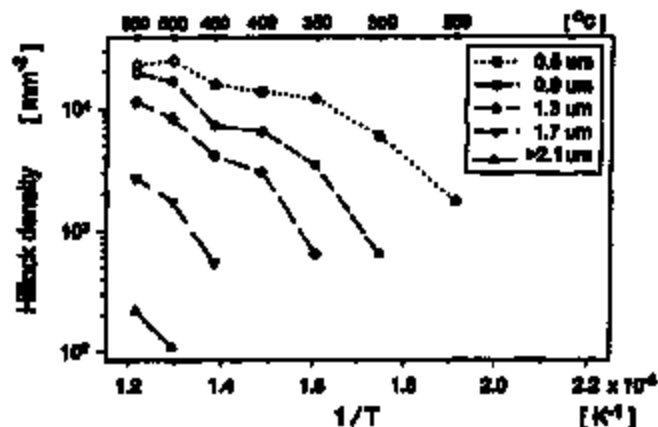
Fig. 7. Distribution of density of aluminum hillocks grouped with regard to their average diameter, as a function of reciprocal of temperature of 5 min isothermal annealing in an RTP reactor in an argon atmosphere.

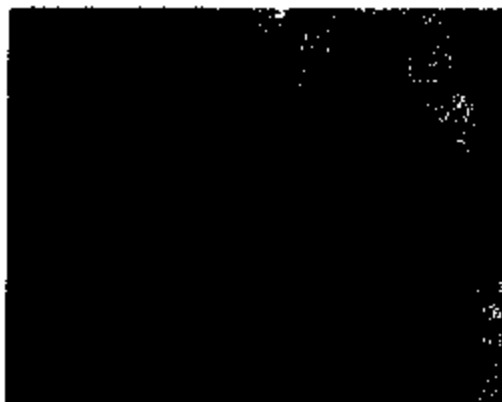
Figure 1: As-deposited Wafer T450

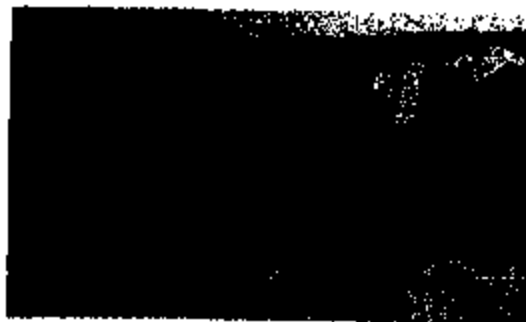
Figure 2: Wafer T450, Large Clusters of Precipitates Decorating Grain Boundaries

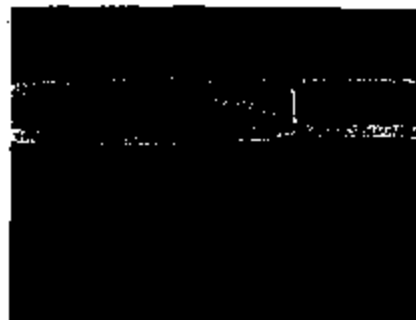
Figure 6: Transgranular Silt Void

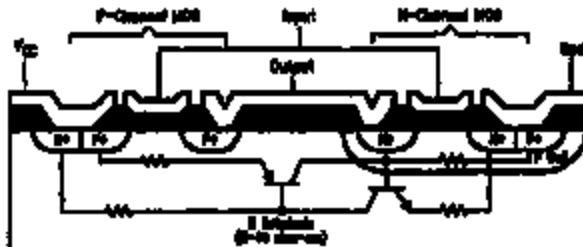
FIGURE 1. Basic CMOS Inverter Cross Section with Latch-Up Circuit Model

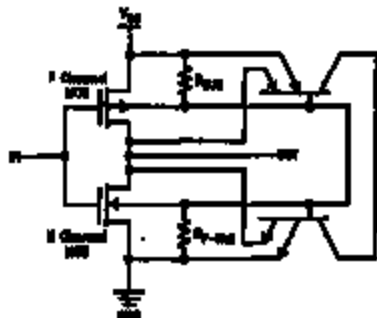
FIGURE 3. N-Substrate CMOS Inverter with Parasitic Diodes

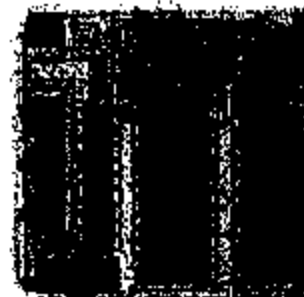
RAL
Reliability Analysis Lab

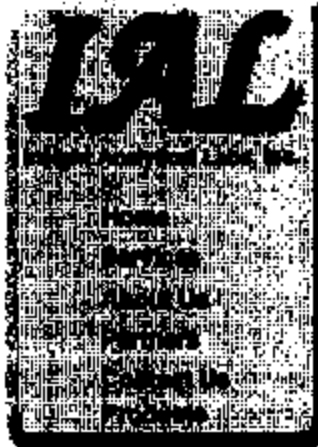
Located in Colorado Springs (map to our location) at the Pikes Peak, Insight Analytical Labs (IAL) was created to address the failure analysis and reliability needs of the semiconductor industry in this locale. As its reputation for quality work at competitive prices spread, IAL's customer base expanded to include companies from all over the United States, Canada, and Europe. We are a one-stop failure analysis lab.

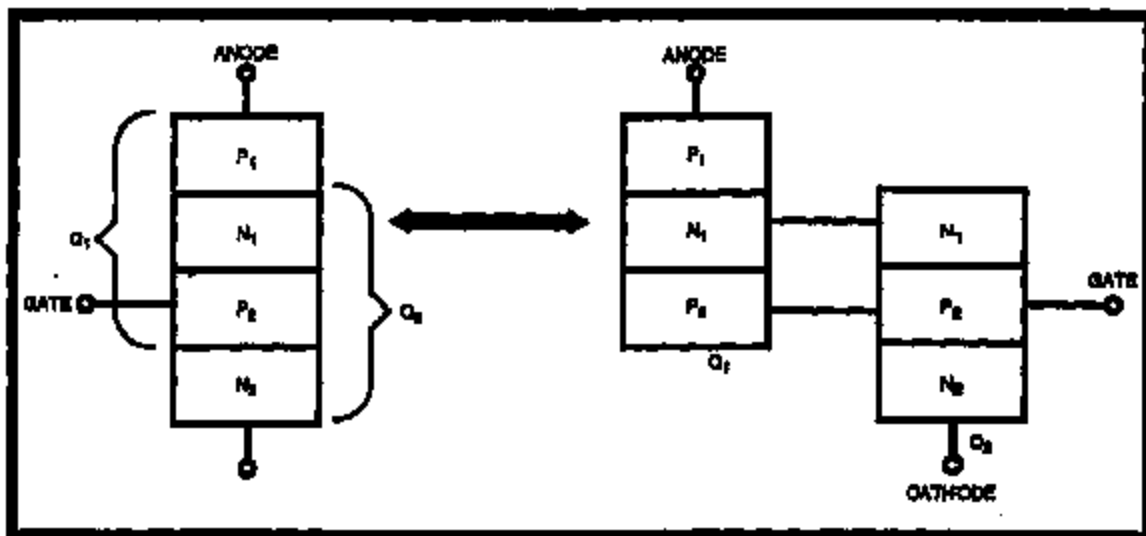
Figure 1 - Four-Layer SCR Structure

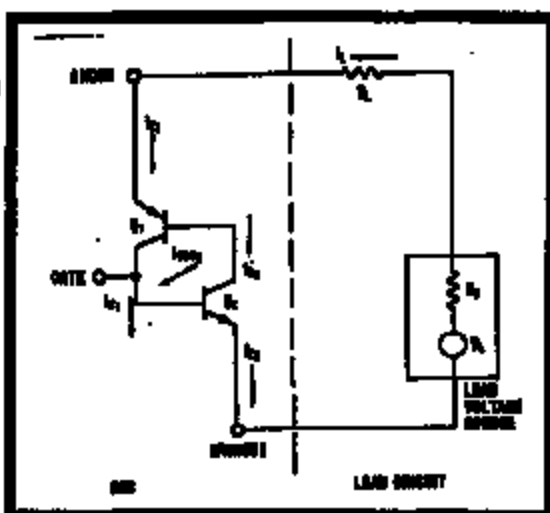
Figure 2 - Bipolar Model of an SCR

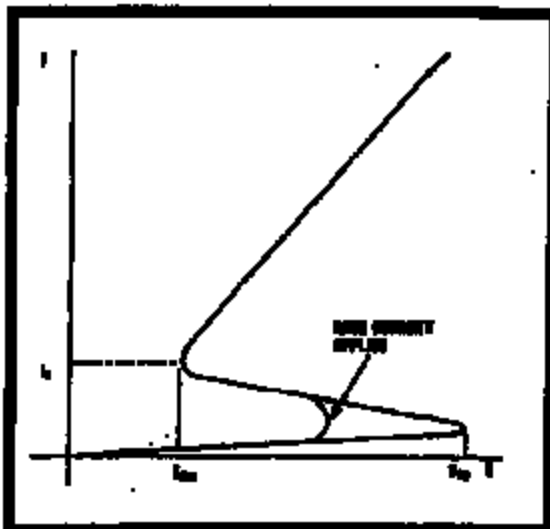
Figure 3 - SCR Current-Voltage Characteristics

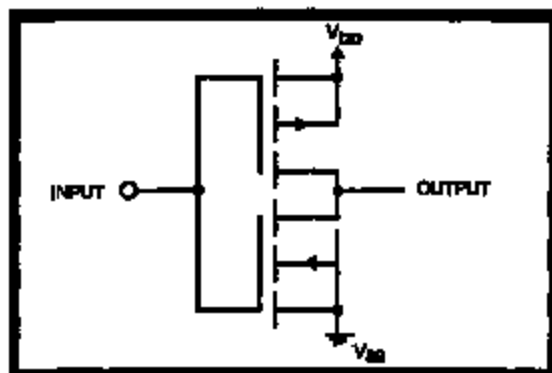
Figure 4 - Typical Output Circuit

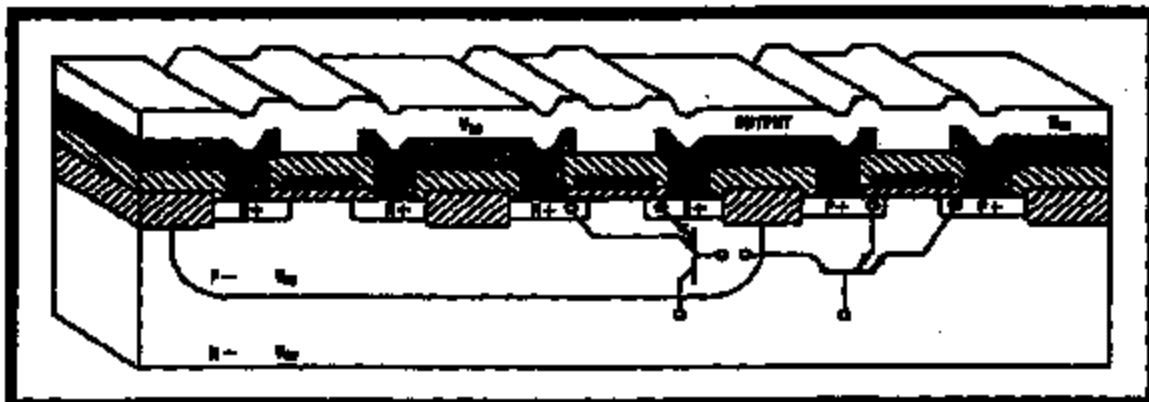
Figure 6 - Output SCR structure

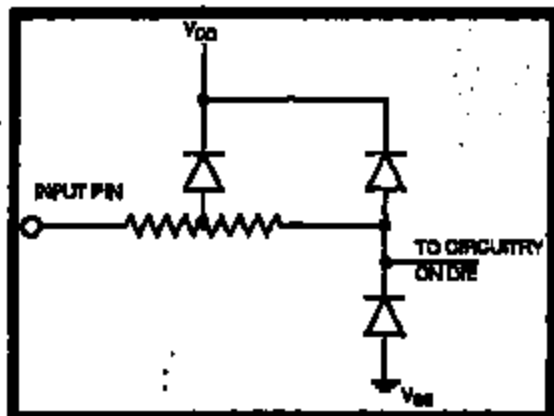
Figure 6 - Input Protection Circuit Schematic

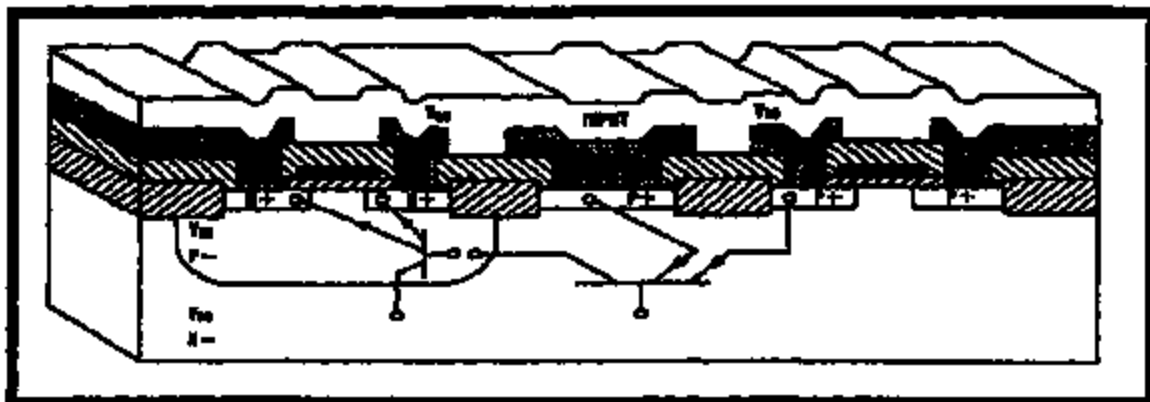
Figure 7 - Input SCR Structure with V_{DD} Diode

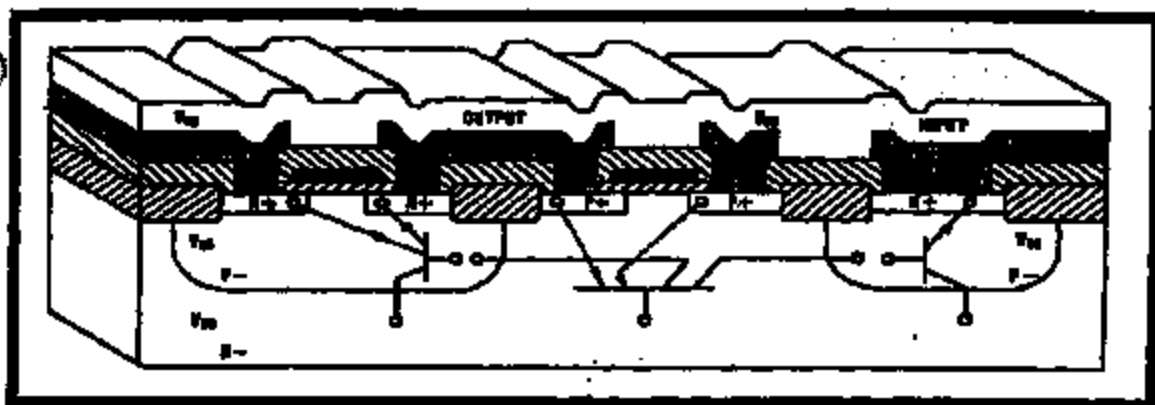
Figure 8 - Input SCR Structure with V_{DD} Diode

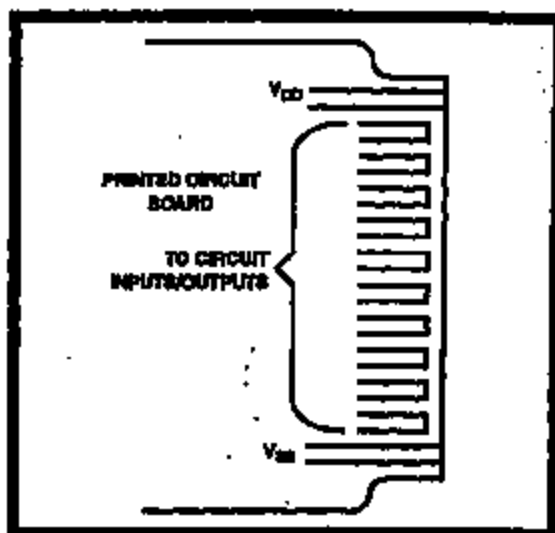
Figure 9 - PCB with inset V0 Edge Terminals

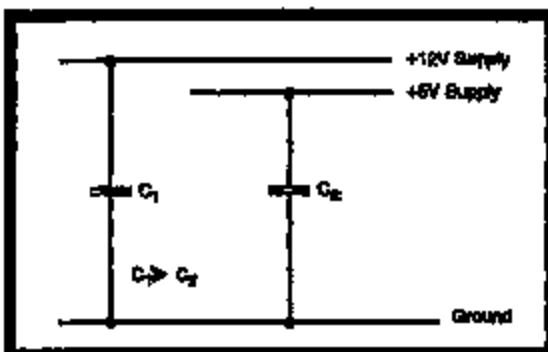
Figure 10 - Local Decoupling Scheme in Multi-Supply System

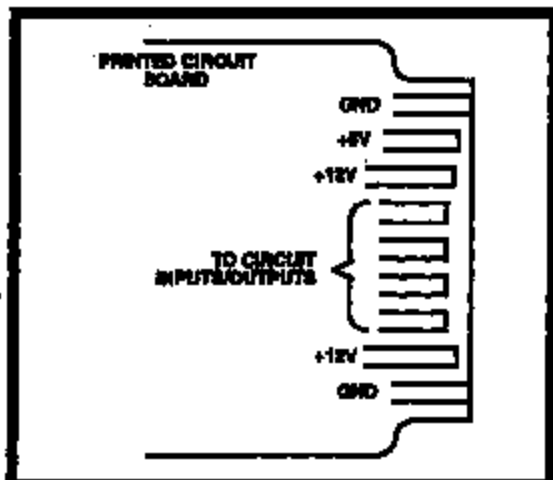
Figure 11 - Multi-Level Indentations of V0 Edge Terminals

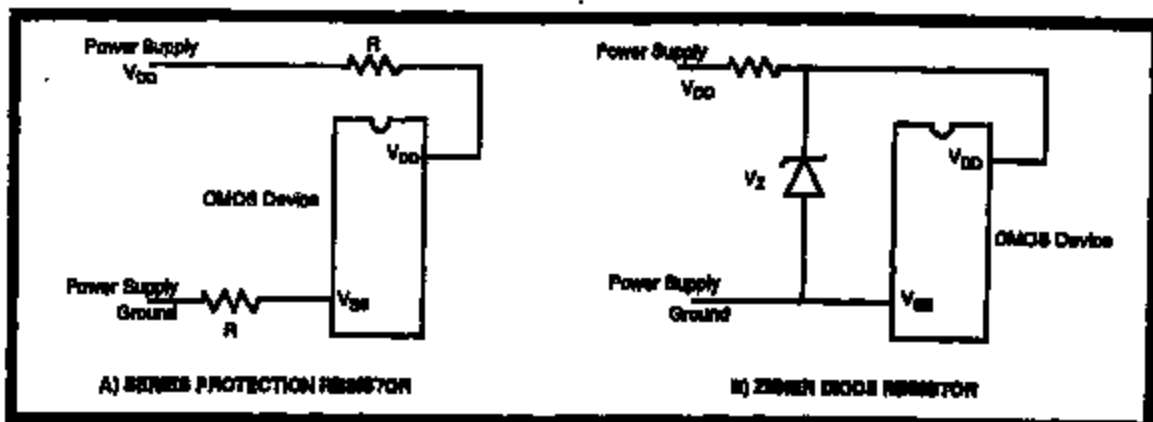
Figure 12 - Power Supply Over-Voltage Protection

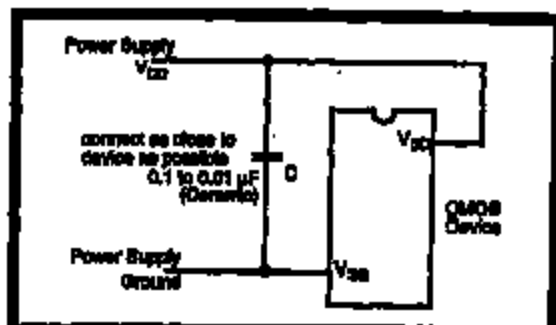
Fig. 13 - High Frequency Power Supply Decoupling

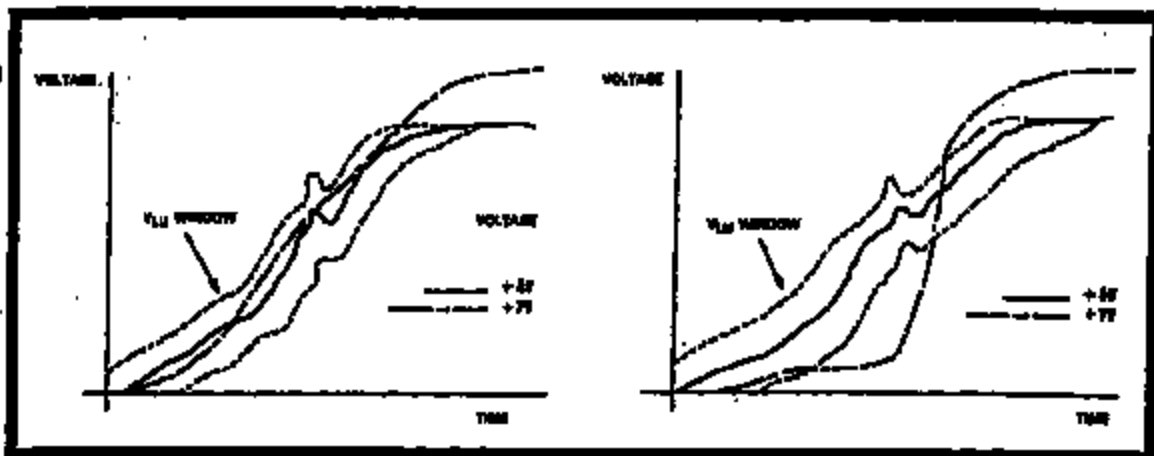
Figure 14 - Power supply sequencing

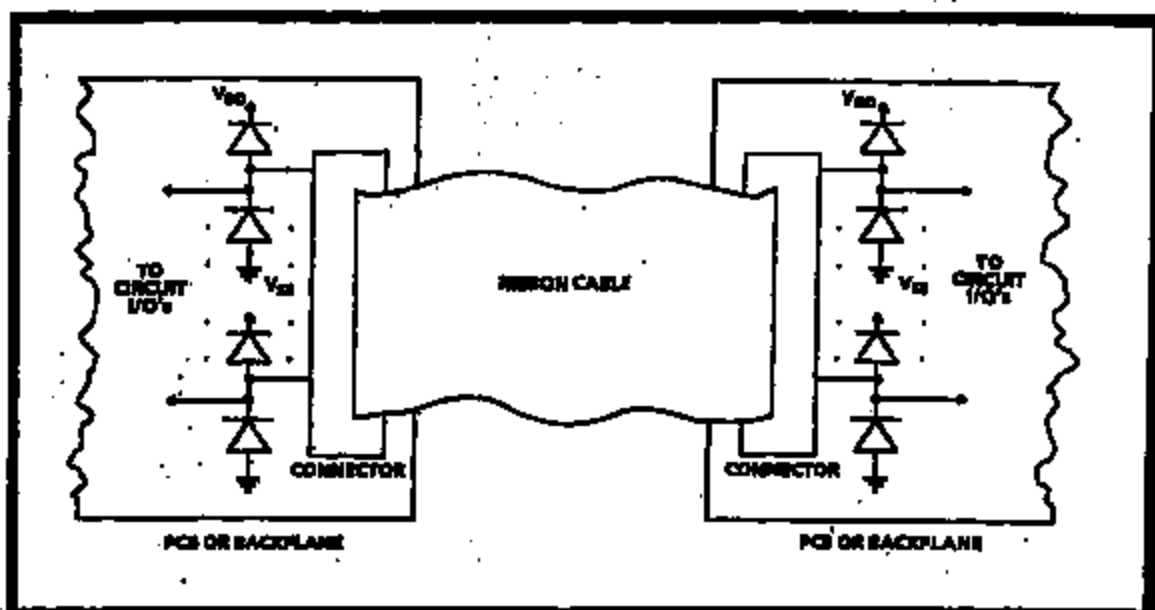
Figure 20 - External Clamping Diodes

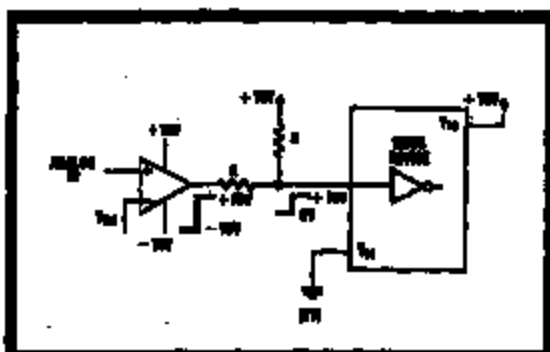
Fig. 22 - Voltage Divider to Limit Voltage Swing on CMOS Input

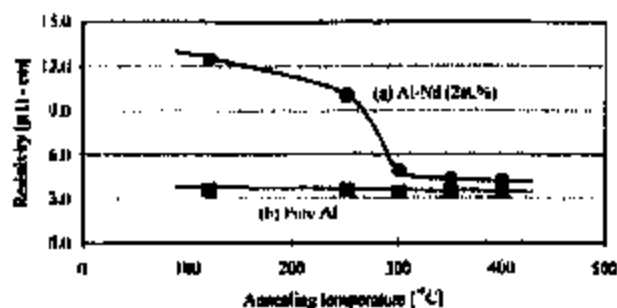
Fig. 3. Resistivity vs. annealing temperature: (a) Al–Nd (2 at.%) alloy, and (b) pure Al.

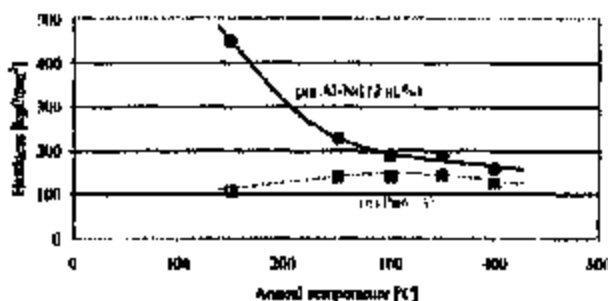
Fig. 7. Hardness vs. annealing temperature: (a) Al-Nd (2 at.%) alloy, and (b) pure Al.

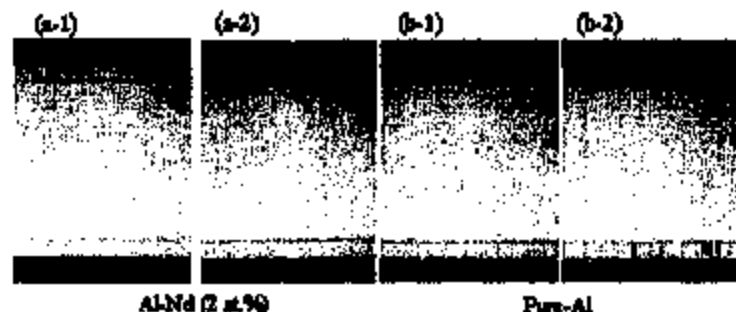
Fig. 8. Photographs of TAB-pads: (a-1) Al-Nd (2 at.%) alloy before scratch test; (a-2) Al-Nd (2 at.%) after scratch test and surface cleaning; (b-1) pure Al before scratch test; and (b-2) pure Al after scratch test and surface cleaning.

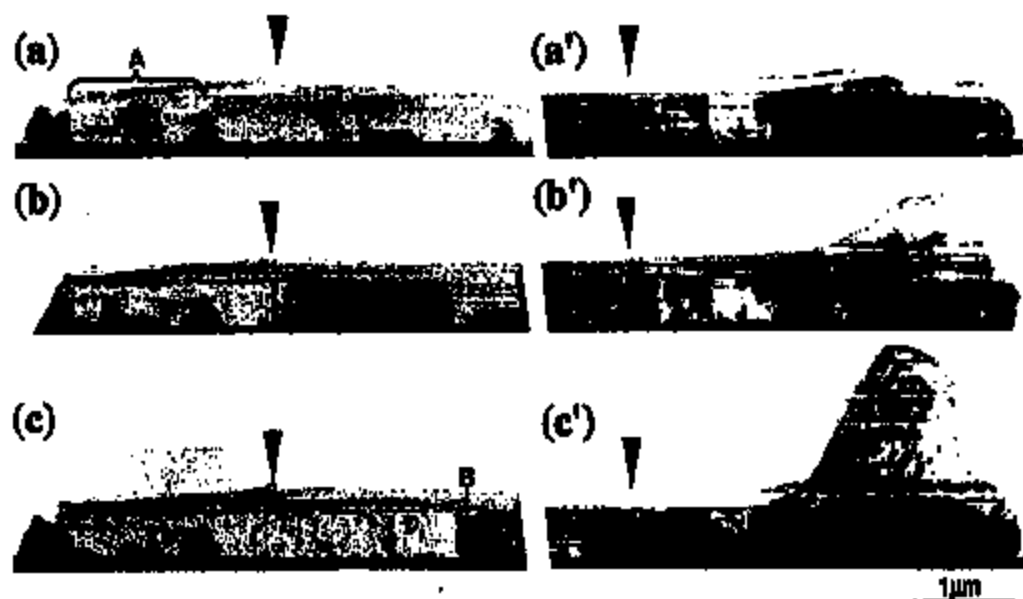
Fig. 1. Successive stages of electromigration in an Al-on-TiN line observed by side-view TEM. Damage evolution at the anode and the cathode of the line during current feeding in the forward direction are depicted in (a)–(c) and (a')–(c'), respectively. Current feeding time t for each figure is as follows: (a) $t = 720$ s, (a') $t = 2.8$ ks, (b) $t = 7.4$ ks, (b') $t = 1.6$ ks, (c) $t = 2.9$ ks, and (c') $t = 7.6$ ks.

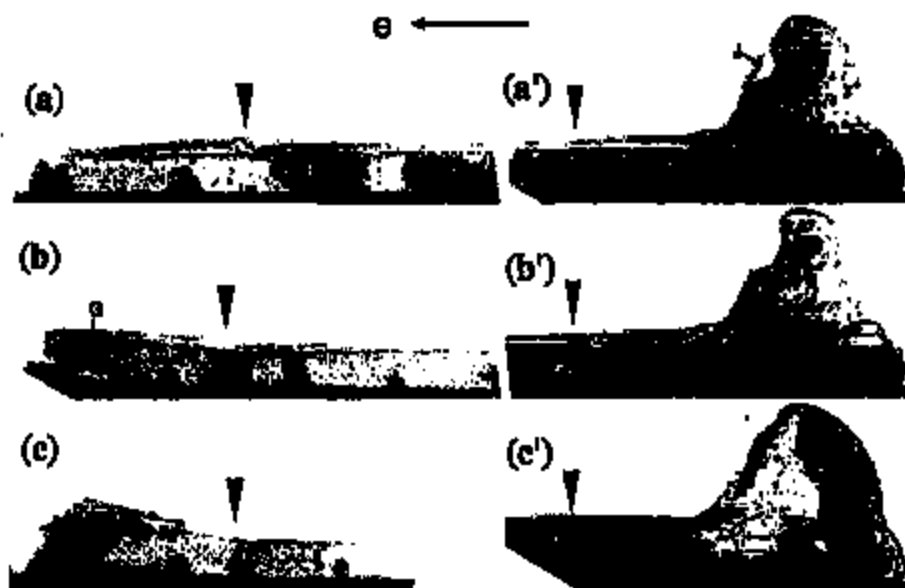
Fig. 2. Electromigration-induced damage at the (new) anode and the (new) cathode of the line during current feeding in the reverse direction are depicted in (a)–(c) and (a')–(c'), respectively. Current feeding time t (after the reversal) is as follows: (a) $t = 1.1$ ks, (a') $t = 11.9$ ks, (b) $t = 15.9$ ks, (b') $t = 2.5$ ks, (c) $t = 2.8$ ks, and (c') $t = 15.7$ ks. The black triangle-shaped arrows in Fig. 1(a)–1(c) and 2(a)–2(c) indicate a fixed position of the sample, and those in Fig. 1(a')–1(c') and 2(a')–2(c') another fixed position. The width of the Ti/TiN layer in this sample was $2 \mu\text{m}$.

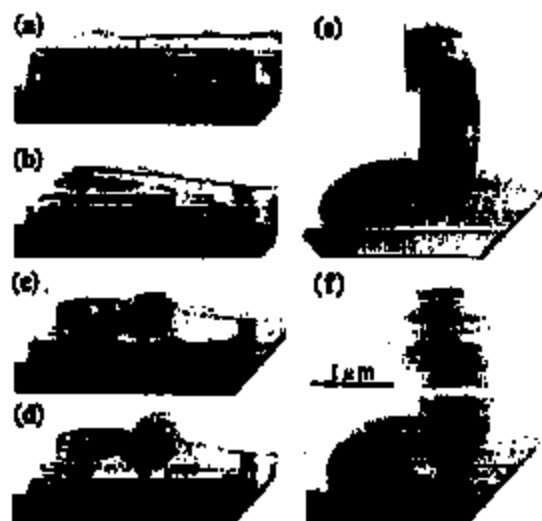
Fig. 3. Successive stages of whisker growth at the anode of an Al-on-TiN line. In this experiment, a 19 mA current was first fed for 3.5 ks and then the current was increased to 25 mA. Current feeding time t is as follows: (a) $t = 0 \text{ s}$, (b) $t = 4.08 \text{ ks}$, (c) $t = 5.70 \text{ ks}$, (d) $t = 6.16 \text{ ks}$, (e) $t = 9.78 \text{ ks}$, and (f) $t = 12.48 \text{ ks}$. Electrode flowed from right to left. The width of the Ti/TiN layer in this sample was $0.7 \mu\text{m}$.

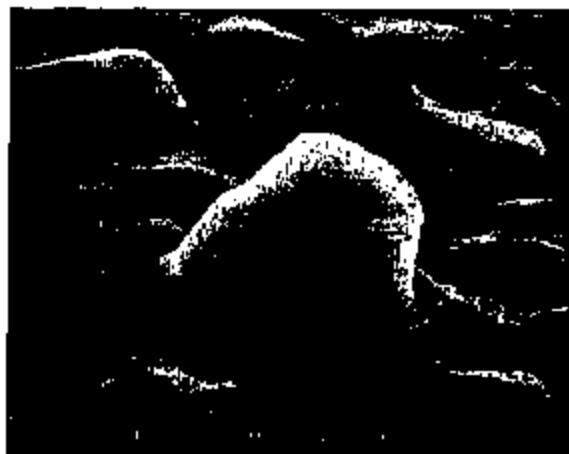
Fig. 1. SEM micrograph of a hillock with a relatively smooth, rounded appearance.

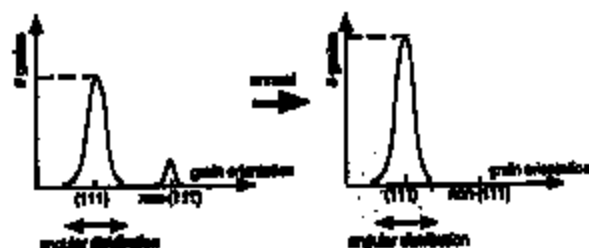
Fig. 6. Schematic representation of changes in the grains' orientations as a result of annealing and increased deposition temperature.

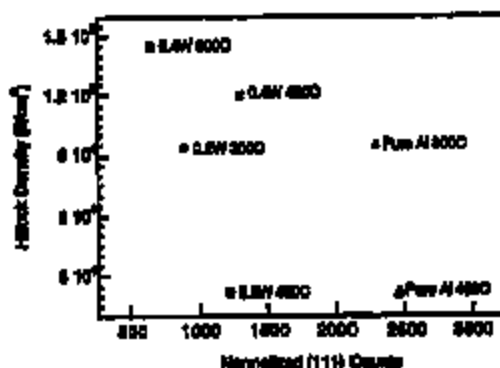
Fig. 8. Hillock density plotted as a function of (111) texture for pure Al, 0.2 W, and 0.4 W films. Films with greater (111) texture formed fewer hillocks.

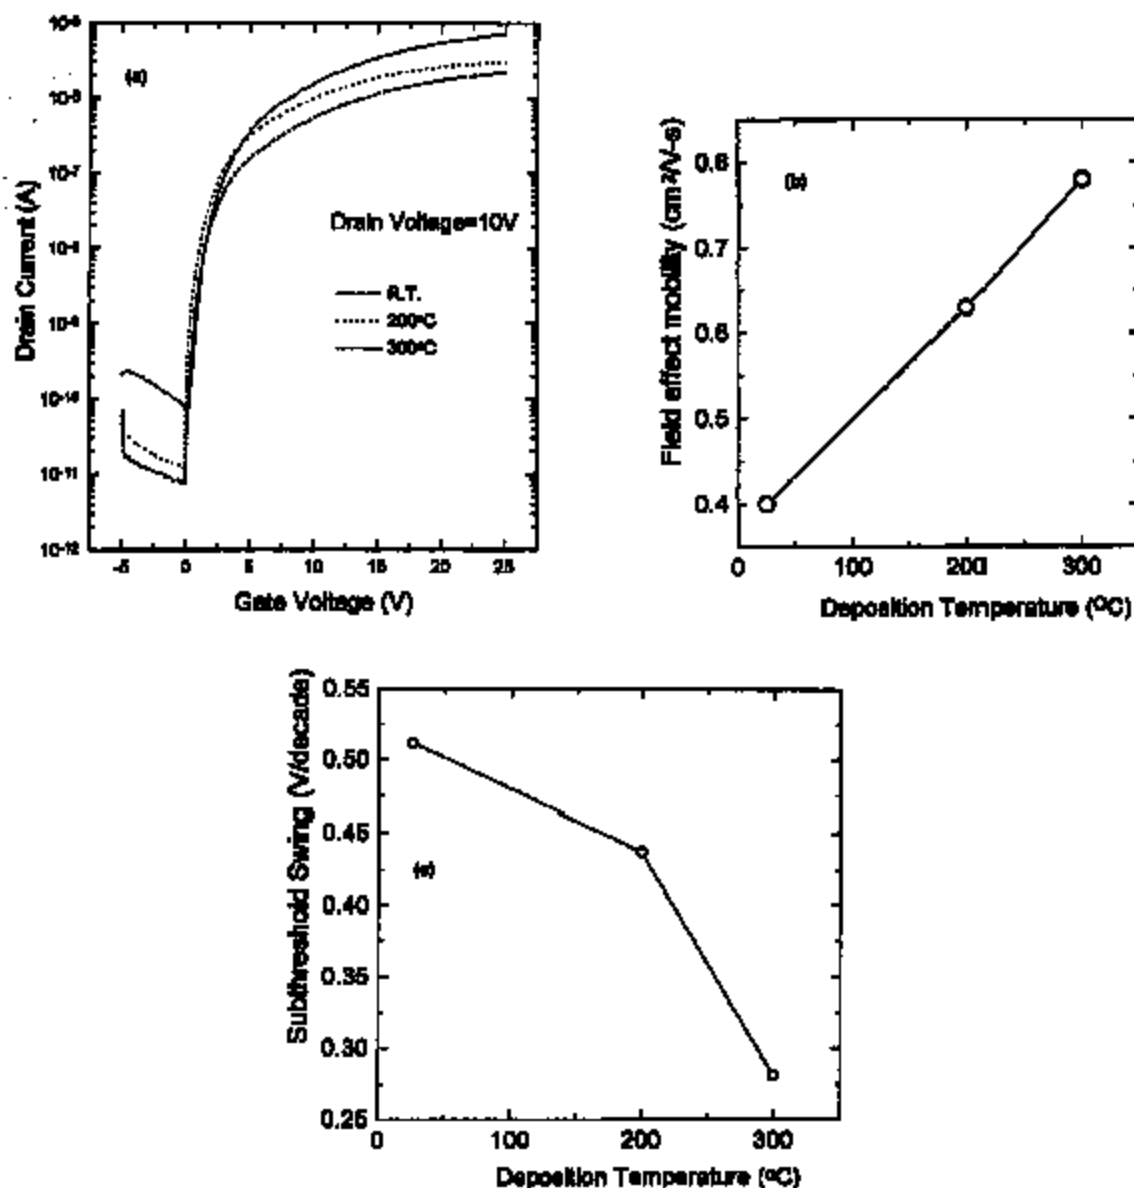
Fig. 3. Device characterization of double-layered insulator a-Si:H TFTs with the Al gate deposited at various temperatures: (a) transfer characteristics measured at a drain voltage of 10 V, (b) field effect mobility, (c) subthreshold swing.

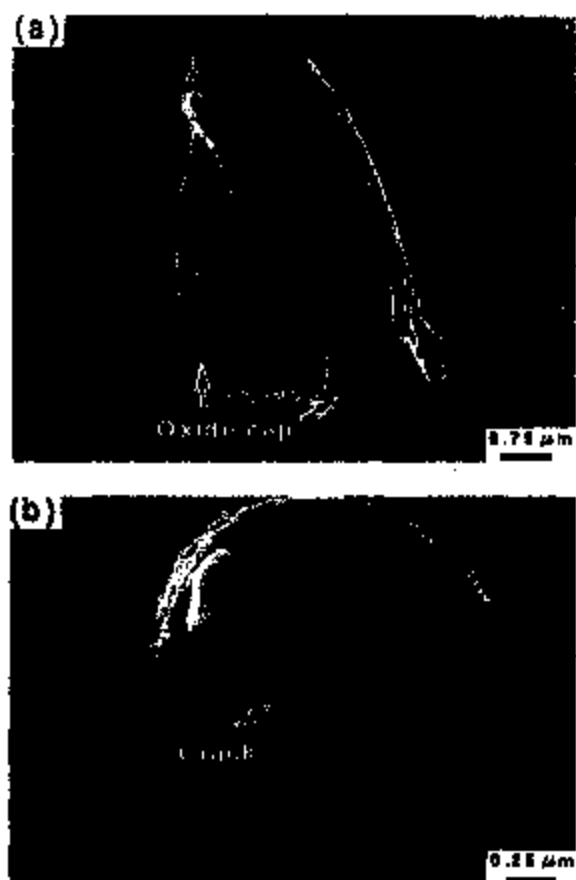
Fig. 2. Hillocks formed in Al alloy films with an anodic oxide cap having a thickness of 20 nm: (a) an Al-2 at.% Ta alloy film, (b) an Al-2 at.% Cu alloy film. The samples were annealed at 573 K for 1 h.

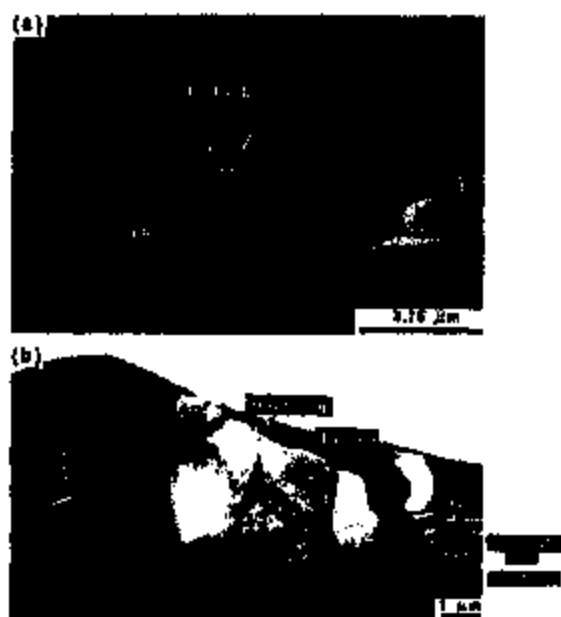
Fig. 3. Hillocks formed in an Al-2 at.% Ta alloy film with an anodic oxide cap having a thickness of 50 nm: (a) SEM appearance, (b) TBM cross-sectional microstructure. The samples were annealed at 573 K for 1 h.

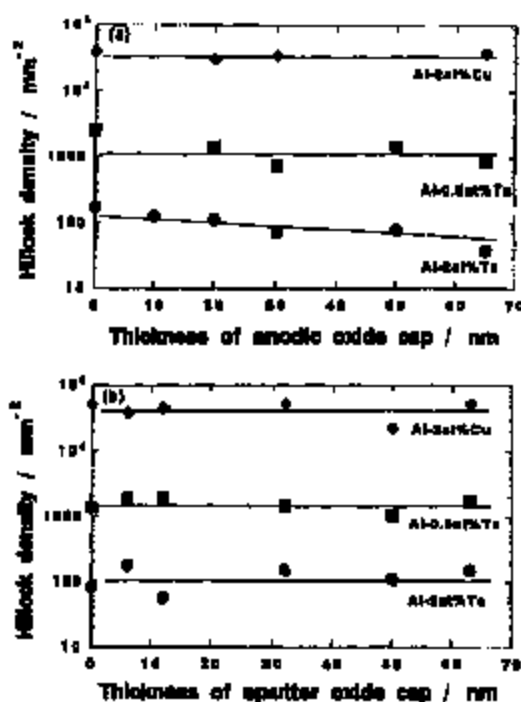
Fig. 5. Hillock density in Al alloy films after annealing at 573 K for 1 h as a function of oxide cap (thickness): (a) with anodic oxide, (b) with sputter oxide.

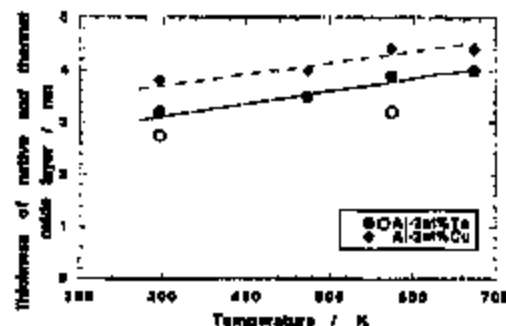
Fig. 8. Thickness of native and thermal oxide in Al alloy films: (●, ◆) measured by Auger electron spectrometer, (○) measured by TEM micrographs.

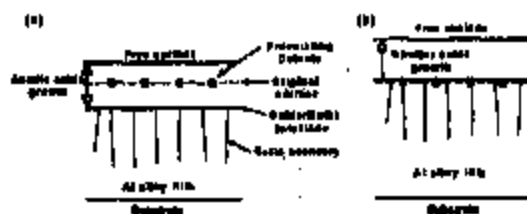
Fig. 9. Schematic drawings (illustrating cross-sectional structure of encapsulated films in association with original surface and preexisting surface defects): (a) with an anodic oxide cap, (b) with a sputter-deposited oxide cap.

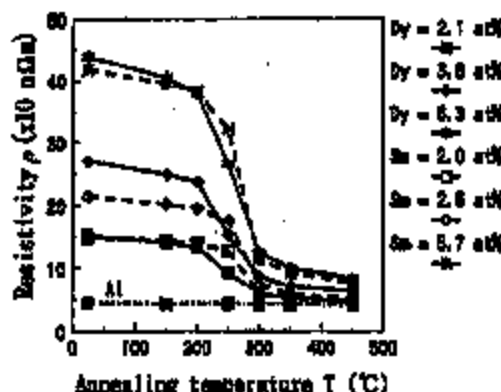
Fig. 5. Change in resistivity ρ of Al–RE alloy films (RE = Sm and Dy) as a function of the isochronal annealing temperature (for 30 min) and composition.

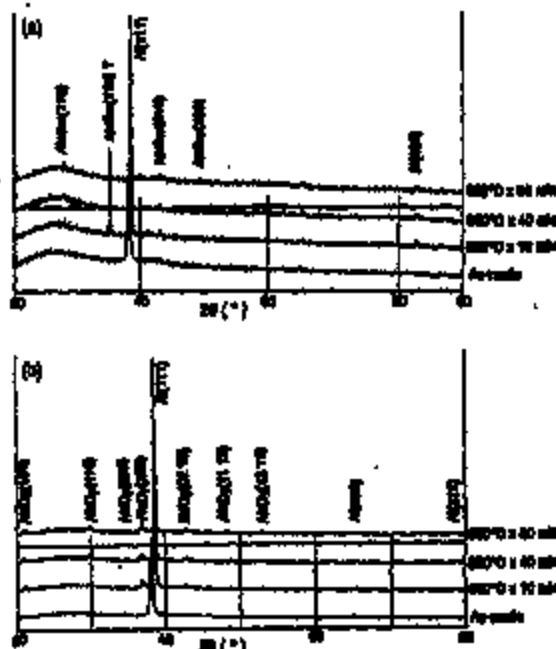
Fig. 8. X-ray diffraction profiles of (a) $\text{Al}_{77.5}\text{Sm}_{22.5}$ and (b) $\text{Al}_{66.4}\text{Dy}_{33.6}$ alloy thin films annealed isothermally at 350°C .

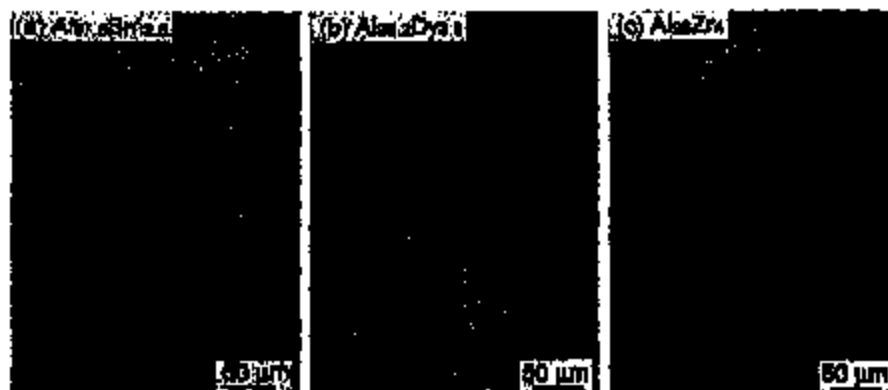
Fig. 9. Polarized optical micrographs of Al alloy thin film surfaces annealed at 350°C for 80 min: (a) $\text{Al}_{77.5}\text{Sm}_{22.5}$, (b) $\text{Al}_{66.4}\text{Dy}_{33.6}$ and (c) $\text{Al}_{90}\text{Zr}_{10}$.

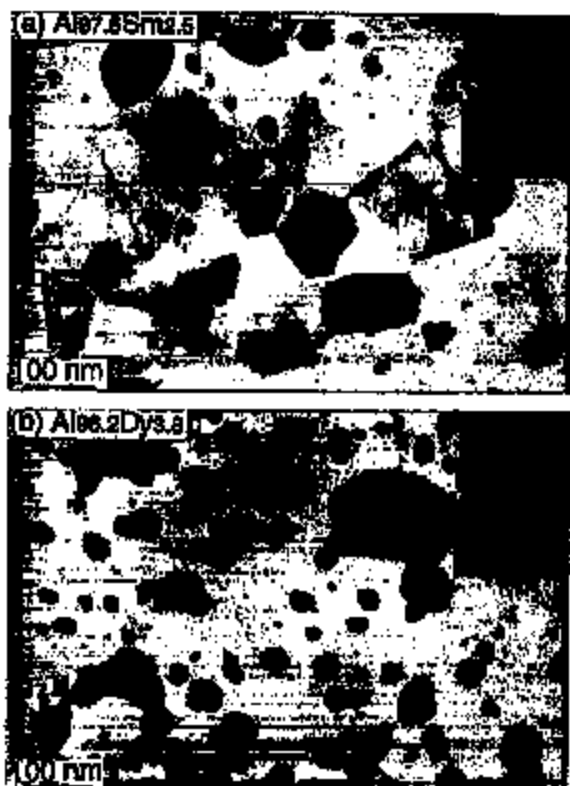
Fig. 10. Bright field images and diffraction patterns of (a) $\text{Al}_{0.75}\text{Sm}_{0.25}$ and (b) $\text{Al}_{0.75}\text{Dy}_{0.25}$ alloy thin films annealed at 350 °C for 80 min.

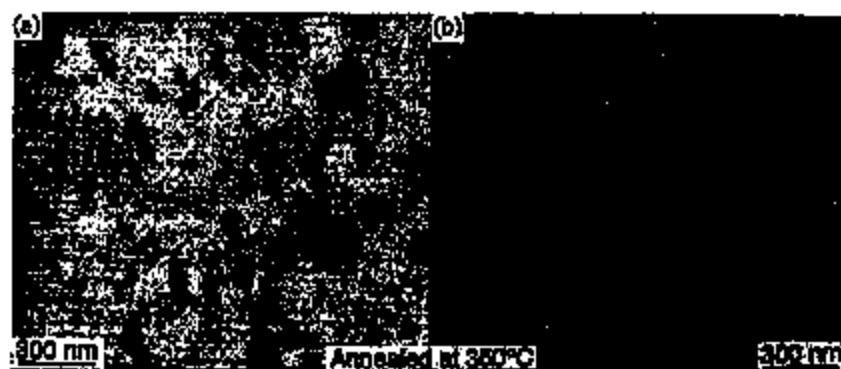
Fig. 11. (a) STEM image of the $\text{Al}_{0.75}\text{Sm}_{0.25}$ alloy film sample annealed at 350 °C for 80 min in Fig. 10(a), and (b) the distribution of Sm measured by EDX in the same area as (a).

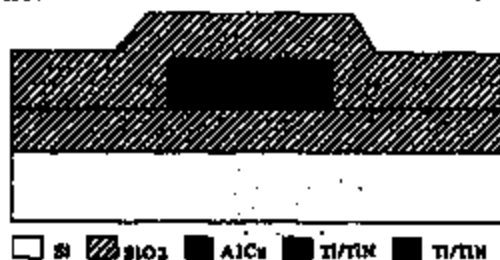
Figure 1. Cross-section of the test structure

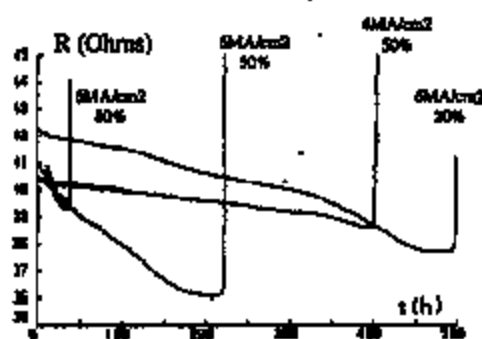
Figure 3 Resistance vs Time - $f=10\text{kHz}$

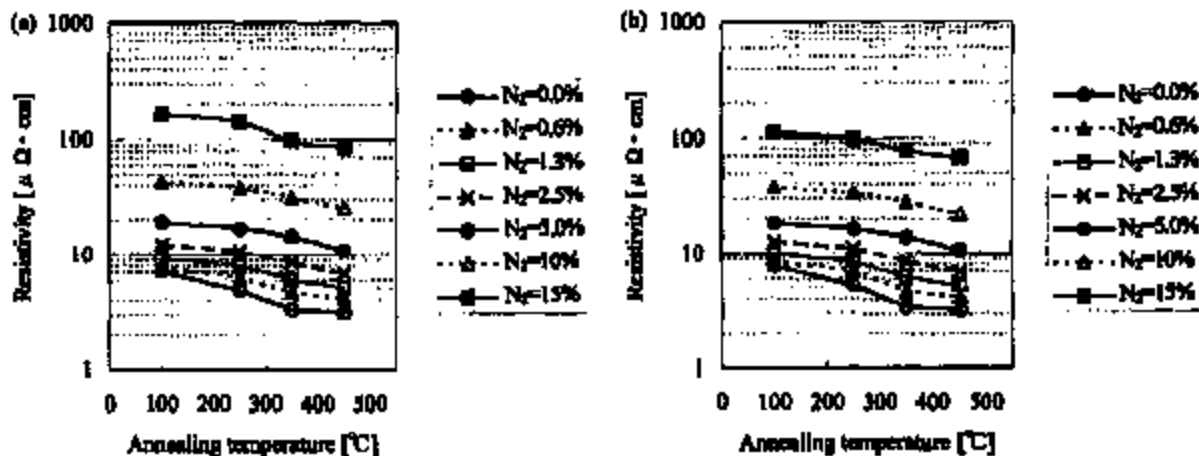
Fig. 2. Resistivity versus annealing temperature: (a) nitric Al-Y (1 at.% Y) alloy, (b) nitric Al-Gd (1 at.% Gd) alloy.
