FORD 8/5/03

LETTER TO ODI

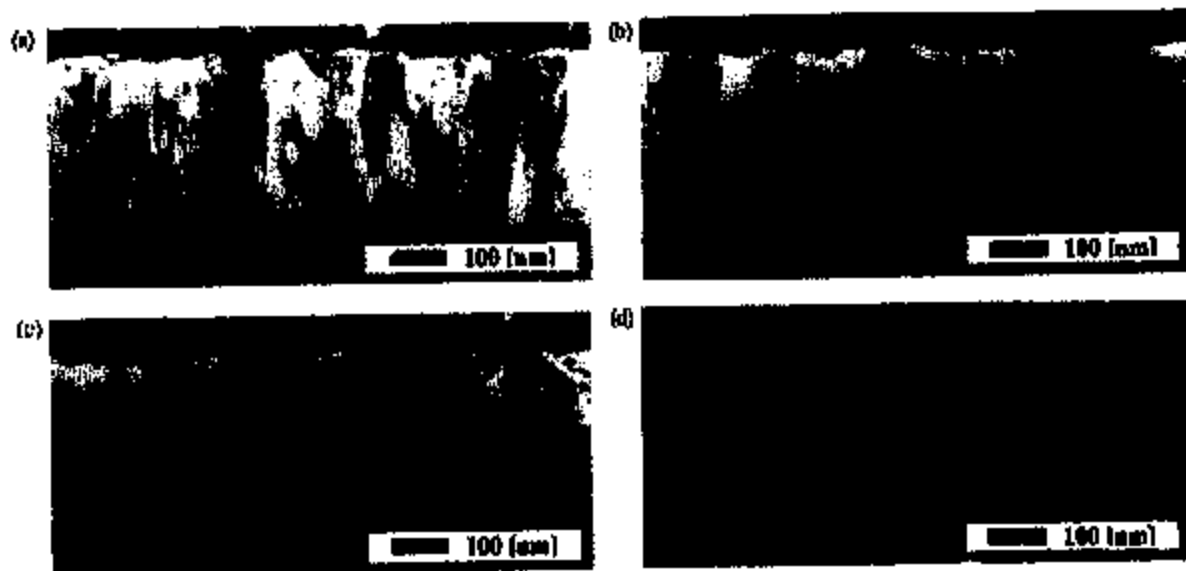
Fig. 3. Cross-sectional TEM views: (a) as-deposited Al-Y (1 at.% Y) alloy, (b) 350°C-annealed Al-Y (1 at.% Y) alloy, (c) as-deposited nitric Al-Y (1 at.% Y, 4.6 at.% N) alloy, (d) 350°C-annealed nitric Al-Y (1 at.% Y, 4.6 at.% N) alloy.

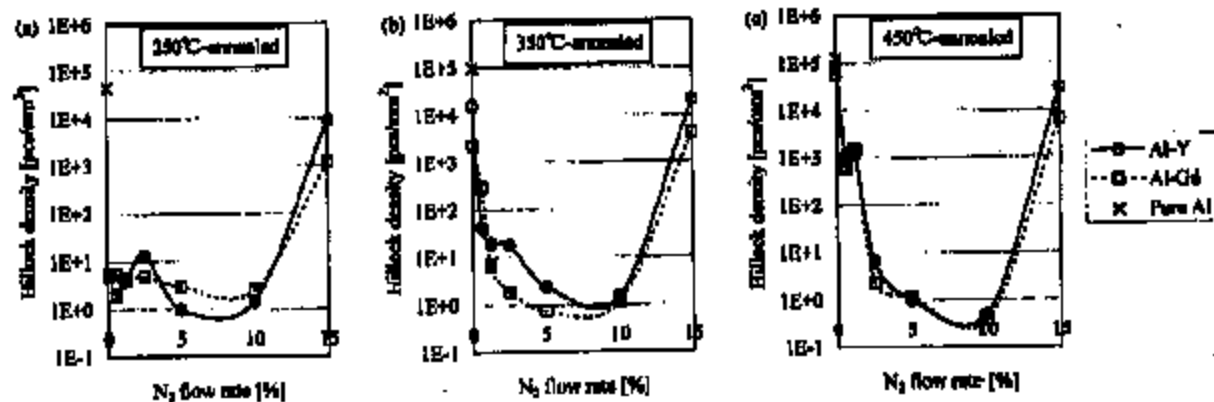
Fig. 4. Hf/Al thickness density versus N_2 flow rate: (a) 250°C-annealed, (b) 350°C-annealed, (c) 450°C-annealed.

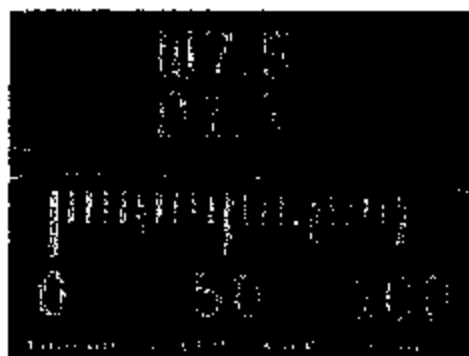
film of 0.4 μ m. The film/substrate assembly was then annealed at 723 K for about 30 min. The processing followed the conventional technique in China to manufacture micron-width interconnects, and was carried out in the Institute of Microelectronics, Tsinghua University. The thin films were then etched to testing lines of 100 μ m length and various widths (from 1.5 to 11.5 μ m). The failure times of various tests are listed in Table 1. They are substantially lower than the testing data reported in the literature. The specimens were observed under a field-emission scanning electron microscope (Hitachi S-4200) at the Institute of Physics, Chinese Academy of Science. The intercon-

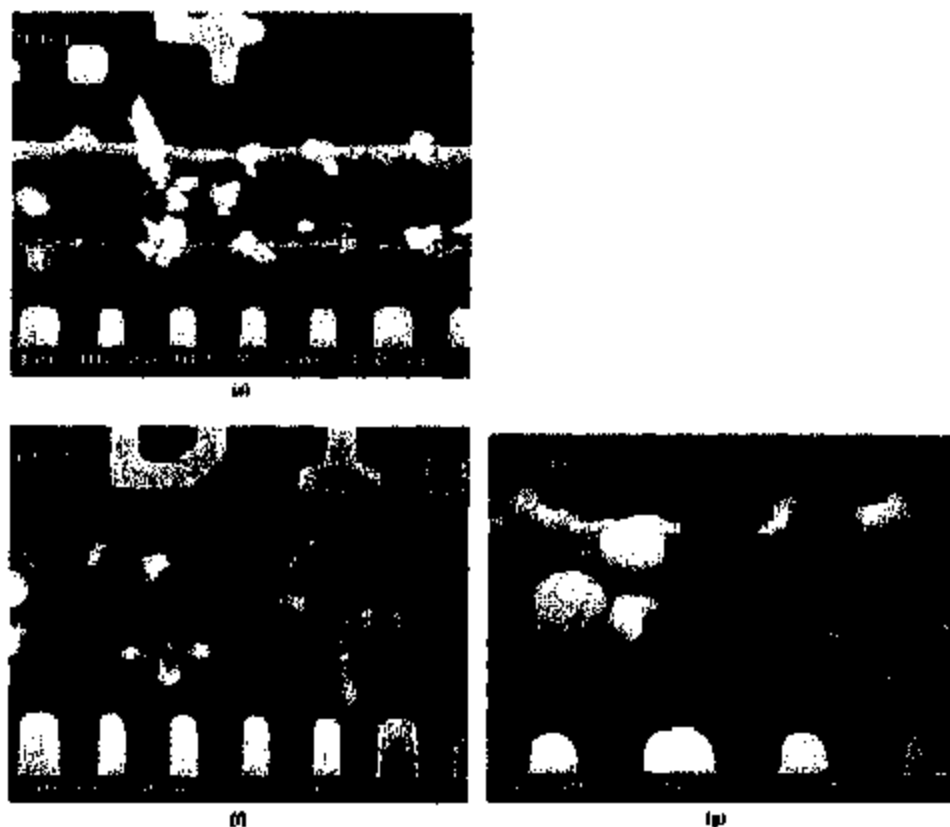
Fig. 1. SEM micrographs following a time sequence showing the damage of an interconnect under electromigration: (a) initial configuration; (b)-(d) 520 h; (e) 904 h; (f), (g) 1171 h.

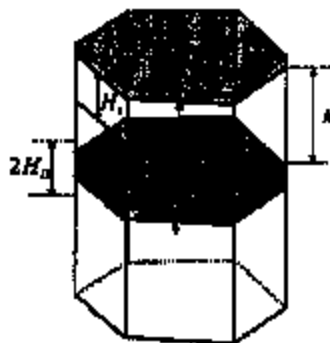
Fig. 5. Geometry and various characteristic lengths for the protruding motion of a grain.

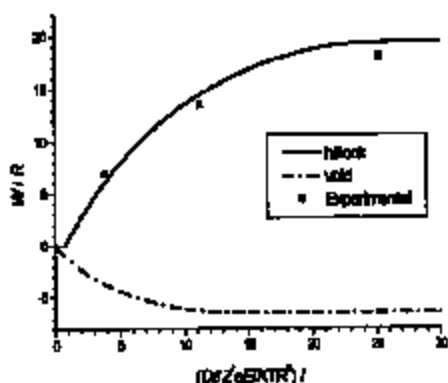
Fig. 9. Protruding height and the sinking depth vs the normalized time, $J_2 = 2.34u(J_1)$.

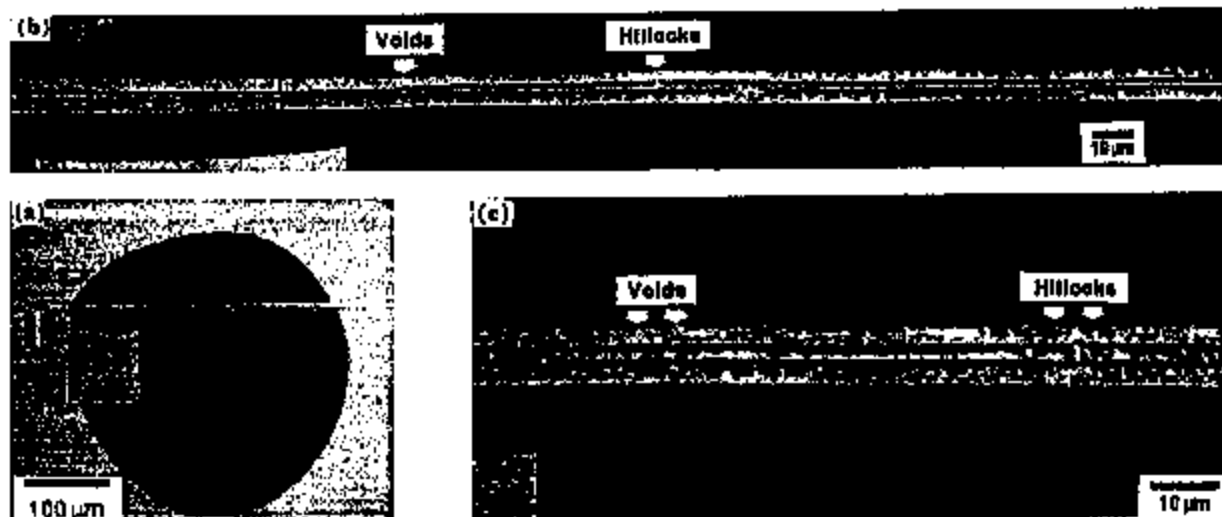
Fig. 3. (a) Low magnification SEM image (montage of two micrographs) for a 2.1 μm wide line (with guard rails) before electromigration stressing, showing the electron-transparent area. (b) and (c) Backscattered electron images in SEM for the electron-transparent segment after failure, showing voids and hillocks in distinct regions on either side of the centre of the transparent segment, with the depletion of the Al-Cu precipitates between these regions. (c) A close-up of (b).

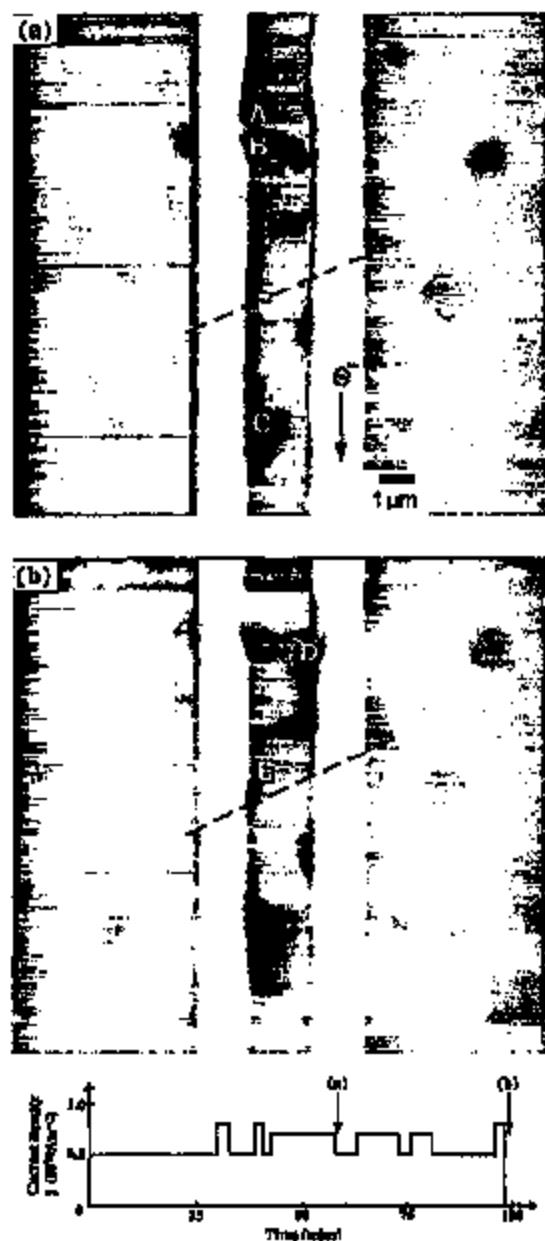
Fig. 4. TEM images for a segment of test line, (a) after 58 min and (b) after a further 40 min of in-situ electroemigration testing (profile shown at bottom of figure). Comparison of (a) and (b) shows the formation of an Al-Cu hillock at D, the dissolution of an Al-Cu precipitate at C, and the migration of a precipitate at E—all consistent with the migration of copper parallel to the electron flow (top to bottom).

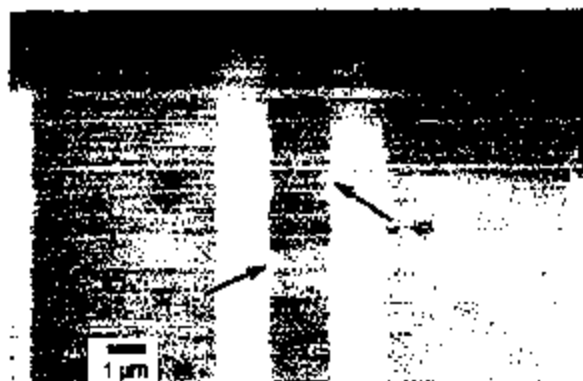
Fig. 5. TEM image showing the initiation of voids at the end of the electro-transparent segment of line. The voids developed early, at its edge of the line and beneath the oxide skin. Electron flow: top to bottom.

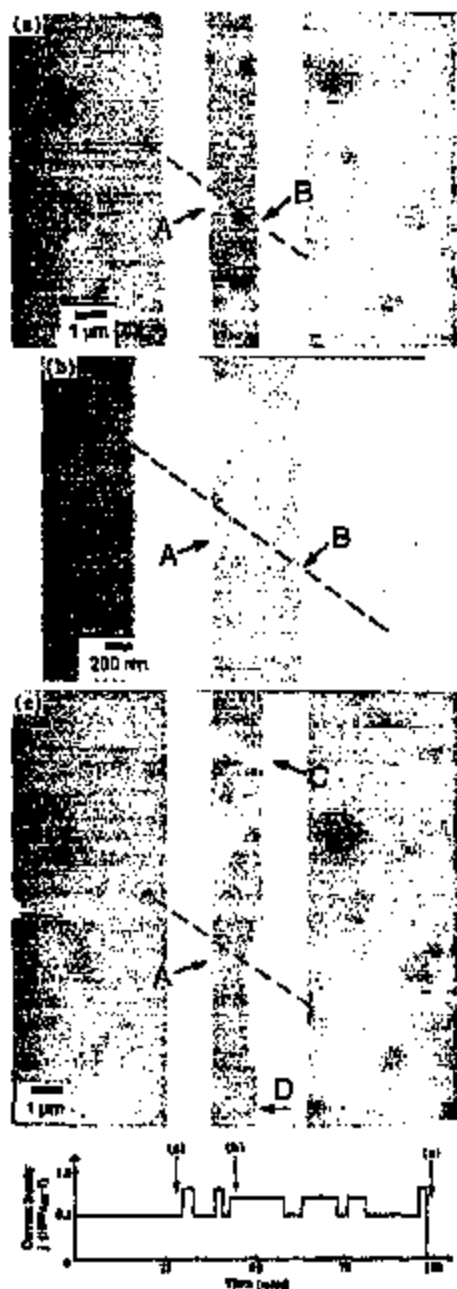
Fig. 6. TEM images of a line segment, showing that voids which develop early stop growing even in the region of maximum atomic flux divergence giving the maximum voiding under electromigration testing. In (a) there are two early voids at A and B with precipitates nearby. After another 13 min of electromigration testing, the slightly higher magnification image (b) shows the depletion of Al-Cu precipitates but unaltered voids at A and B. In (c), the line has failed at C, but despite the heavy damage site in this region of high $\partial D/\partial x$ (Fig. 2(b)), the early void at A has still not grown further. The timing and current density at which each micrograph was taken are presented in the diagram at the bottom of the figure. Electron flow: top to bottom.

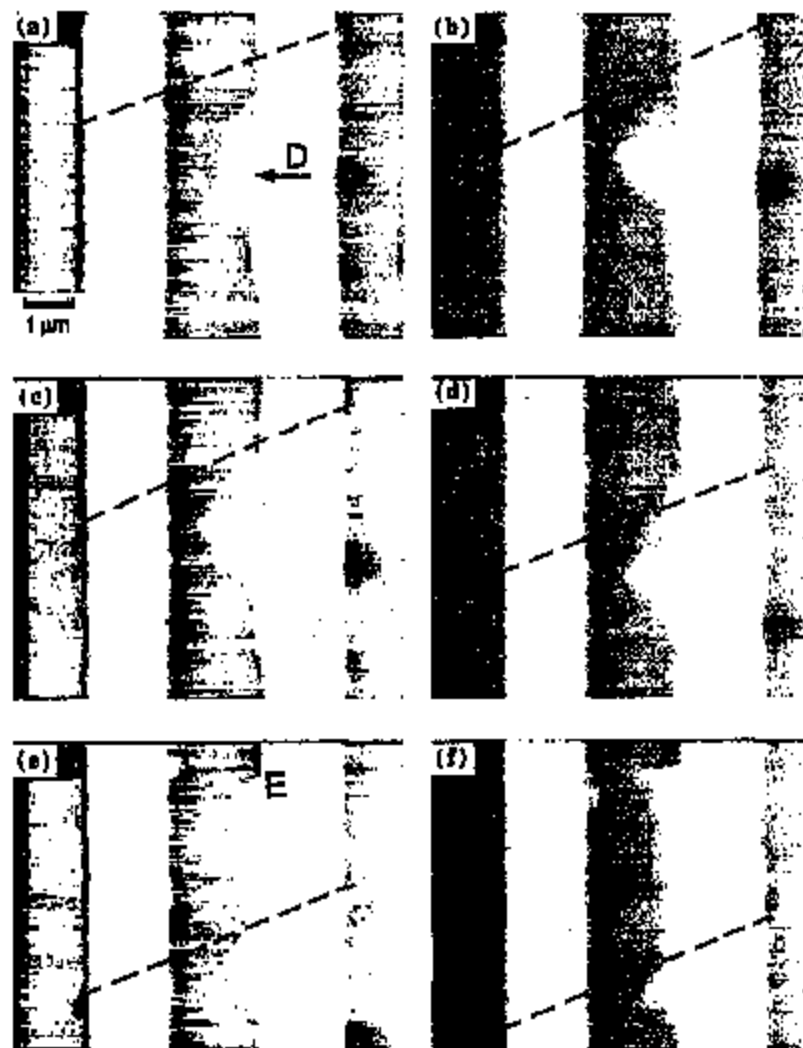
Fig. 8 shows a sequence of micrographs from a different segment of line. For the specimen film used, the predominant contrast is from thickness variations. Again, no damage was evident after 30 min at the initial electromigration stress of $0.5 \times 10^{20} \text{ A m}^{-2}$ (0.5 J). After a further 33 min in which

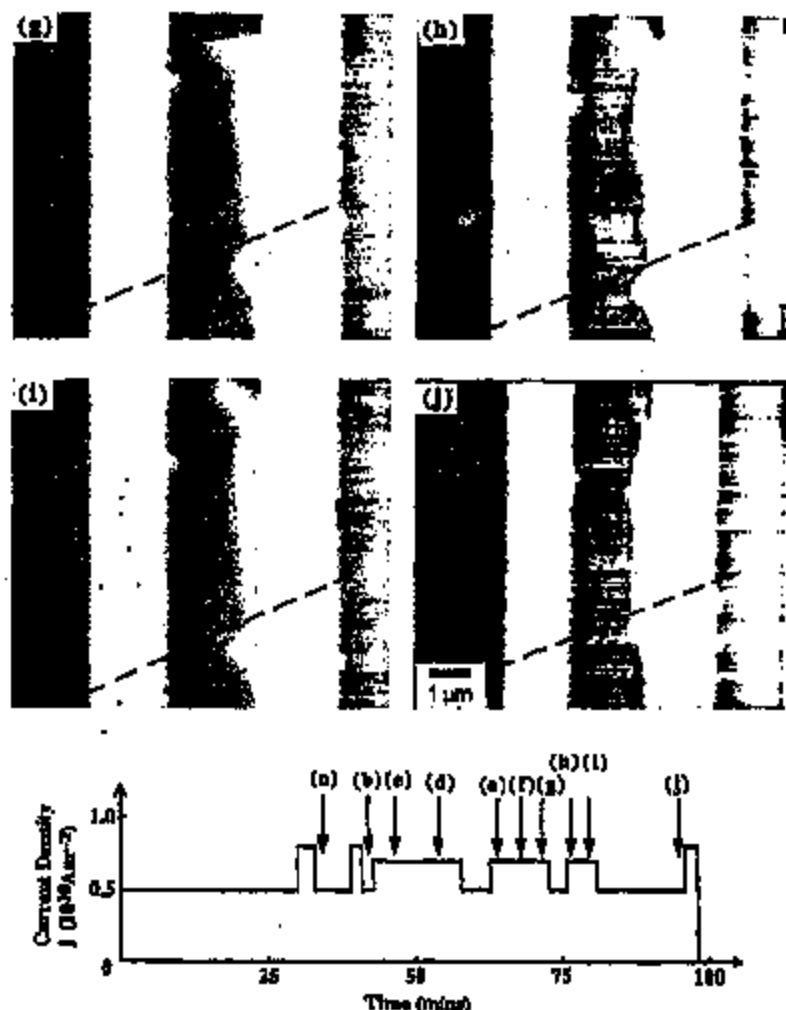
Fig. 7. Sequential TDM images (a)–(j) for a segment of line under is-sin electroigration testing, showing the evolution (initially, growth along the line, partial refilling, growth across grain boundaries and growth along a grain boundary) of a void stressed with a current density ranging between $0.5 \times 10^{10} \text{ A m}^{-2}$ and $0.8 \times 10^{10} \text{ A m}^{-2}$. The timing and current density at which each micrograph was taken are presented in the diagram at the bottom of the figure. Electron flow: top to bottom.

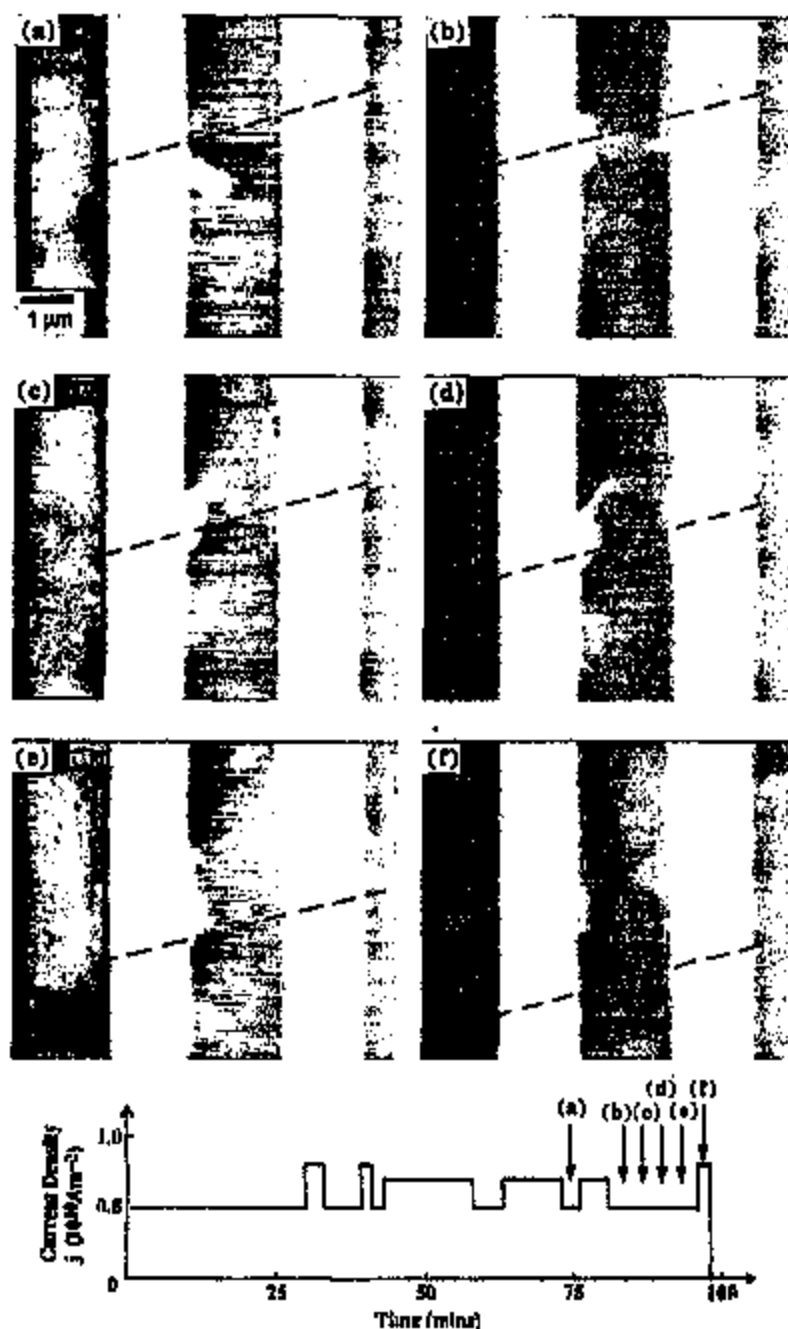
Fig. 8. Sequential TEM images (a)–(f) for a segment of line under in-situ electromigration testing, showing the growing and healing of a void. The timing and current density at which each micrograph was taken are presented in the diagram at the bottom of the figure. Electron flow: top to bottom.

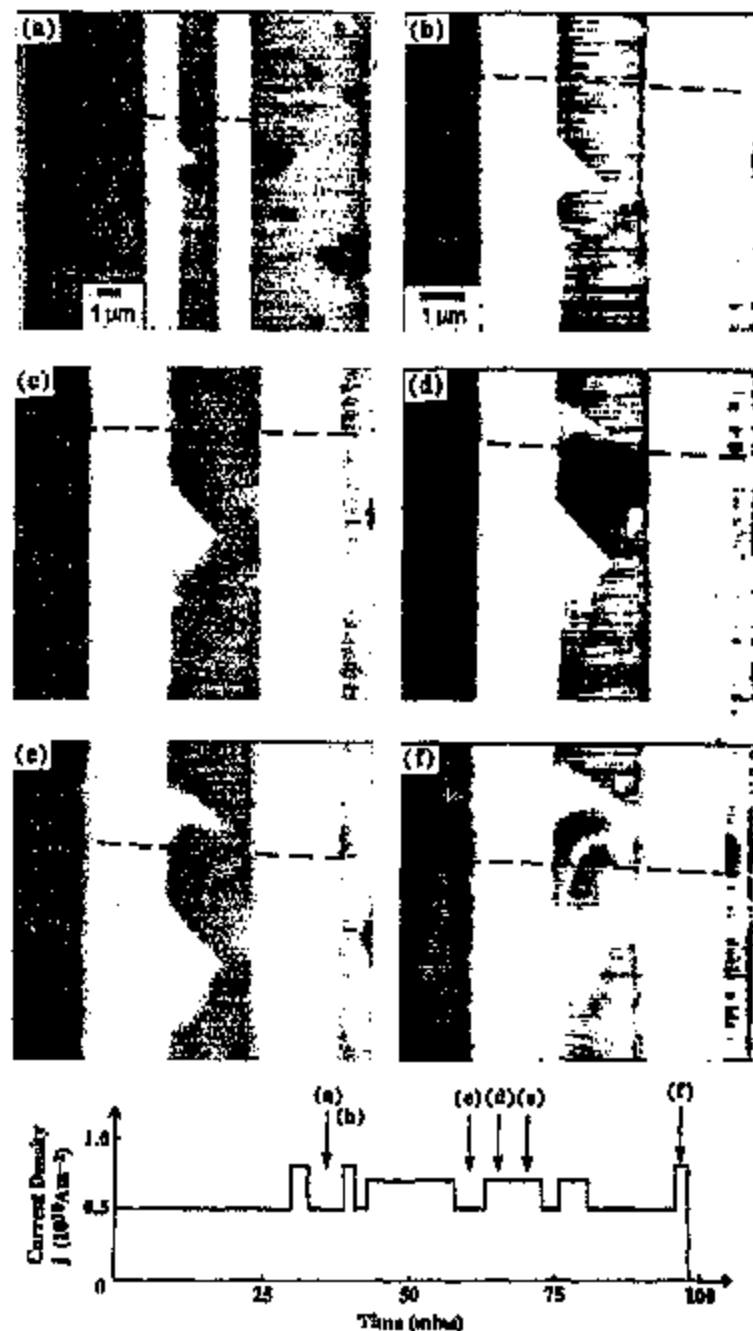
Fig. 9. Sequential TEM images (a)–(f) for a segment of line under in-situ electroemigration testing, showing the development of voids to failure. The development suggests that for uncritical voids, the compressive stress built up at the downstream end of the grain boundaries can be relaxed by plastic flow towards large voids nearby and that there can thus be failure. The timing and current density at which each micrograph was taken are presented in the diagram at the bottom of the figure. Electron flow: top to bottom.

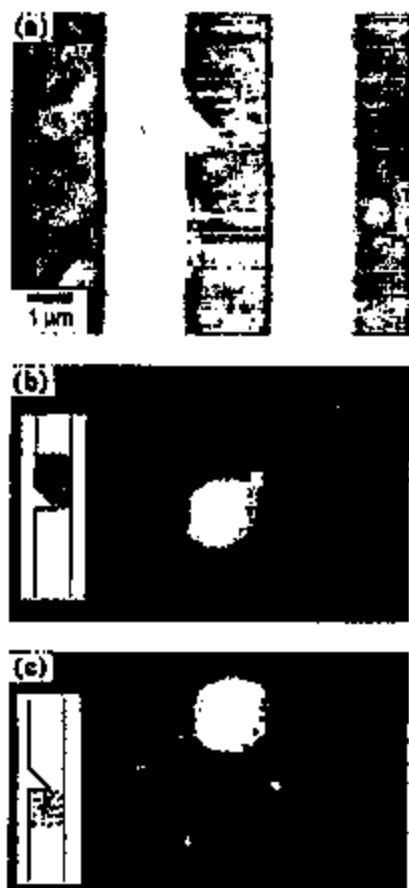
Fig. 10. TEM images for the line segment shown in Fig. 9(b) but in different tilt conditions, confirming that the planar feature is a grain boundary across the width of the test line. The diffraction patterns in (b) and (c) for the grains above and below the boundary demonstrate that they are two different grains.

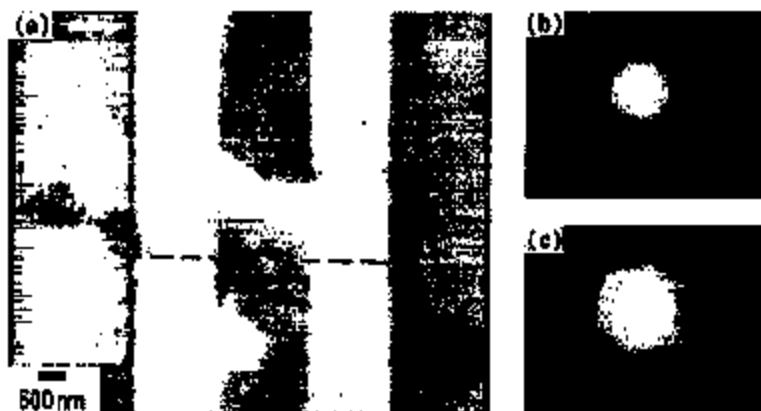
Fig. 11. TEM images of the failure site shown in Fig. 9(f) but taken 4 days after it failed, showing a wider open-circuit gap than in Fig. 9(f). The diffraction patterns in (b) and (c) for the Al line above and below the failure site respectively, do not show any particular relationship in crystallographic orientation.

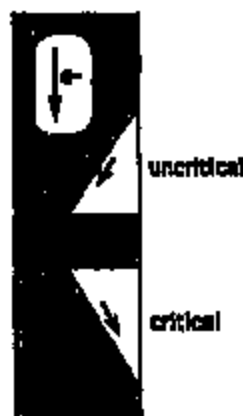
Fig. 12. Schematic diagram of critical and uncritical void geometries as proposed by Auz et al. [32]. The predominant atomic transport is along the internal free surface of the metallization as shown by the small arrows.

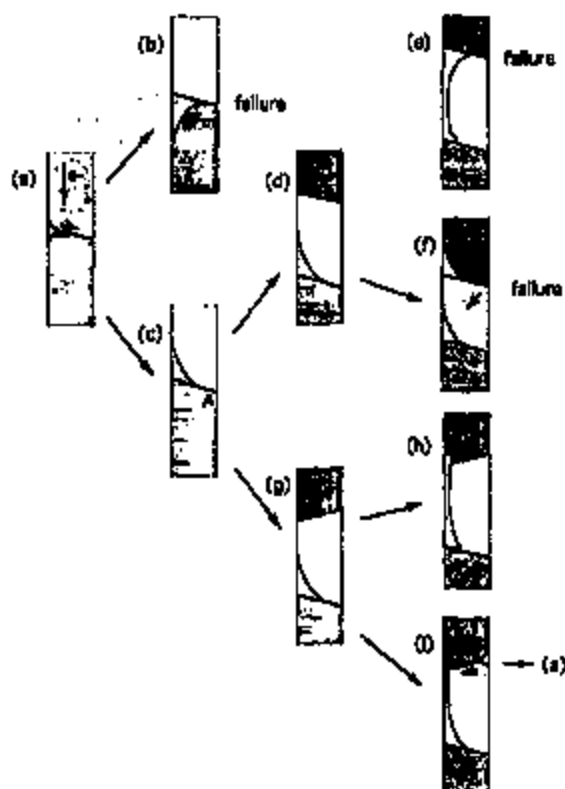
Fig. 13. A schematic model for electromigration-induced open-circuit failure in bamboo lines with inclined grain boundaries, showing possible alternative sequences of events. The shading indicates distinct grains. The unshaded areas are voids forming under the original oxide skin of the line. Damage is concentrated at boundaries which are inclined to the current. Precipitates are not considered in the model as copper depletion (and consequent precipitate dissolution) usually precedes damage.

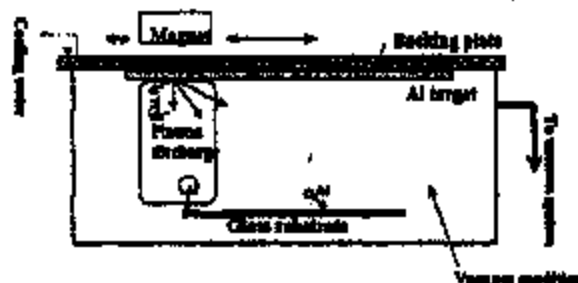
Fig. 1. Cross-sectional schematic diagram of the sputtering chamber.

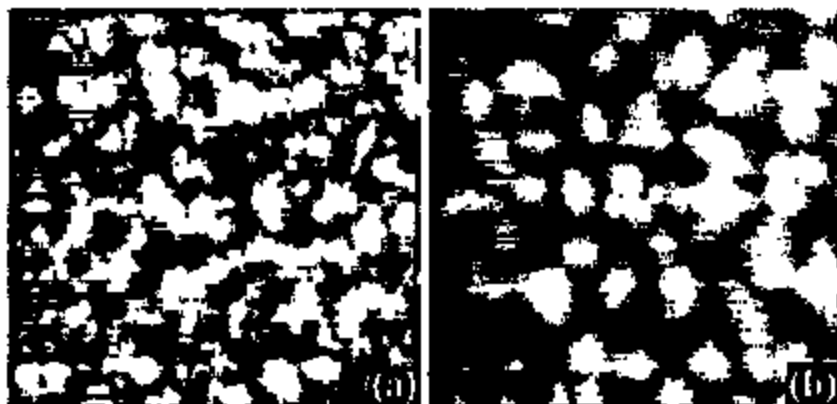
Fig. 2. Two-dimensional AFM images of Al-0.2 wt.% Cu films corresponding to the samples in Table 1: (a) Sample C (20 U/min.), (b) Sample D (60 U/min.). Scale: 2000 \times 2000 nm.

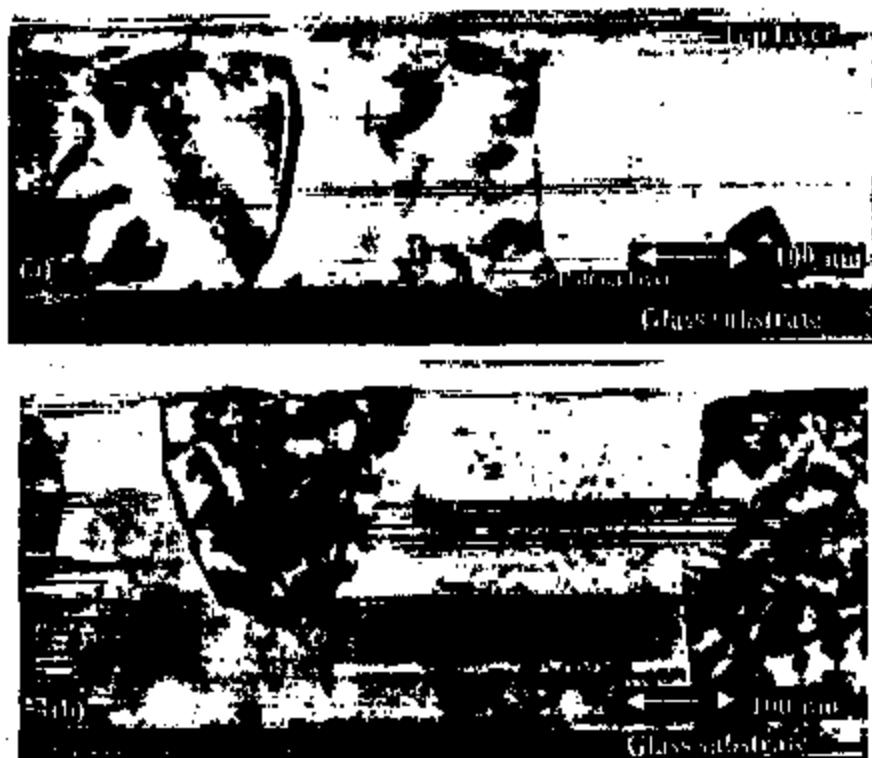
Fig. 3. Cross-sectional TEM micrographs of Al-0.2 wt.% Cu films corresponding to the samples in Fig. 2: (a) Sample C, (b) Sample D.

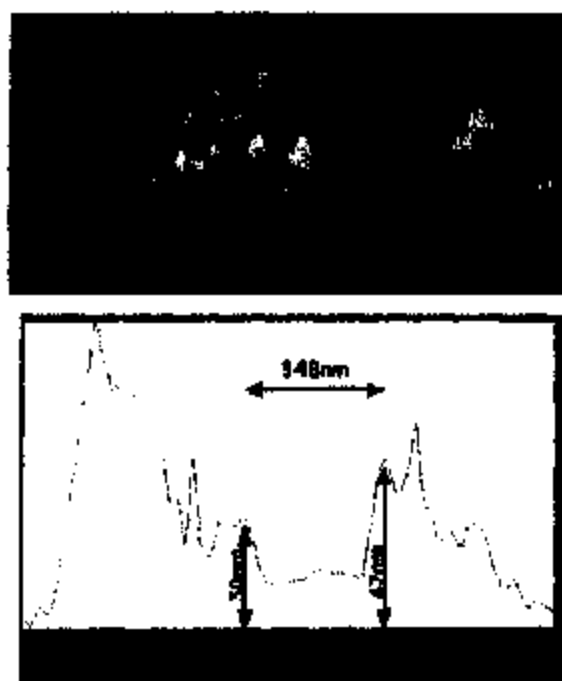
Fig. 7. Surface profile of anodized silicon surface by AFM measurement.

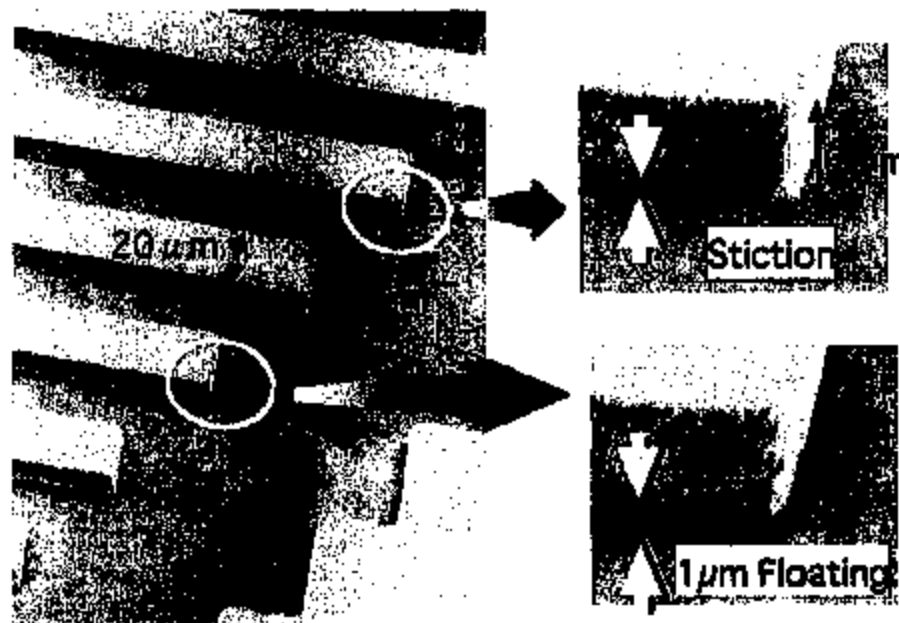
Fig. 12. Evaluation of stiction for SOI cantilever beams using BEM measurement method.

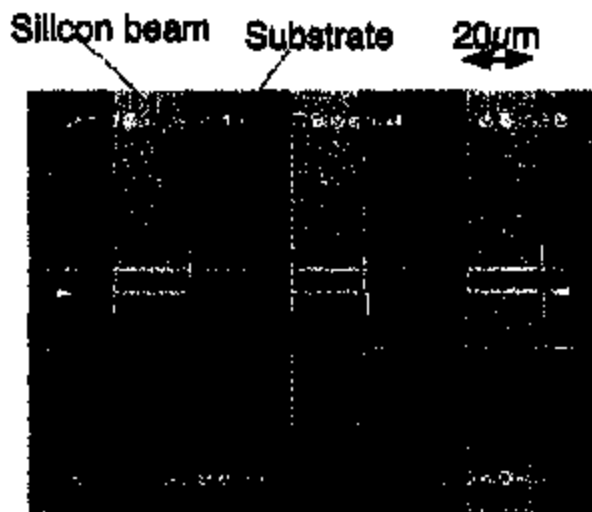
Fig. 13. Photograph of SOI cantilever beams under Laser displacement measurement equipment.

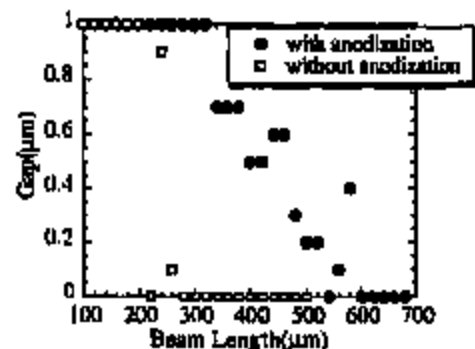
Fig. 14. Relation between gap and beam's length after rise and drying process for doubly clamped cantilever beams.

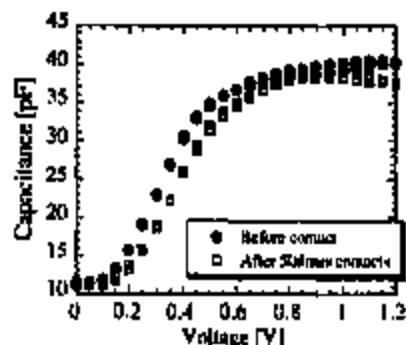
Fig. 15. C-V characteristics of SOI accelerometer using anodization method.

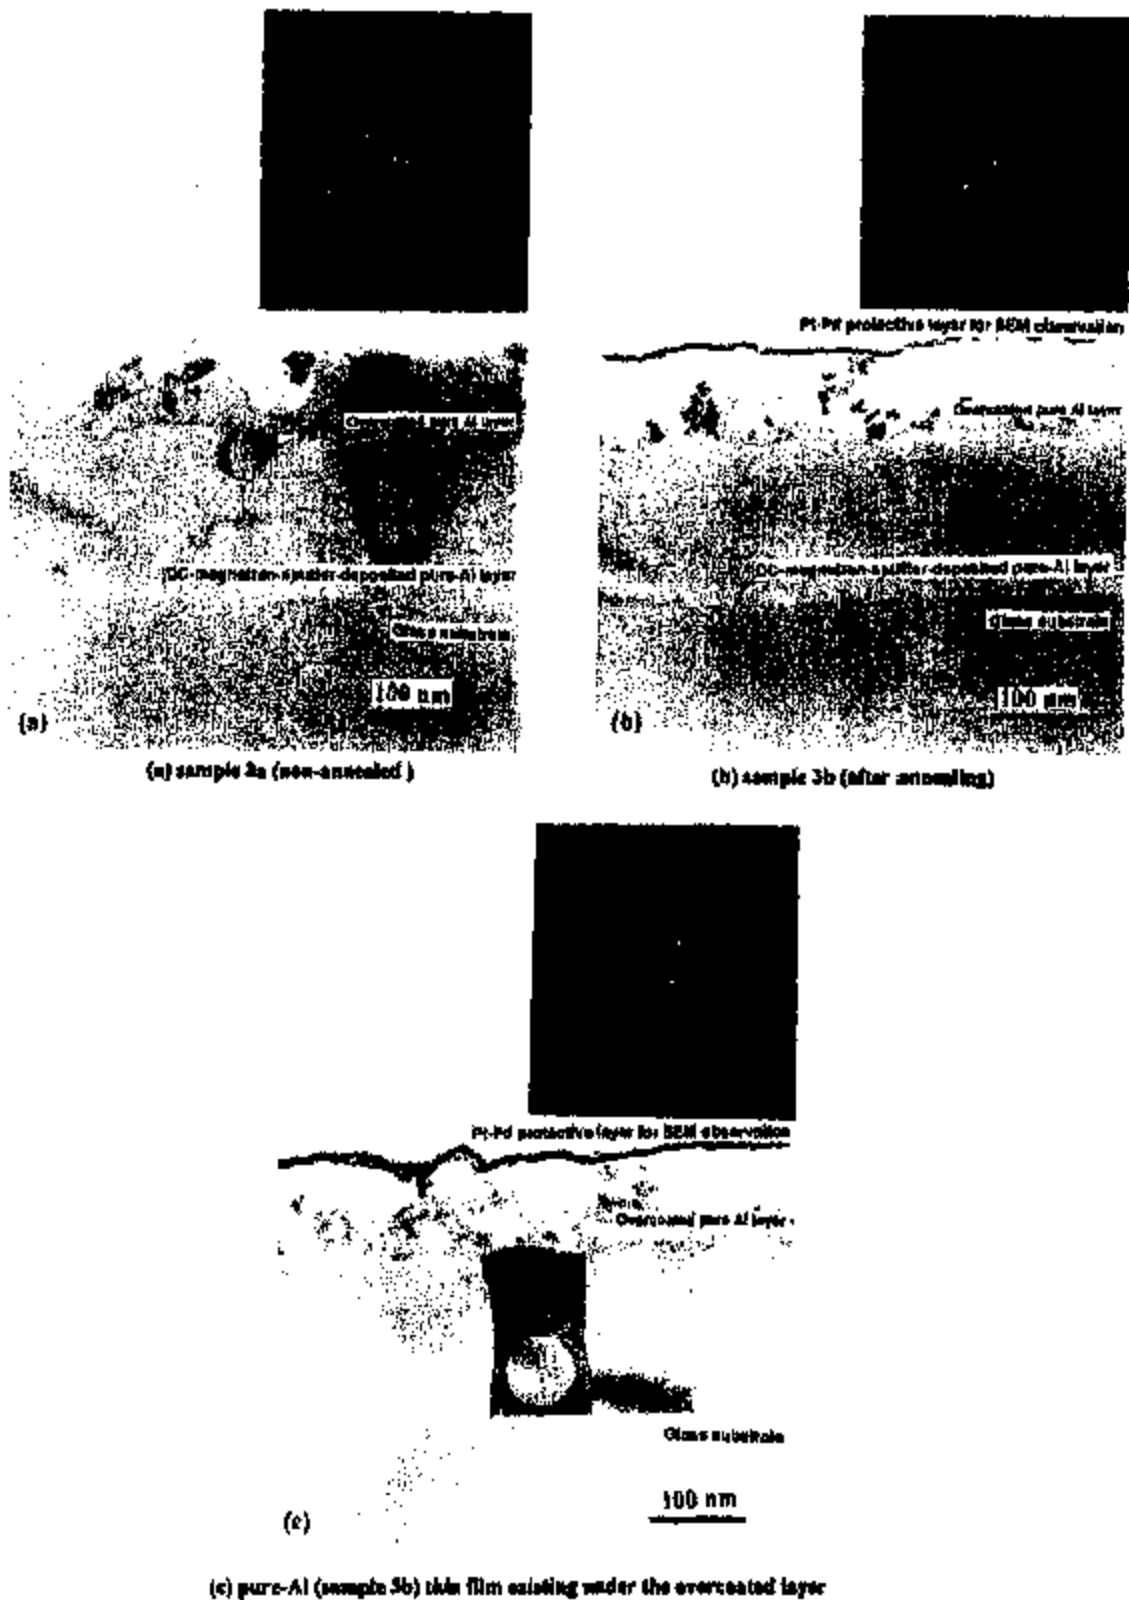
Fig. 4. Cross-sectional TEM images and analyses of the grain orientation caused by electron diffraction: (a) sample 3a (non-annealed); (b) sample 3b (after annealing); (c) pure Al (sample 3b) thin film existing under the overcoated layer.

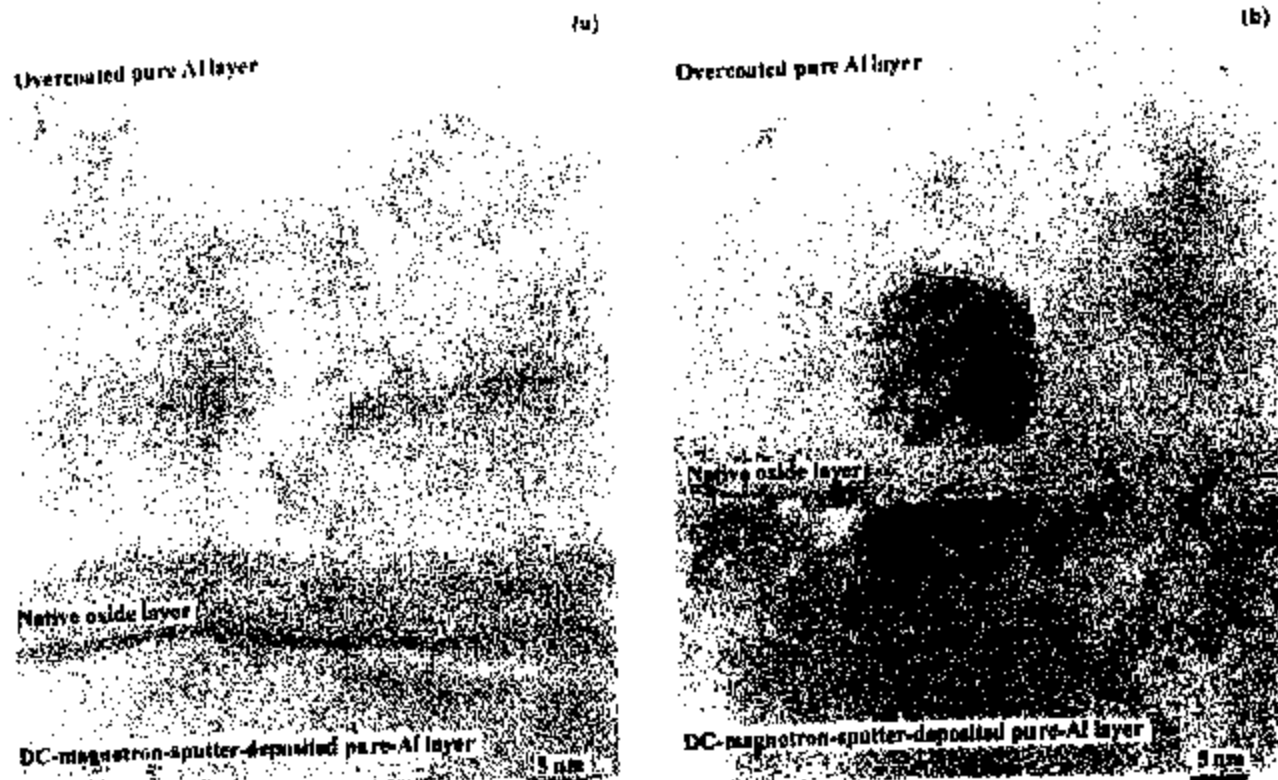
Fig. 5. Detailed nanostructure micrographs obtained by means of cross-sectional TEM corresponding to: (a) sample 3a; (b) sample 3b.

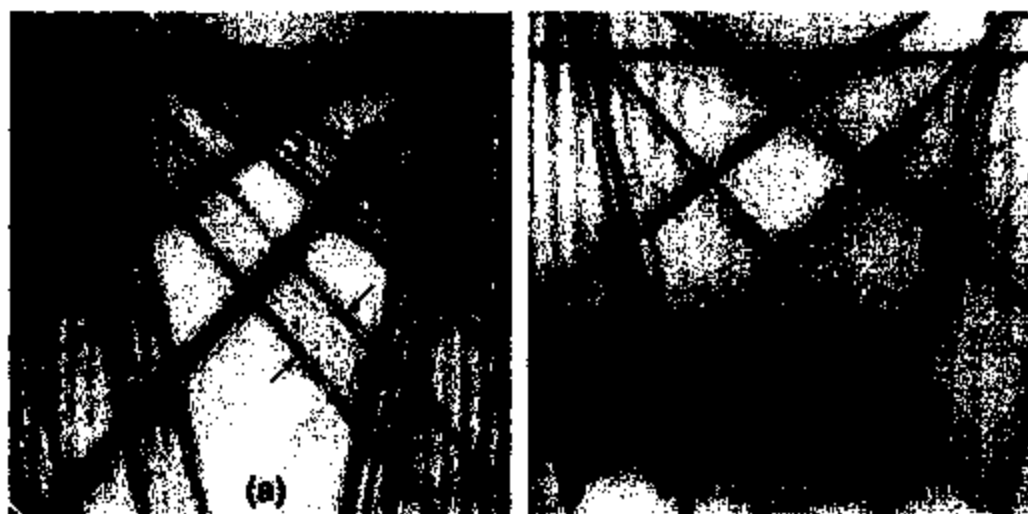
Fig. 3. (a) CBED pattern taken with the spot positioned close to the substrate interface. Some of the HOLZ lines show a pronounced splitting which is caused by a bending of the lattice planes close to the substrate. (b) From the central part of the interconnect line undisturbed patterns can be obtained.

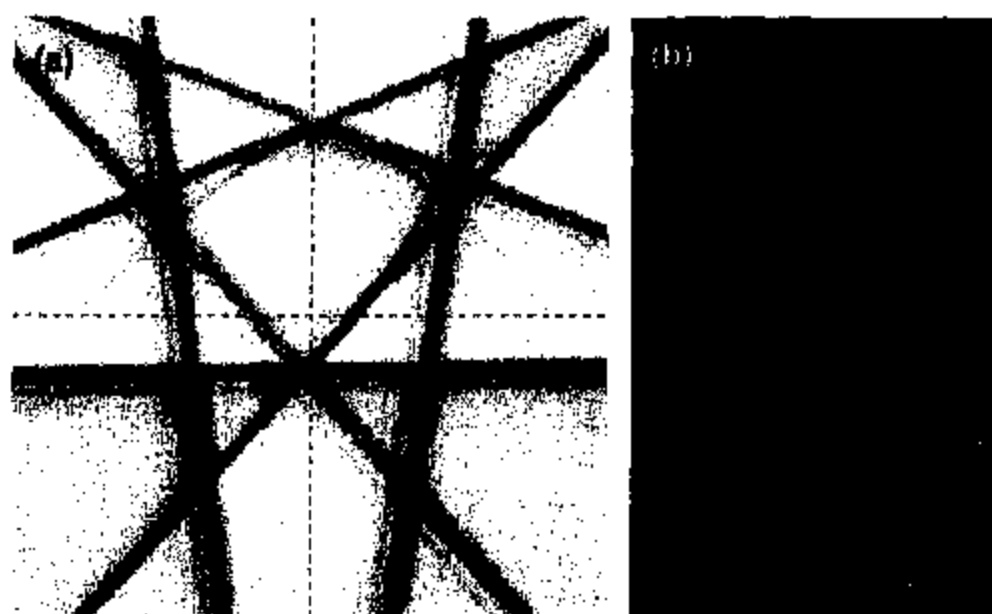
Fig. 4. (a) Central portion of a [1 3 3] CBED pattern acquired in the centre of the line and the corresponding Hough transform (b). Because of the unidirectional strain, the symmetry of the pattern is broken with respect to the vertical line.

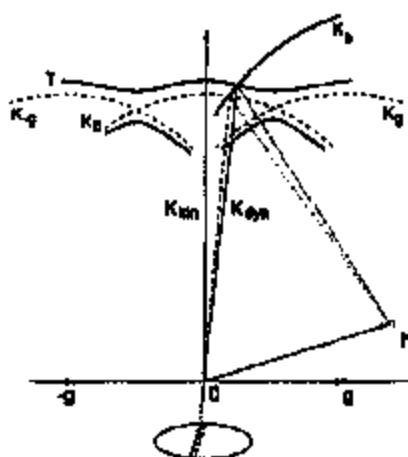
Fig. 5. Schematic drawing of the dispersion surfaces (labelled γ) which result from the strong dynamical interaction of the beam electrons with the crystal. In the crystal, the kinematical wavevectors (labelled K_g , K_h and K_0) are no longer allowed and therefore the interaction with K_0 shifts from K_h to the dispersion surface, leading to a corresponding shift of the HOLZ line in the CBED pattern.

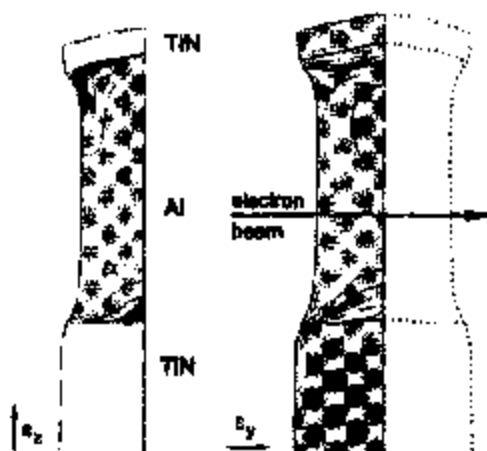
Fig. 7. Strain distribution predicted by the finite element model for the two components ϵ_x and ϵ_y . Shown is the shape of the interconnect after cooling by 100 K (the displacements are enhanced by a factor of 100 for better visibility). In the Al segment the y -component shows a transition from tensile strain at the interface to compressive strain in the central part which is a result of the bending moment of the interconnect.

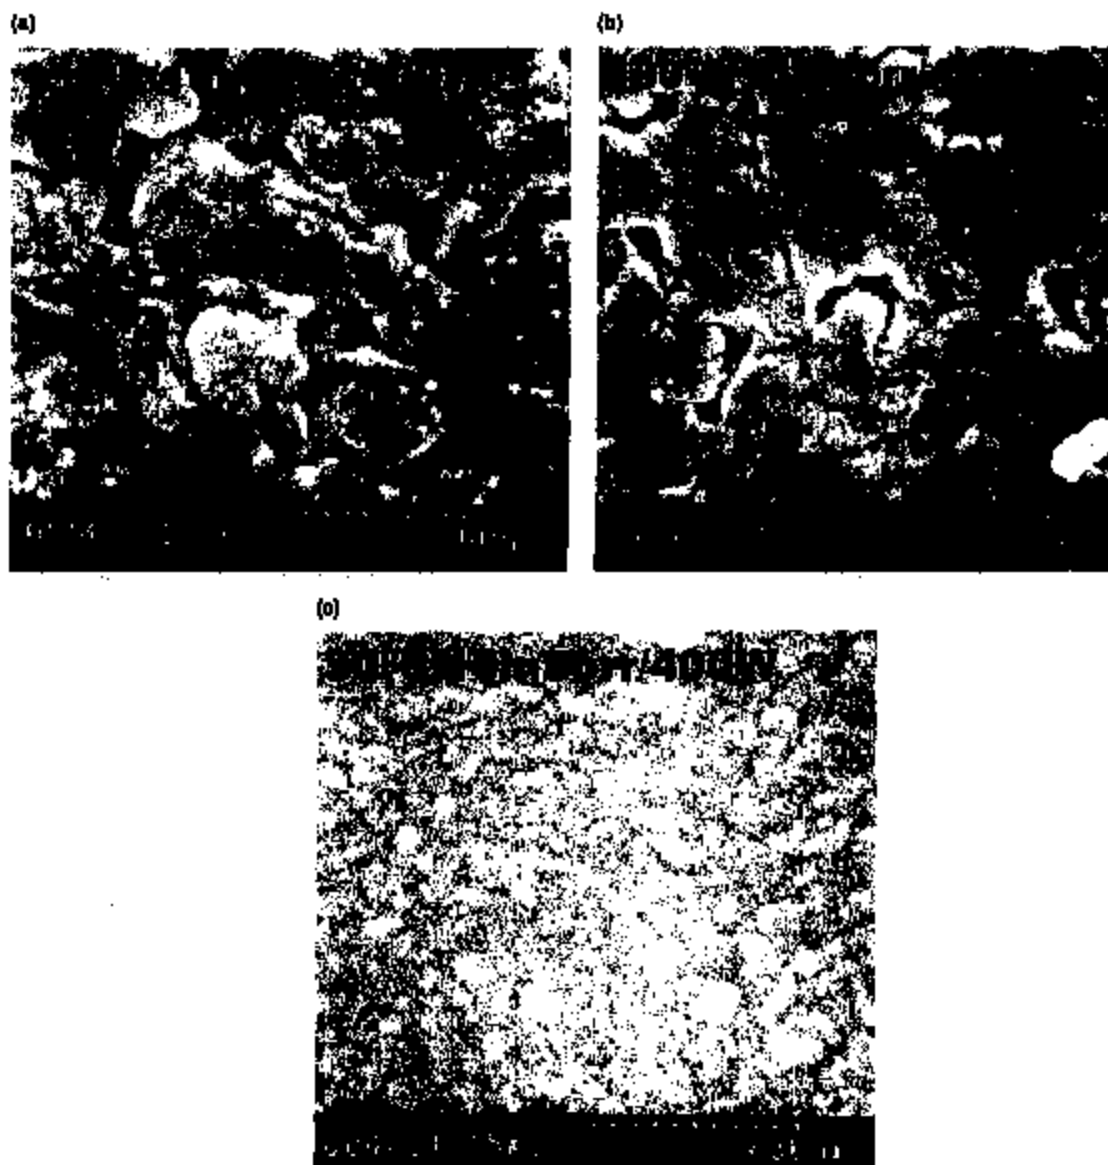
Fig. 1. SEM micrographs of the Al film deposited at (a) 150°C, (b) 100°C, and (c) 30°C, and subject to thermal annealing at 260°C for 12 h. The process pressure and power were fixed at 10 mTorr and 400 W, respectively.

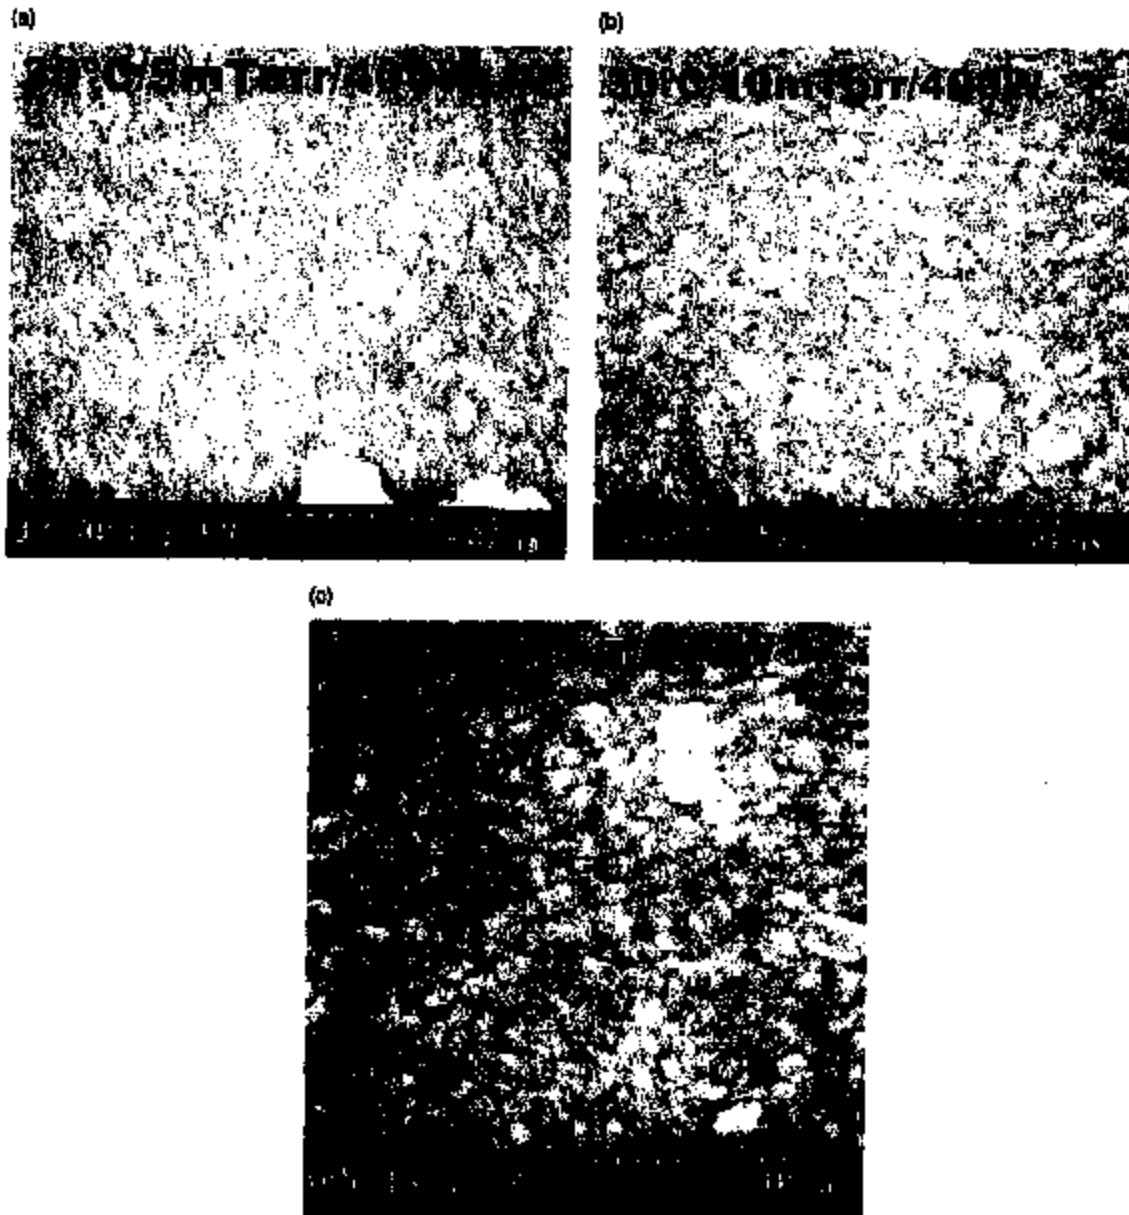
Fig. 2. SEM micrographs of the Al films deposited at (a) 5 mTorr, (b) 10 mTorr, and (c) 20 mTorr, and subject to thermal annealing at 260°C for 12 h. The deposition temperature and power were fixed at 30°C and 400 W, respectively.
