FORD 8/5/03

LETTER TO ODI

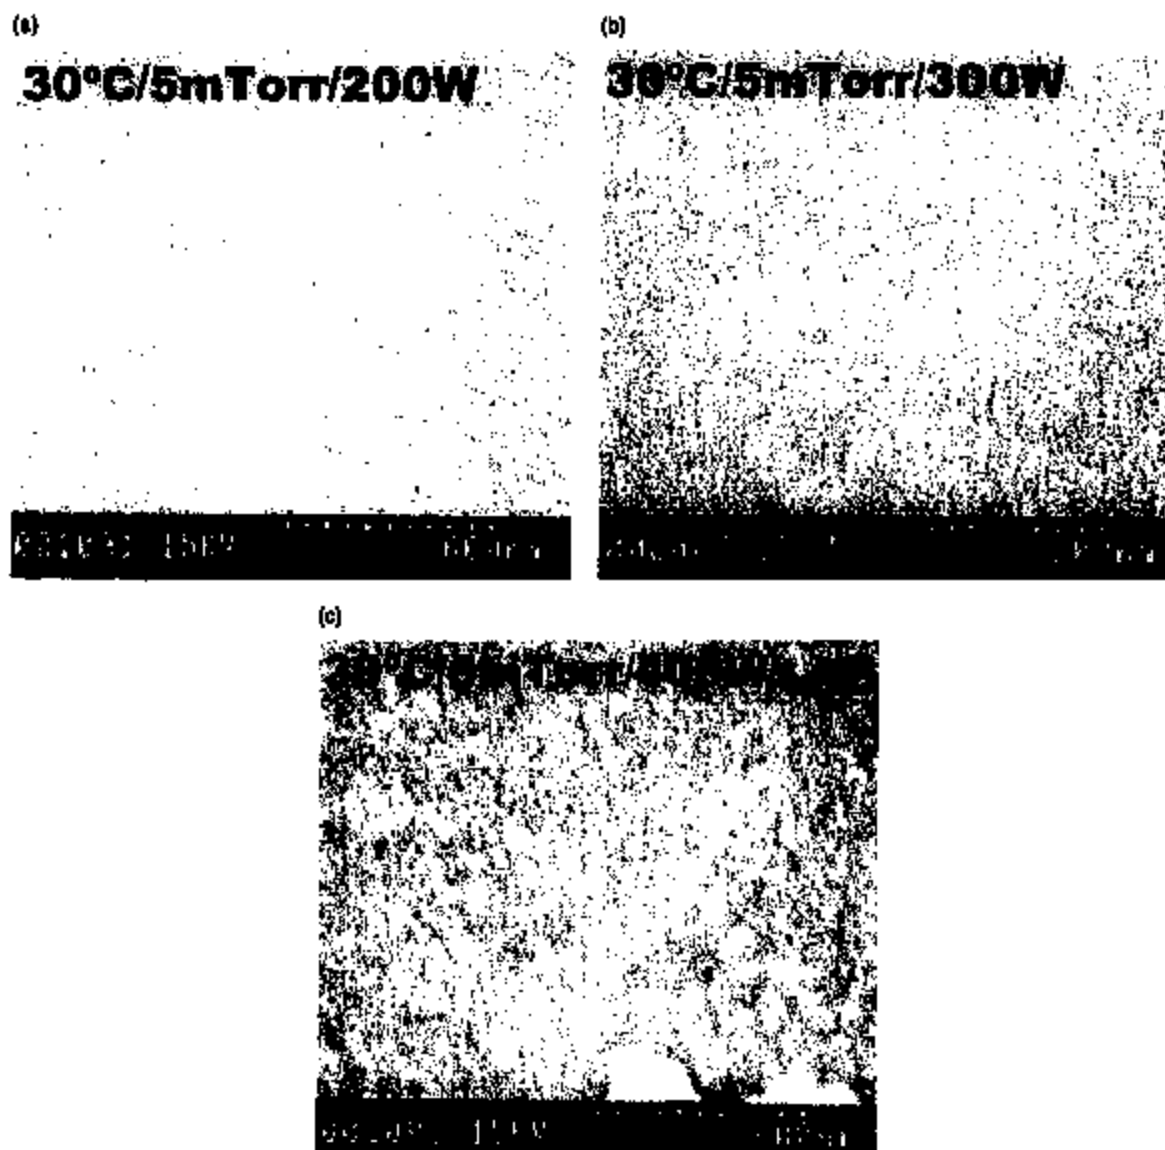
Fig. 3. SEM micrographs of the Al films deposited at (a) 200 W, (b) 300 W, and (c) 400 W, and subject to thermal annealing at 260°C for 12 h. The process pressure and temperature were fixed at 5 mTorr and 30°C, respectively.

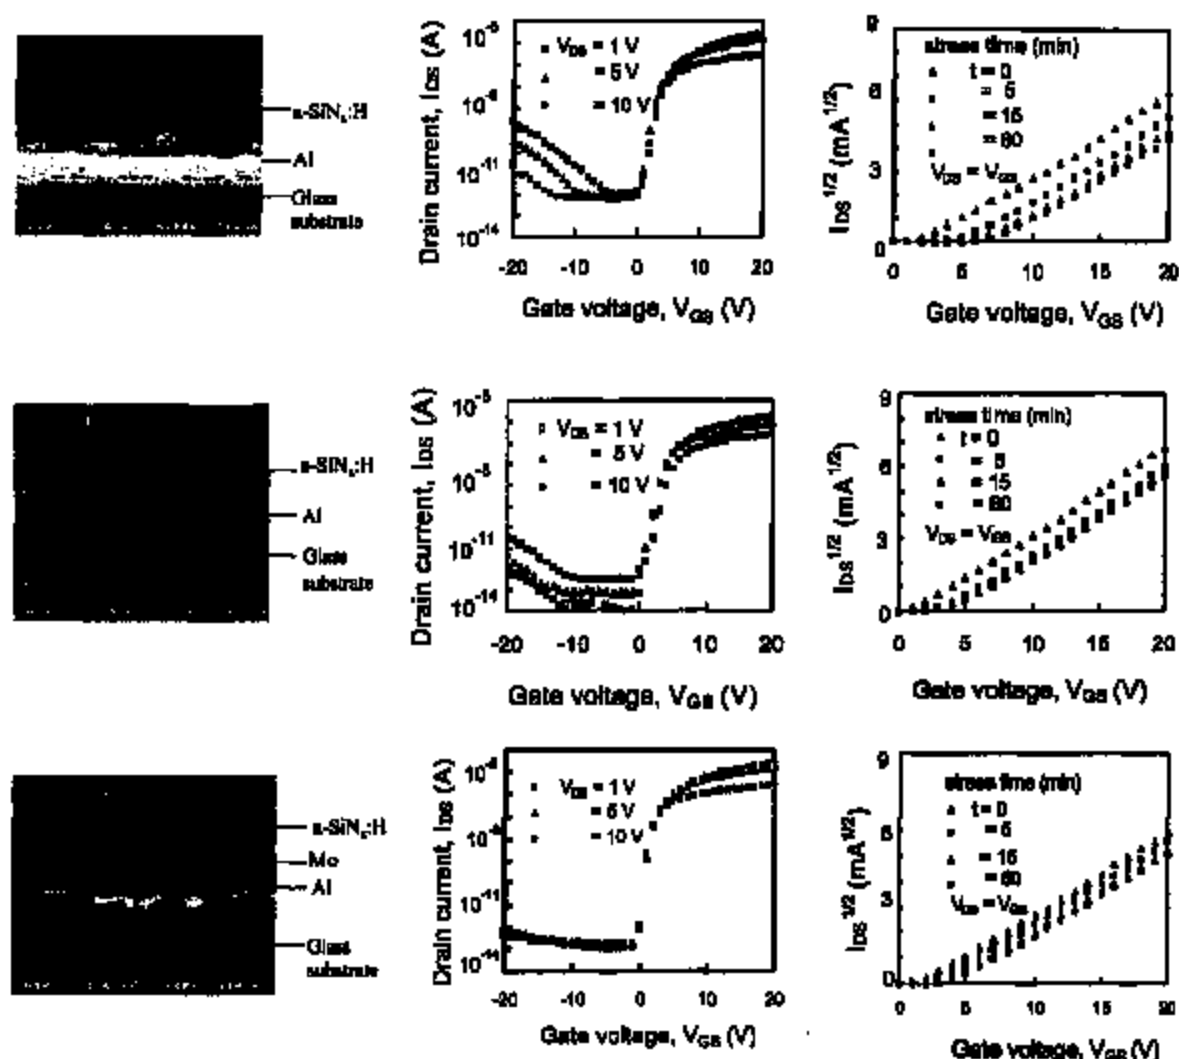
Fig. 4. Cross-sections of the gate/insulator interface and corresponding transfer characteristics (I_{DS} versus V_{GS}), at various drain source voltages (V_{DS}), and stability behavior (for $V_{GS} = V_{DS}$), when subject to electrical stress for time durations of 0, 5, 15, and 60 min. The TFTs were fabricated with the Al gate deposited under the conditions given in Table 2.

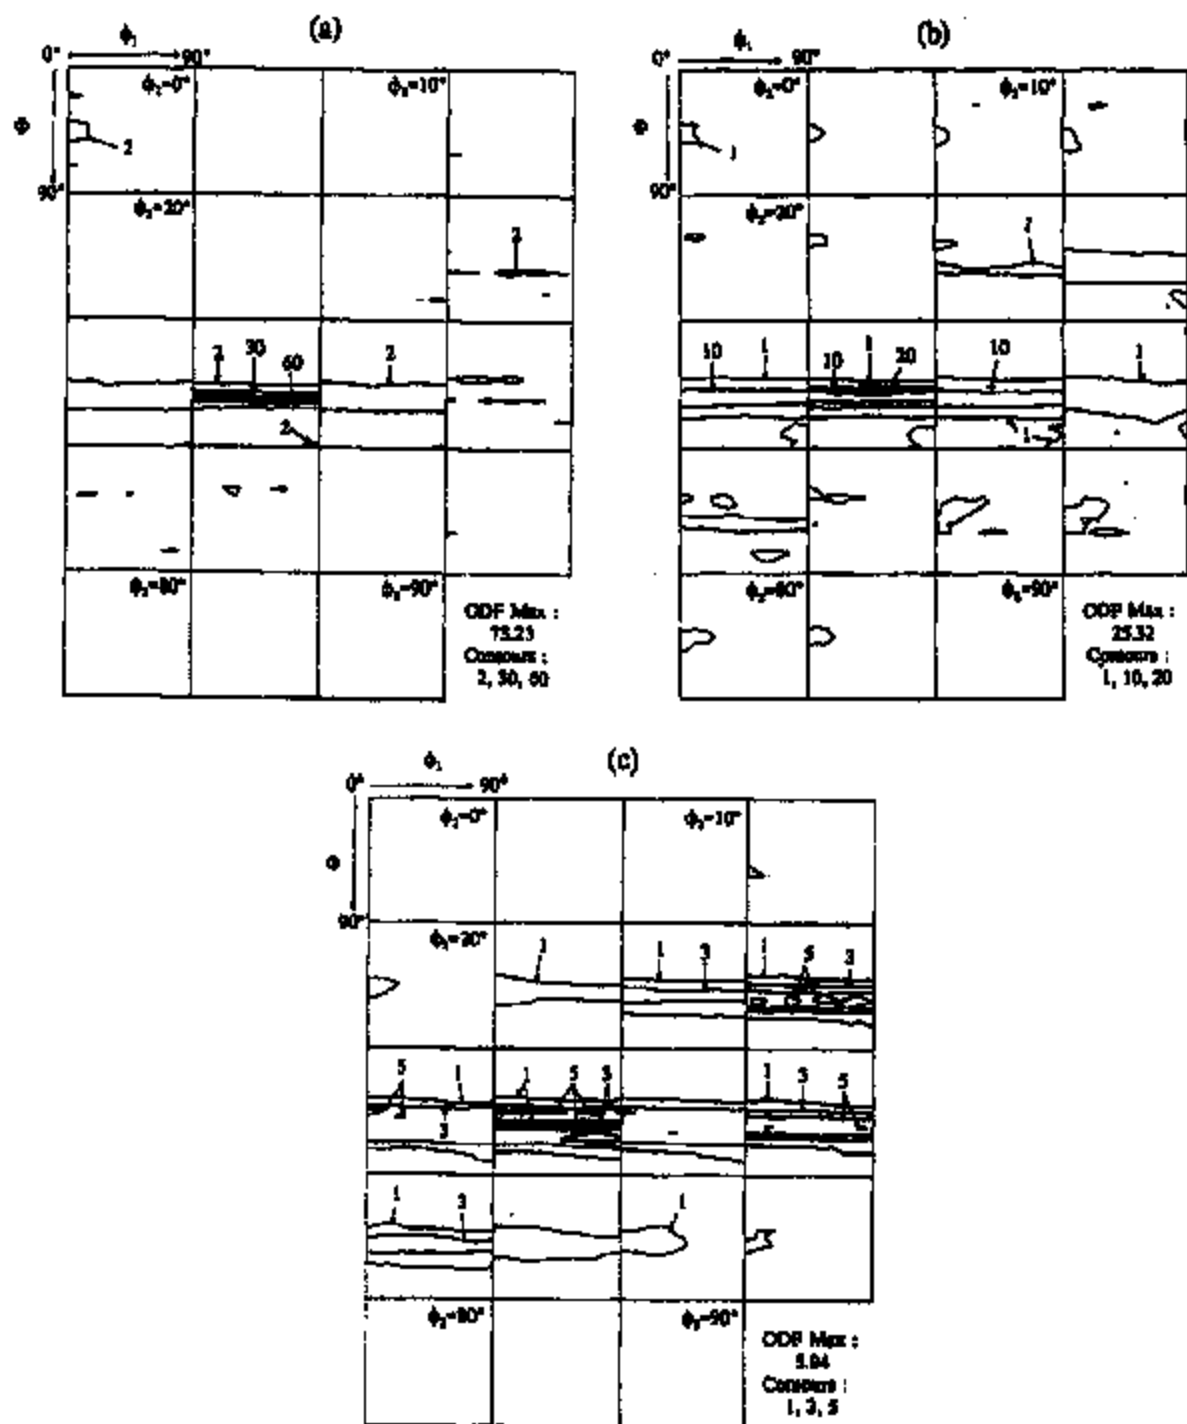
Fig. 1. Orientation distribution function (ODF) for specimens (a) PIB-2/1, (b) PIB-2/2, (c) SP-2.

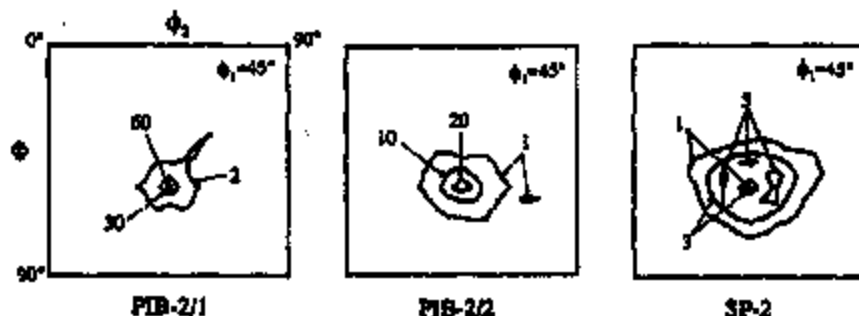
Fig. 2. $\phi_1 = 45^\circ$ sections of the orientation distribution function (ODF) for each specimen.

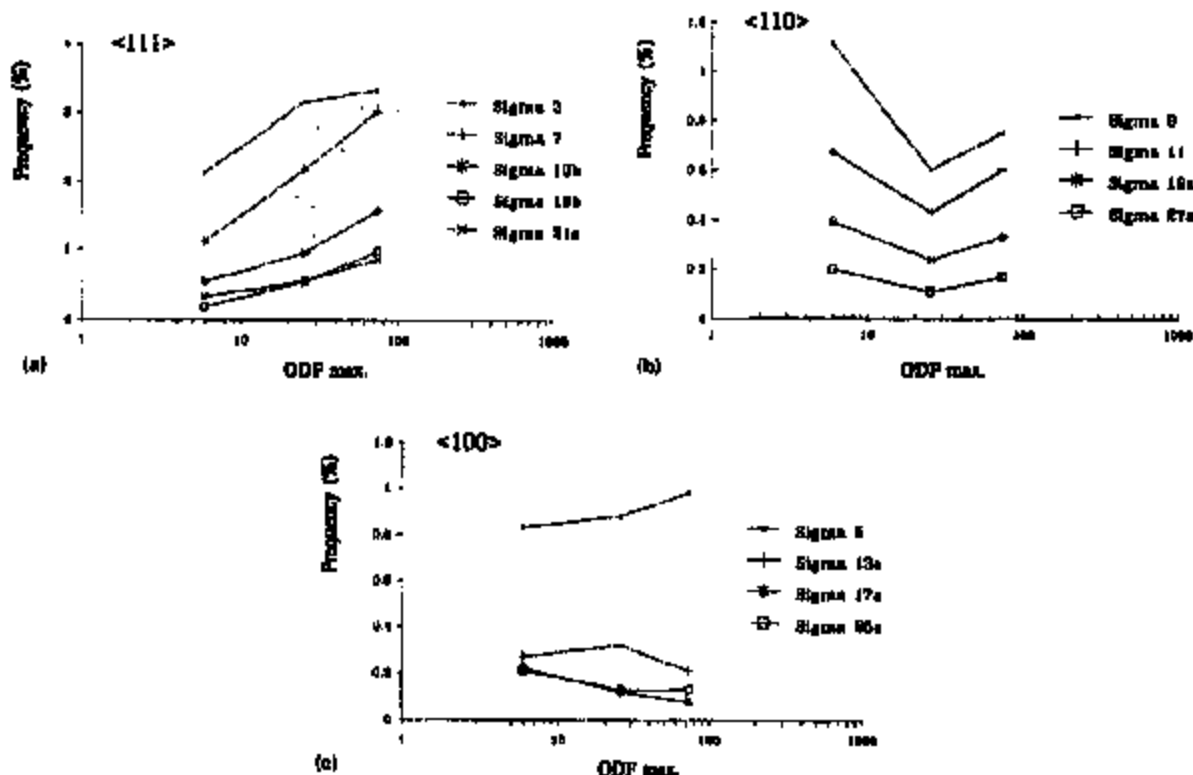
Fig. 4. Frequency of selected CSL boundaries as a function of ODF maximum for: (a) $\langle 111 \rangle$ -type CSL boundaries; (b) $\langle 110 \rangle$ -type CSL boundaries; (c) $\langle 100 \rangle$ -type CSL boundaries.

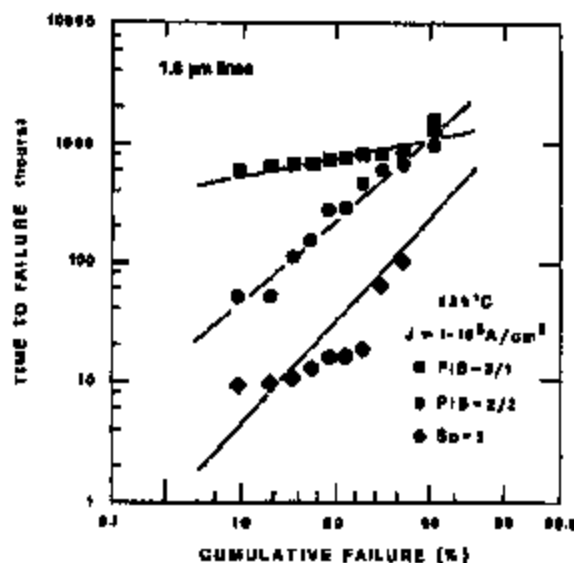
Fig. 5. Electromigration results for three specimens.

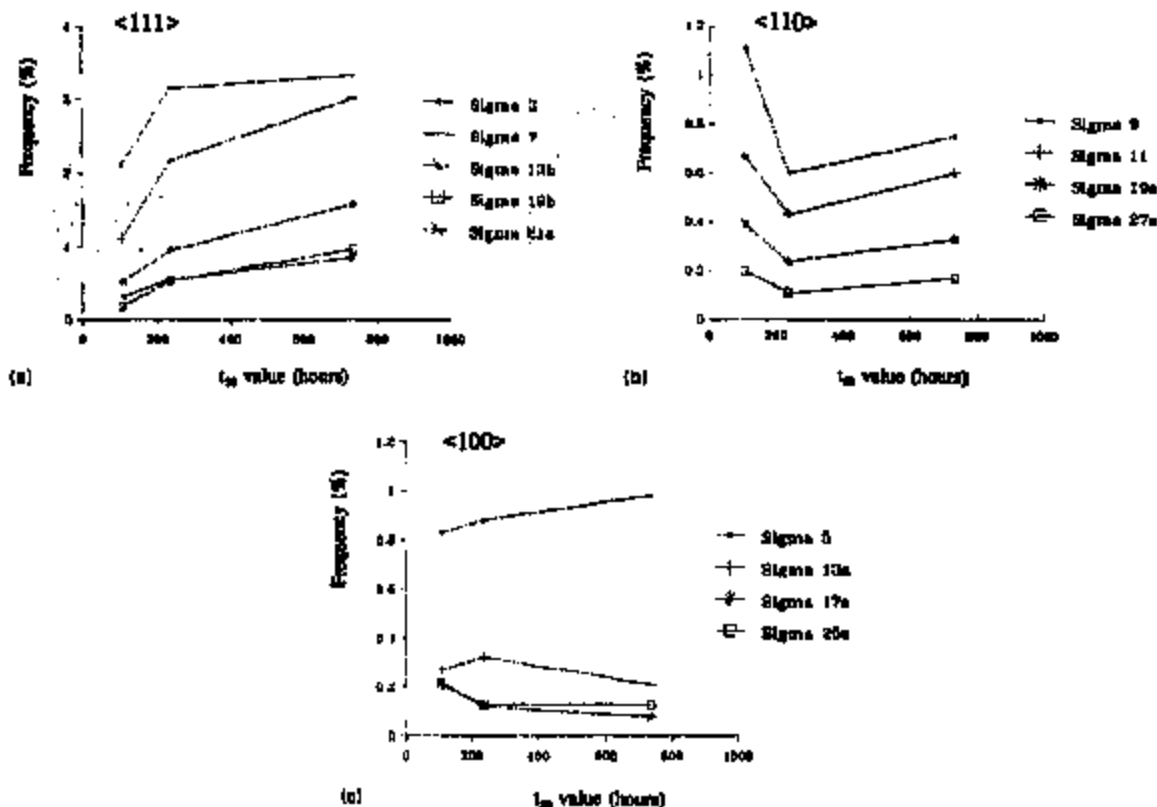
Fig. 6. Frequency of CSL boundaries as a function of median time-to-failure (t_{50} value) for: (a) $\langle 111 \rangle$ -type CSL boundaries; (b) $\langle 110 \rangle$ -type CSL boundaries; (c) $\langle 100 \rangle$ -type CSL boundaries.

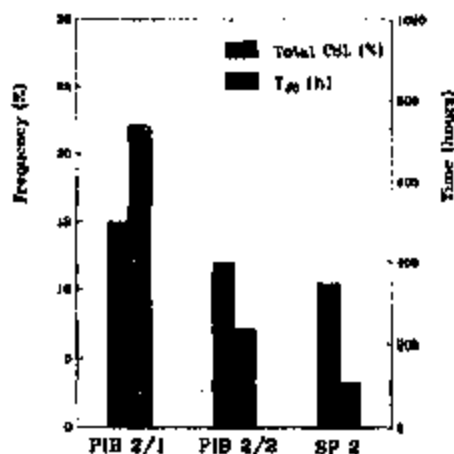
Fig. 7. Comparison of the total frequency of CSL boundaries with the t_{50} value of each specimen.

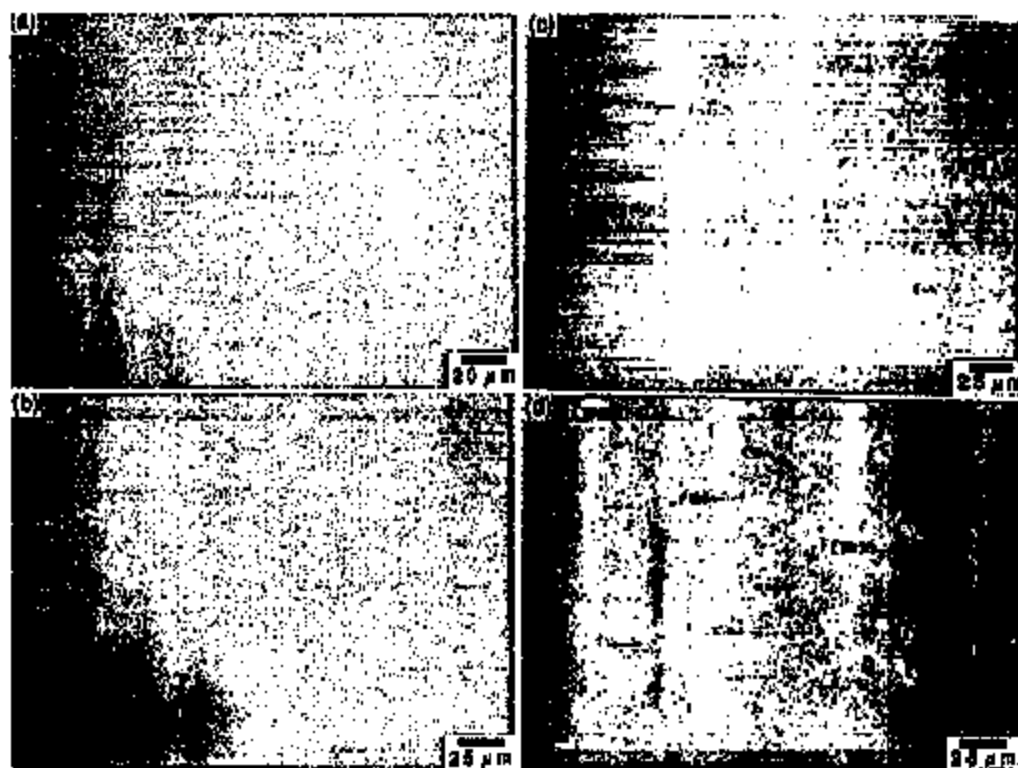
Fig. 2. SEM micrographs of the hillock sequence during isothermal annealing at 533 K: (a) 60 s, (b) 0.6 ks, (c) 2.1 ks, (d) 10.8 ks.

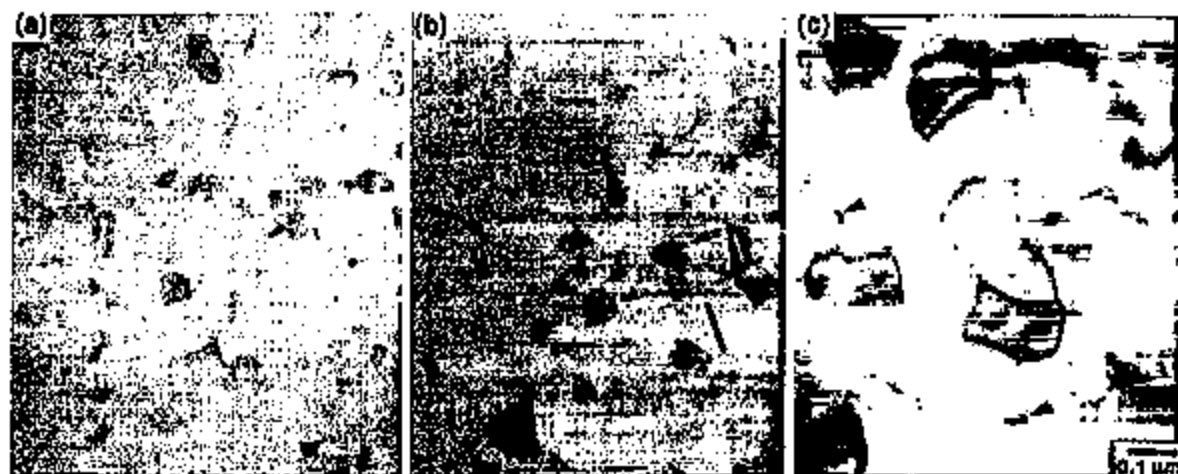
Fig. 3. Plan-view TEM micrographs of Al-2at.%Ta alloy films: (a) as-deposited, (b) annealed at 533 K for 14.4 ks, (c) annealed at 673 K for 3.6 ks.

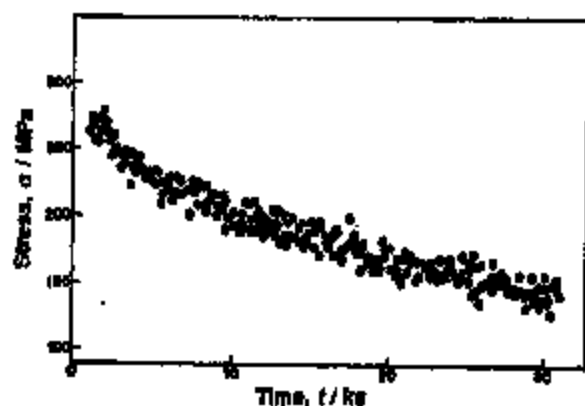
Fig. 5. Annealing-time dependence of compressive stresses for an Al-2at.%Ta alloy film held at 533 K.

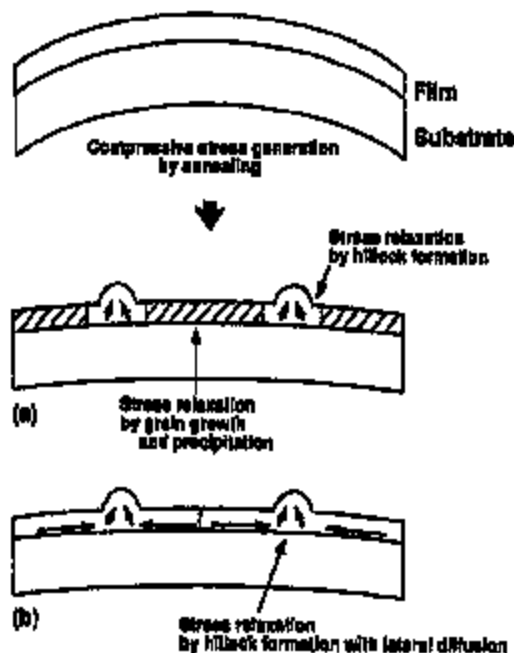
Fig. 7. Schematic drawings of two models relating to the hillock formation behavior on Al-2at.%Ta alloy films.

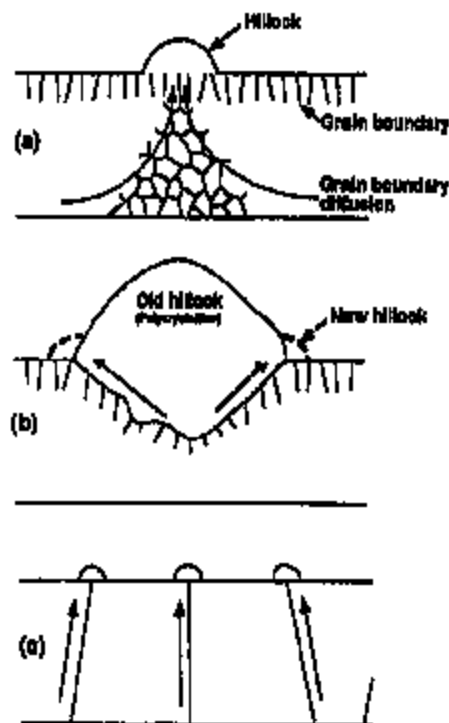
Fig. 8. Schematic drawings of hillock formation comparing a film with fine grains to a film with large grains.

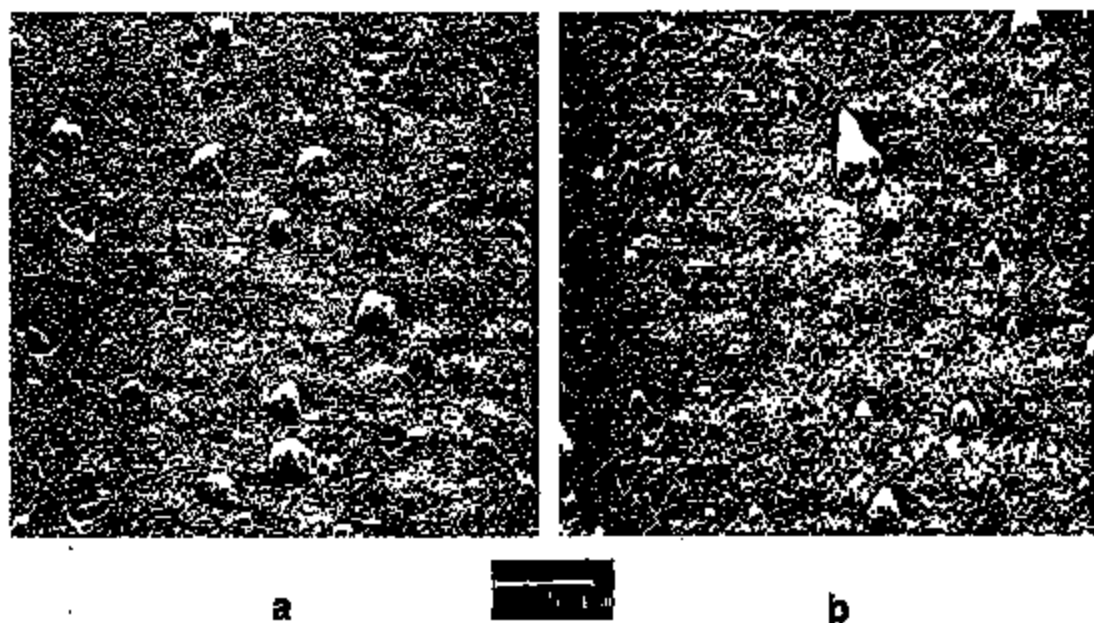
Fig. 1. SEM micrograph of Al surface: (a) unimplanted; (b) implanted with 160 keV Sb⁺ ions to a dose of 5×10^{16} cm⁻².

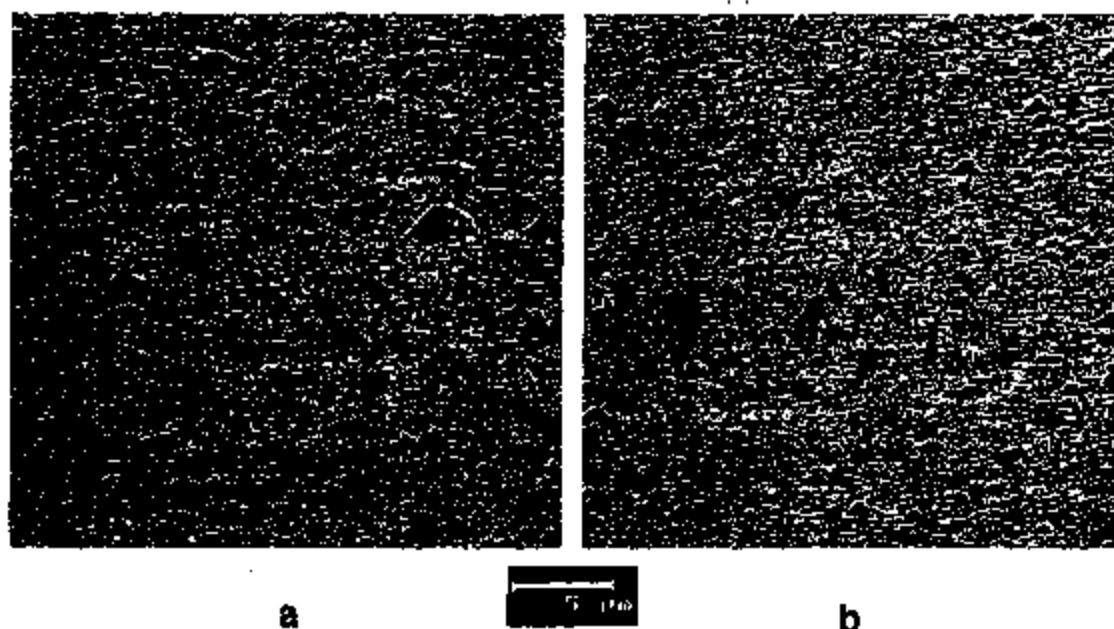
Fig. 2. SEM micrograph of Al:Si 1% surface: (a) unimplanted; (b) implanted with 130 keV Cr^+ ions to a dose of $9 \times 10^{15} \text{ cm}^{-2}$, both annealed at 450°C.

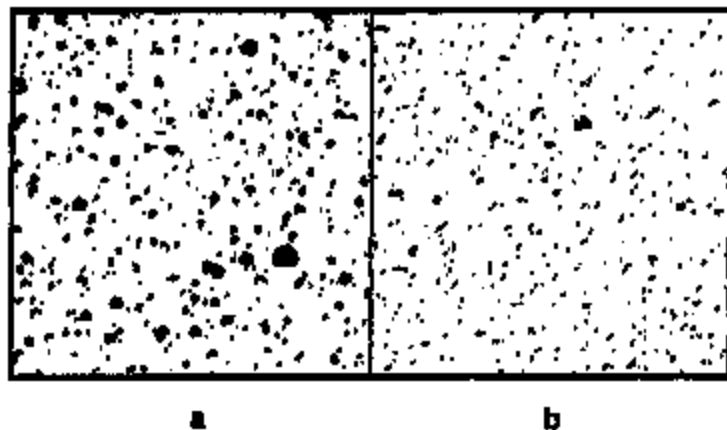
Fig. 3. Al surface examined by hillock recognition method: (a) unimplanted; (b) implanted with boron, $2.5 \times 10^{16} \text{ cm}^{-2}$.

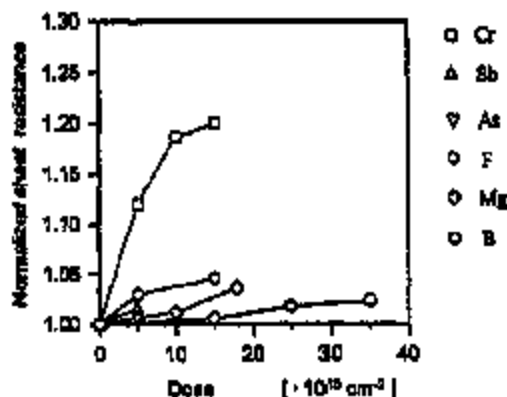
Fig. 5. Sheet resistance measurements of the implanted Al layers relative to unimplanted ones.

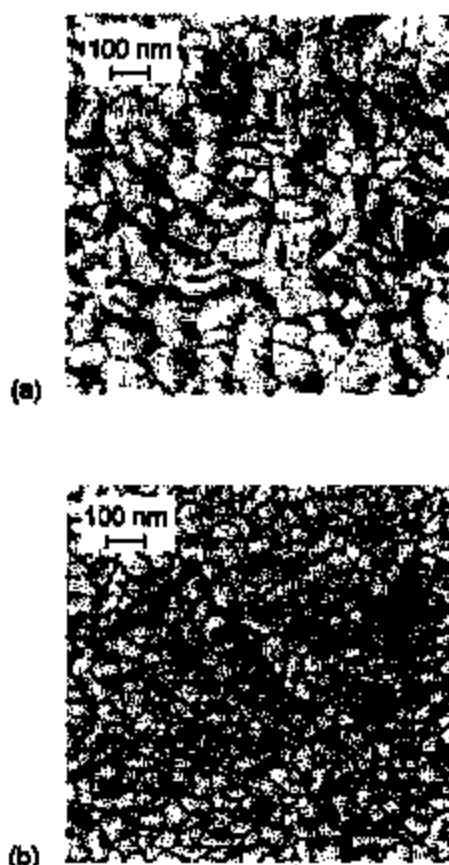
Fig. 1. $1 \times 1 \mu\text{m}^2$ AFM images of: (a) the pure Al film and (b) the Al-3 wt% Cu film obtained in the phase sensitive tapping mode.

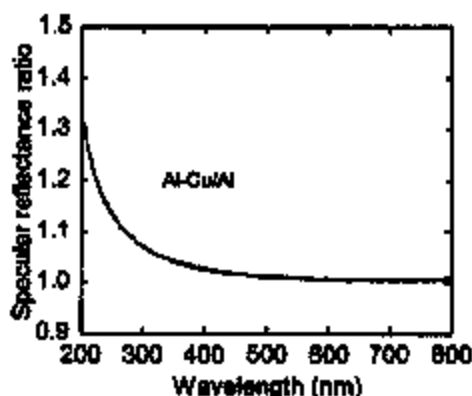
Fig. 3. Specular reflectance ratio (Al-Cu film/Al film) versus wavelength for samples that have been heated to 130°C (Al) and 180°C (Al-3 at.% Cu). The enhanced reflectance of the Al-Cu film in the shorter wavelengths is attributed to less light scattering losses from hillocks.

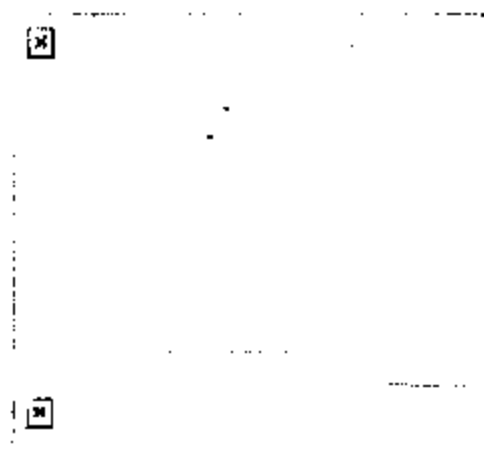
Figure 2: Resistance ratio measured from Al-1%Si-1%Cu films, as deposited from targets of different precipitate levels, as a function of temperature.

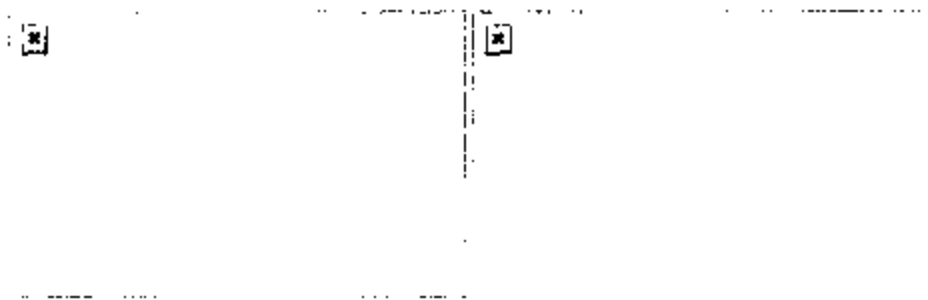
Figure 7: Calculated reflectivity spectra using Lorentz-Drude model with scalar scattering theory, a) effect of film resistivity, b) effect of RMS surface roughness.

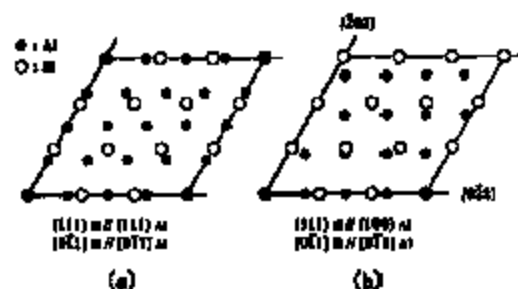
Fig. 1. (a) Schematic diagram showing the superlattice for the Al(1 1 1)/Si(1 1 1) interface. In this model, four Al lattice spacings match three Si lattice spacings. (b) one of the superlattices for the Al(1 0 0)/Si(1 1 1) interface. Only [0 -1 1] direction matches. Open circles and solid circles indicate the position of Si lattice and Al lattice, respectively.

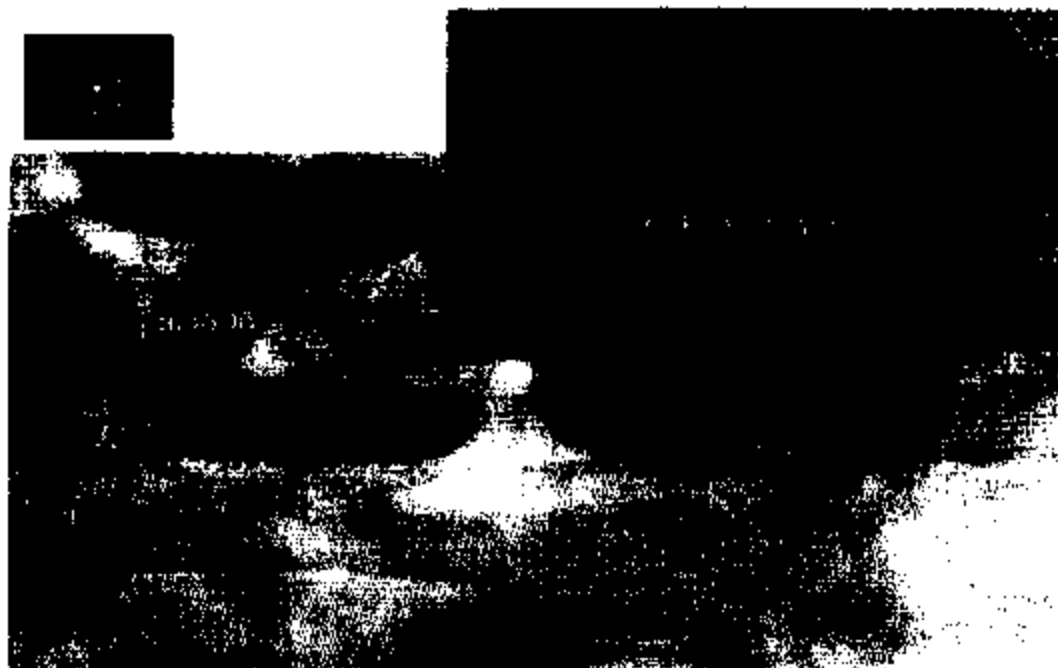
Fig. 2. Cross-sectional lattice image of Al(1 1 1)/Si(1 1 1) interface. An aluminum film deposited by GTC-CVD technique. Incident electron beam is parallel to Si [1 1 0] direction.

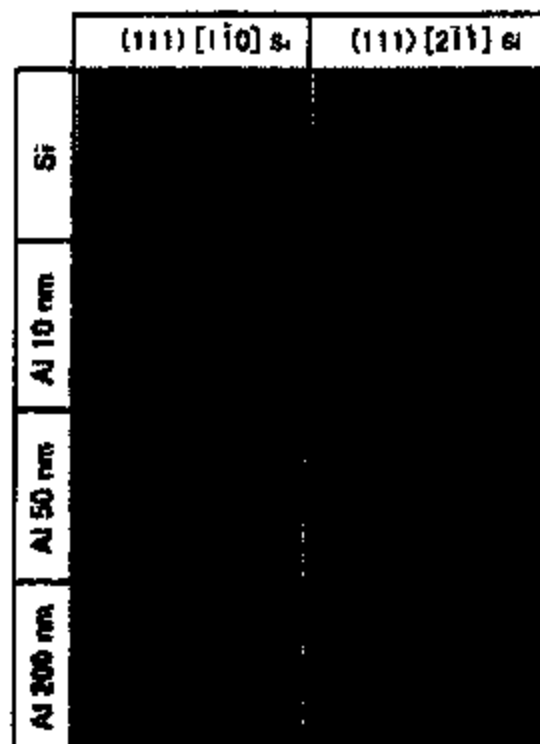
Fig. 3. In situ observation of Al epitaxial growth on Si(1 1 1) substrate by sputtering. In initial stage, three kinds of Al(1 0 0) domains were observed. Subsequently, the Al(1 1 1) domains grow by reorientation of the Al(1 0 0) domains. Finally, only the Al(1 1 1) structure remained.

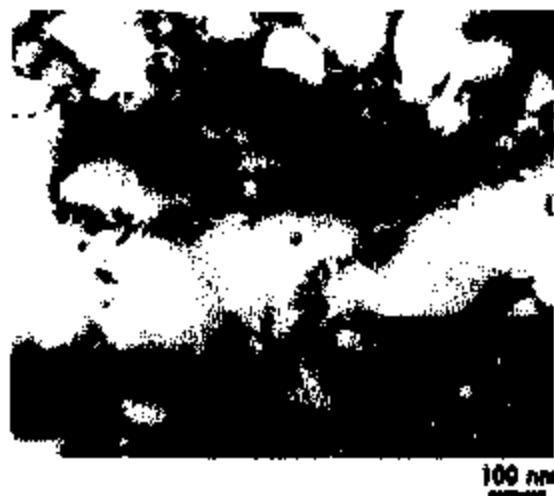
Fig. 4. A bright-field image and a selective area diffraction pattern of the 400 nm thick *qs*-Al film deposited by sputtering. Many dislocation arrays were observed.

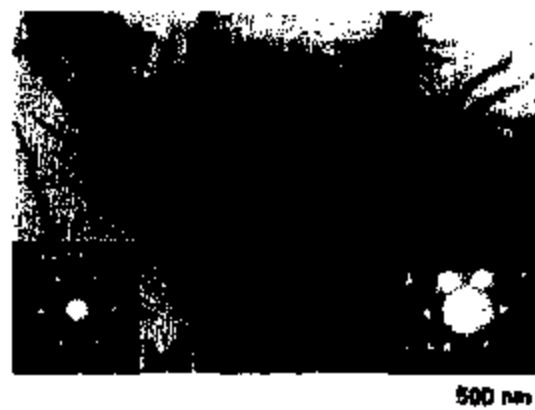
Fig. 5. A bright-field image and selective area diffraction pattern of the 400 nm thick *s*-Al(Cu) film deposited by GTC-CVD technique and subsequently implanted with Cu. In SAD on grain boundary, some streaks attributed to GP-zone were observed at ambient temperature.

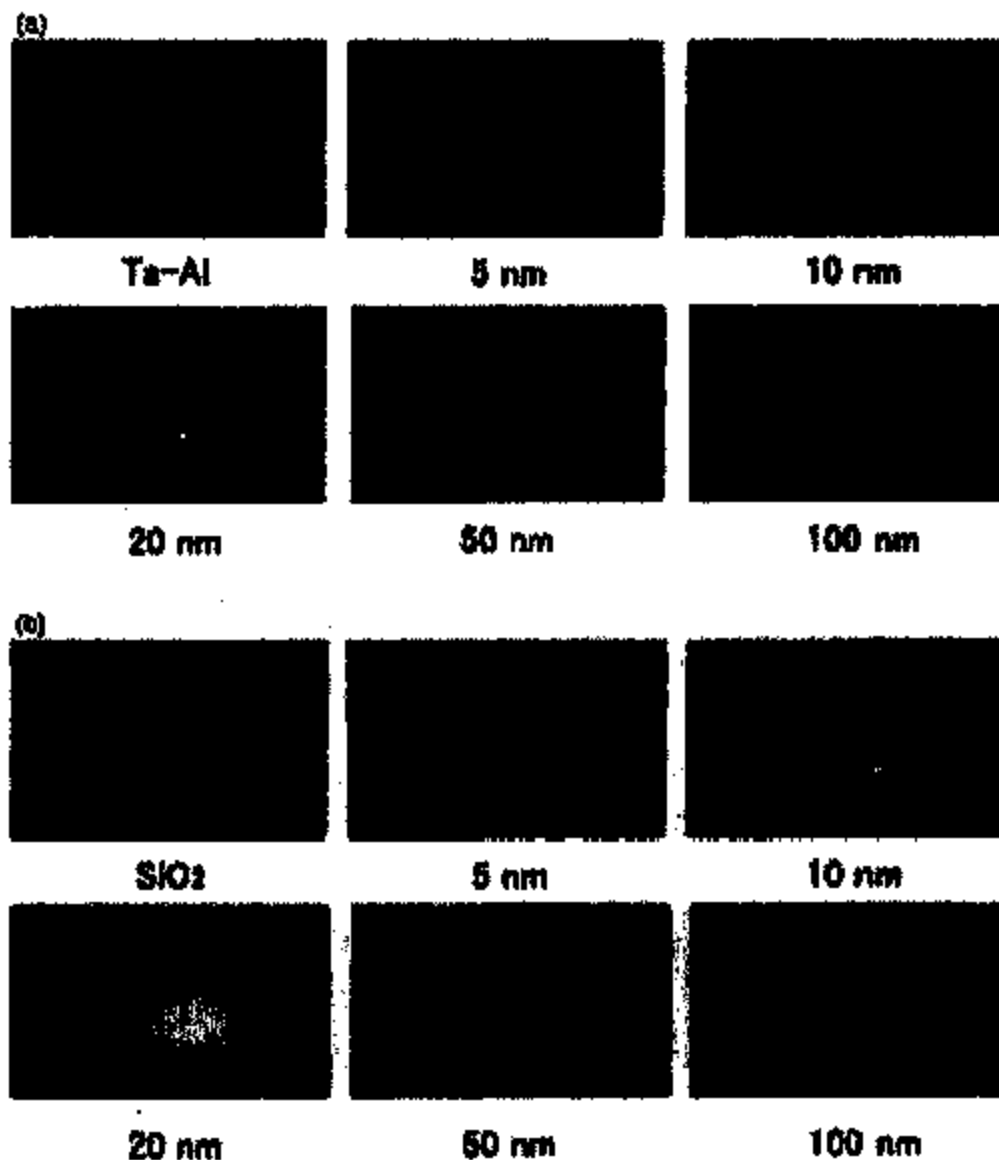
Fig. 6. (a) In situ RHEED observation results of growth of Al deposited on the amorphous Ta-Al underlayer; (b) In situ RHEED observation results of growth of Al deposited on SiO₂.

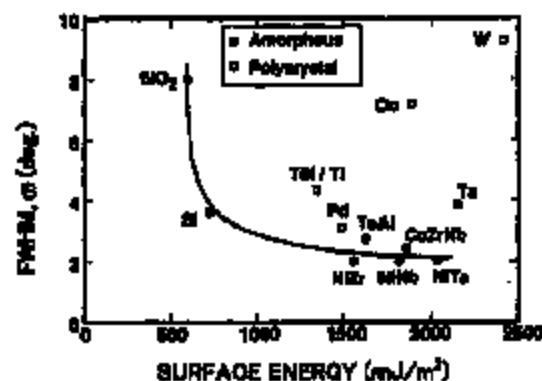
Fig. 7. The relationship between surface energy of underlayer and the FWHM values of 20 nm thick Al films deposited on the underlayers. The open squares and closed circles indicate polycrystalline underlayers and amorphous underlayers, respectively.

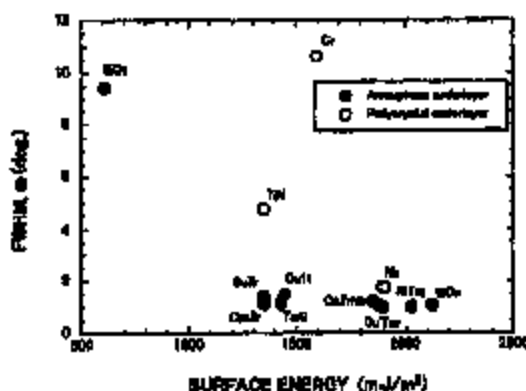
Fig. 8. The relationship between surface energy of underlayer and the FWHM values of 100 nm thick Cu films deposited on the underlayers. The open circles and closed circles indicate polycrystalline underlayers and amorphous underlayers, respectively.

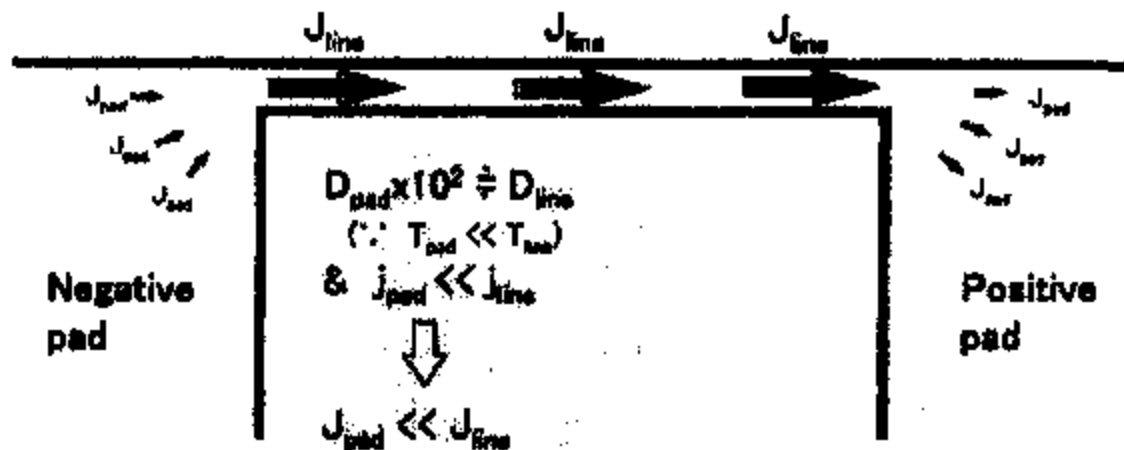
Fig. 10. Schematic diagram of highly accelerated EM test condition.

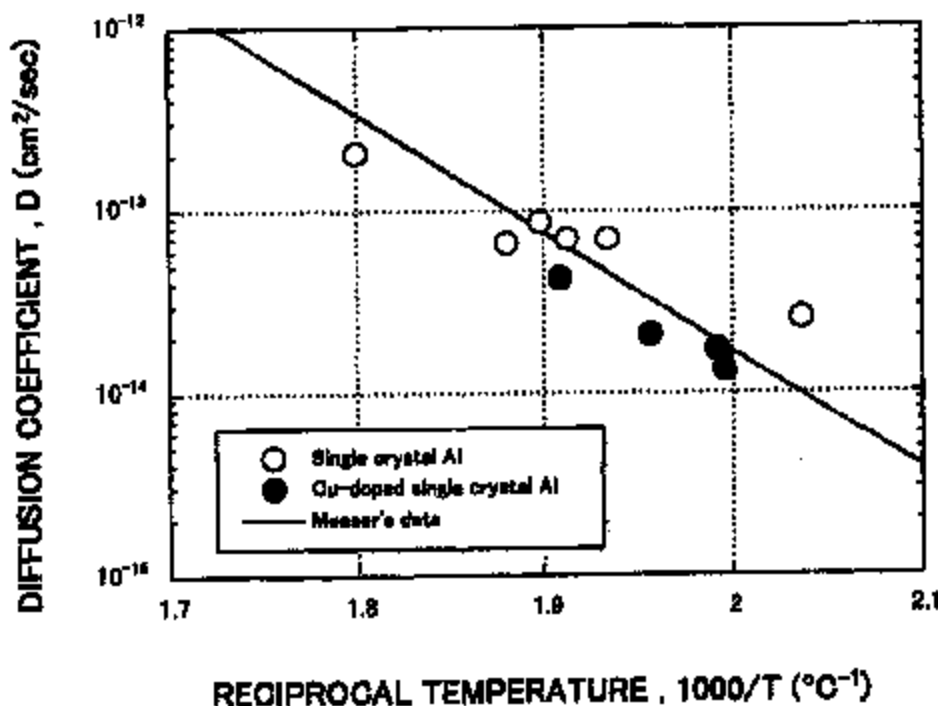
Fig. 12. Arrhenius plot of the Al diffusion coefficients obtained from void growth rate. The open circles and the closed circles indicate s-Al and p-Al(Cu), respectively, and solid line presents Meuser's data.

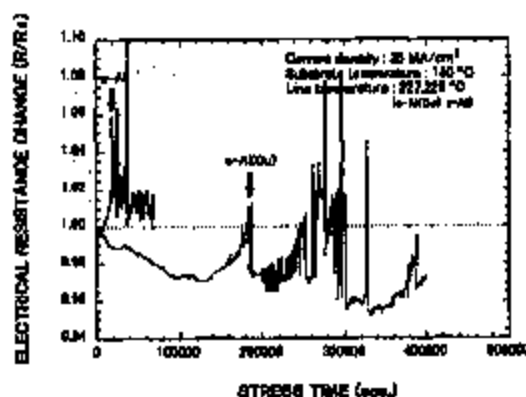
Fig. 13. Electrical resistance change for s-Al and s-Al(Cu) lines during EM accelerated testing with current density of 35 MA/cm².

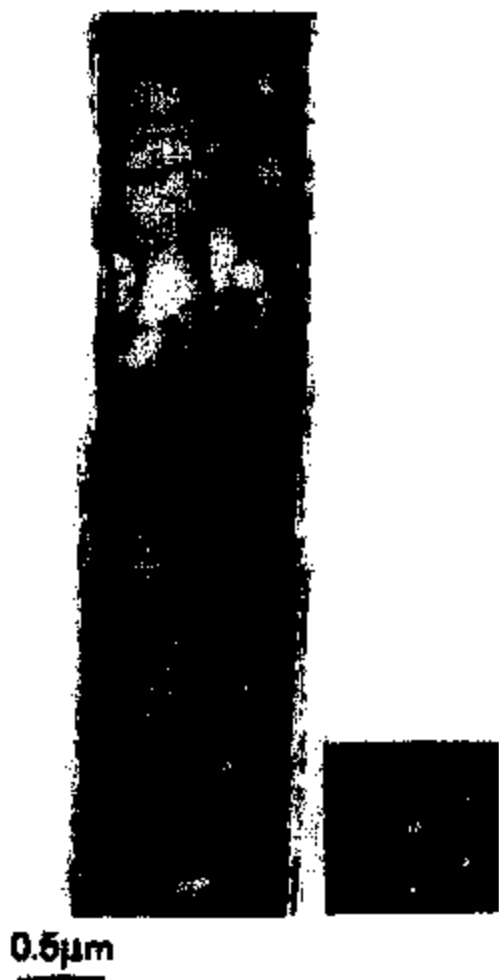
Fig. 14. Bright-field image and selected area diffraction pattern of qe-Al line after EM accelerated test.

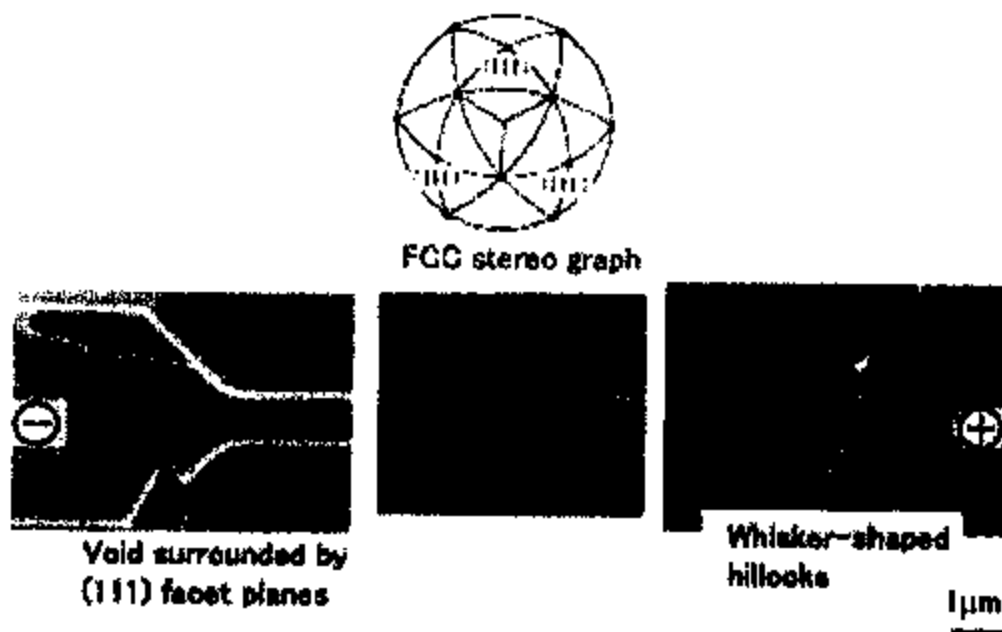
Fig. 15. SEM photograph of qz-Al line after EM acceleration test.

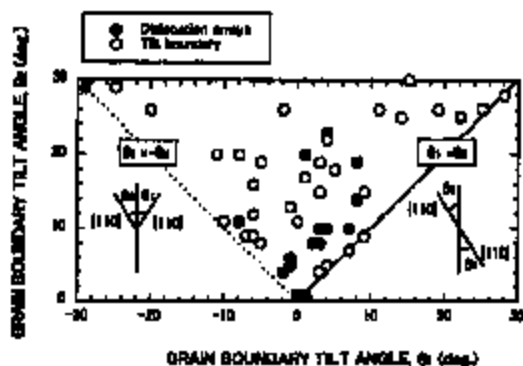
Fig. 18. Misorientation angle between the grains on both sides at grain boundary closed circle: dislocation array; open circle: tilt boundary.

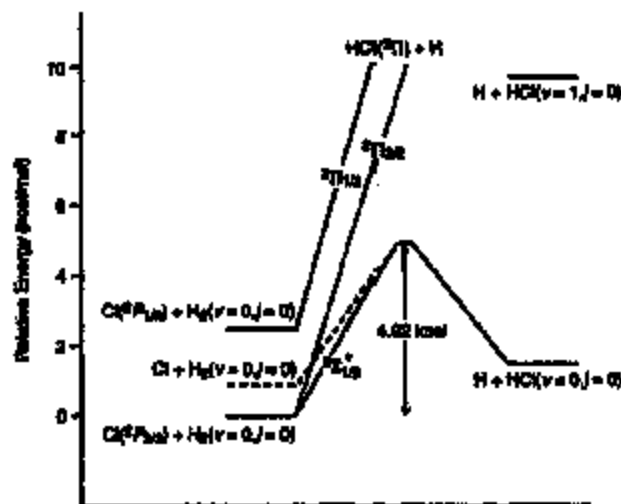
¹Department of Chemistry and Biochemistry and Institute for Physical Sciences and Technology, University of Maryland, College Park, MD 20742-5021, USA.
²Institut für Theoretische Chemie, Universität Stuttgart, D-70569 Stuttgart, Germany.

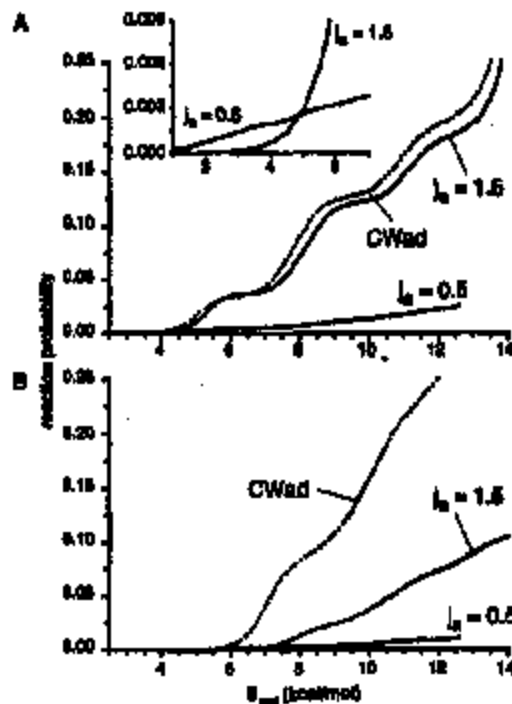
obically allowed) SO state corresponds to the successive opening of additional vibrational states at the barrier.

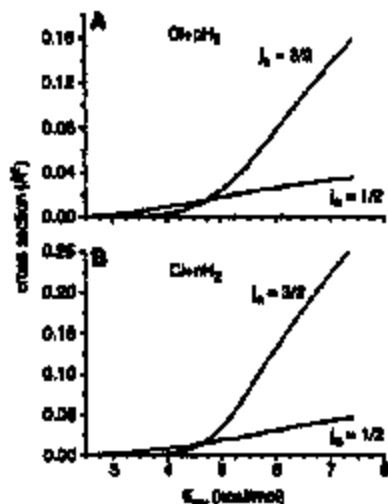
Fig. 5. (A) Integral cross sections for reaction of Cl in its ground ($j_0 = 0/2$) and excited ($j_0 = 1/2$) SO states with p -H₂. (B) Similar integral cross sections for reaction with n -H₂. The relative rotational state populations of the $j = 0, 1$ and 2 H₂ rotational levels were taken from [4–6].

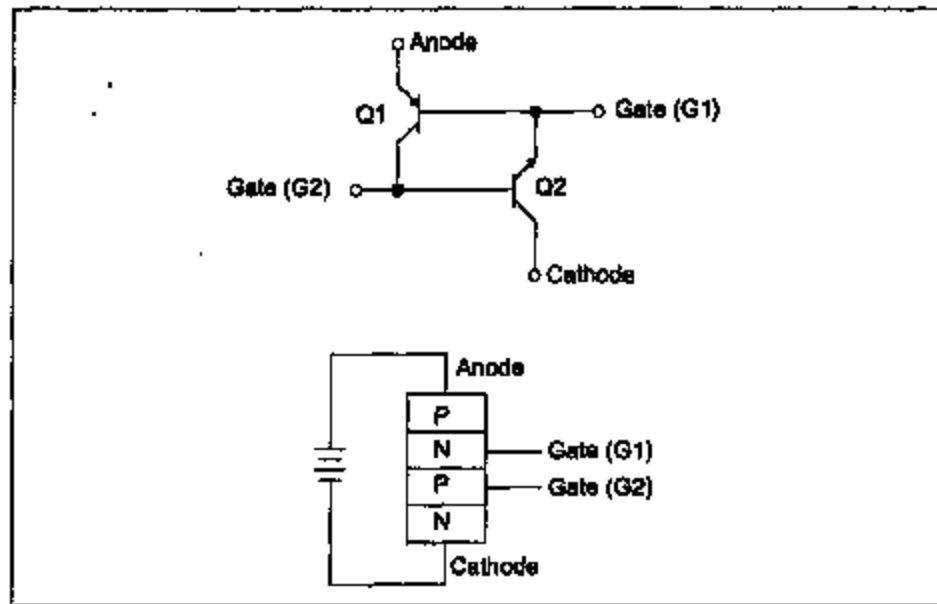
1.1 SCR Latch-Up Description

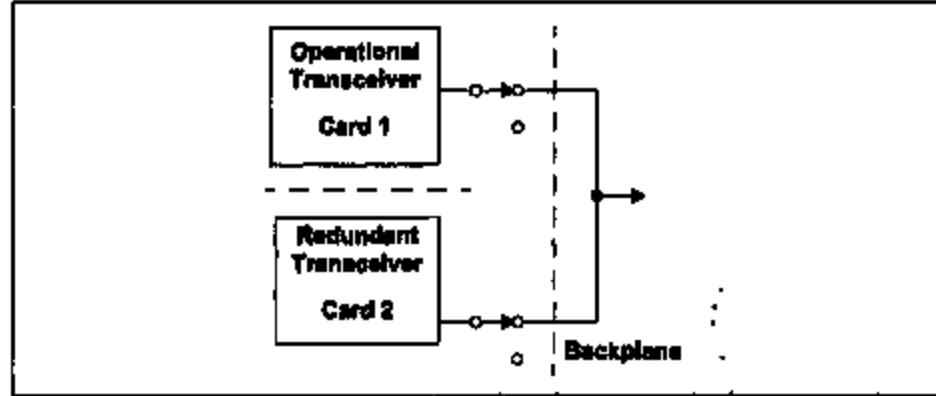
Figure 2. Applications of Redundancy

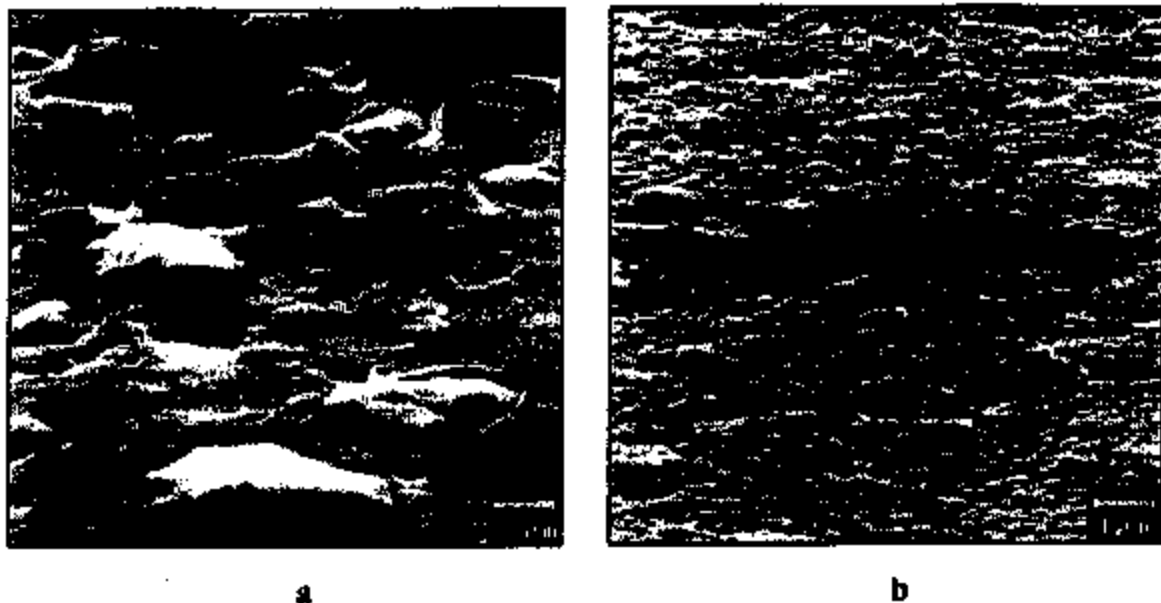
Fig. 1. Metallization surface examined by SEM after annealing (450°C, 30 min): (a) magnetron sputtered Al layer 1 μm thick; (b) similar layer of Al:Si:Cu alloy.

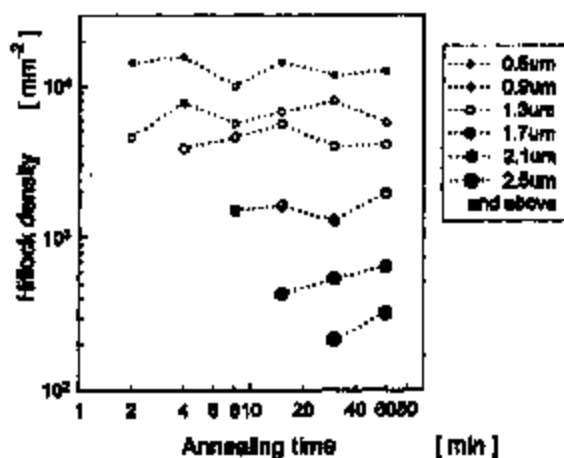
Fig. 2. Surface density of hillocks as a function of annealing time at a temperature of 400°C in N_2 for sputter-deposited Al layer of $0.7 \mu\text{m}$ thickness.

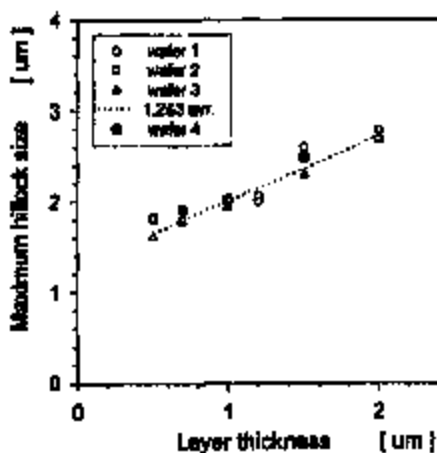
Fig. 4. Maximum hillock size versus Al layer thickness after furnace annealing at a temperature of 400°C for 8 min in N_2 (samples 1, 2 and 3). Sample no. 4 was annealed at 450°C for 5 min.
