FORD 8/5/03

LETTER TO ODI

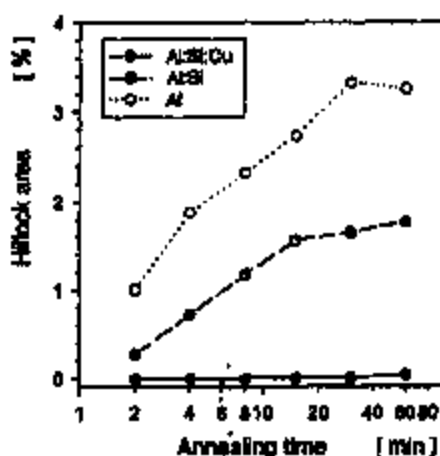
Fig. 5. Total area of hillocks normalized to the sample area as a function of annealing time at a temperature of 400°C in N_2 atmosphere for 1 μm thick Al and Al-based metallization layers.

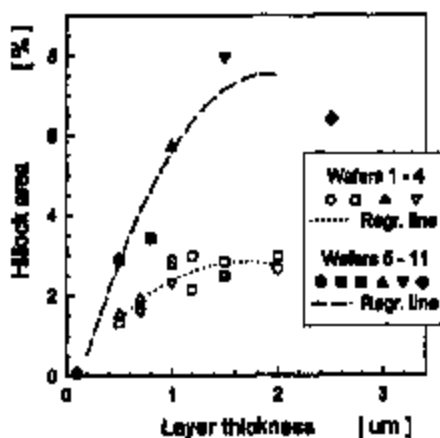
Fig. 6. Total area of hillocks normalized to the sample area versus Al layer thickness. Samples 1–4 were annealed at a temperature of 400°C for 8 min; samples 5–11 at 'standard' conditions (450°C, 30 min).

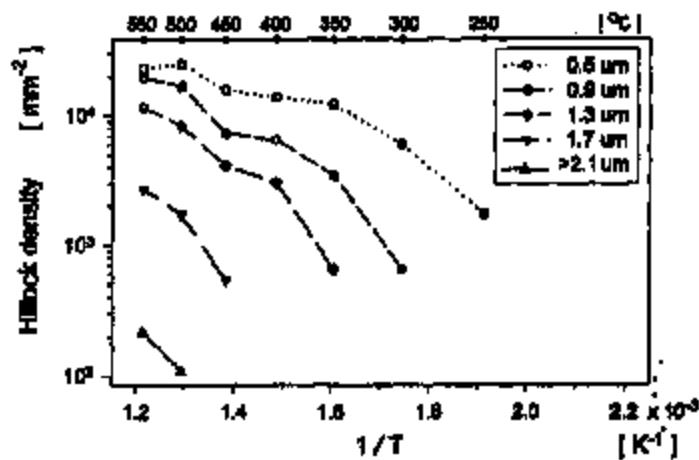
Fig. 7. Distribution of density of aluminum hillocks grouped with regard to their average diameters, as a function of reciprocal of temperature of 5 min isochronal annealings in an RTP reactor in an argon atmosphere.

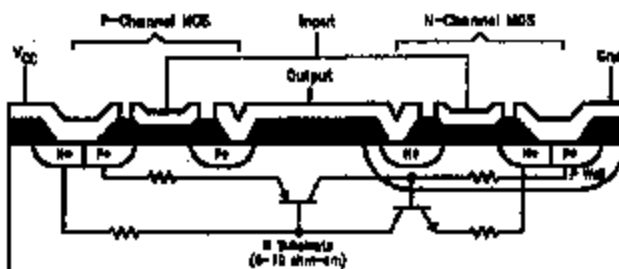
FIGURE 1. Basic CMOS Inverter Cross Section with Latch-Up Circuit Model

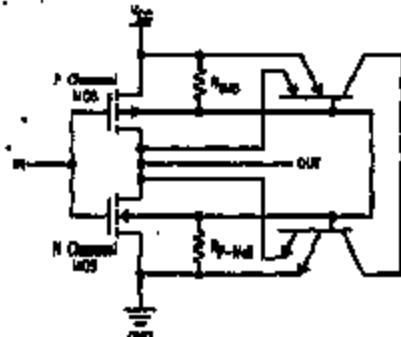
FIGURE 3. N-Substrate CMOS Inverter with Parasitic Bipolars

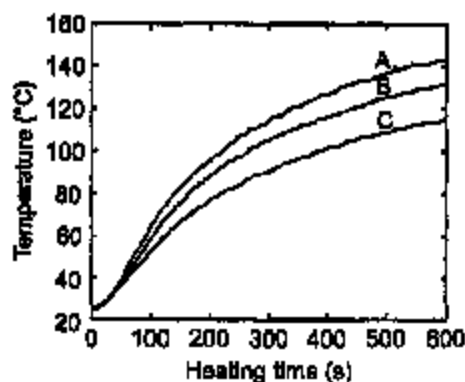
Fig. 2. Thermal runtimes plotted as sample temperature vs. heating time.

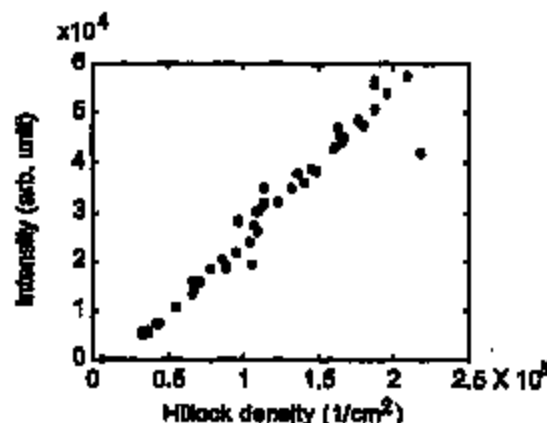
Fig. 3. Average intensity of CCD camera image vs. number of hillocks/cm² present for the images acquired in thermal treatment C. The average intensity is a measure related to that obtained by total integrated scattering.

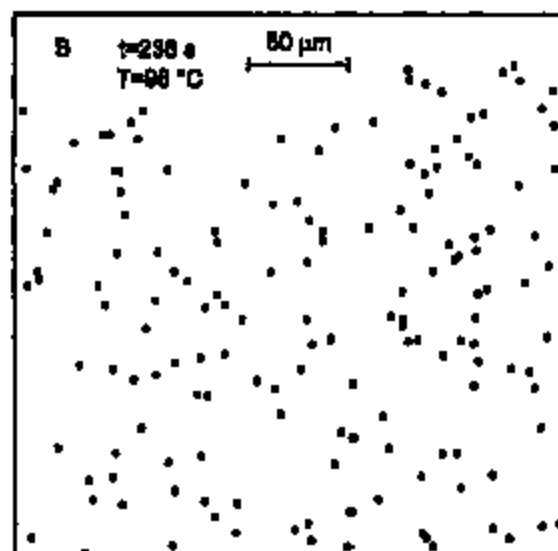
Fig. 6. The hillocks often tended to line up along distorted ring shaped patterns. The smaller sizes have been enlarged for easier observation.

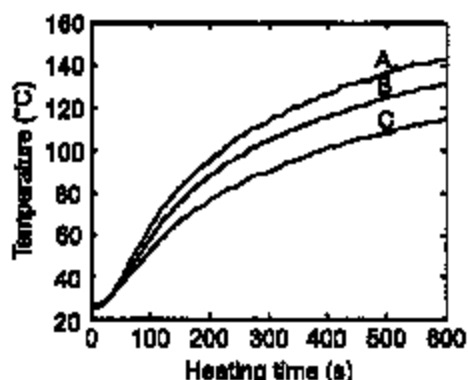
Fig. 2. Thermal treatments plotted as sample temperature vs. heating time.

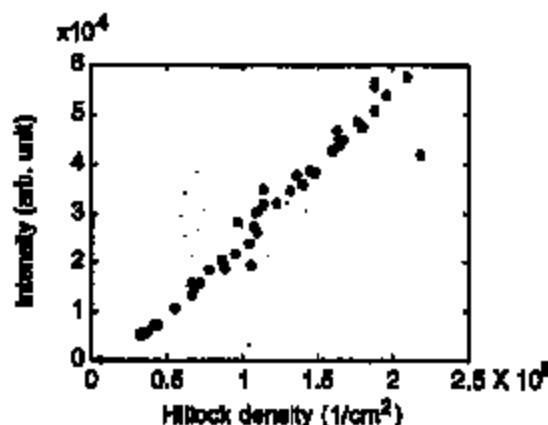
Fig. 3. Average intensity of CCD camera image vs. number of hillocks/cm² present for the images acquired in thermal treatment C. The average intensity is a variable related to that obtained by total integrated scattering.

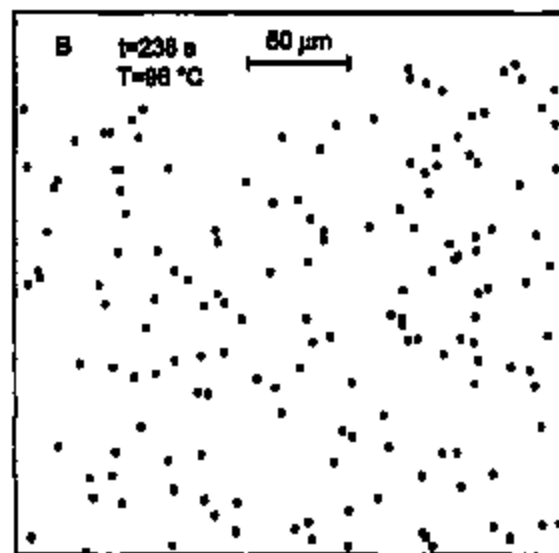
Fig. 6. The hillocks often tended to line up along distorted ring shaped patterns. The smaller sizes have been enlarged for easier observation.

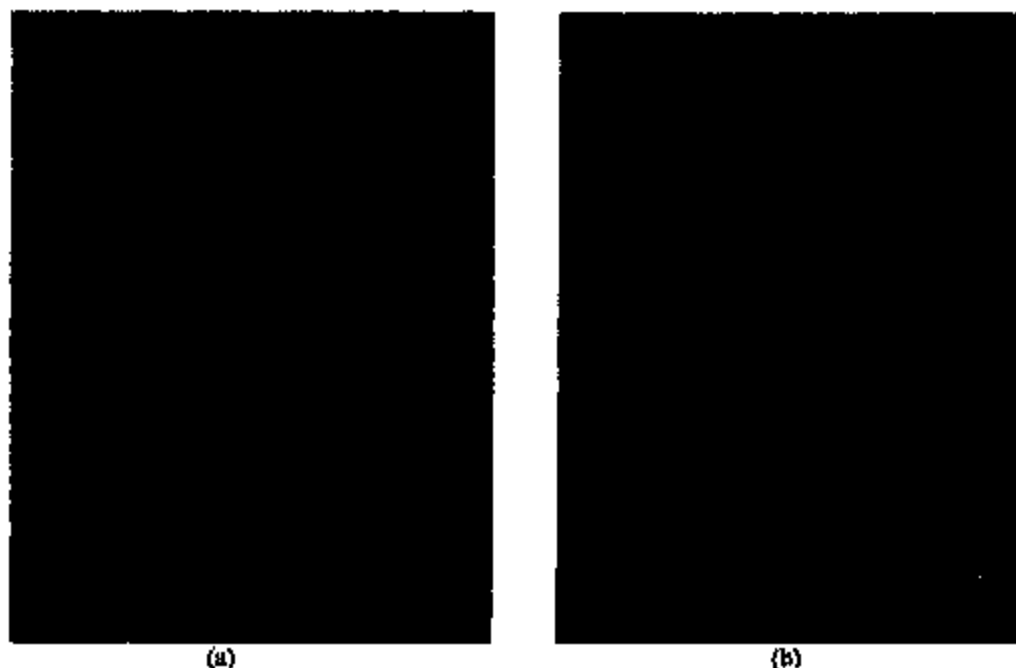
Fig. 2. Scanning electron micrographs of (a) a single hillock, (b) an unusually big hillock.

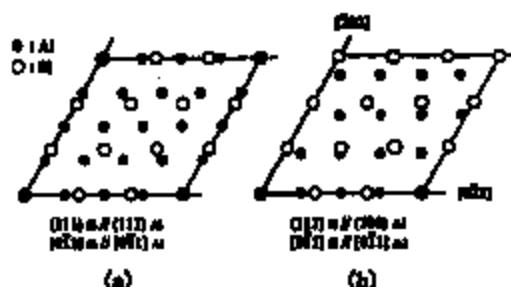
Fig. 1. (a) Schematic diagram showing the superlattice for the Al(1 1 1)/Si(1 1 1) interface. In this model, four Al lattice spacings match three Si lattice spacings; (b) one of the superlattices for the Al(1 0 0)/Si(1 1 1) interface. Only [0 -1 1] direction matches. Open circles and solid circles indicate the positions of Si lattice and Al lattice, respectively.

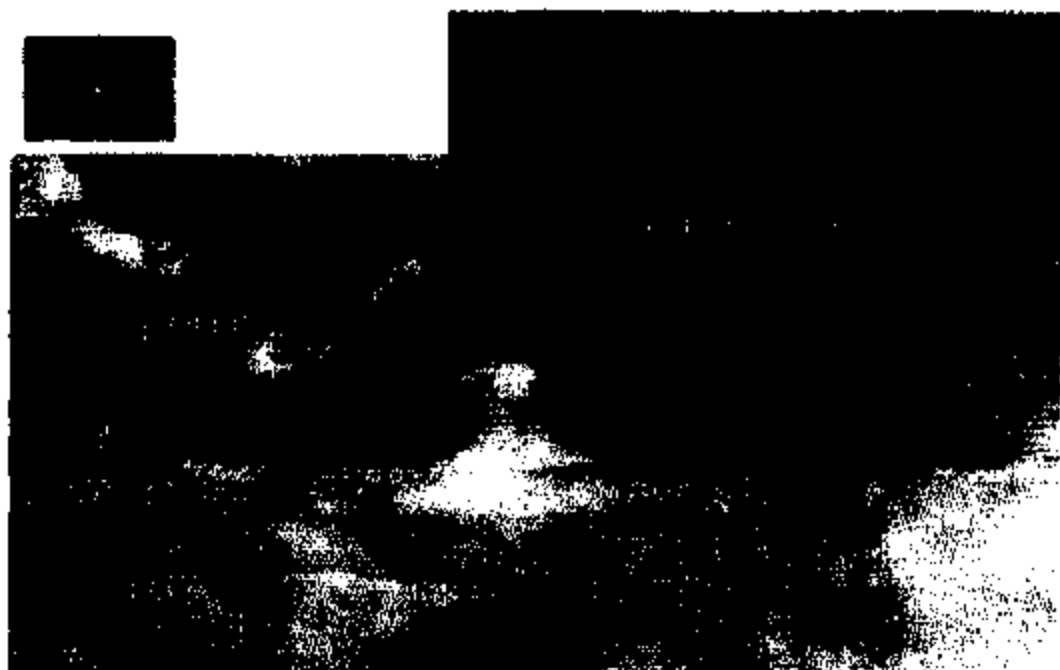
Fig. 2. Cross-sectional lattice image of Al(1 1 1)/Si(1 1 1) interface. An aluminum film deposited by GTC-CVD technique. Incident electron beam is parallel to Si [1 1 0] direction.

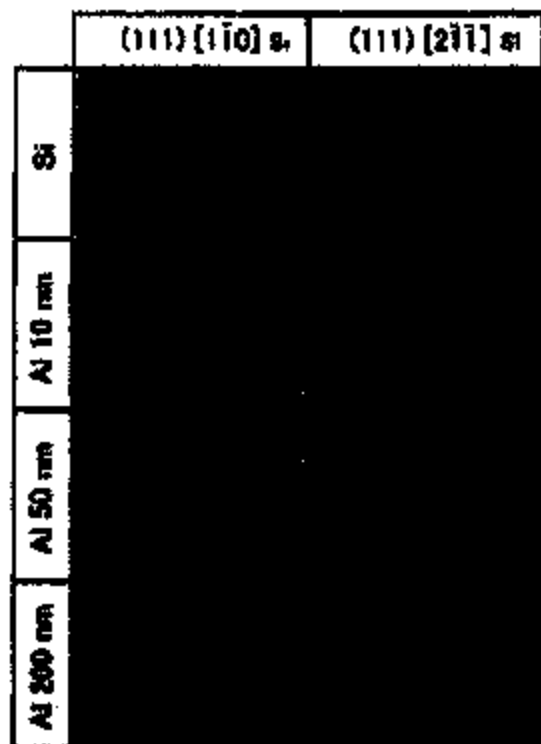
Fig. 3. In situ observation of Al epitaxial growth on Si(111) substrate by sputtering. In initial stage, three kinds of Al(100) domains were observed. Subsequently, the Al(111) domains grew by reorientation of the Al(100) domains. Finally, only the Al(111) structure remained.

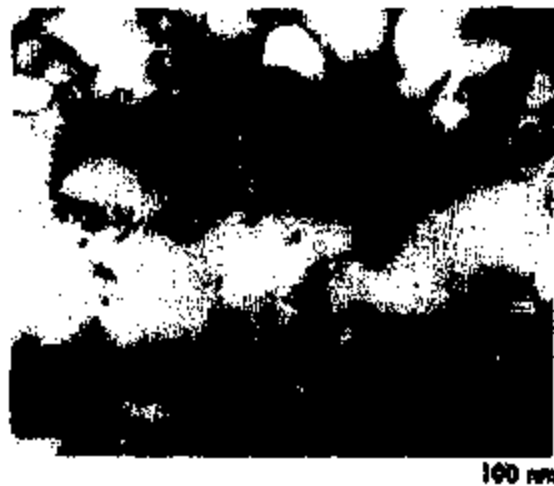
Fig. 4. A bright-field image and a selective area diffraction pattern of the 400 nm thick qs-Al film deposited by sputtering. Many dislocation arrays were observed.

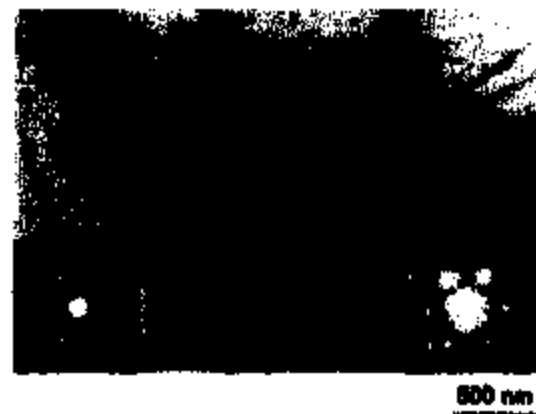
Fig. 5. A bright-field image and selective area diffraction patterns of the 400 nm thick s-Al(Cu) film deposited by GTC-CVD technique and subsequently implanted with Cu. In SAD on grain boundary, some streaks attributed to GP-zones were observed at ambient temperature.

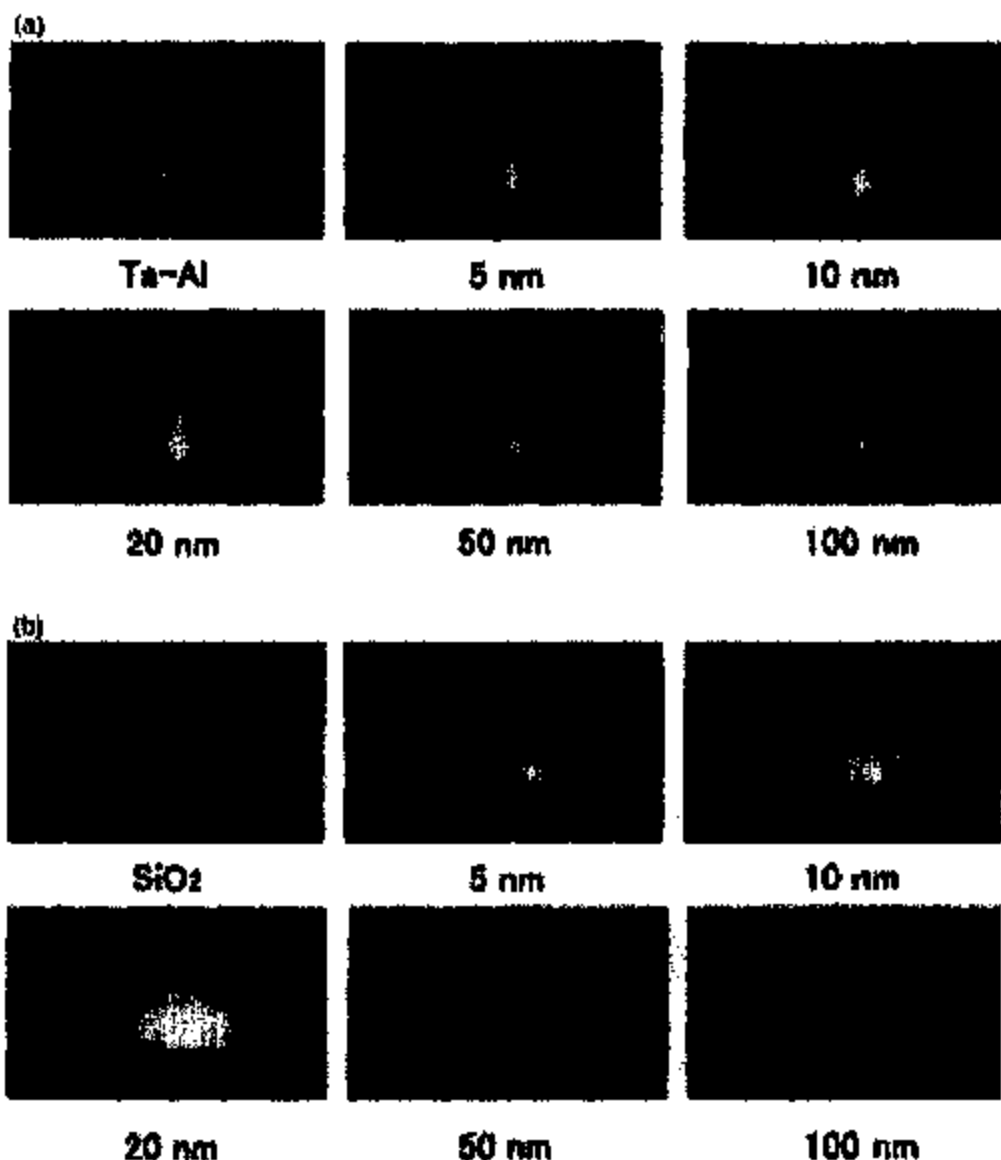
Fig. 6. (a) In situ RHEED observation results of growth of Al deposited on the amorphous Ta-Al underlayer; (b) In situ RHEED observation results of growth of Al deposited on SiO₂.

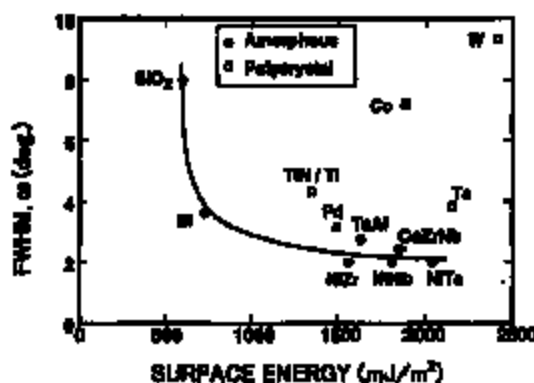
Fig. 7. The relationship between surface energy of underlayer and the FWHM values of 20 nm thick Al films deposited on the underlayers. The open squares and closed circles indicate polycrystalline underlayers and amorphous underlayers, respectively.

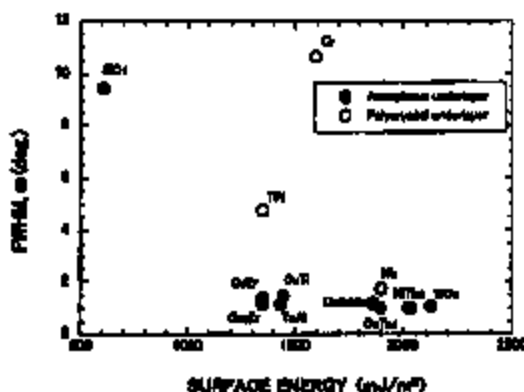
Fig. 8. The relationship between surface energy of underlayer and the FWHM values of 100 nm thick Cu films deposited on the underlayers. The open circles and closed circles indicate polycrystalline underlayers and amorphous underlayers, respectively.

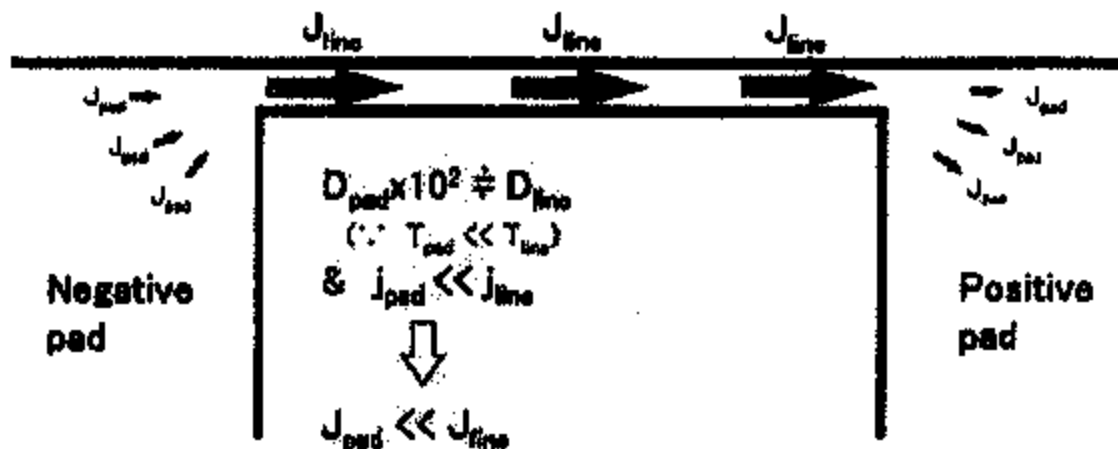
Fig. 10. Schematic diagram of highly accelerated EM test condition.

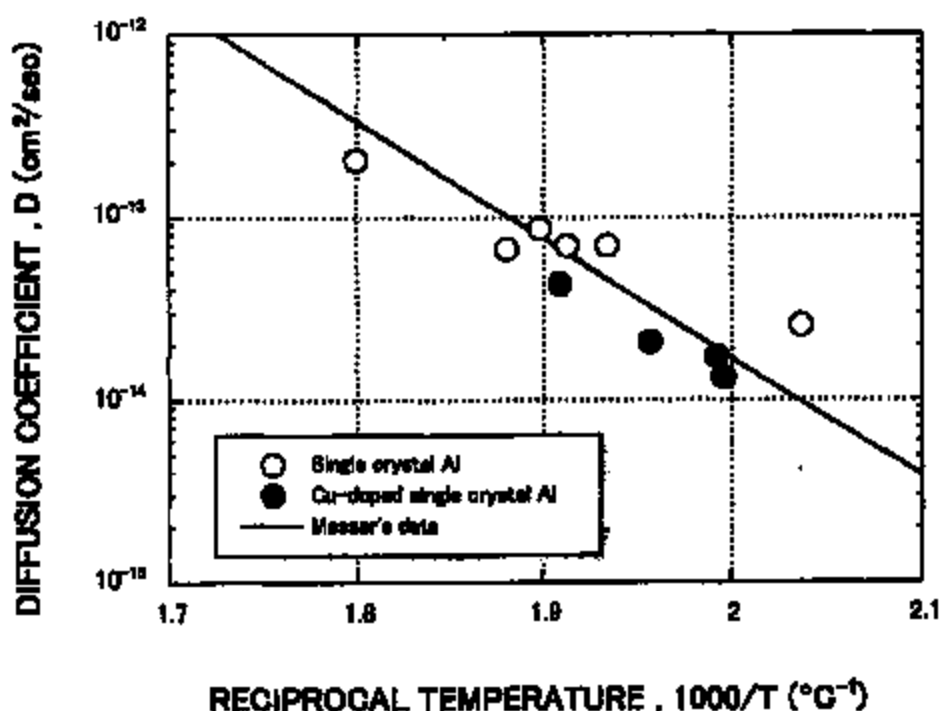
Fig. 12. Arrhenius plot of the Al diffusion coefficients obtained from void growth rate. The open circles and the closed circles indicate s-Al and s-AlCu, respectively, and solid line presents Messer's data.

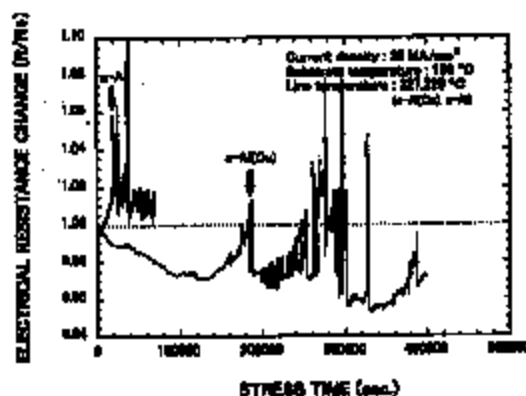
Fig. 13. Electrical resistance change for s-Al and s-Al(Cu) lines during EM accelerated testing with current density of 35 MA/cm².

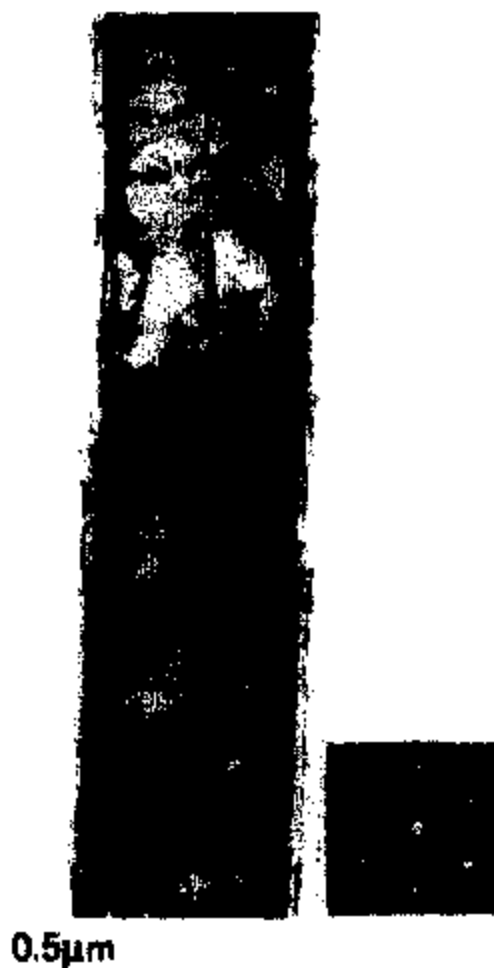
Fig. 14. Bright-field image and selected area diffraction pattern of qs-Al line after EM acceleration test.

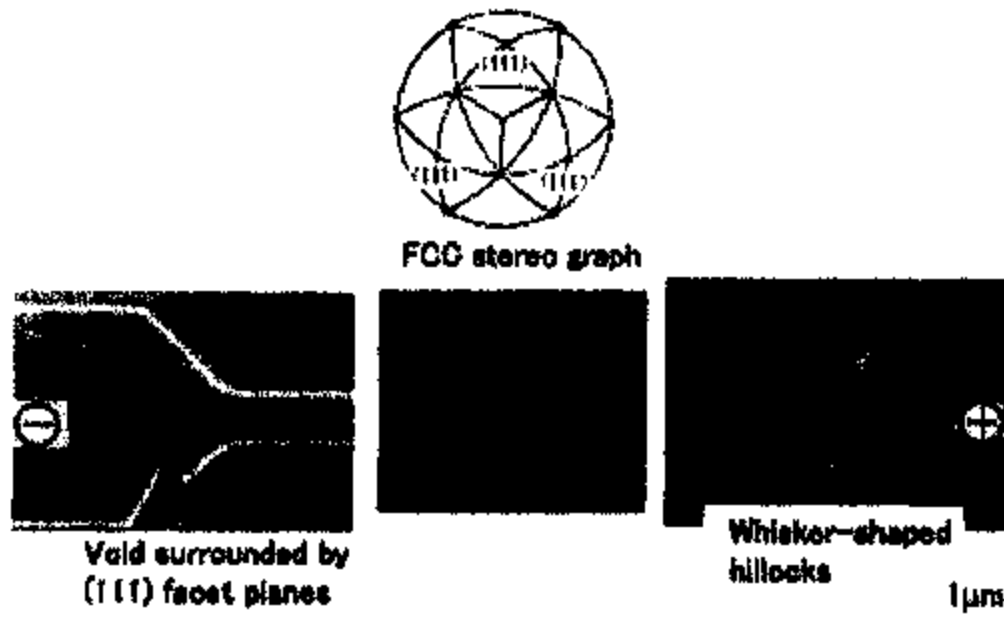
Fig. 15. SEM photograph of qe-Al line after BM acceleration test.

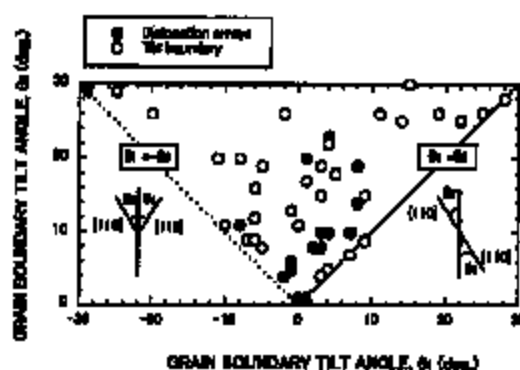
Fig. 18. Misorientation angle between the grains on both sides at grain boundary closed circle : dislocation array; open circle : tilt boundary.

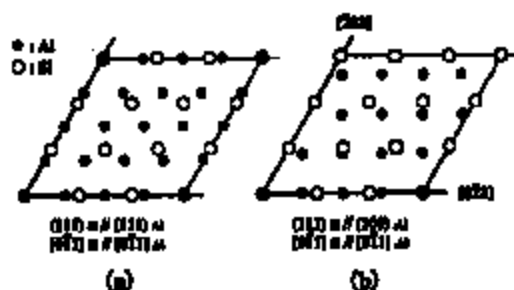
Fig. 1. (a) Schematic diagram showing the superlattice for the Al(1 1 1)/Si(1 1 1) interface. In this model, four Al lattice spacings match three Si lattice spacings; (b) one of the superlattices for the Al(1 0 0)/Si(1 1 1) interface. Only [0 -1] direction matches. Open circles and solid circles indicate the position of Si lattice and Al lattice, respectively.

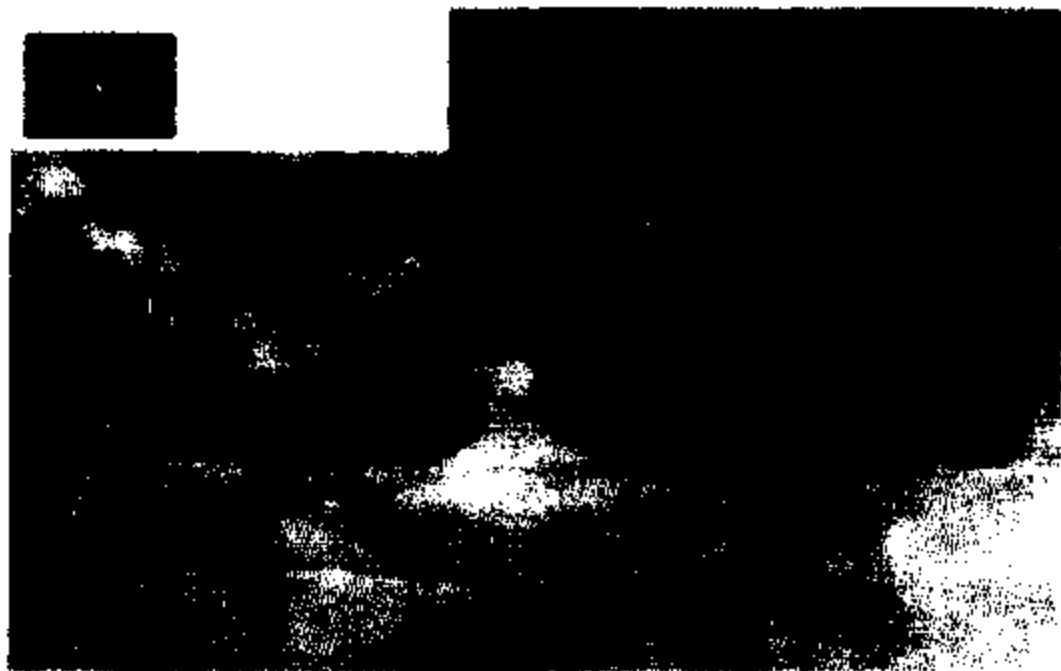
Fig. 2. Cross-sectional lattice image of Al(1 1 1)/Si(1 1 1) interface. An aluminum film deposited by GTC-CVD technique. Incident electron beam is parallel to Si [1 1 0] direction.

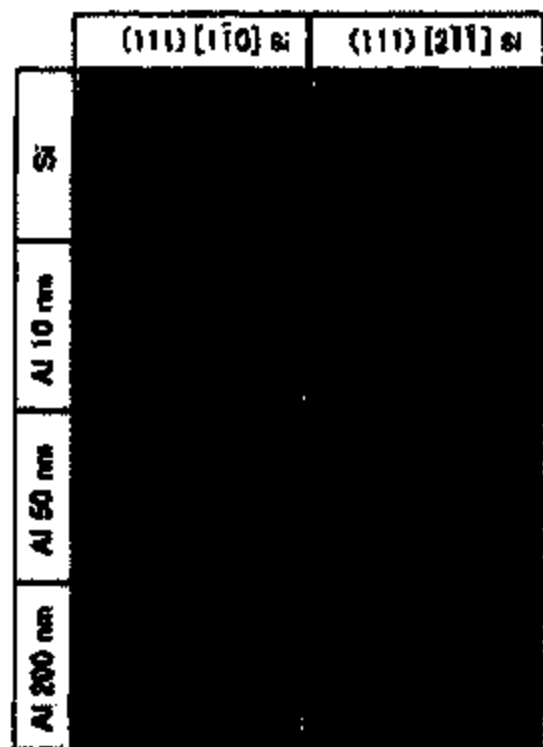
Fig. 3. In situ observation of Al epitaxial growth on Si(111) substrate by sputtering. In initial stage, three kinds of Al(100) domains were observed. Subsequently, the Al(111) domains grew by reorientation of the Al(100) domains. Finally, only the Al(111) structure remained.

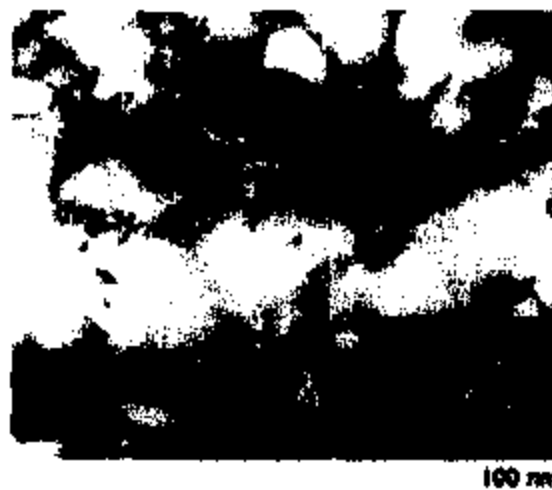
Fig. 4. A bright-field image and a selective area diffraction pattern of the 400 nm thick qa-Al film deposited by sputtering. Many dislocation arrays were observed.

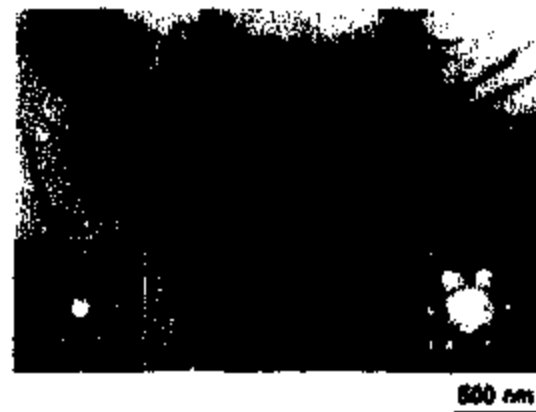
Fig. 5. A bright-field image and selective area diffraction patterns of the 400 nm thick s-Al(Cu) film deposited by GTC-CVD technique and subsequently implanted with Cu. In SAD on grain boundary, some streaks attributed to GP-zones were observed at ambient temperature.

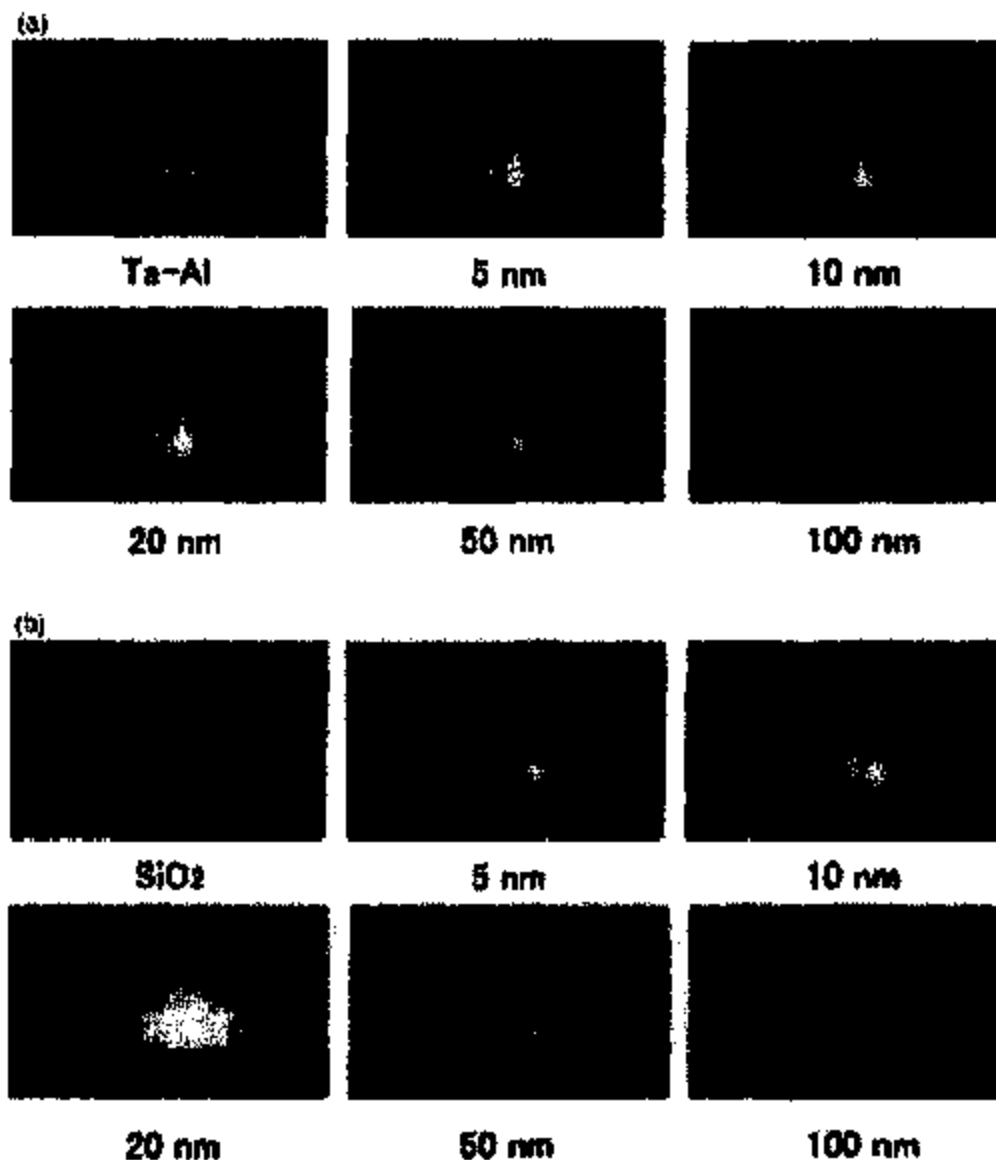
Fig. 6. (a) In situ RHEED observation results of growth of Al deposited on the amorphous Ta-Al underlayer; (b) In situ RHEED observation results of growth of Al deposited on SiO₂.

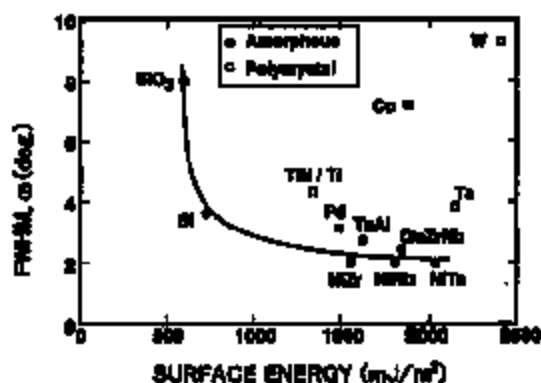
Fig. 7. The relationship between surface energy of underlayer and the FWHM values of 20 nm thick Al films deposited on the underlayers. The open squares and closed circles indicate polycrystalline underlayers and amorphous underlayers, respectively.

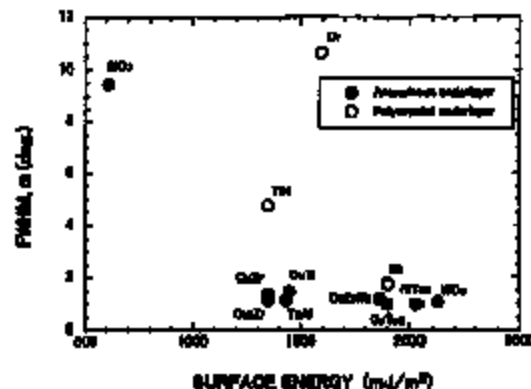
Fig. 8. The relationship between surface energy of underlayer and the FWHM values of 100 nm thick Cu films deposited on the underlayers. The open circles and closed circles indicate polycrystalline underlayers and amorphous underlayers, respectively.

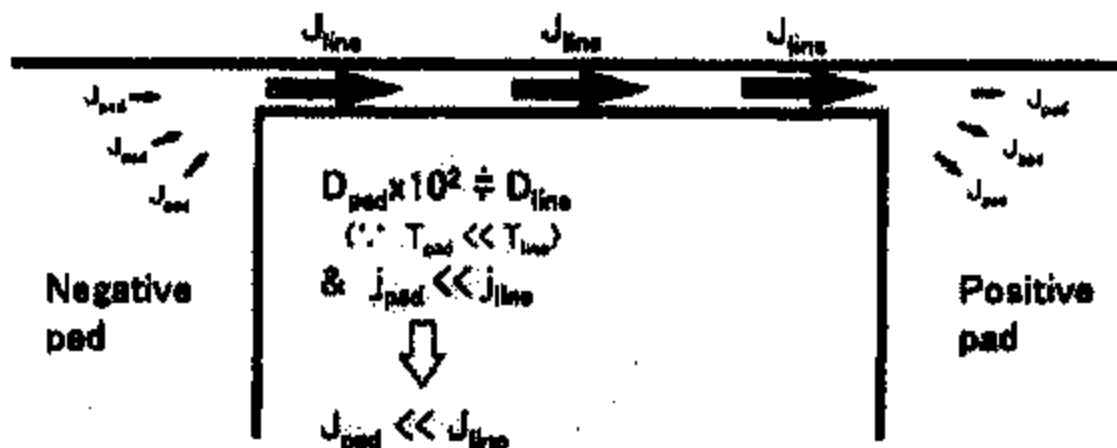
Fig. 10. Schematic diagram of highly accelerated EM test condition.

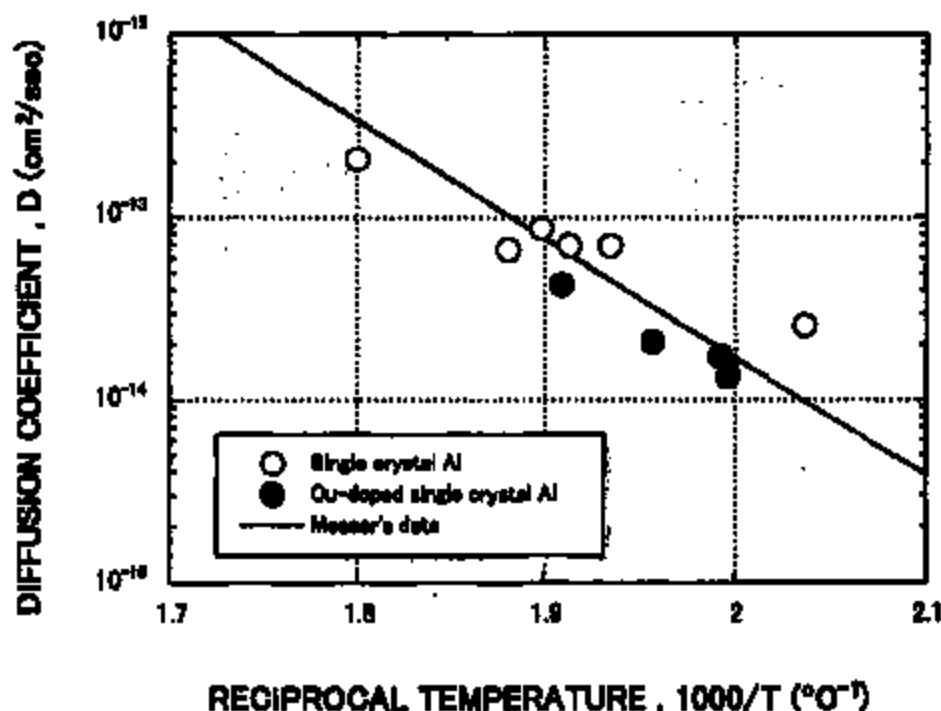
Fig. 12. Arrhenius plot of the Al diffusion coefficients obtained from void growth rate. The open circles and the closed circles indicate s-Al and s-Al(Cu), respectively, and solid line presents Meuser's data.

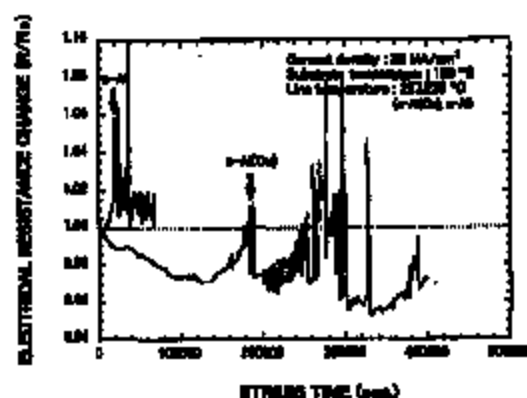
Fig. 13. Electrical resistance change for s-Al and s-Al(Cu) lines during EM accelerated testing with current density of 35 MA/cm².

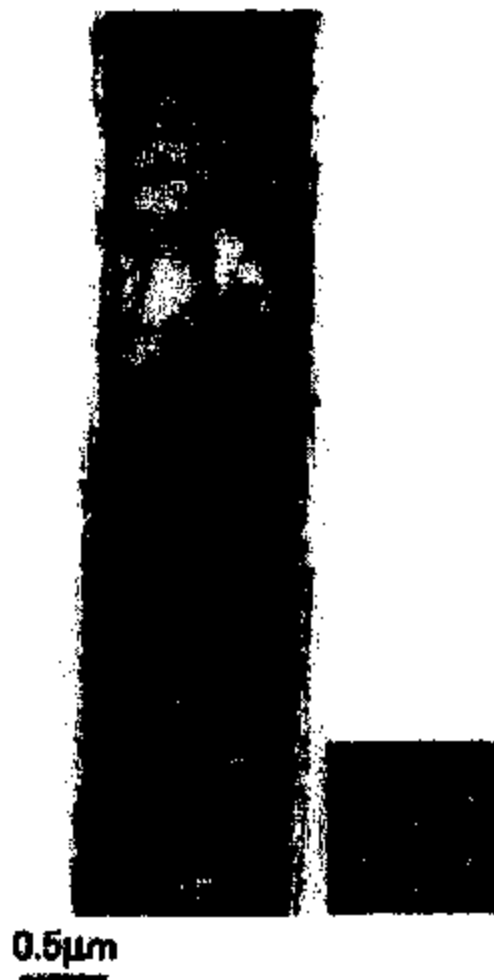
Fig. 14. Bright-field image and selected area diffraction pattern of qe-Al line after EM acceleration test.

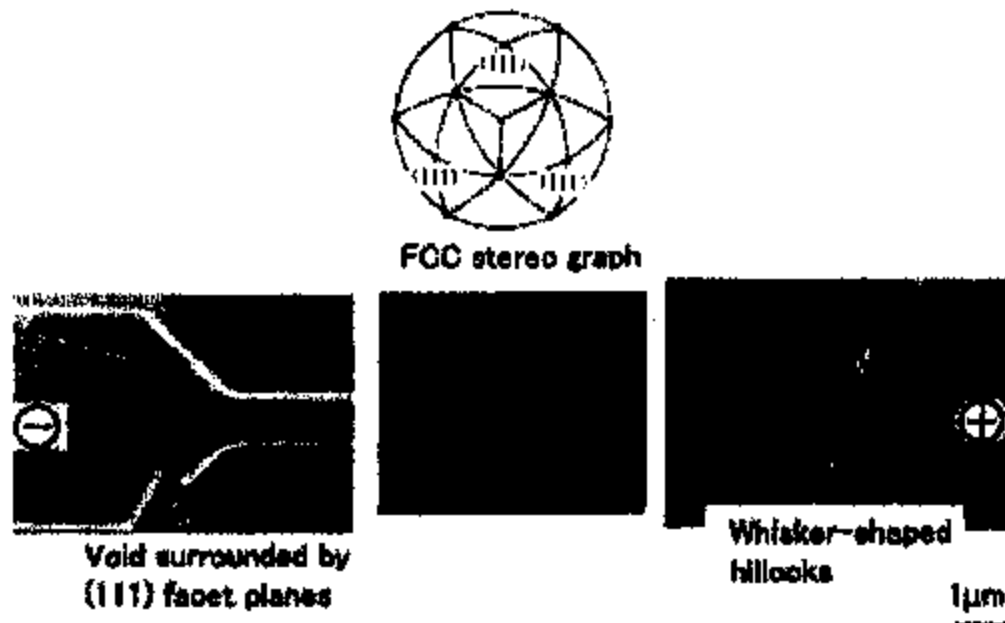
Fig. 15. SEM photograph of qn-Al line after EM acceleration test.

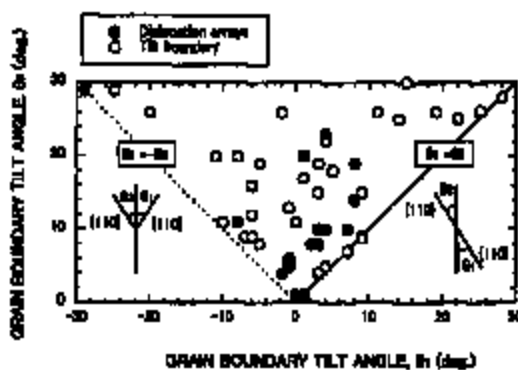
Fig. 18. Misorientation angle between the grains on both sides of grain boundary closed circle : dislocation array; open circle : tilt boundary.

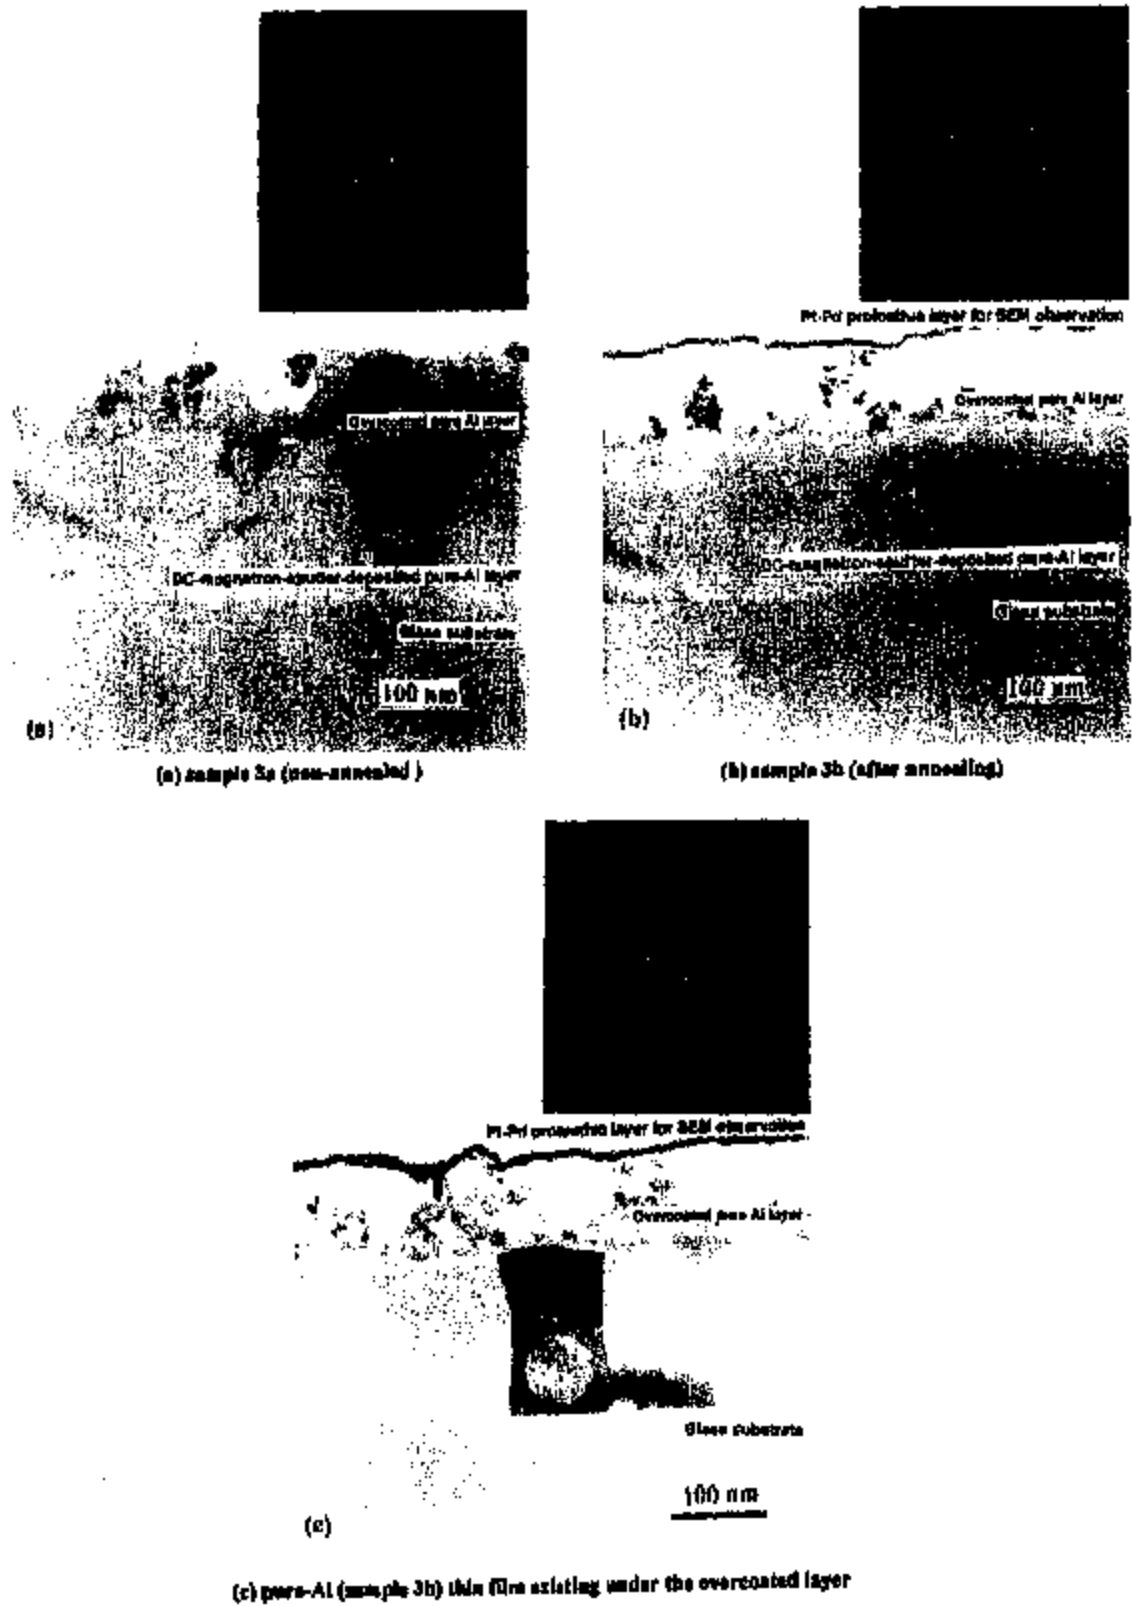
Fig. 4. Cross-sectional TEM images and analysis of the grain orientation caused by electron diffraction: (a) sample 3a (non-annealed); (b) sample 3b (after annealing); (c) pure Al (sample 3b) thin film existing under the overcoated layer.

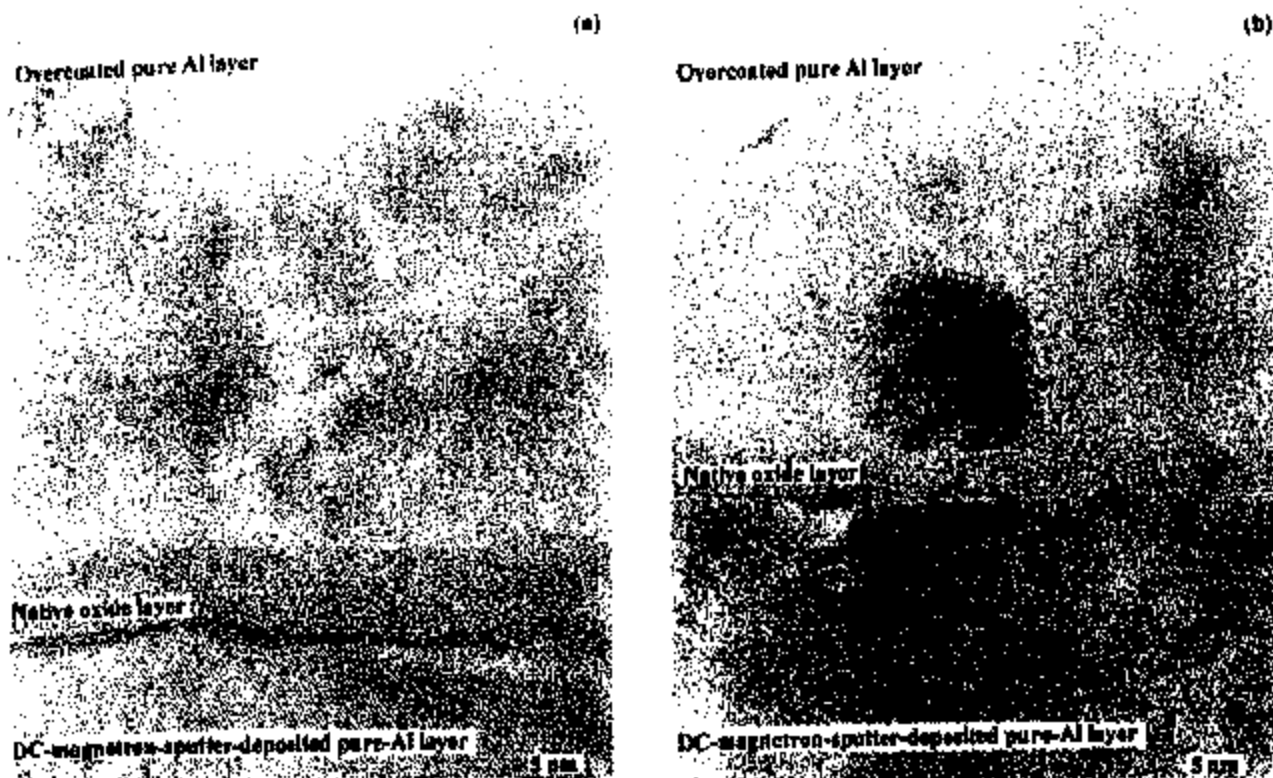
Fig. 3. Detailed nanostructure micrographs obtained by means of cross-sectional TEM corresponding to: (a) sample 3a; (b) sample 3b.

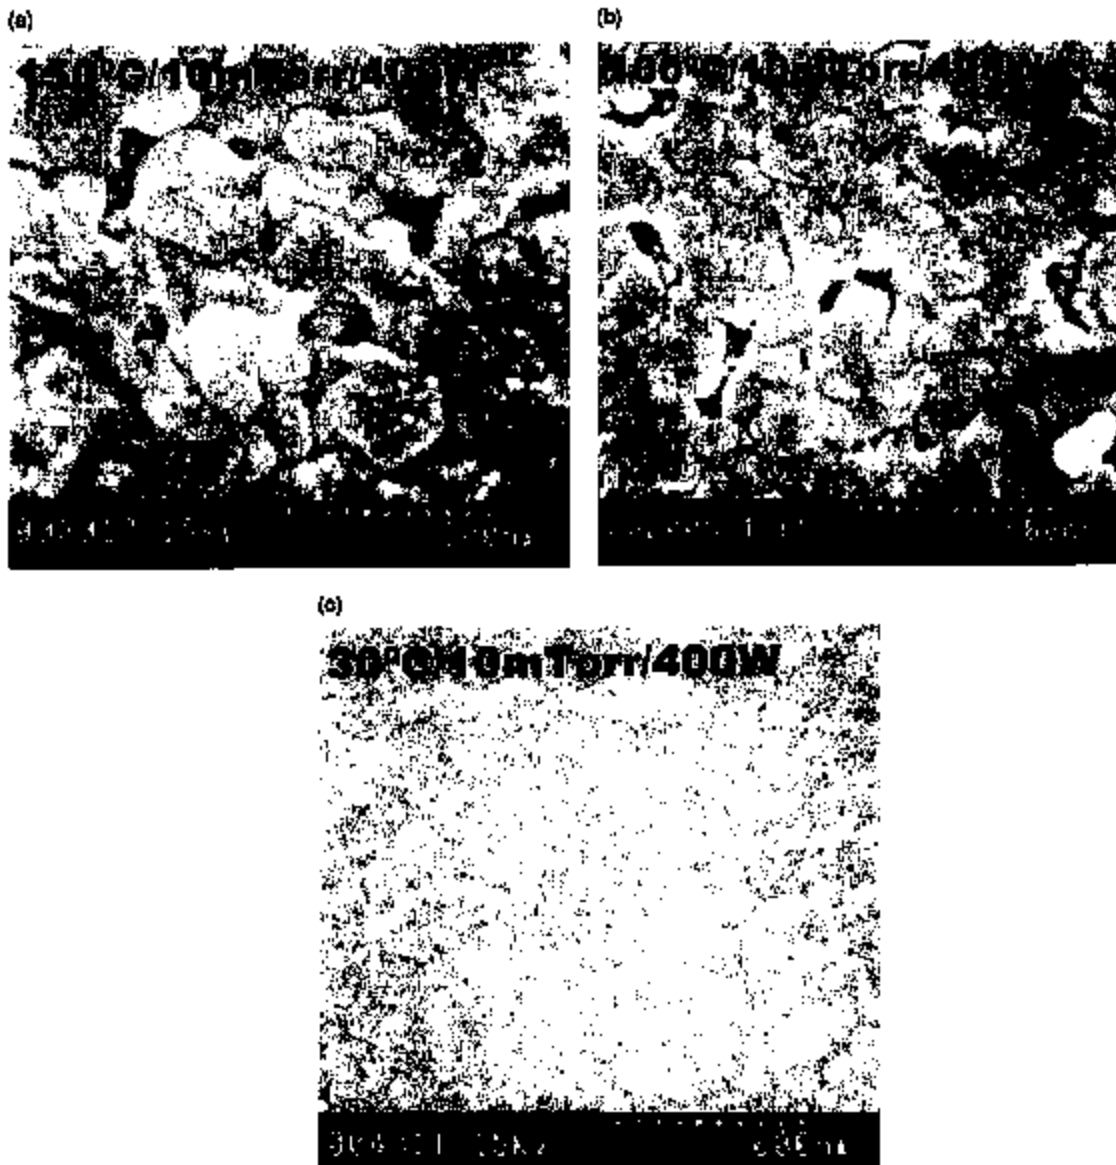
Fig. 1. SEM micrographs of the Al films deposited at (a) 150°C, (b) 100°C, and (c) 30°C, and subject to thermal annealing at 260°C for 12 h. The process pressure and power were fixed at 10 mTorr and 400 W, respectively.

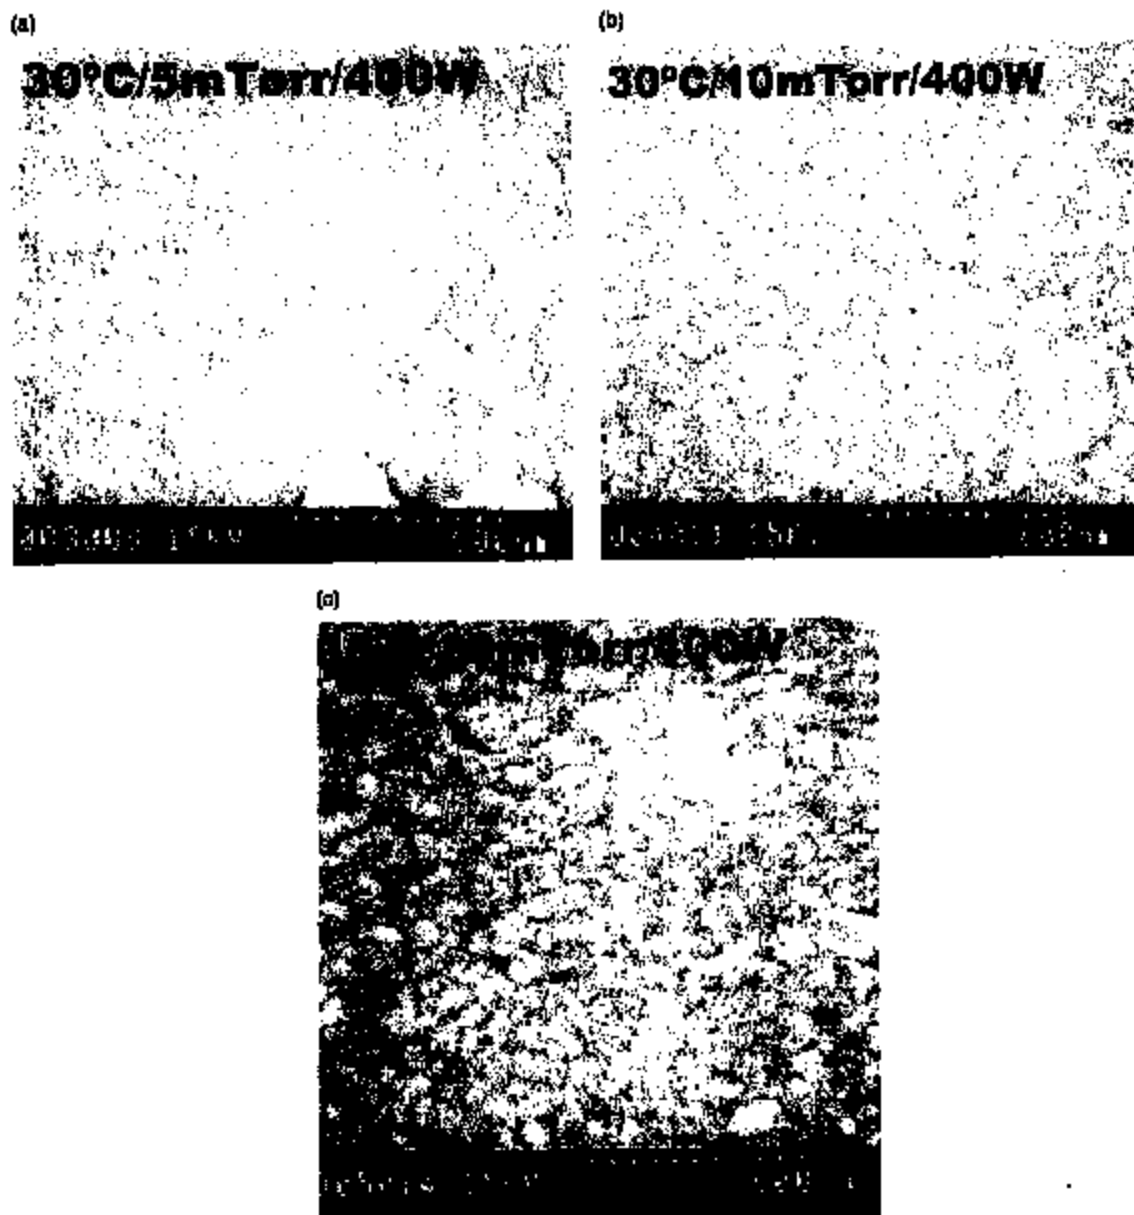
Fig. 2. SEM micrographs of the Al films deposited at (a) 5 mTorr, (b) 10 mTorr, and (c) 20 mTorr, and subject to thermal annealing at 260°C for 12 h. The deposition temperature and power were fixed at 30°C and 400 W, respectively.
