FORD 8/5/03

LETTER TO ODI

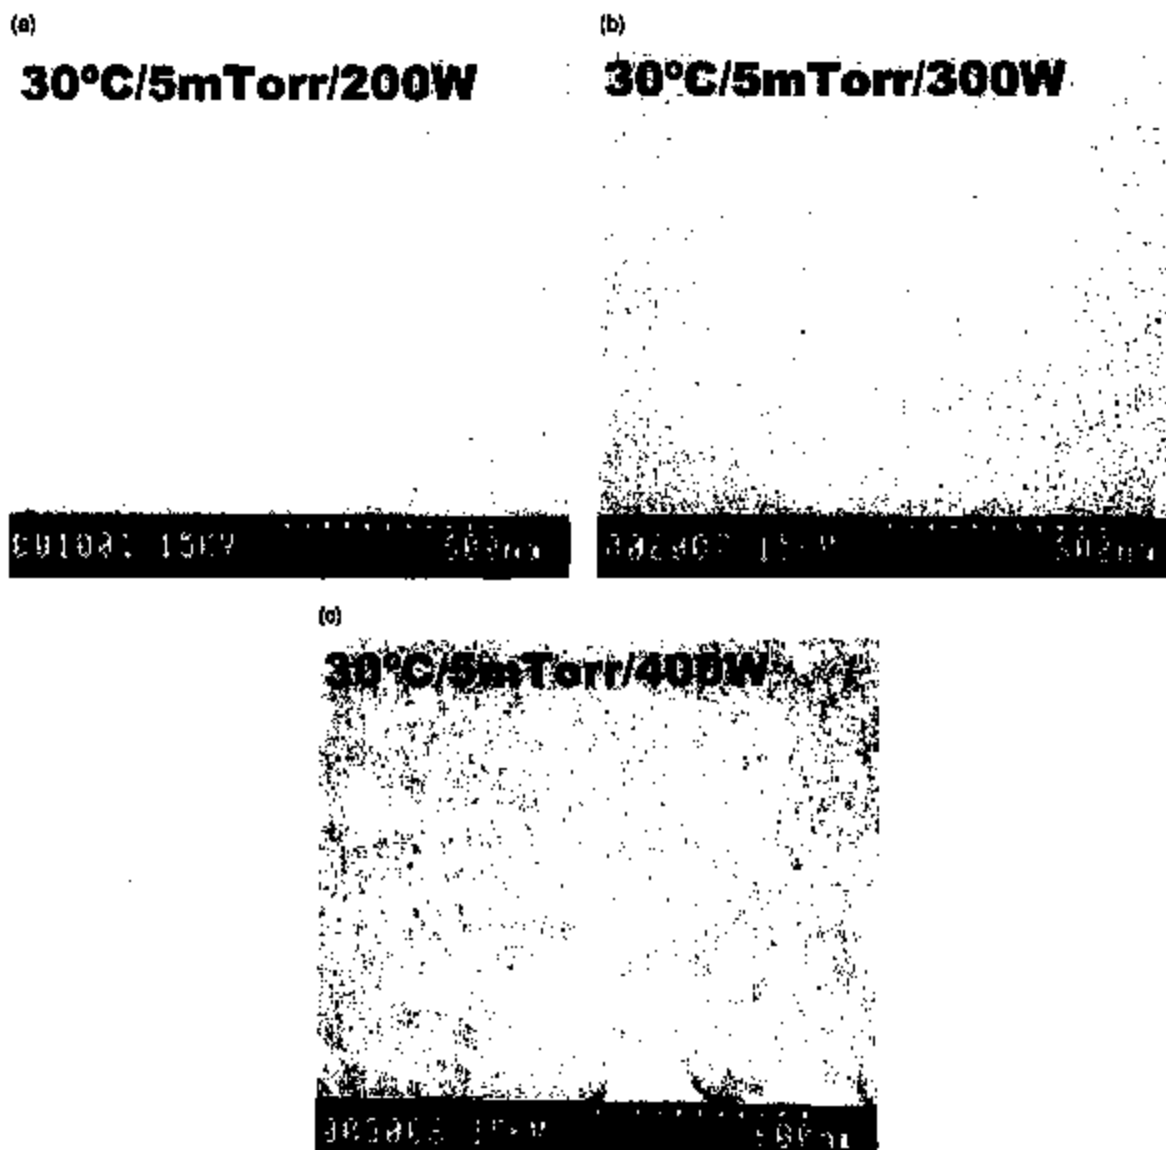
Fig. 3. SEM micrographs of the Al films deposited at (a) 200 W, (b) 300 W, and (c) 400 W, and subject to thermal annealing at 260°C for 12 h. The process pressure and temperature were fixed at 5 mTorr and 30°C, respectively.

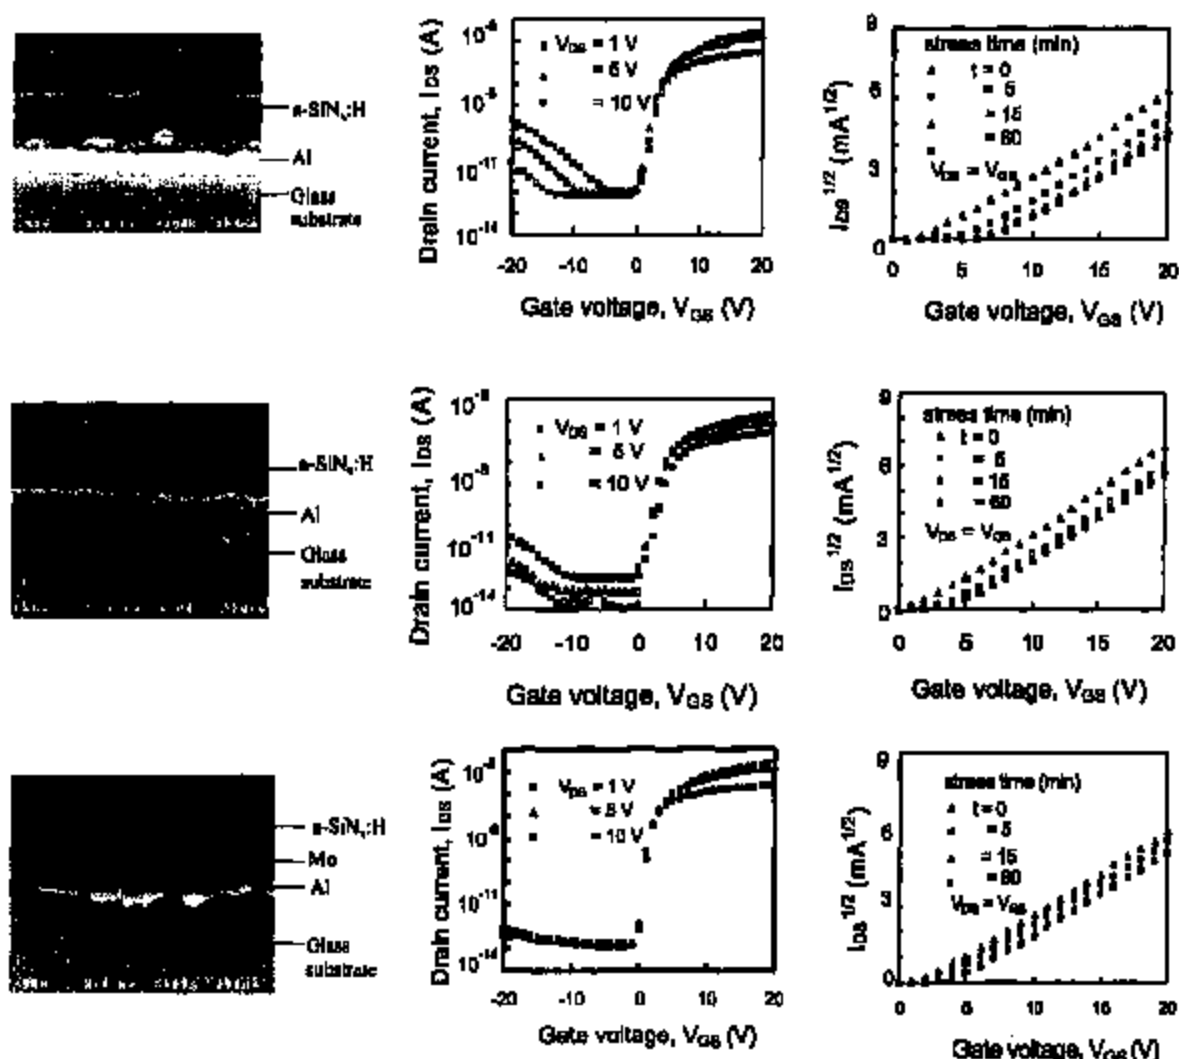
Fig. 4. Cross-sections of the gate/insulator interface and corresponding transfer characteristics (I_{DS} versus V_{GS}), at various drain source voltages (V_{DS}), and stability behavior (for $V_{GS} = V_{DS}$), when subject to electrical stress for time durations of 0, 5, 15, and 60 min. The TFTs were fabricated with the Al gate deposited under the conditions given in Table 2.

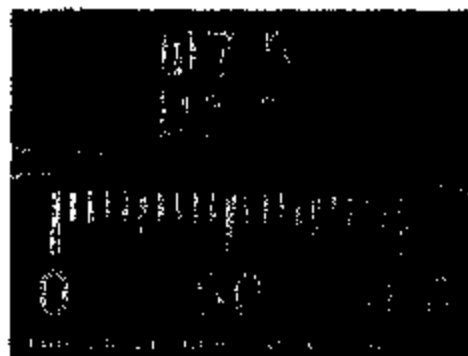
film of 0.4 μ m. The film/substrate assembly was then annealed at 723 K for about 30 min. The processing followed the conventional technique in China to manufacture micron-width interconnects, and was carried out in the Institute of Microelectronics, Tsinghua University. The thin films were then etched to testing lines of 100 μ m length and various widths (from 1.5 to 11.5 μ m). The failure times of various tests are listed in Table 1. They are substantially lower than the testing data reported in the literature. The specimens were observed under a field-emission scanning electron microscope (Hitachi S-4200) at the Institute of Physics, Chinese Academy of Science. The intercon-

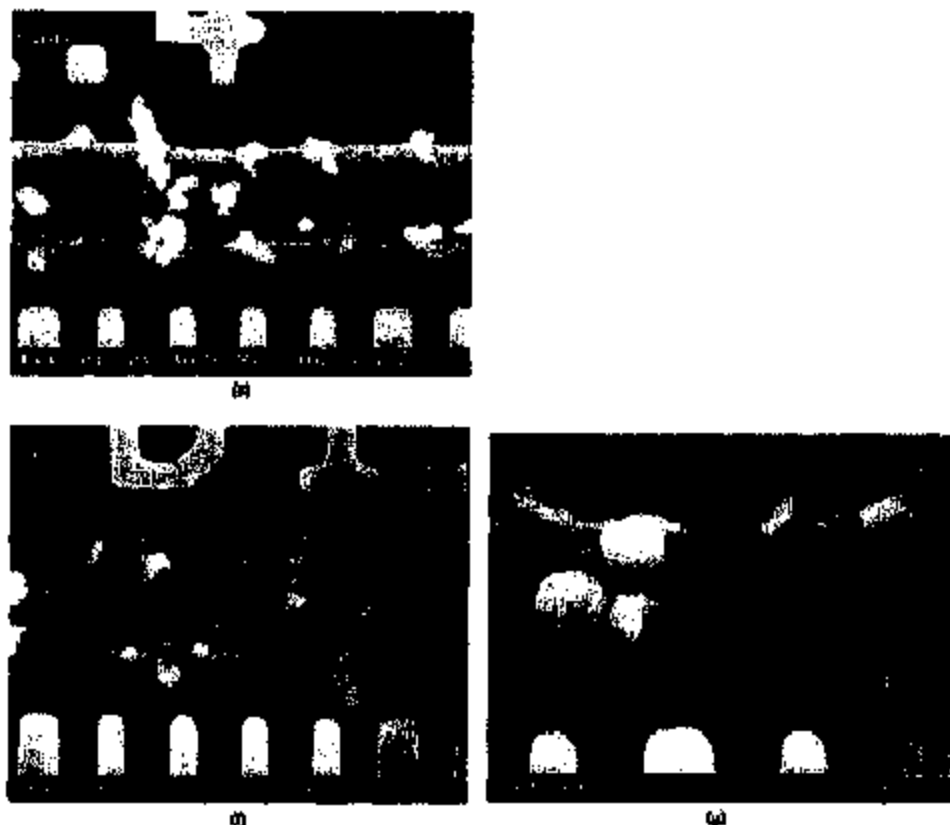
Fig. 1. SEM micrographs following a time sequence showing the damage of an interconnect under electromigration: (a) initial configuration; (b)–(d) 520 h; (e) 904 h; (f), (g) 1171 h.

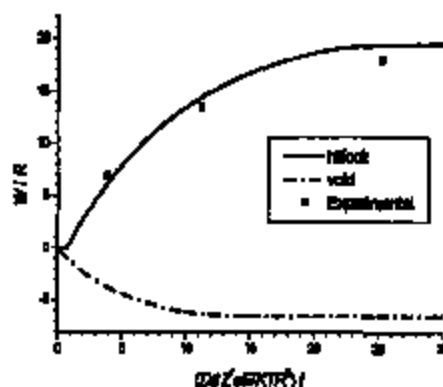
Fig. 9. Protruding height and the sinking depth vs. the normalized time, $J_1 = 2.34(J_d)$.

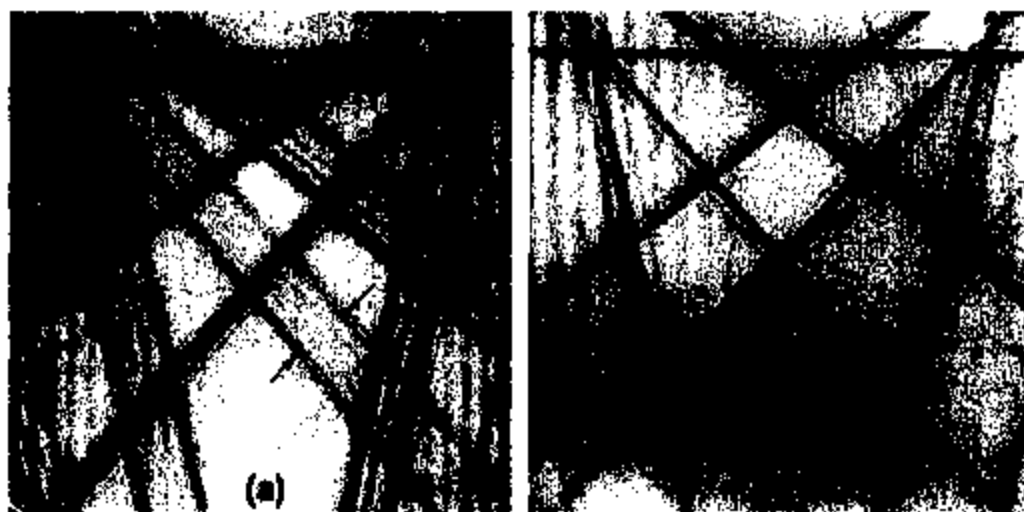
Fig. 3. (a) CBED pattern taken with the spot positioned close to the substrate interface. Some of the HOLZ lines show a pronounced splitting which is caused by a bending of the lattice planes close to the substrate. (b) From the central part of the interconnect line undisturbed patterns can be obtained.

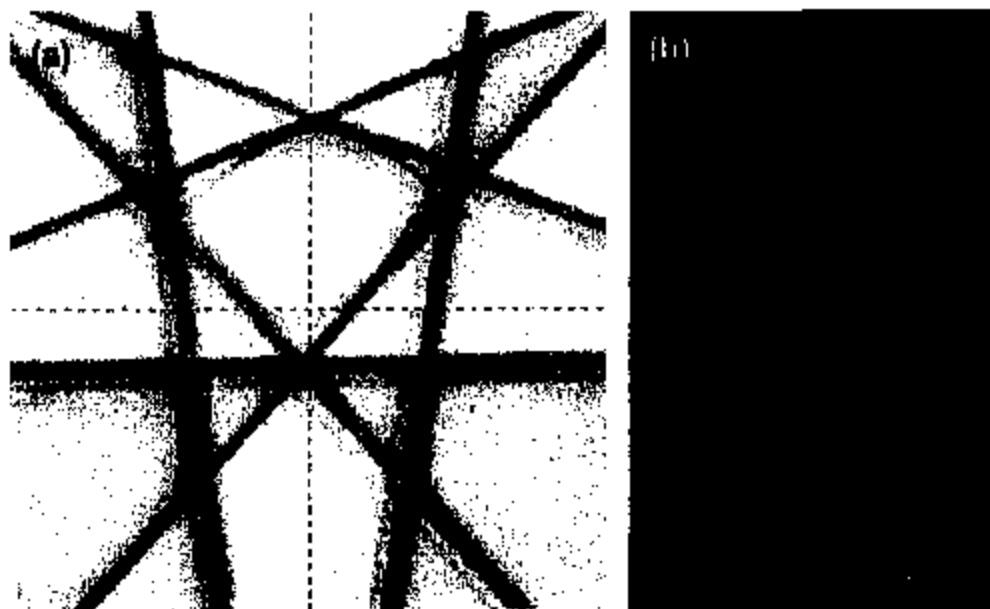
Fig. 4. (a) Central portion of a [1 3 3] CBED pattern acquired in the centre of the line and the corresponding Hough transform (b). Because of the unidirectional strain, the symmetry of the pattern is broken with respect to the vertical line.

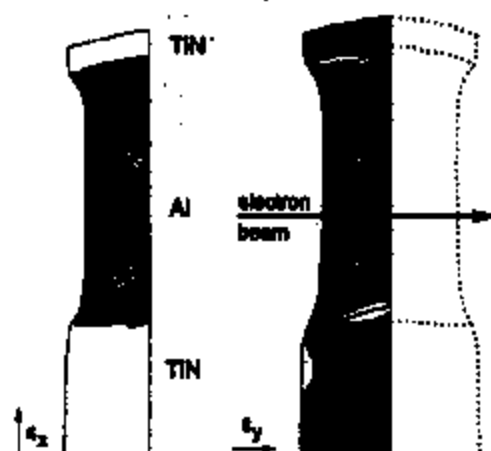
Fig. 7. Strain distribution predicted by the finite element model for the two components ϵ_x and ϵ_y . Shown is the shape of the interconnect after cooling by 100 K (the displacements are enhanced by a factor of 100 for better visibility). In the Al segment the y -component shows a transition from tensile strain at the interface to compressive strain in the central part which is a result of the bending moment of the interconnect.

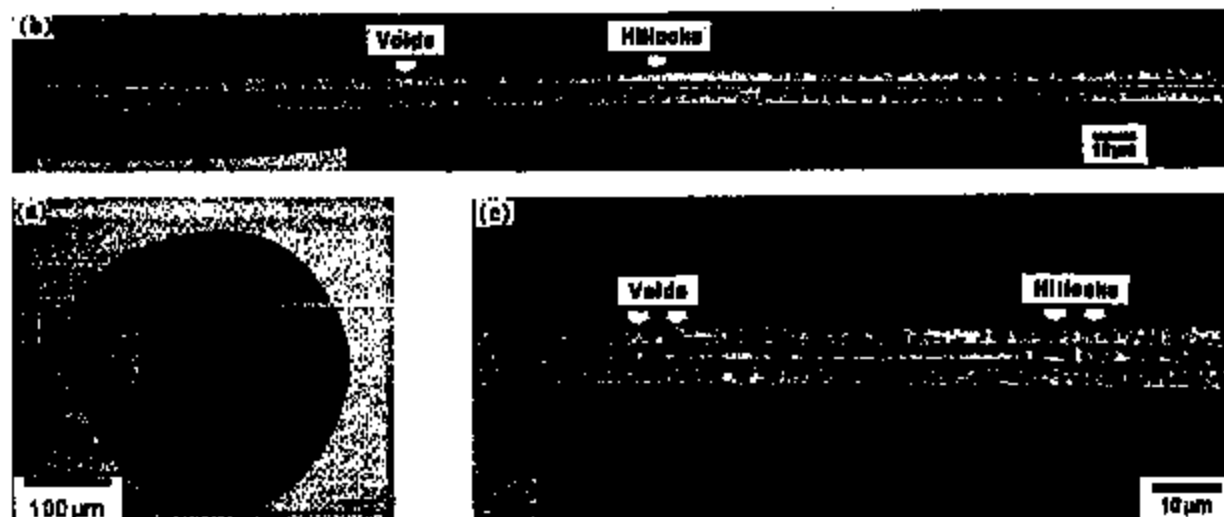
Fig. 3. (a) Low magnification SEM image (montage of two micrographs) for a 2.1 μm wide line (with guard rails) before electromigration stressing, showing the electron-transparent area. (b) and (c) Backscattered electron images in SEM for the electron-transparent segment after failure, showing voids and hillocks in distinct regions on either side of the centre of the transparent segment, with the depletion of the Al-Cu precipitates between these regions. (c) A close-up of (b).

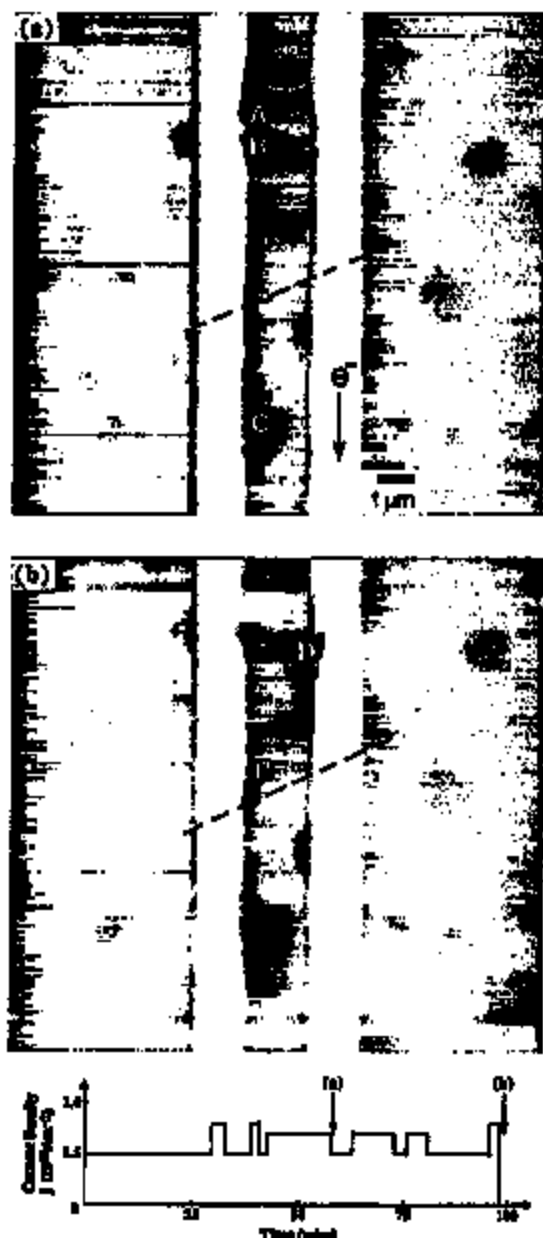
Fig. 4. TEM images for a segment of test line, (a) after 58 min and (b) after a further 40 min of *in-situ* electro-migration testing (profile shown at bottom of figure). Comparison of (a) and (b) shows the formation of an Al-Cu hillock at D, the dissolution of an Al-Cu precipitate at C, and the migration of a precipitate at B—all consistent with the migration of copper parallel to the electron flow (top to bottom).

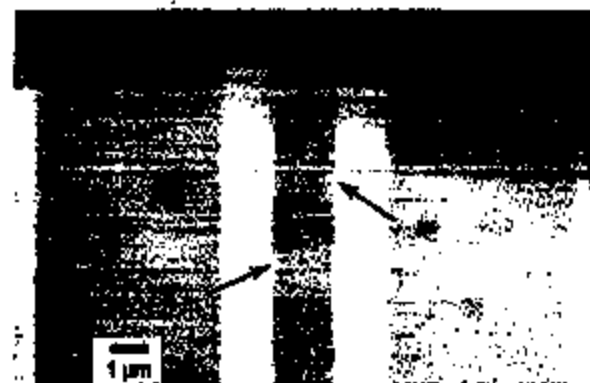
Fig. 5. TEM image showing the initiation of voids at the end of the electron-transparent segment of line. The voids developed only, at the edge of the line and beneath the oxide skin. Electron flow: top to bottom.

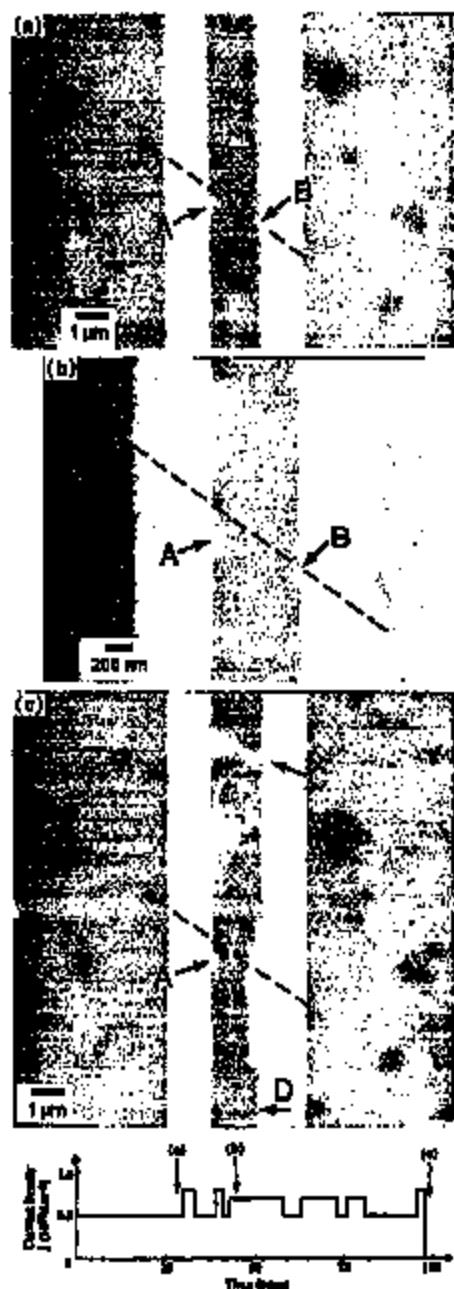
Fig. 6. TEM images of a line segment, showing that voids which develop early may grow even in the region of maximum anodic flux divergence giving the maximum voiding under electromigration testing. In (a) there are two early voids at A and B with precipitates nearby. After another 13 min of electromigration testing, the slightly higher magnification image (b) shows the depletion of Al-Cu precipitates but coarsened voids at A and B. In (c), the line has failed at C, but despite the heavy damage site in this region of high Ed/kt (Fig. 3(b)), the early void at A has still not grown further. The timing and current density at which each micrograph was taken are presented in the diagram at the bottom of the figure. Electro flow: top to bottom.

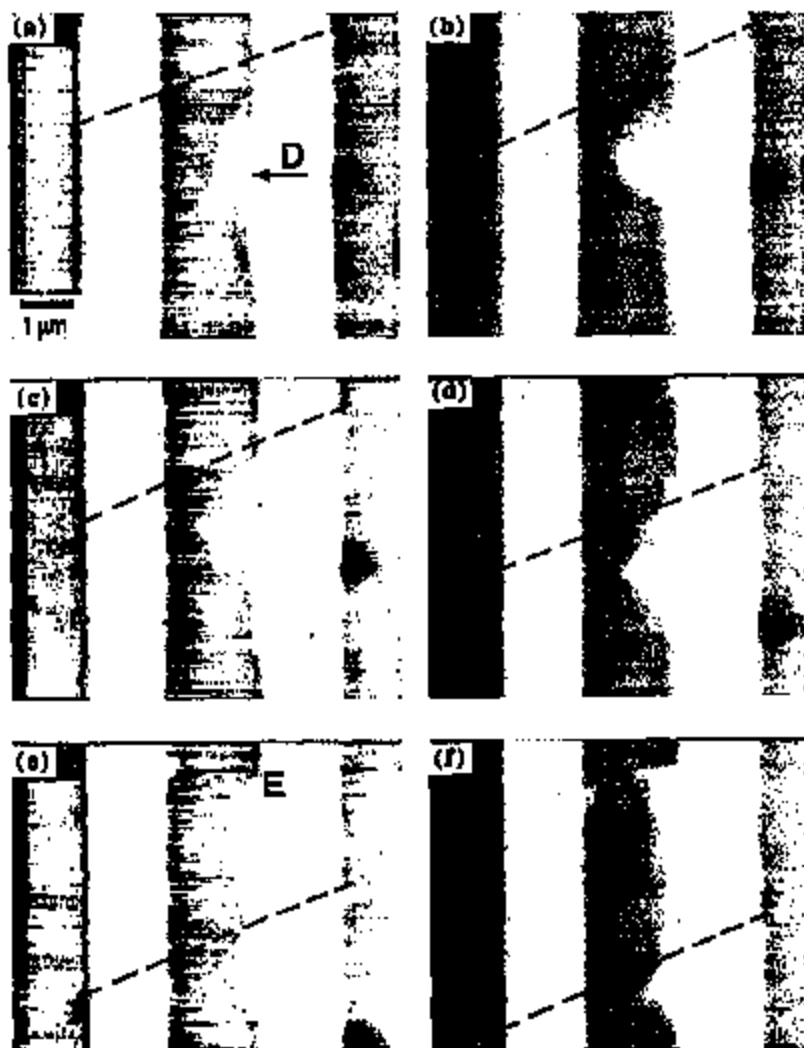
Fig. 8 shows a sequence of micrographs from a different segment of line. For the specimen tilt used, the predominant contrast is from thickness variations. Again, no damage was evident after 30 min at the initial electromigration stress of $0.5 \times 10^{10} \text{ A m}^{-2}$ (0.5 j). After a further 33 min in which

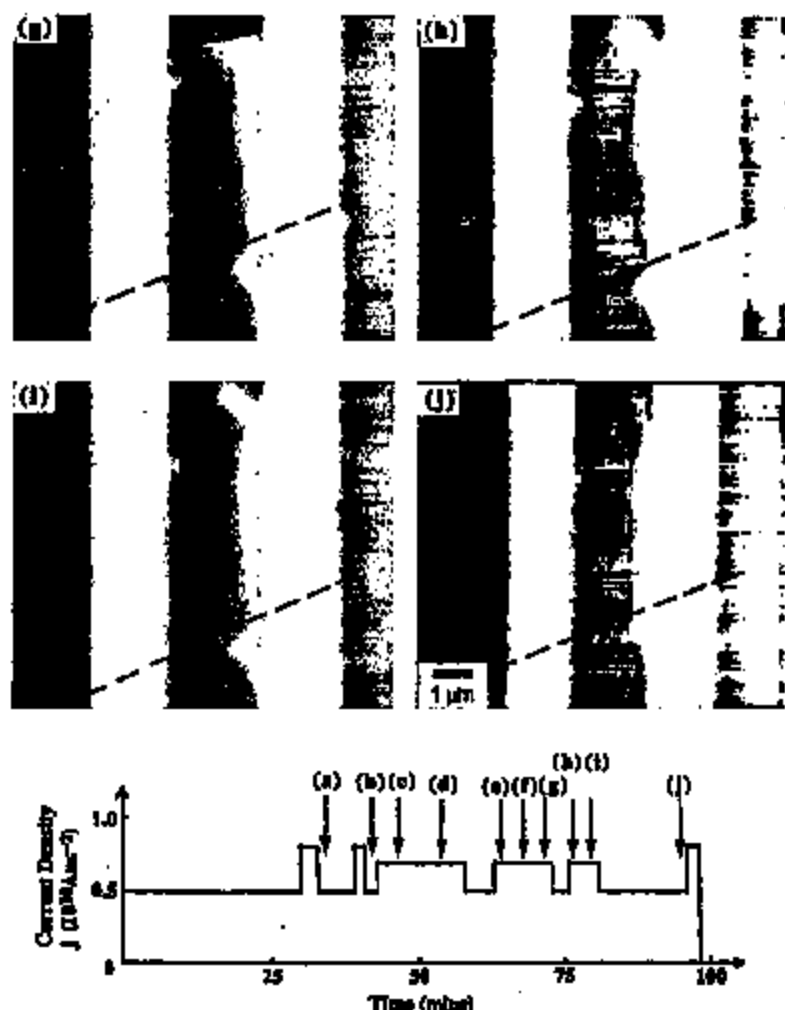
Fig. 7. Sequential TEM images (a)–(j) for a segment of line under in-situ electroigration testing, showing the evolution (initiation, growth along the line, partial refilling, growth across grain boundaries and growth along a grain boundary) of a void stressed with a current density ranging between $0.5 \times 10^{10} \text{ A m}^{-2}$ and $0.8 \times 10^{10} \text{ A m}^{-2}$. The timing and current density at which each micrograph was taken are presented in the diagram at the bottom of the figure. Electron flow: top to bottom.

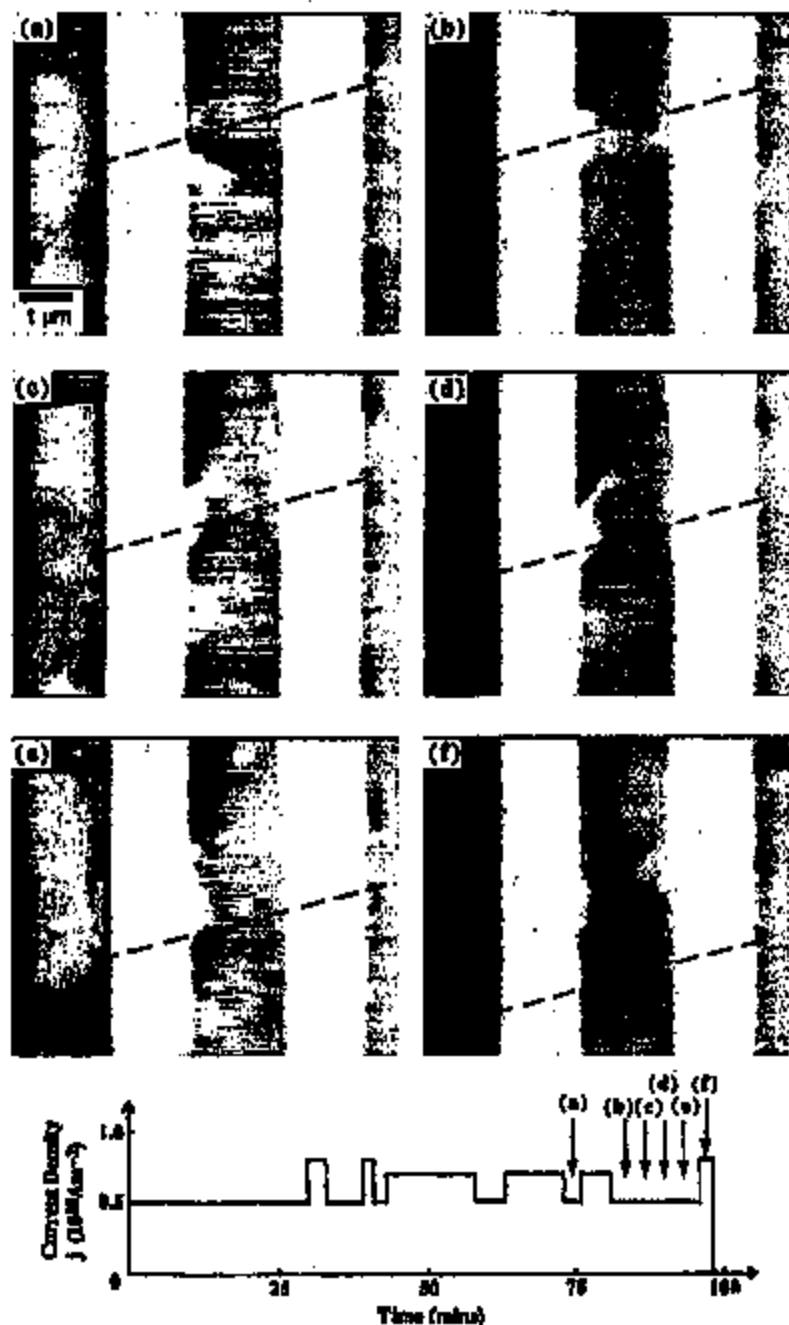
Fig. 8. Sequential TEM images (a)–(f) for a segment of line under in-situ electro migration testing, showing the growing and healing of a void. The timing and current density at which each micrograph was taken are presented in the diagram at the bottom of the figure. Electron flow: top to bottom.

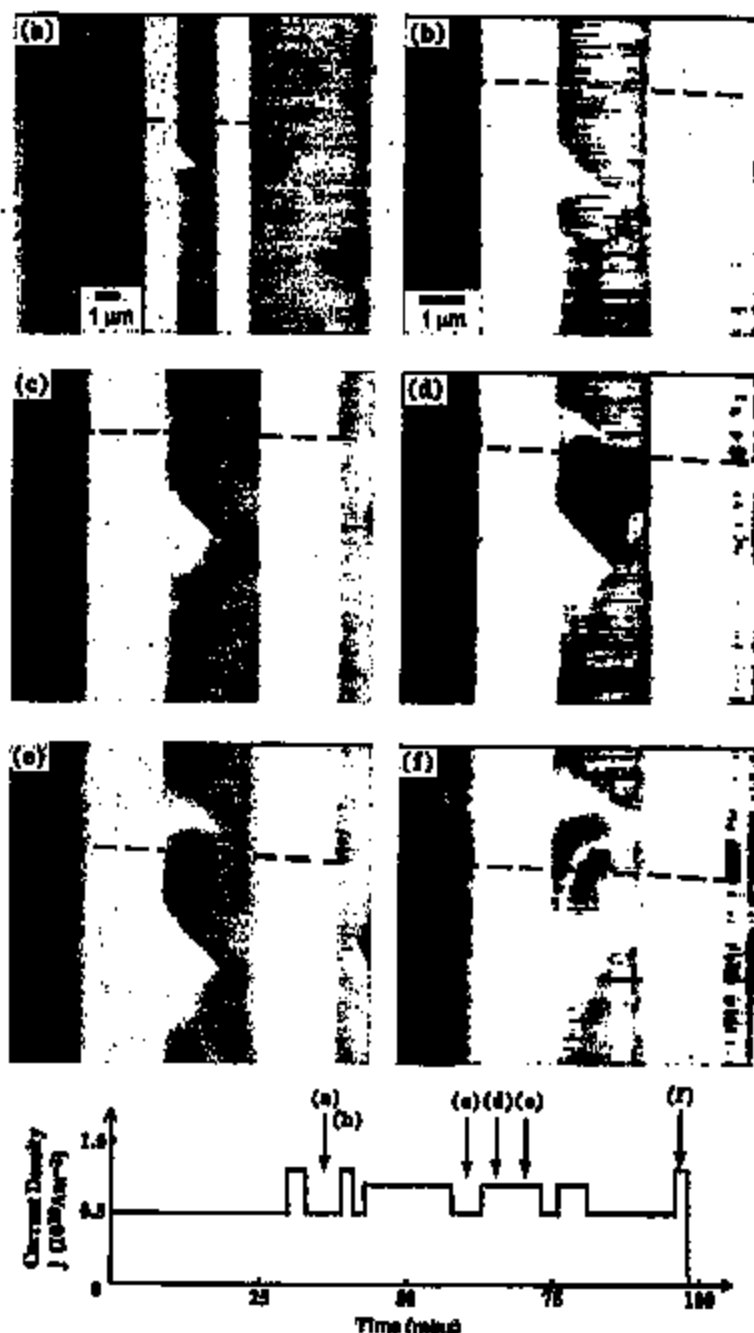
Fig. 9. Sequential TEM images (a)-(f) for a segment of line under in-situ electroigration testing, showing the development of voids to filars. The development suggests that for uncoupled voids, the compressive stress built up at the downstream end of the grain boundaries can be relieved by plastic flow towards large voids nearby and that there can thus be failure. The timing and current density at which each micrograph was taken are presented in the diagram at the bottom of the figure. Electron flow: top to bottom.

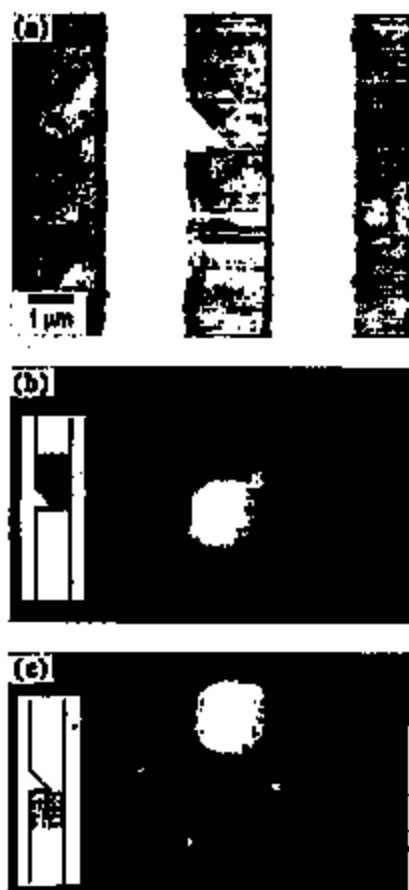
Fig. 10. TEM images for the line segment shown in Fig. 9(b) but in different tilt conditions, indicating that the planar feature is a grain boundary across the width of the test line. The diffraction patterns in (b) and (c) for the grains above and below the boundary demonstrate that they are two different grains.

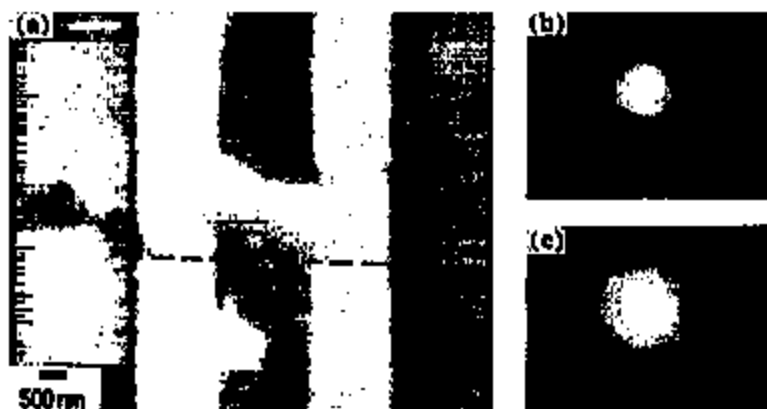
Fig. 11. TEM image of the failure site shown in Fig. 9(f) but taken 4 days after it failed, showing a wider open-circuit gap than in Fig. 9(f). The diffraction patterns in (b) and (c) for the Al line above and below the failure site respectively, do not show any particular relationship in crystallographic orientation.

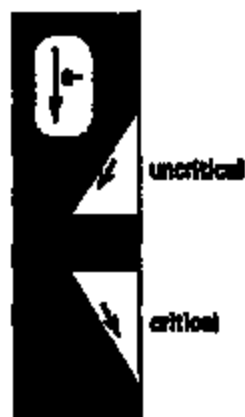
Fig. 12. Schematic diagram of critical and uncritical void geometries as proposed by Auzi et al. [32]. The predominant atomic transport is along the internal free surface of the metallization as shown by the small arrows.

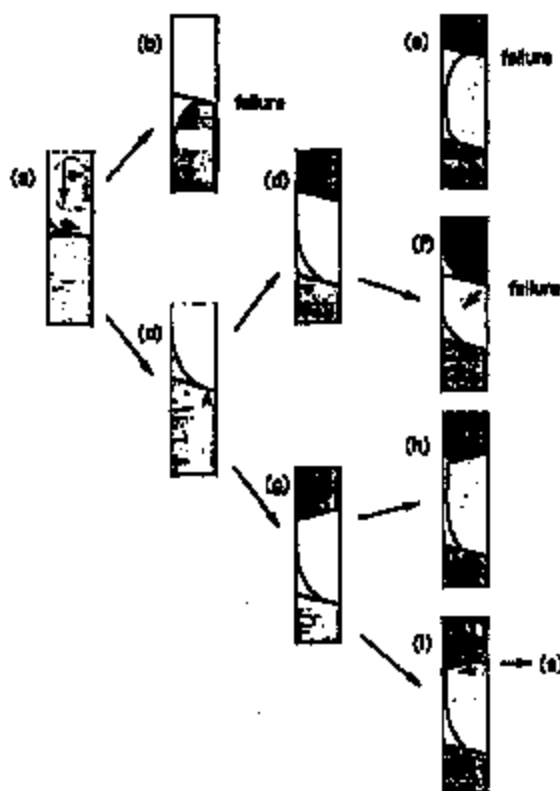
Fig. 13. A schematic model for electromigration-induced open-circuit failure in bamboo lines with inclined grain boundaries, showing possible alternative sequences of events. The shading indicates distinct grains. The unshaded areas are voids forming under the original oxide skin of the line. Damage is concentrated at boundaries which are inclined to the current. Precipitates are not considered in the model as copper depletion (and consequent precipitate dissolution) usually precedes damage.

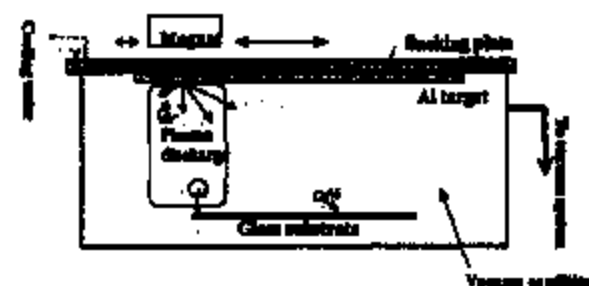
Fig. 1. Cross-sectional schematic diagram of the sputtering chamber.

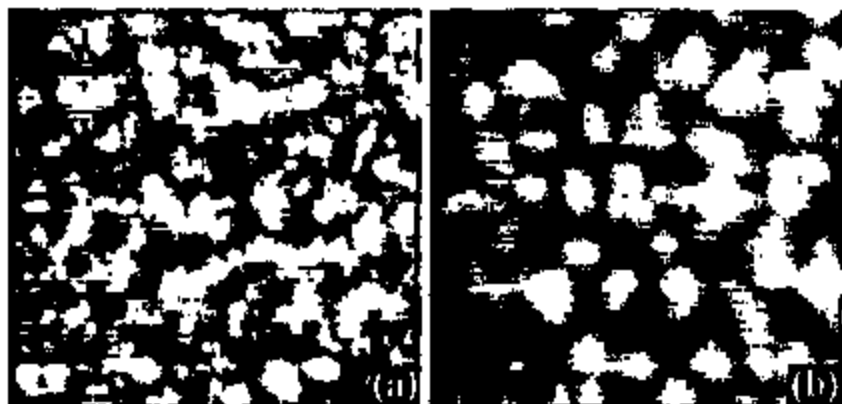
Fig. 2. Two-dimensional AFM images of Al-0.2 wt.% Cu films corresponding to the samples in Table 1: (a) Sample C (20 mins.), (b) Sample D (90 mins.). Scale: 2000 × 2000 nm.

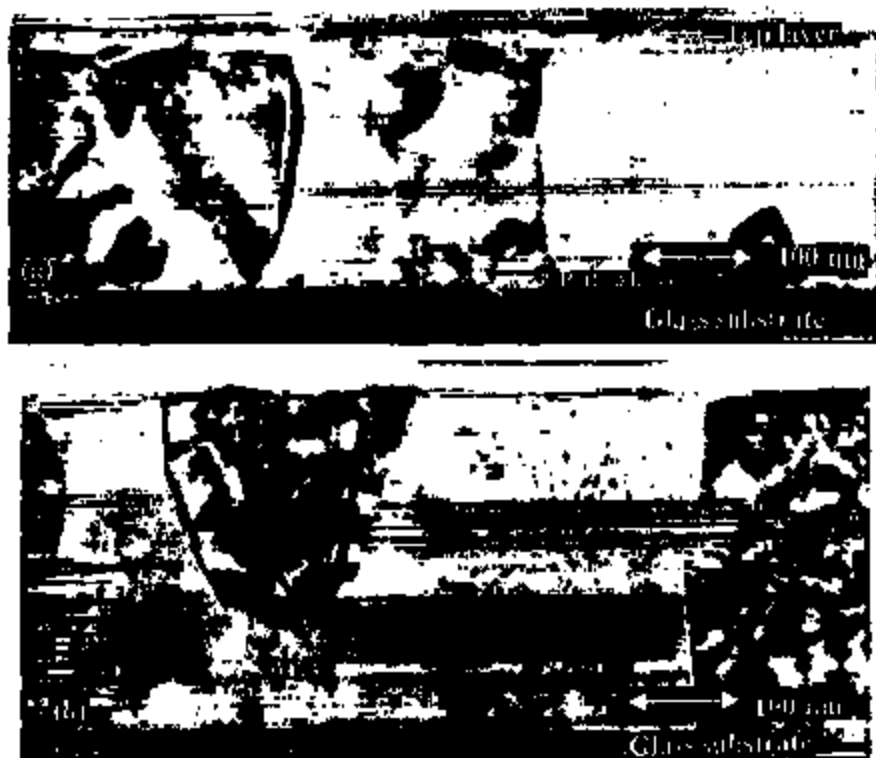
Fig. 3. Cross-sectional TEM micrographs of Al-0.2 wt.% Cu film corresponding to the samples in Fig. 2: (a) Sample C, (b) Sample D.

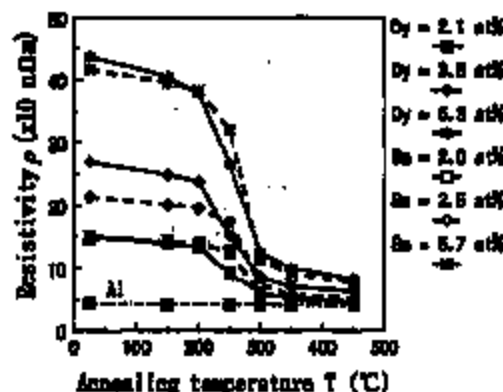
Fig. 5. Change in resistivity ρ of Al-RE alloy films (RE=Sm and Dy) as a function of the background annealing temperature (for 30 min) and composition.

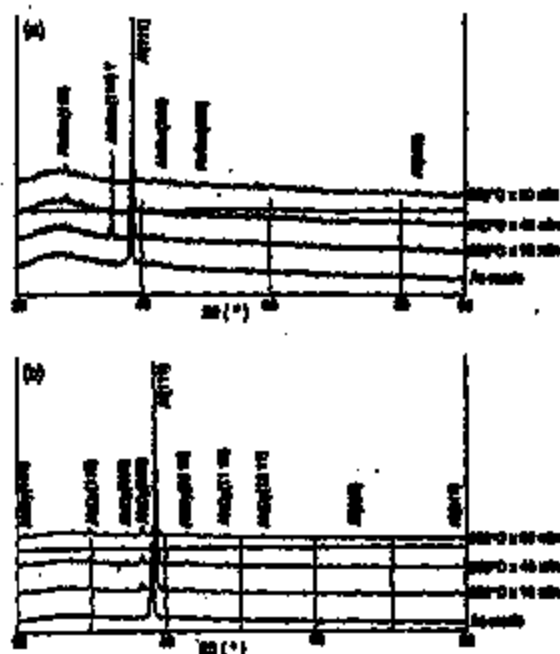
Fig. 8. X-ray diffraction profiles of (a) $\text{Al}_{71.9}\text{Sm}_{2.1}$ and (b) $\text{Al}_{64.3}\text{Dy}_{3.7}$ alloy thin films annealed isothermally at 350°C .

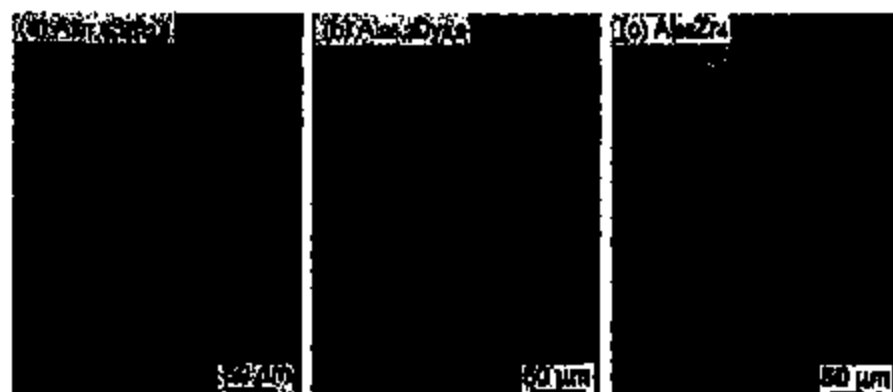
Fig. 9. Polarized optical micrographs of Al alloy thin film surfaces annealed at 350°C for 80 min: (a) $\text{Al}_{71.9}\text{Sm}_{2.1}$, (b) $\text{Al}_{64.3}\text{Dy}_{3.7}$, and (c) $\text{Al}_{60}\text{Zr}_4$.

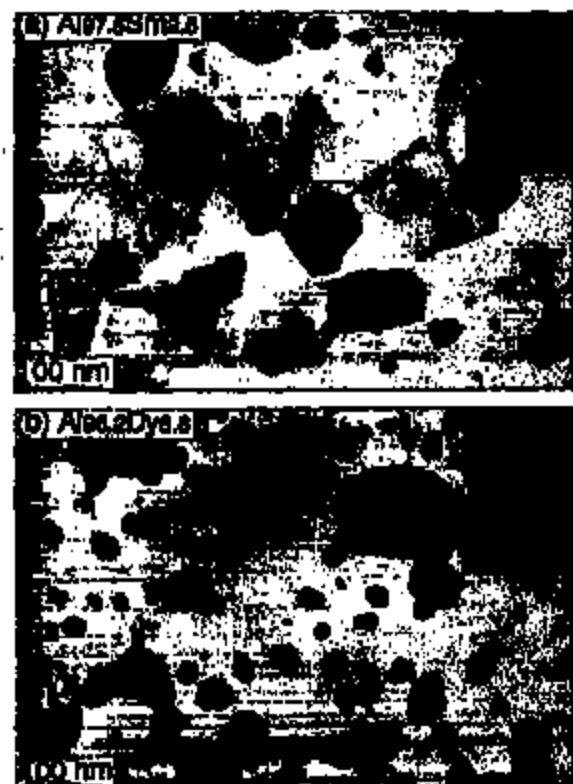
Fig. 10. Bright field images and diffraction patterns of (a) $\text{Al}_{97.8}\text{Sm}_{2.2}$ and (b) $\text{Al}_{98.5}\text{Dy}_{1.5}$ alloy thin films annealed at 250 °C for 60 min.

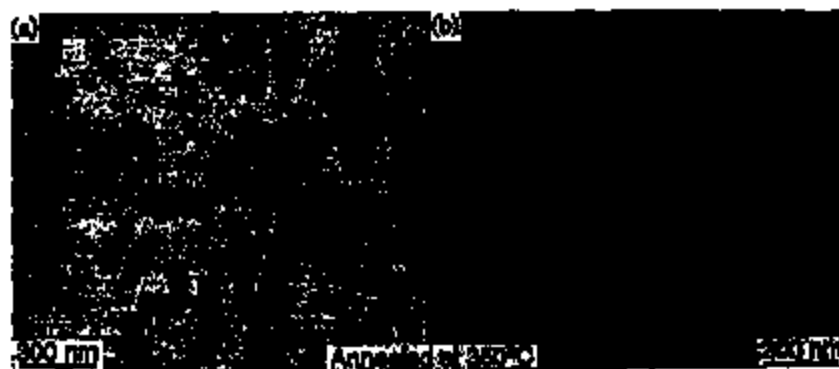
Fig. 11. (a) STEM image of the $\text{Al}_{97.8}\text{Sm}_{2.2}$ alloy film sample annealed at 250 °C for 60 min in Fig. 10(a), and (b) the distribution of Sm measured by EDX in the same area as (a).

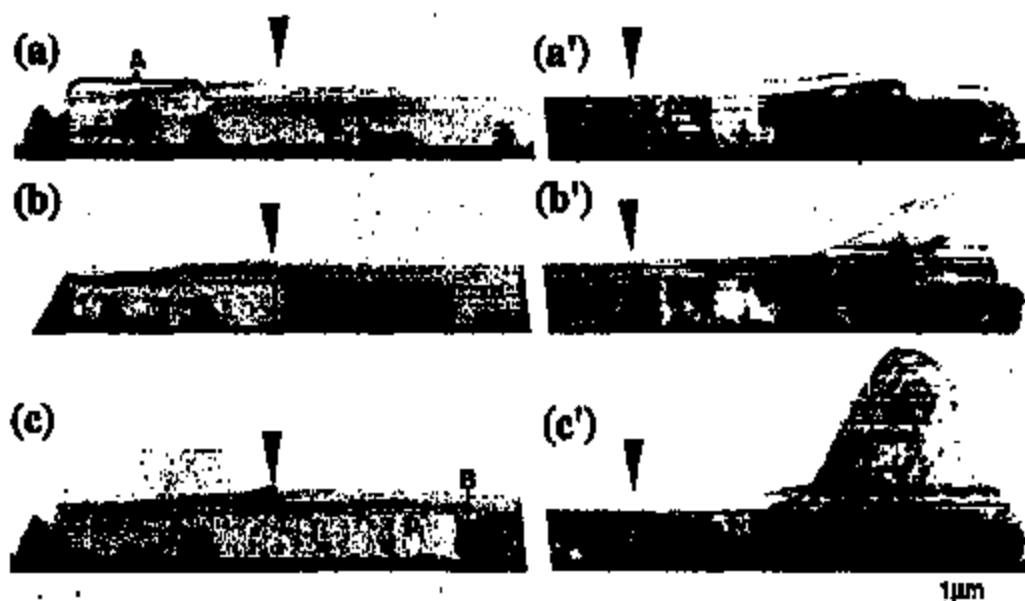
Fig. 1. Successive stages of electromigration in an Al-on-TiN line observed by side-view TEM. Damage evolution at the cathode and the anode of the line during current feeding in the forward direction are depicted in (a)–(c) and (a')–(c'), respectively. Current feeding time t for each figure is as follows: (a) $t = 720$ s, (b) $t = 2.8$ ks, (c) $t = 7.4$ ks, (a') $t = 1.6$ ks, (b') $t = 2.9$ ks, and (c') $t = 7.6$ ks.

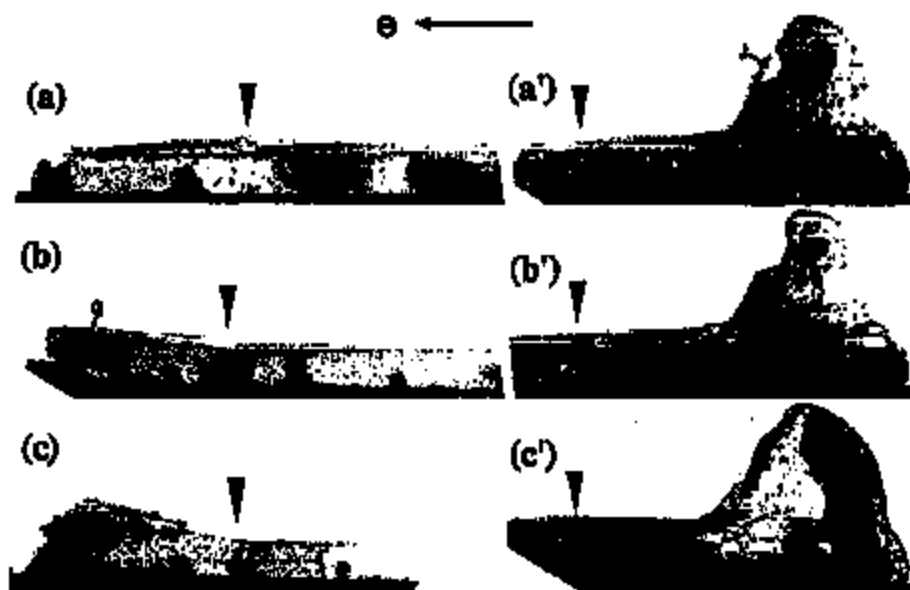
Fig. 2. Electromigration-induced damage at the (new) anode and the (new) cathode of the line during current feeding in the reverse direction are depicted in (a)–(c) and (a')–(c'), respectively. Current feeding time t (after the reversal) is as follows: (a) $t = 1.1$ ks, (b) $t = 11.9$ ks, (c) $t = 15.9$ ks, (a') $t = 2.5$ ks, (b') $t = 2.8$ ks, and (c') $t = 15.7$ ks. The black triangle-shaped arrows in Fig. 1(a)–1(c)/Fig. 2(a)–2(c) indicate a fixed position of the sample, and those in Fig. 1(a')–1(c')/Fig. 2(a')–2(c') another fixed position. The width of the Ti/TiN layer in this sample was $2 \mu\text{m}$.

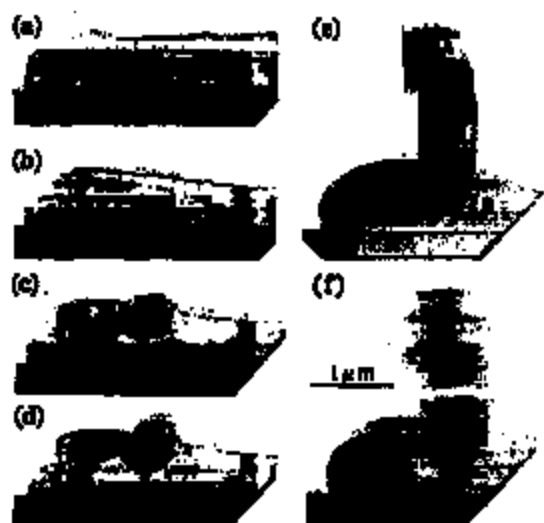
Fig. 3. Successive stages of whisker growth at the anode of an Al-on-TiN line. In this experiment, a 19 mA current was first fed for 5.3 ks and then the current was increased to 23 mA. Current feeding time t is as follows: (a) $t = 0 \text{ s}$, (b) $t = 4.08 \text{ ks}$, (c) $t = 5.70 \text{ ks}$, (d) $t = 6.18 \text{ ks}$, (e) $t = 9.78 \text{ ks}$, and (f) $t = 11.48 \text{ ks}$. Electrons flowed from right to left. The width of the Ti/TiN layer in this sample was $0.7 \mu\text{m}$.

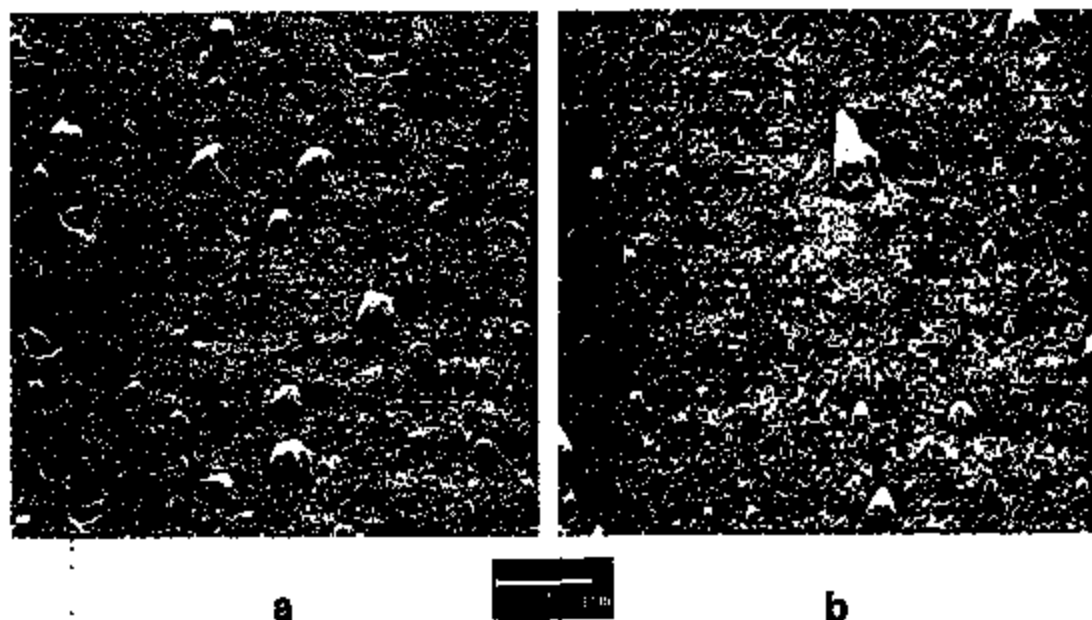
Fig. 1. SEM micrograph of Al surface: (a) unimplanted; (b) implanted with 160 keV Sb⁺ ions to a dose of 5×10^{15} cm⁻².

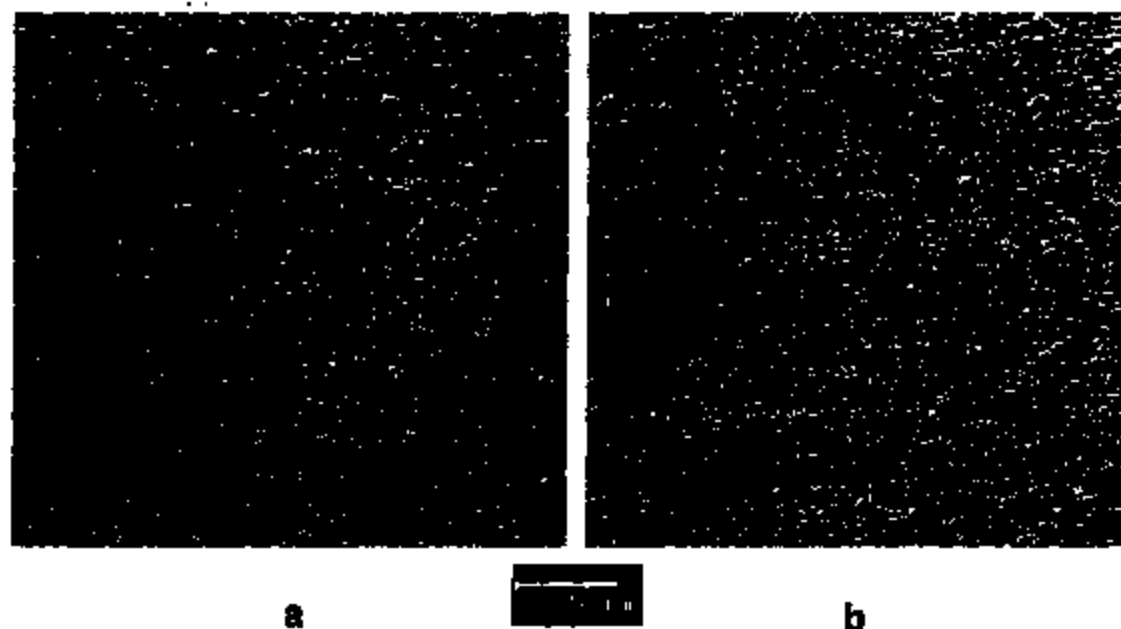
Fig. 2. SEM micrograph of Al:Si 1% surface: (a) unimplanted; (b) implanted with 150 keV Cr^+ ions to a dose of $9 \times 10^{19} \text{ cm}^{-2}$, both annealed at 450°C.

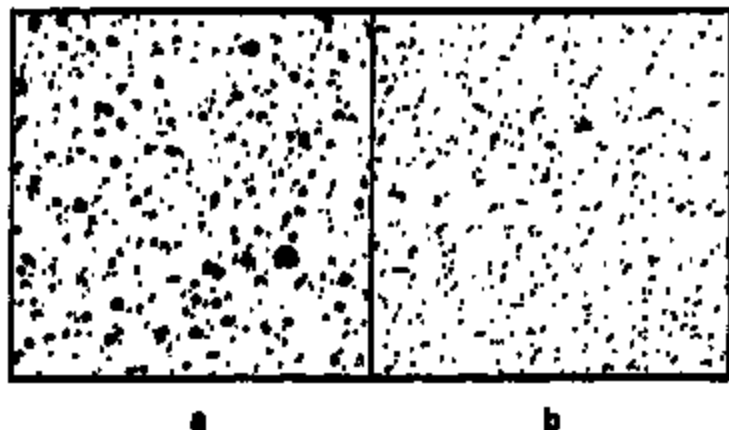
Fig. 3. Al surface analyzed by hillock recognition method: (a) unimplanted; (b) implanted with boron, $2.5 \times 10^{19} \text{ cm}^{-2}$.

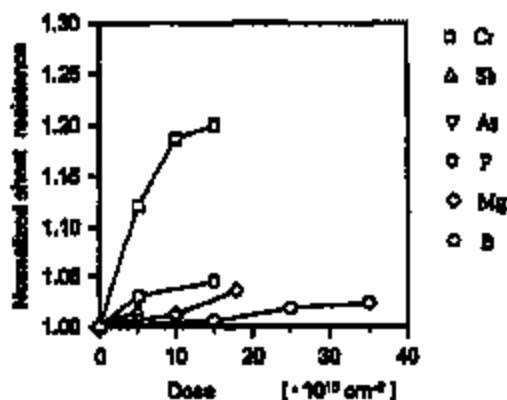
Fig. 5. Sheet resistance measurements of the implanted Al layers relative to unimplanted ones.
