U.S. Department  
of Transportation  
**National Highway  
Traffic Safety  
Administration**

# ODI RESUME

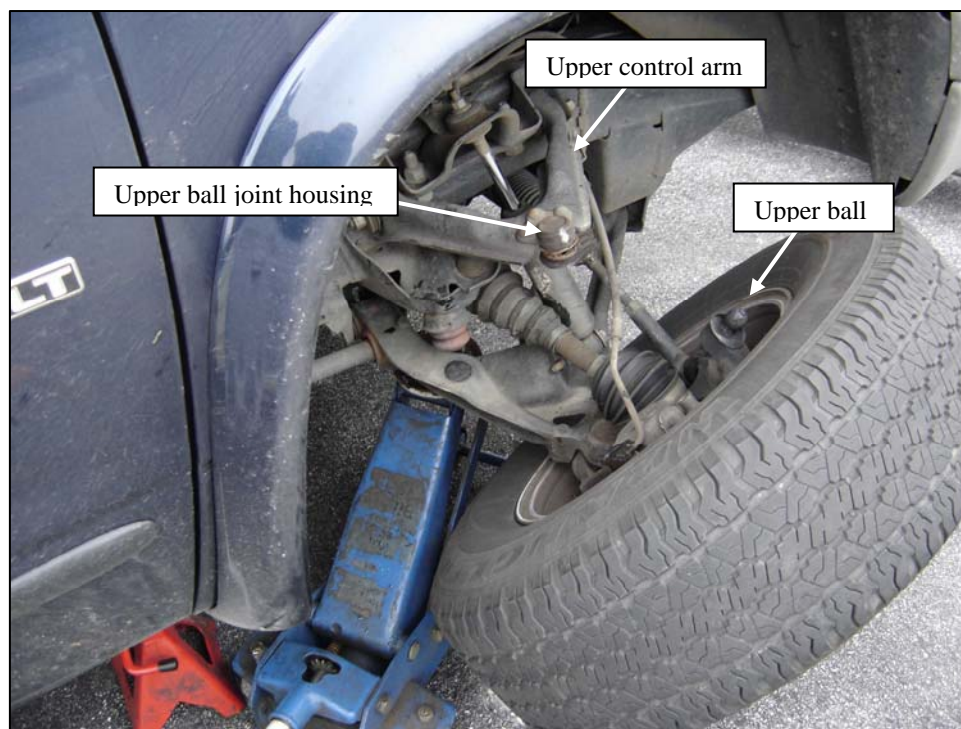
Figure 1. Front suspension upper ball joint separation – MY 2001 Dodge Dakota 4x4 - 57,400 miles – 5 mph.

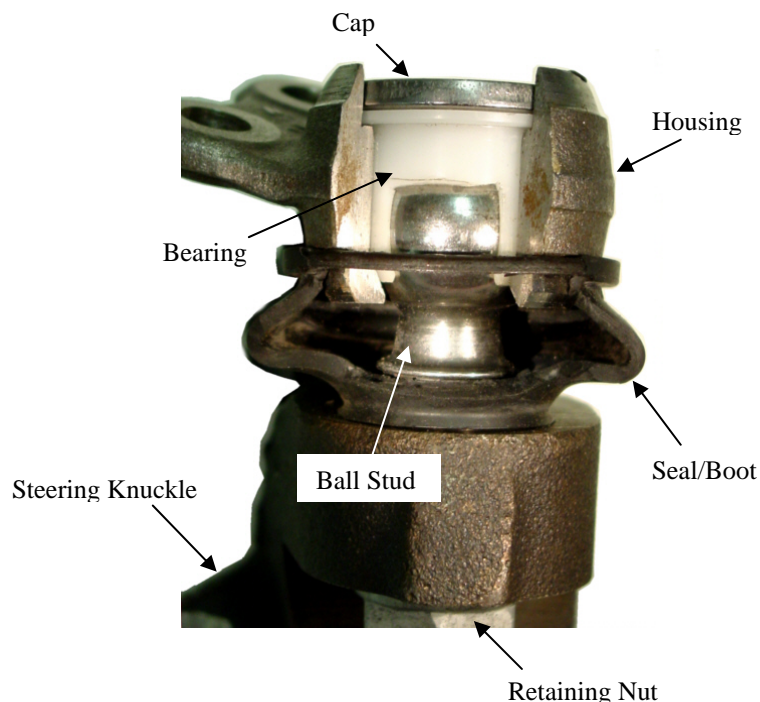
Figure 2. Upper ball joint cutaway (one-piece bearing).

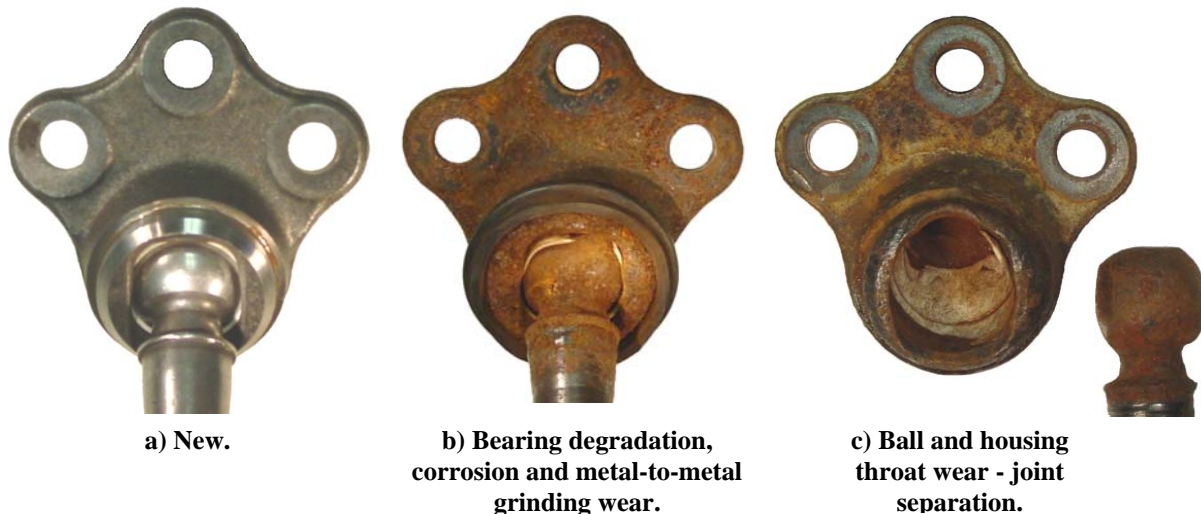
Figure 3. Failure mechanism, NCM ball joint.

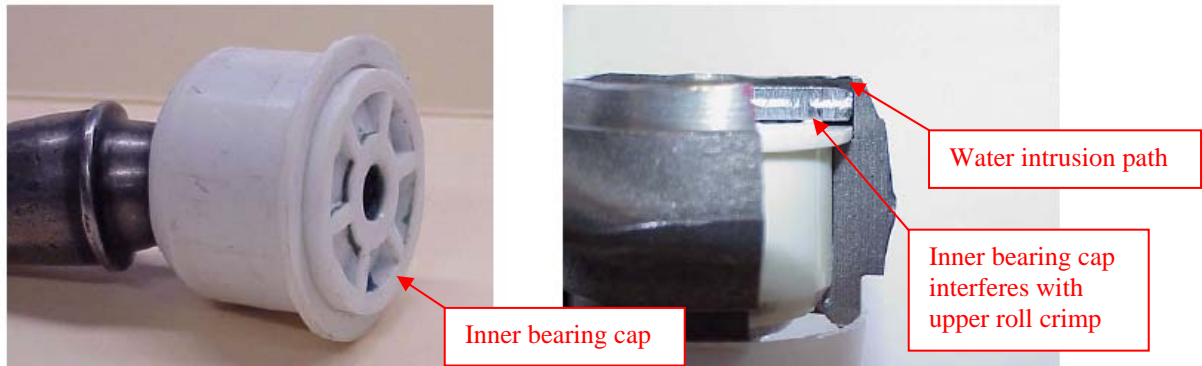
Figure 4. Two-piece bearing with ball stud (left), upper crimp water intrusion path (right).

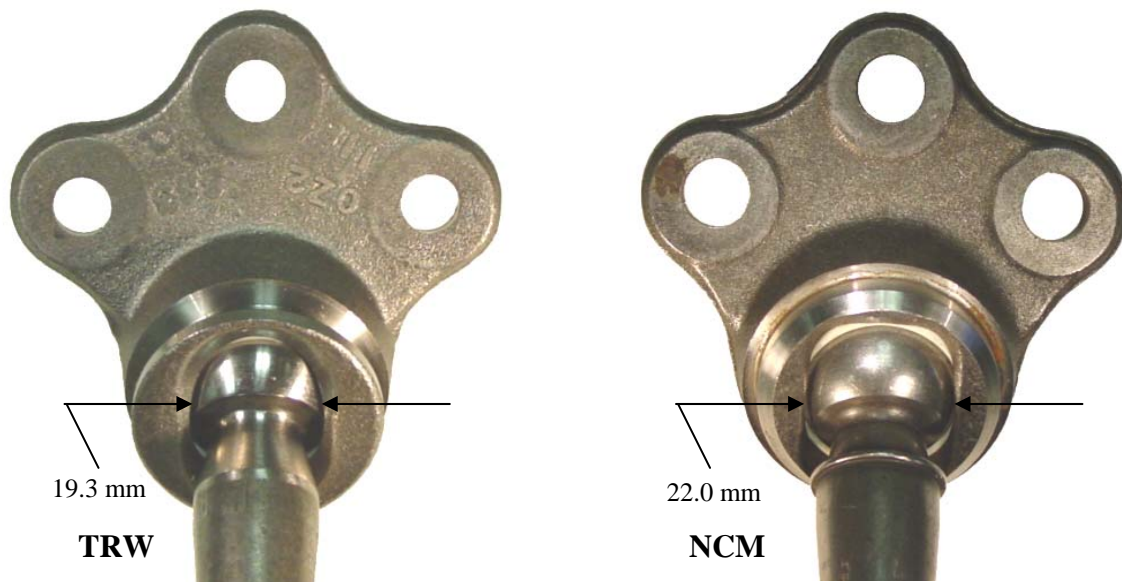
Figure 5. Upper ball joint throat opening, TRW and NCM.

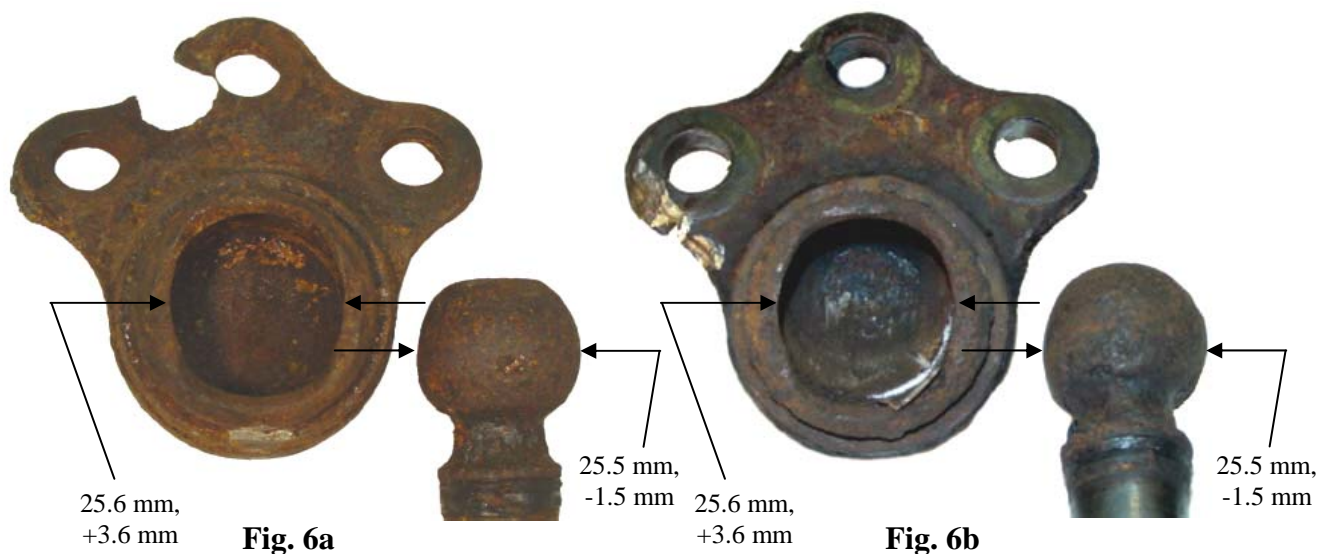
Figure 6. Separated NCM upper ball joints:

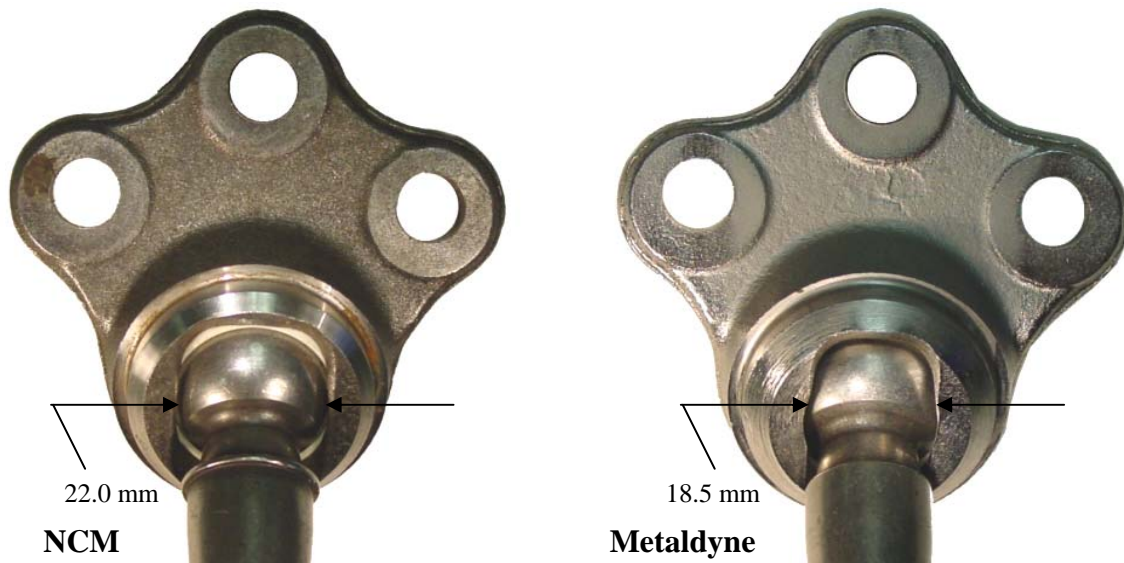
Figure 7. Housing throat opening change, NCM to Metaldyne service/recall part.

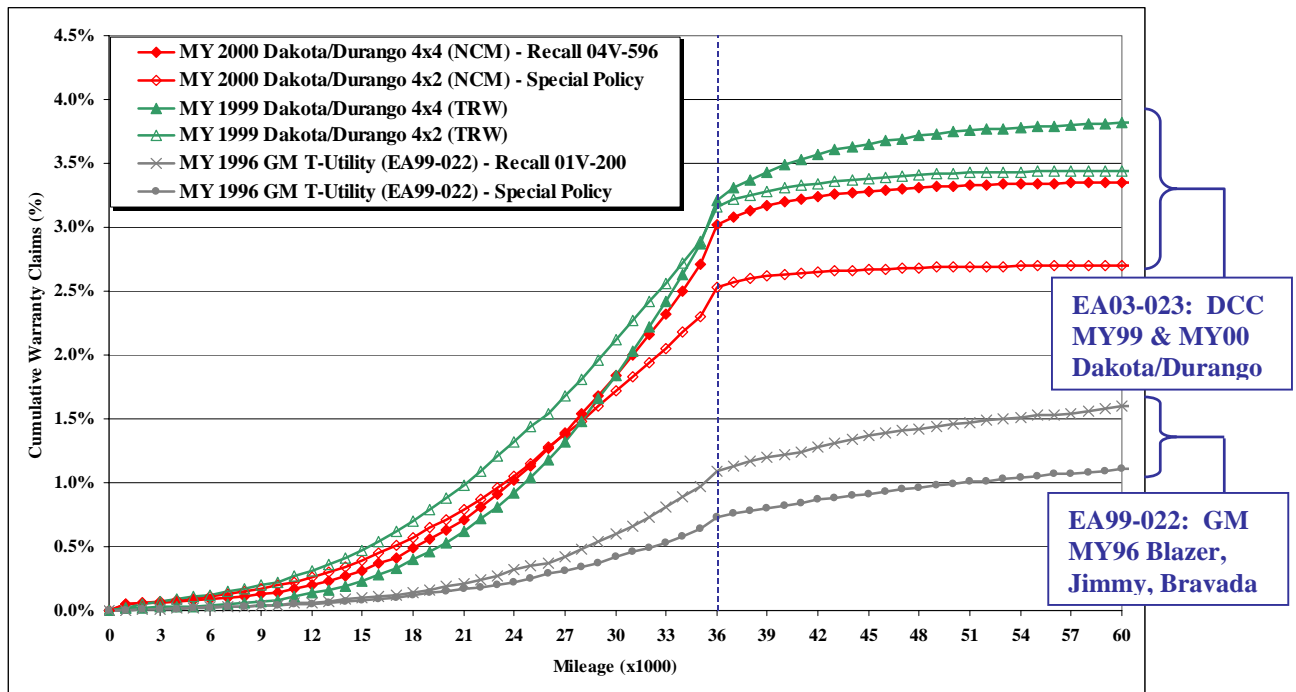
Figure 8. Cumulative warranty claim rates, subject vehicles vs. EA99-022 recall and special policy populations.

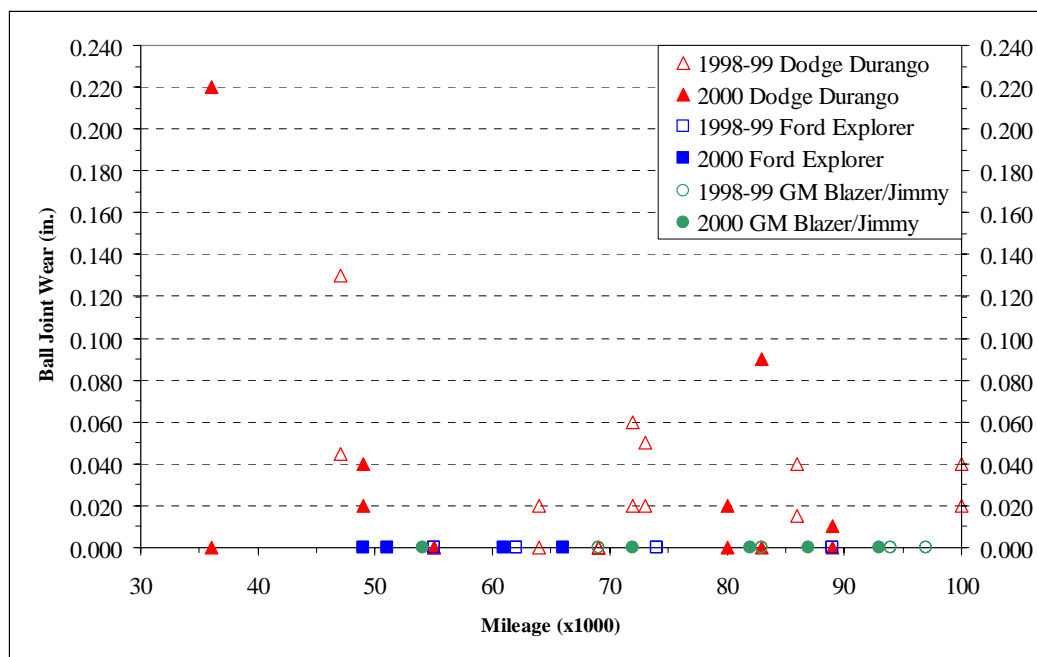
Figure 10. VRTC field survey results.

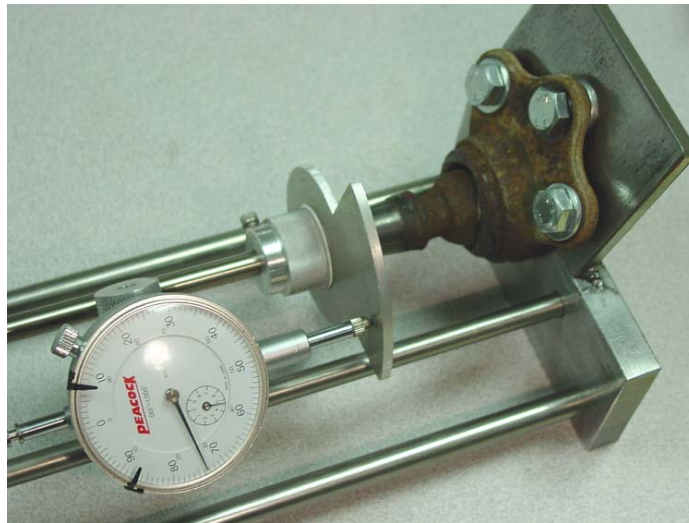
Figure 11. ODI end-play measuring fixture.

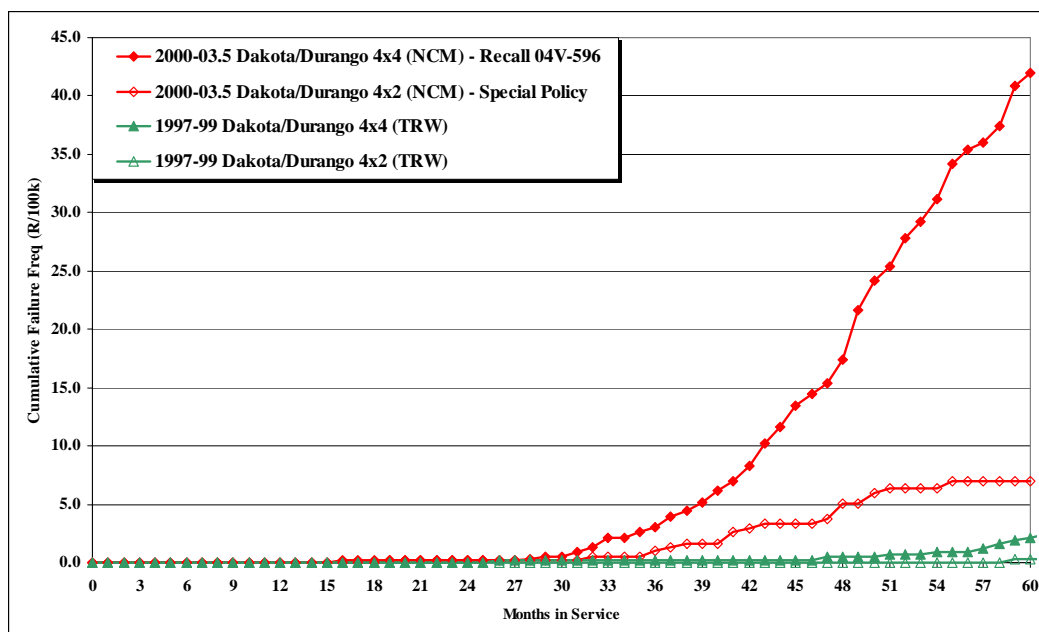
Figure 12. Cumulative failure frequency plot, subject vehicles.

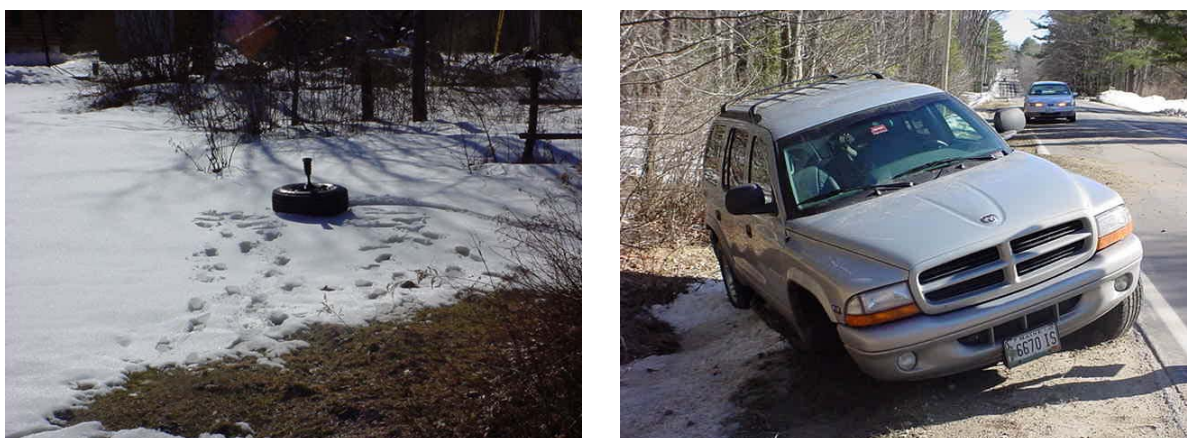
Figure 13. MY 2000 Durango 4x4 - 60,000 miles – 45 mph (DCC count = YES).

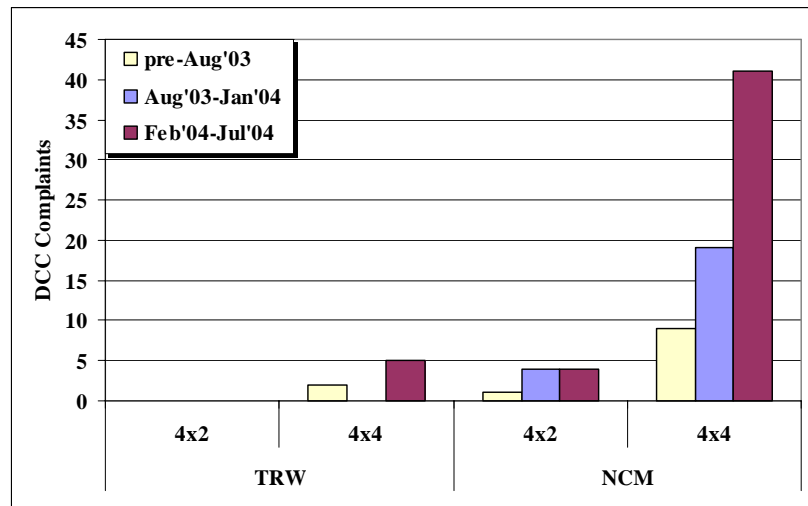
Figure 14. Complaint trends – DCC “confirmed” or “potential” upper ball joint separations by reporting period (does not include ODI complaints).

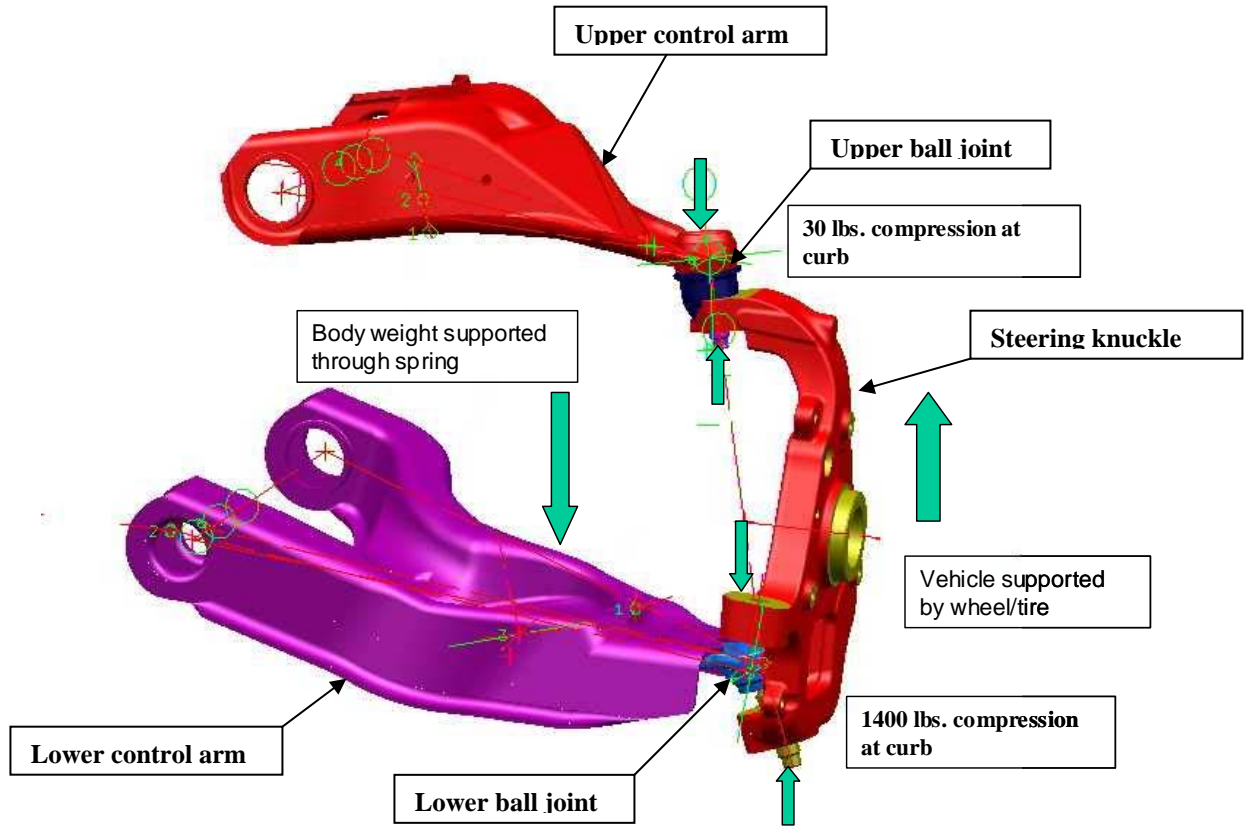
Figure 15. Durango Front Suspension at Curb.

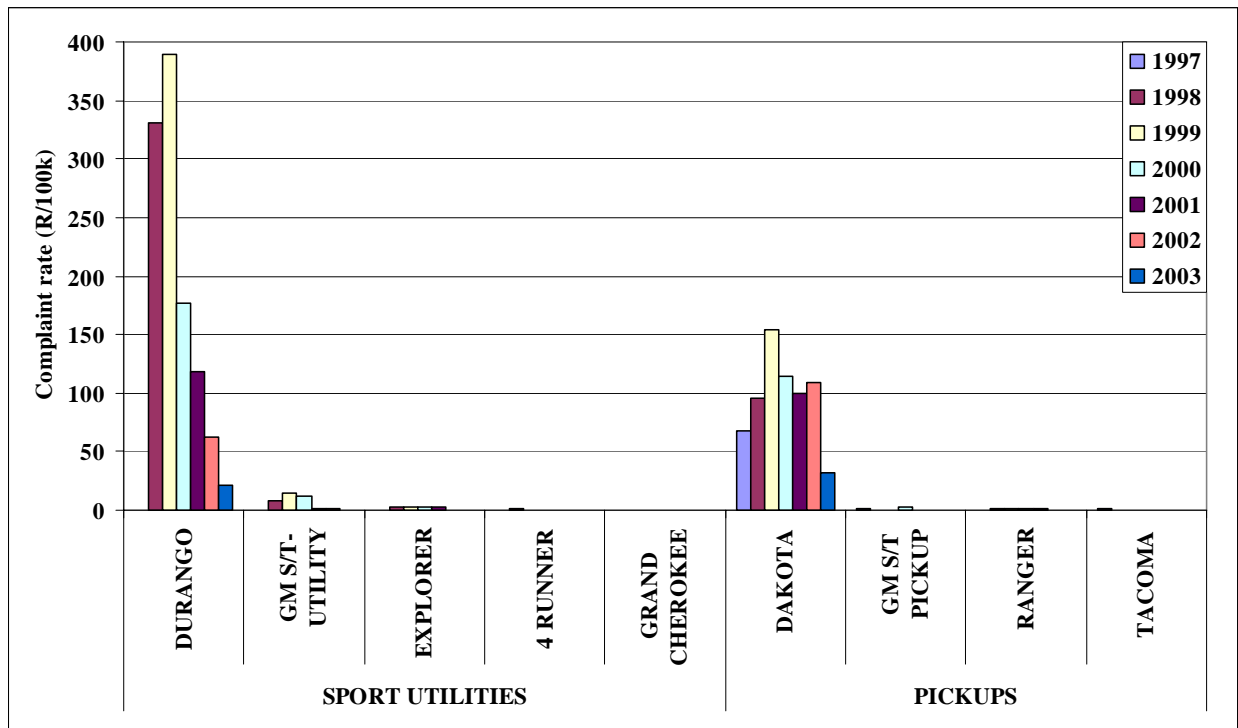
Figure 18. Subject vehicles compared with peers (MY 1997-2003 pickup trucks MY 1998-2003 sport utilities), ODI front suspension ball joint complaint rate.

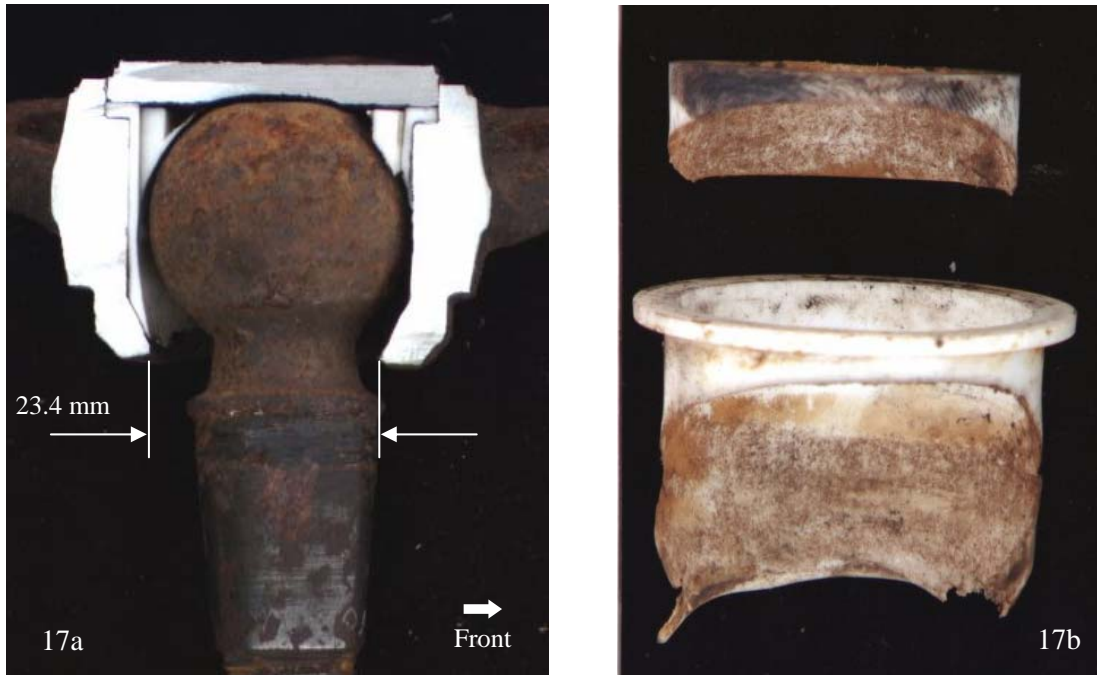
Figure 19. Sectioned upper ball joint – MY 2002 Dakota 4x4 – 44,000 miles – 0.263 inches end-play:  
(a) sectioned part – ball wear = 1.1 mm, throat wear = 1.4 mm; and (b) bearing wear, inboard view.

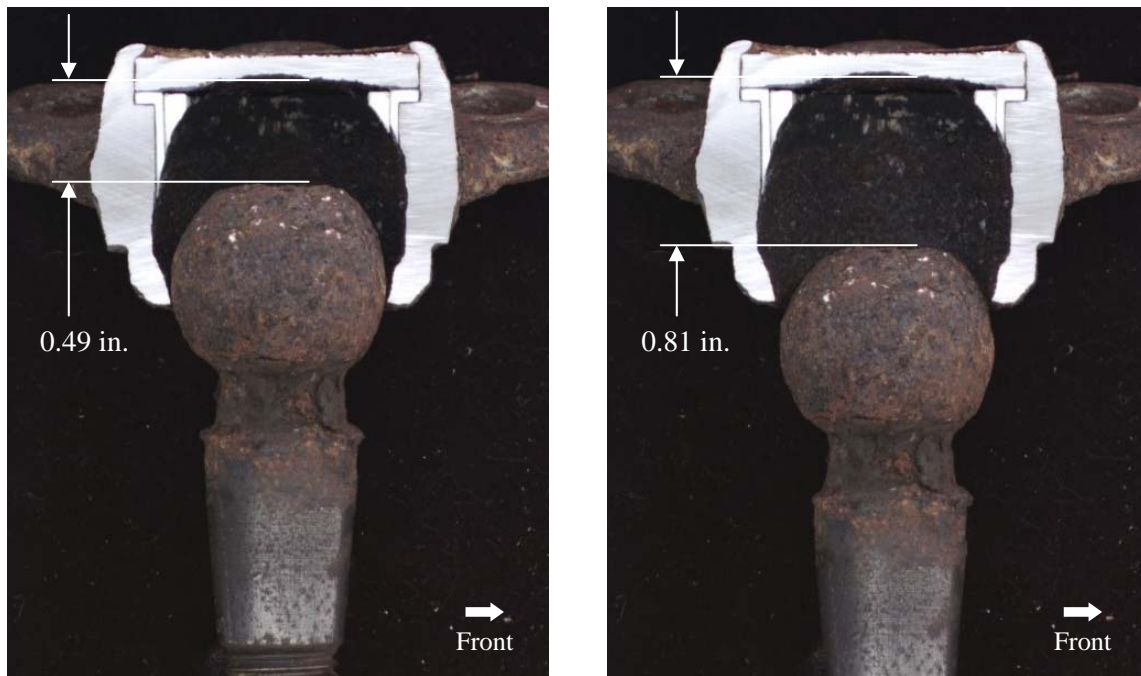
Figure 20. Sectioned right-front upper ball joint from separation incident;  
MY 2001 Dakota 4x4 – 27,900 miles – 55 mph – wheel separation;  
DCC count = NO (“Insufficient information available”).

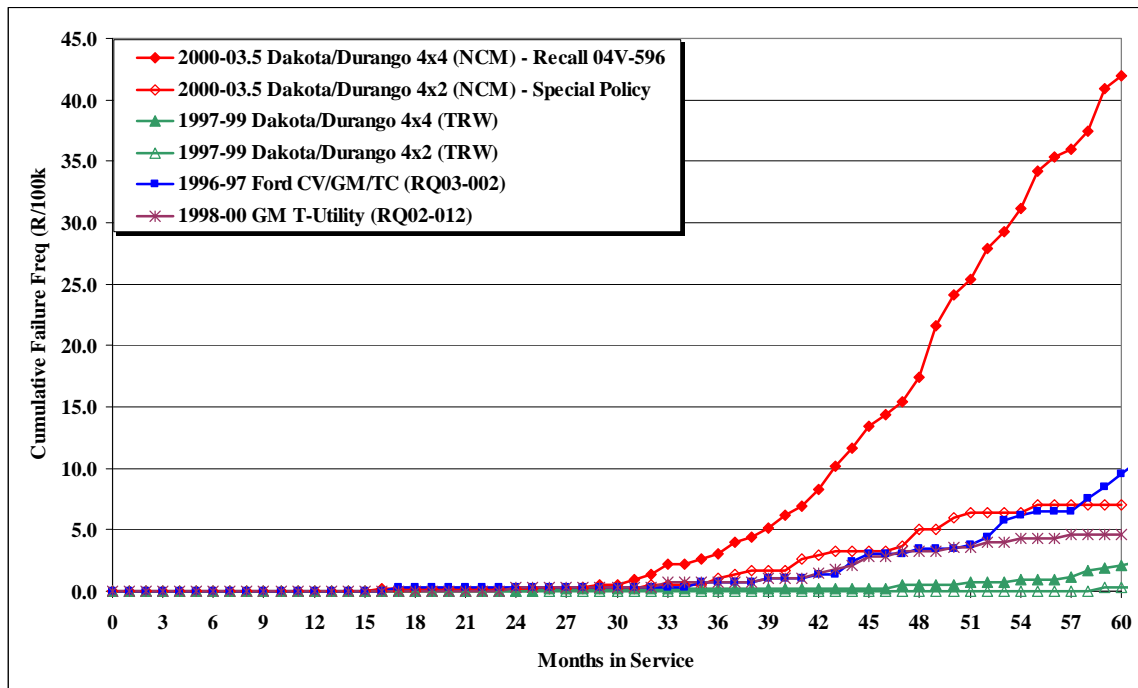
Figure 23. Cumulative failure frequency, subject vehicles using ODI complaints and peer investigations (RQ02-012 and RQ03-002).

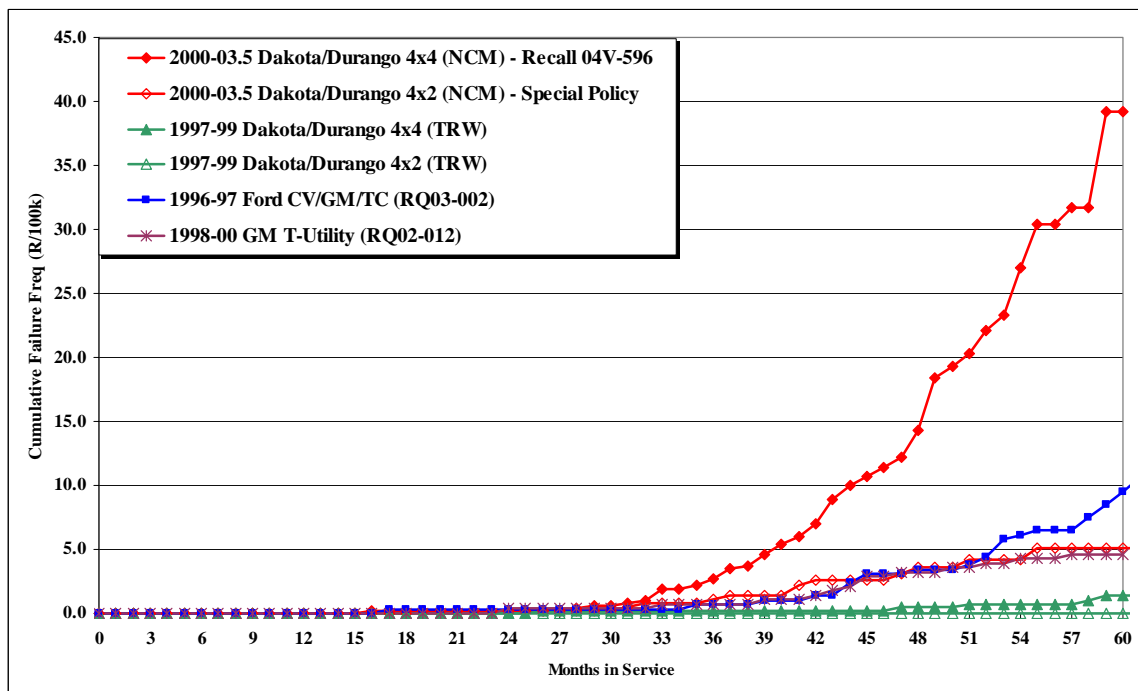
Figure 24. Cumulative failure frequency, subject vehicles using DCC complaints and peer investigations (RQ02-012 and RQ03-002).

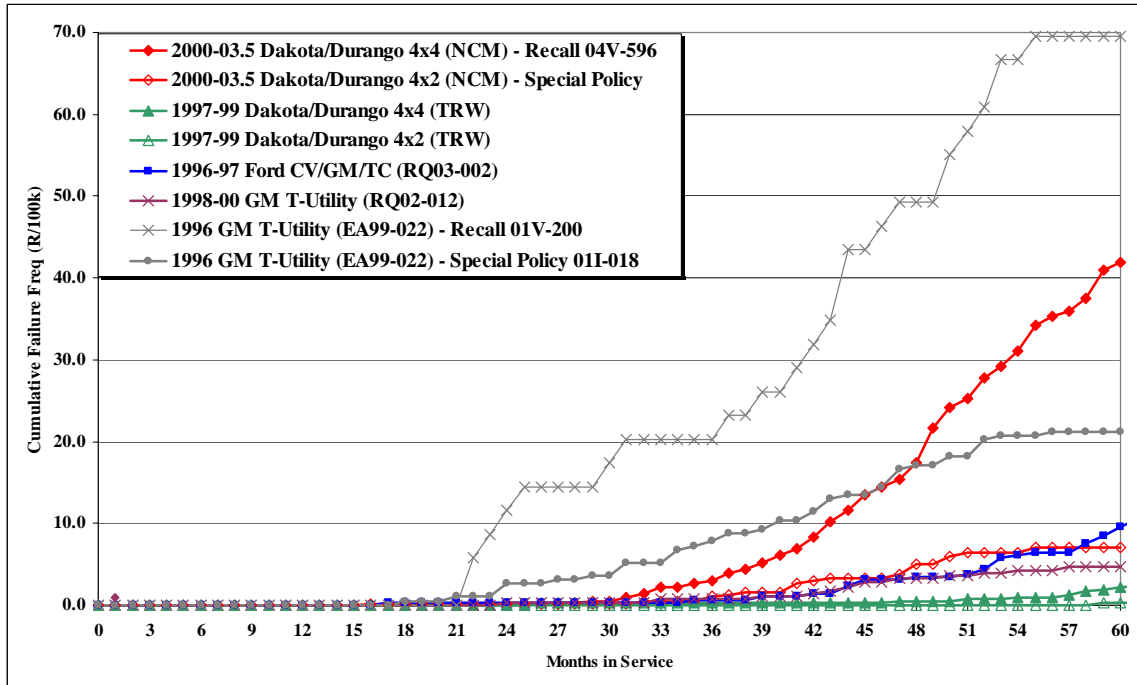
Figure 25. Cumulative failure frequency, subject vehicles using ODI complaints and peer investigations (RQ02-012, RQ03-002, and EA99-022).

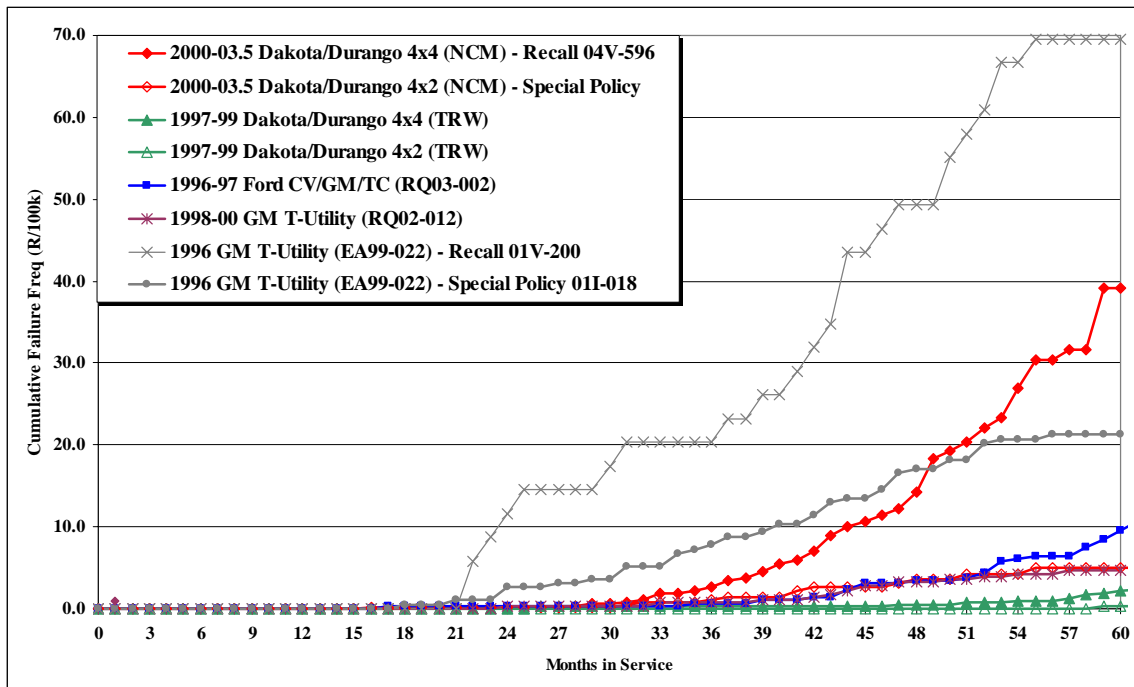
Figure 26. Cumulative failure frequency, subject vehicles using DCC complaints and peer investigations (RQ02-012, RQ03-002, and EA99-022).

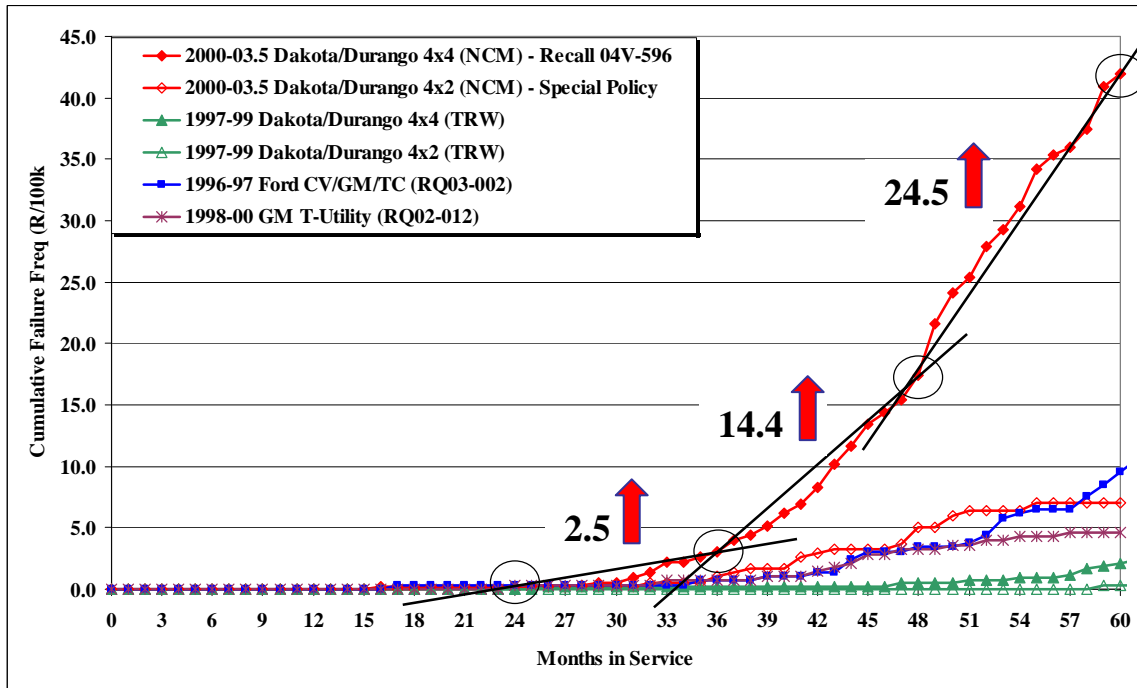
Figure 27. Failure trend analysis, using ODI complaints.

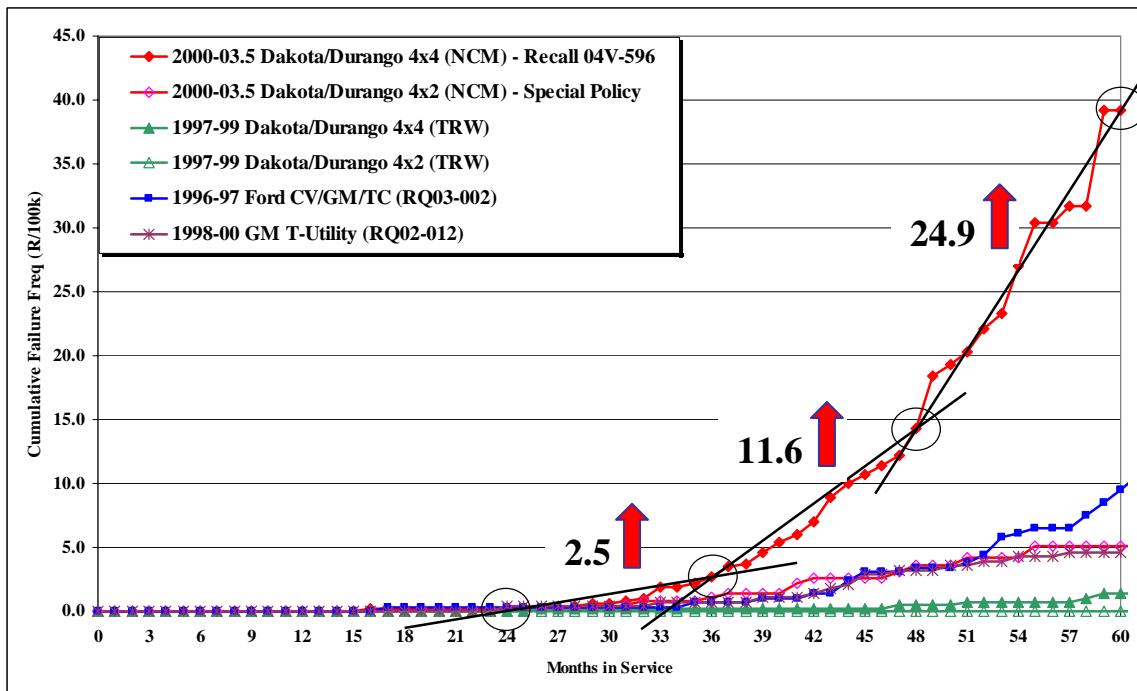
Figure 28. Failure trend analysis, using DCC complaints.

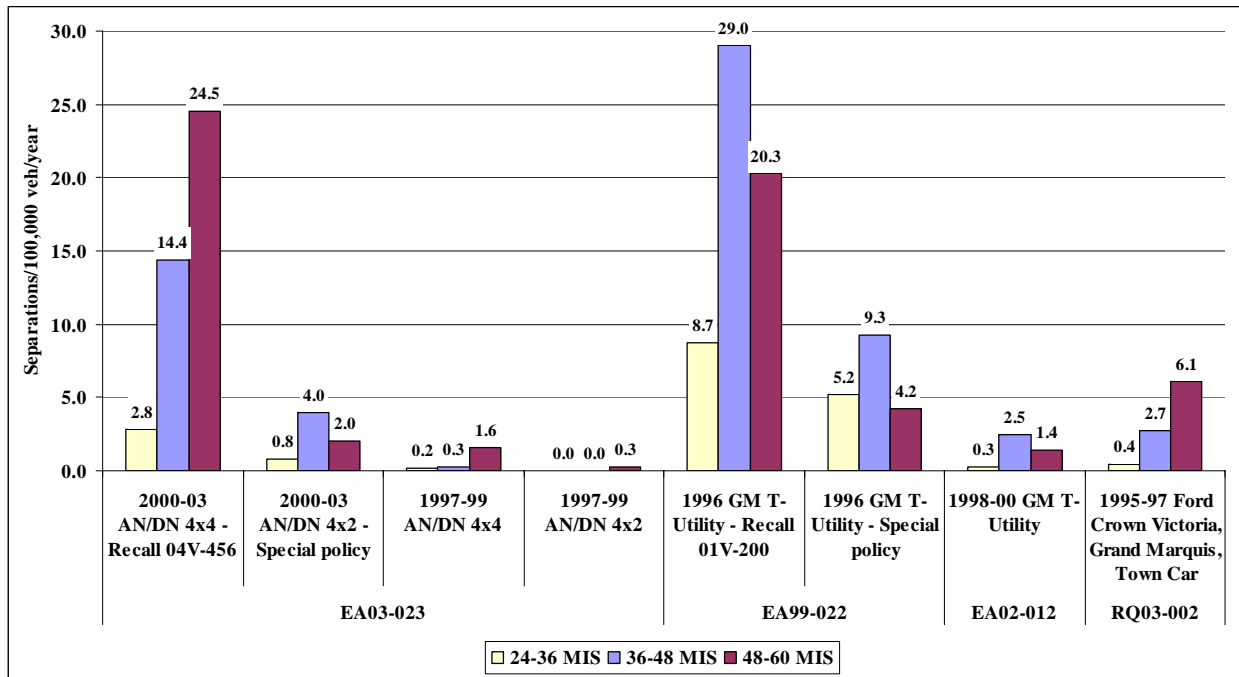
Figure 29. Separation rate trends from: (1) 24-36 months in service; (2) 36-48 months in service; and (3) 48-60 months in service, for subject vehicles using ODI counts and peer investigations.
