Investigation: EA06-018 Date Opened: 10/30/2006 Date Closed: 12/03/2007 Principal Investigator: Chris Lash Subject: Front suspension crossmember corrosion

ENGINEERING ANALYSIS CLOSING REPORT

<u>SUBJECT</u>: Front suspension crossmember corrosion.

EA No.: EA06-018 Date Opened: 30-Oct-2006 Date Closed: -Nov-2007

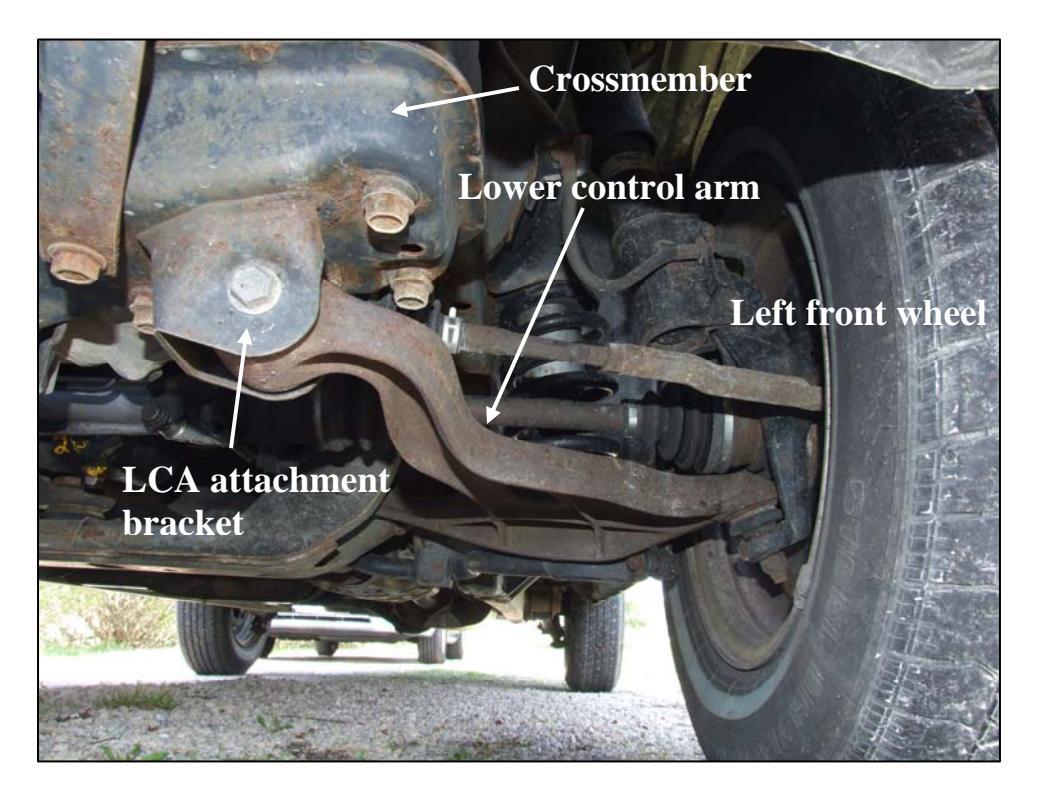
Figure 2. Front crossmember and left LCA attachment bracket, MY 2000 Chevrolet Tracker 4x4.

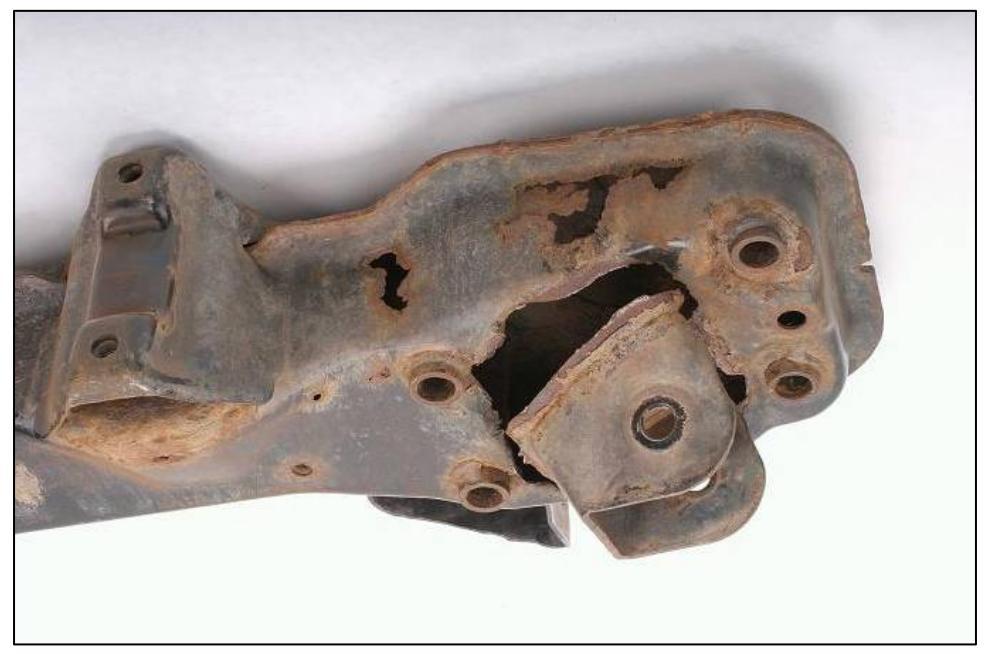
THE ALLEGED DEFECT: Corrosion of the front suspension crossmember that can result in separation of the LCA front attachment.

Figure 3. Partially separated right LCA attachment, MY 2000 Chevrolet Tracker, Michigan, 92,000 miles.

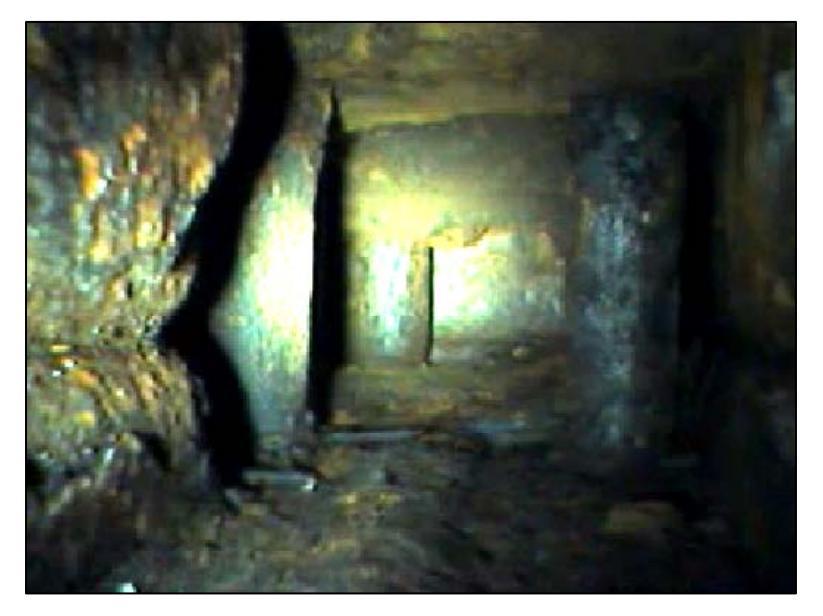
FAILURE MECHANISM: Because the E-Coating application did not provide adequate corrosion protection on the interior of the crossmember, water and mud/salt from the road surface can enter through seams and holes and initiate crevice corrosion. Perforations may develop in areas of accelerated crevice corrosion. As perforations in the area of the LCA attachment grow, the bracket can fail, causing complete or partial separation of the LCA from the crossmember. Figure 4 shows the inside of a crossmember that was replaced for LCA separation after approximately 6 years of service.

Figure 4. Crevice corrosion inside crossmember.

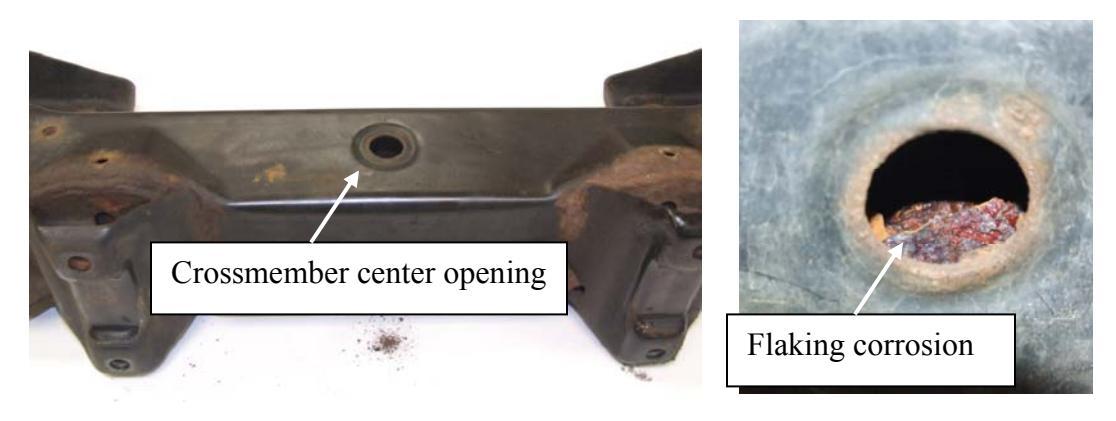
Figures 6a and 6b. Crossmember center opening used to assess interior corrosion.

Because the corrosion initiates on the inside of the parts, VRTC visually inspected the inside of 7 crossmembers through an opening in the center of the crossmember (Figure 6a). Though each of the 7 vehicles inspected in this manner exhibited a different degree of external corrosion, all 7 crossmembers showed significant levels of interior corrosion (i.e., loose, flaking corrosion – see Figure 6b).

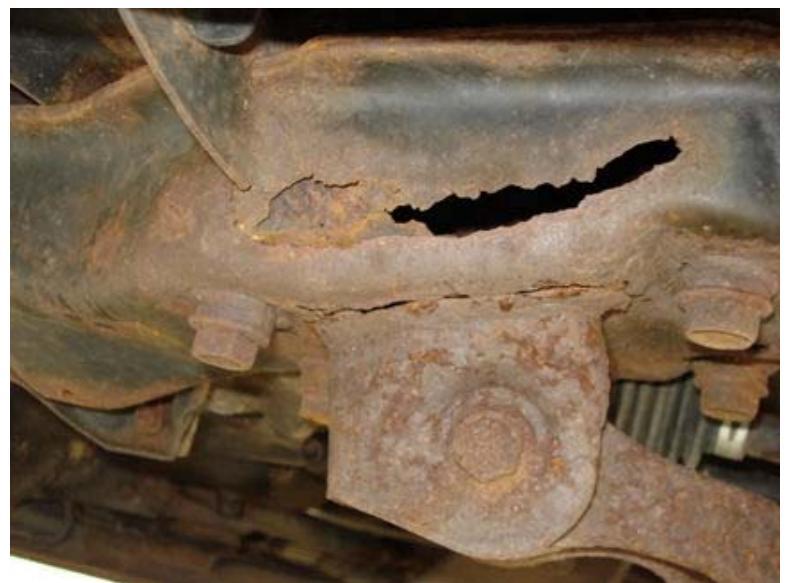
Figure 7 shows an example of a crossmember with a large perforation above the left LCA attachment bracket that has not progressed to the stage where symptoms indicated by GM would be noticed by the driver.

Figure 7. Crossmember perforation above left LCA attachment bracket -MY 1999 Tracker, 69,000 miles, Brunswick, Ohio.

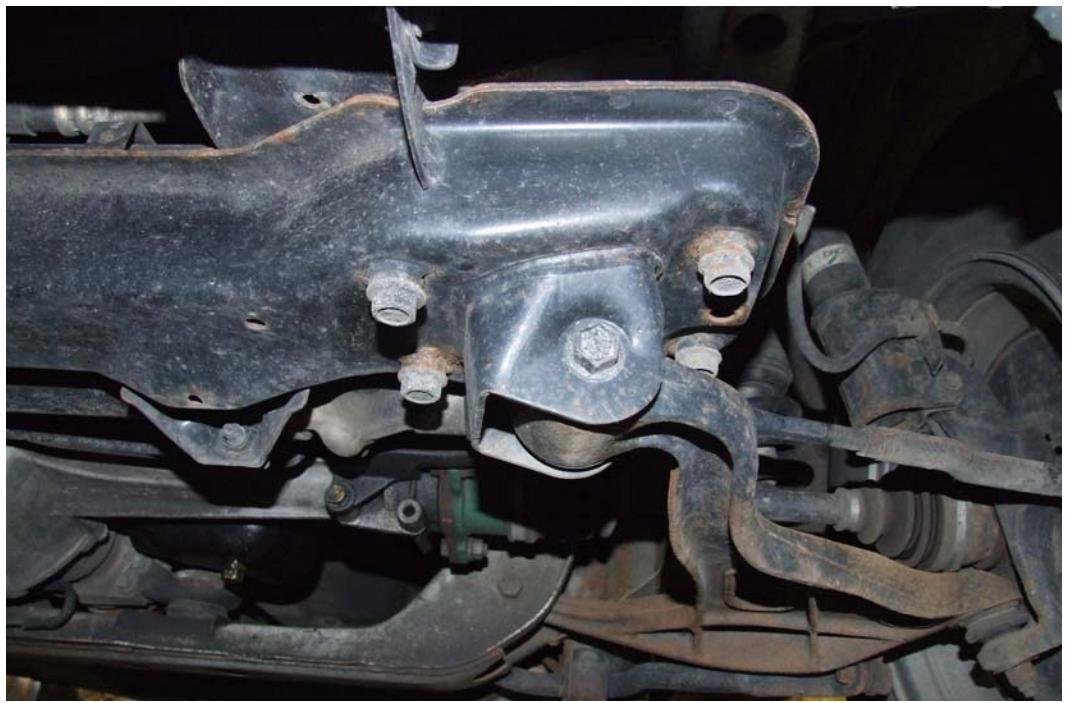
Figure A1. Left LCA attachment, minimal corrosion, Inspection Vehicle #20, MY 2000 Tracker with 79 months in service and 26,765 miles.

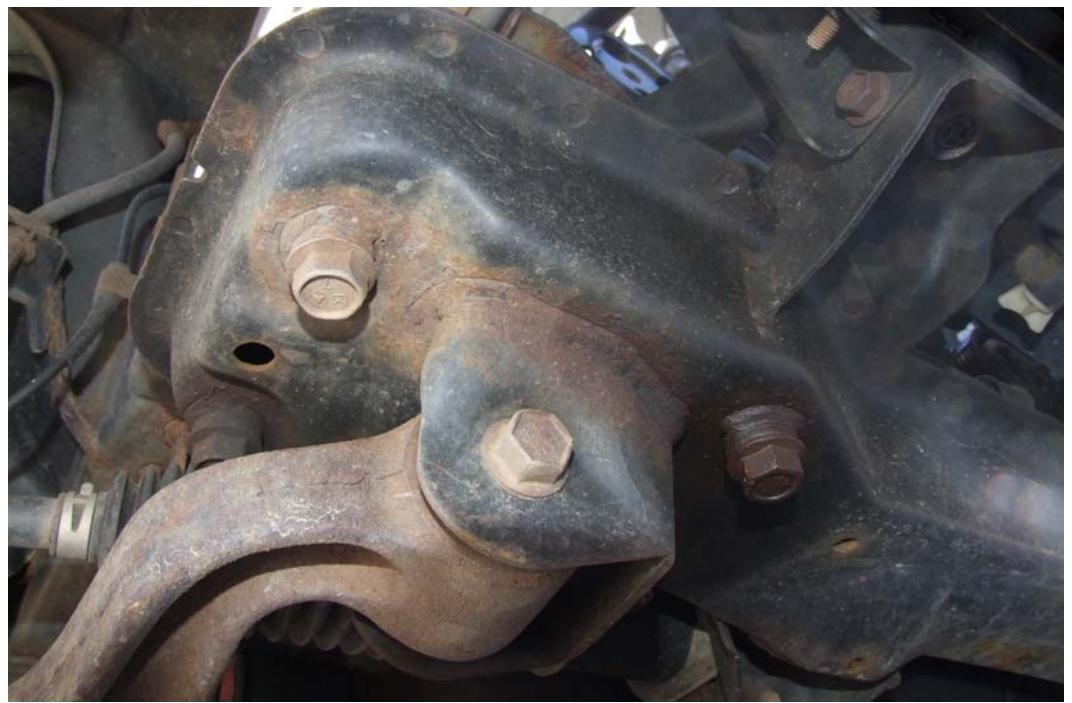
Figure A2. Right LCA attachment, early corrosion, Inspection Vehicle #1, MY 2000 Tracker with 84 months in service and 75,336 miles.

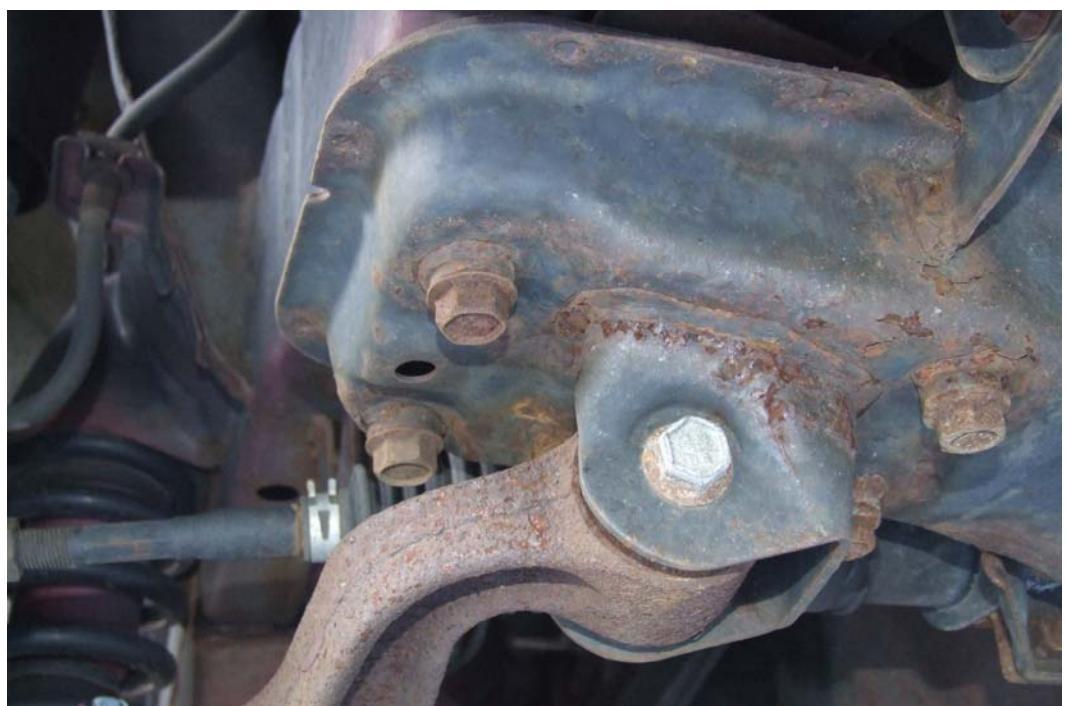
Figure A3. Right LCA attachment, moderate corrosion, , Inspection Vehicle #11, MY 2000 Tracker with 82 months in service and 75,371 miles.

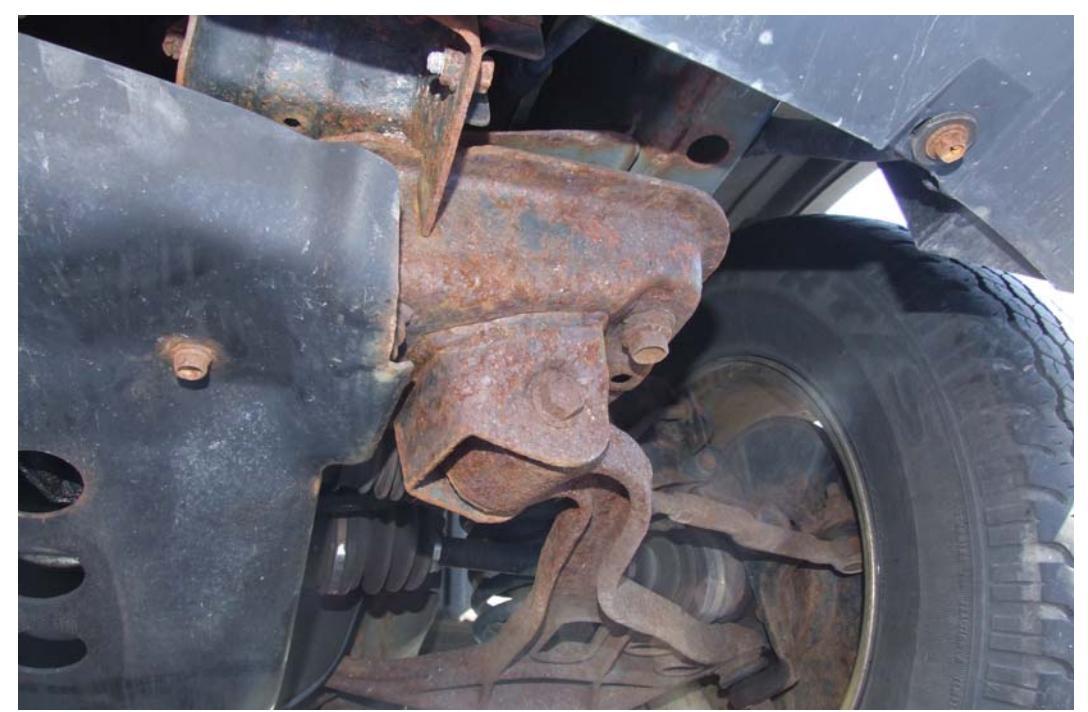
Figure A4. Left LCA attachment, exterior flaking corrosion, Inspection Vehicle #13, MY 2001 Tracker with 68 months in service and 54,115 miles.

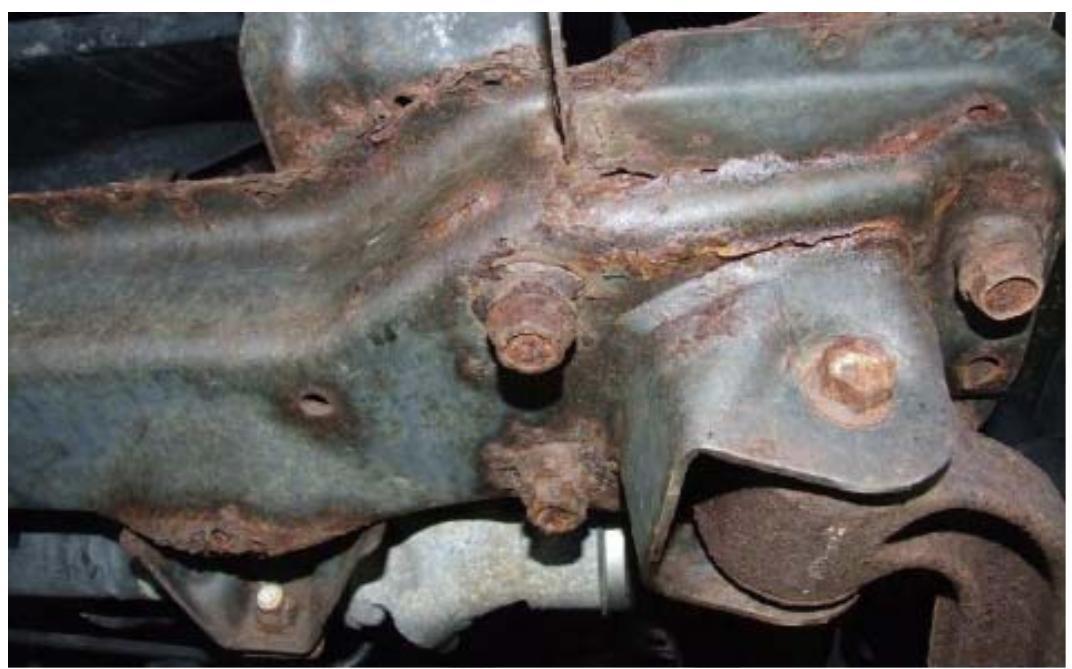
Figure A5. Left LCA attachment, exterior flaking corrosion, Inspection Vehicle #8, MY 2000 Tracker with 84 months in service and 58,208 miles.

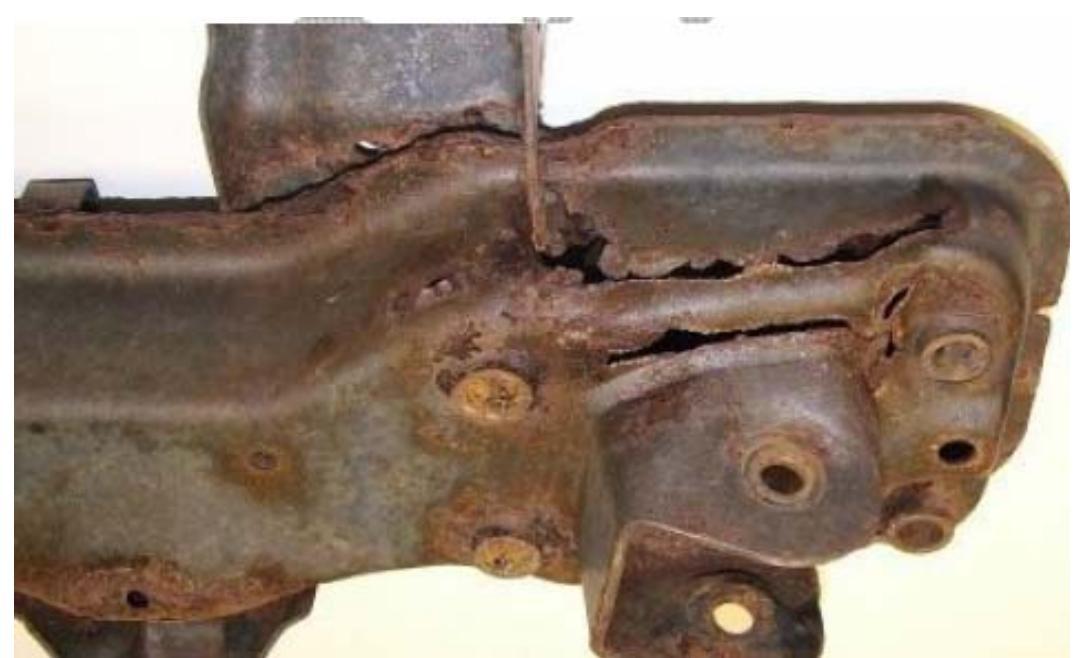
Figure A6. Left LCA attachment, perforated crossmember, Inspection Vehicle #8, MY 2000 Tracker less than one month after initial inspection.

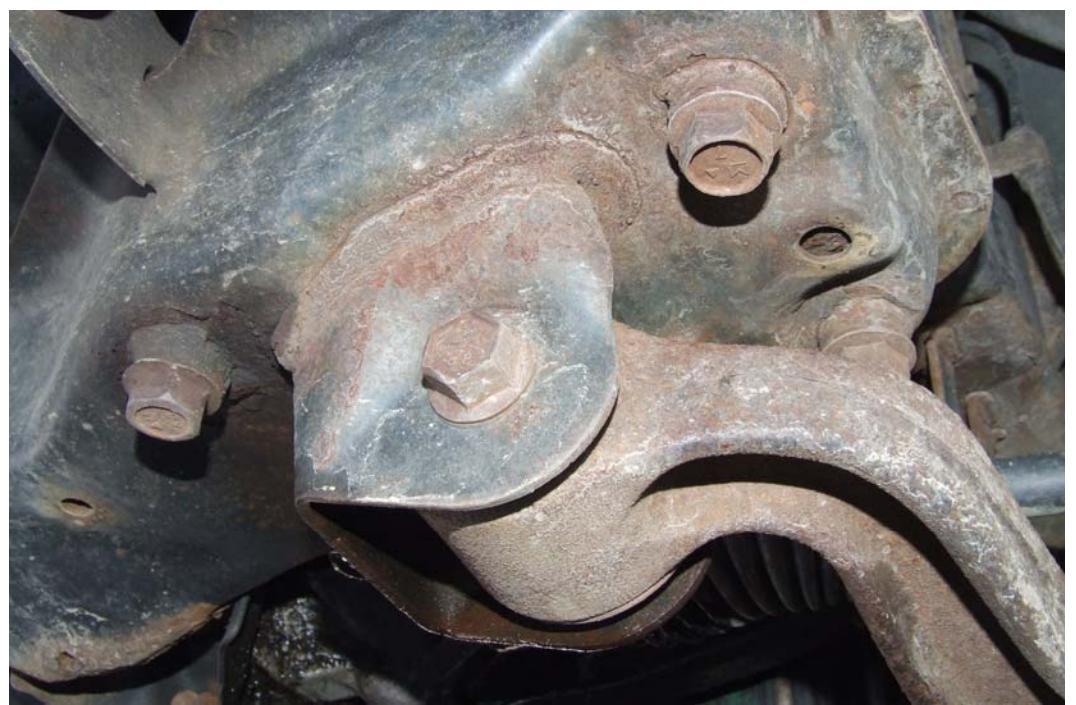
Figure B1. Left LCA attachment showing front surface of crossmember.

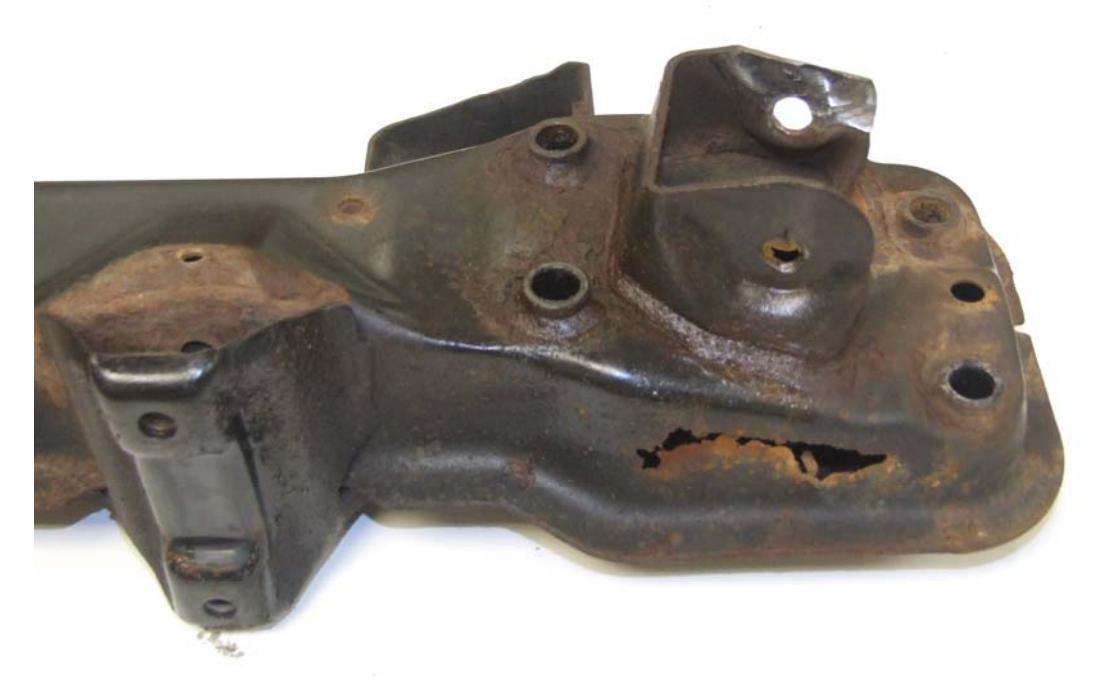
Figure B2. Left LCA attachment showing rear surface after part removal.

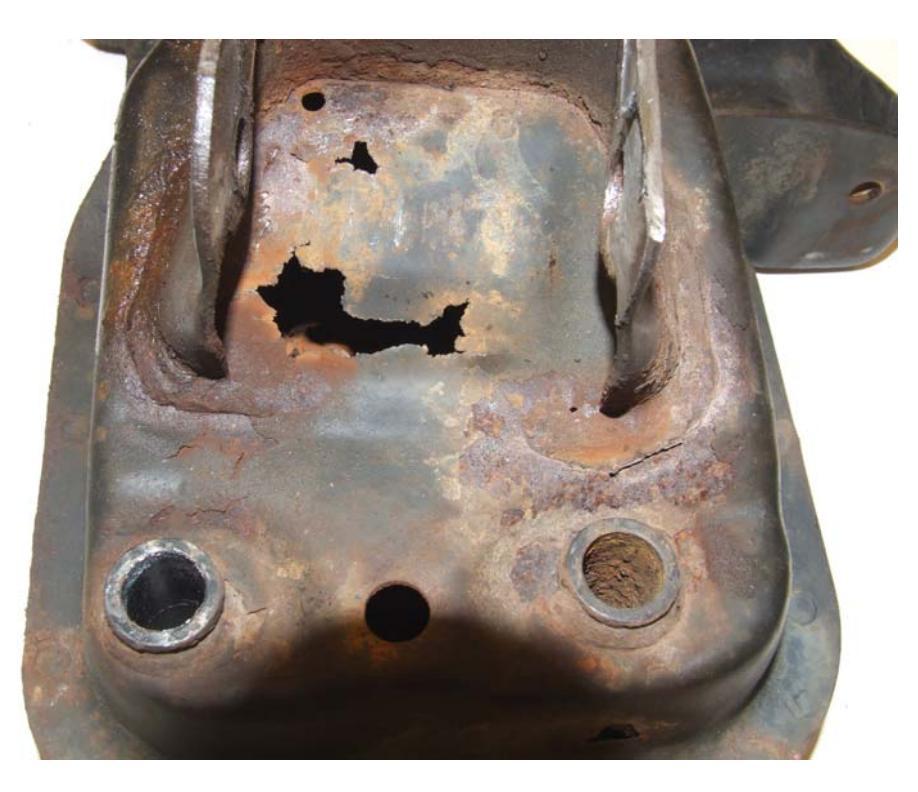
Figure B3. Perforation under the right LCA attachment, not visible during initial vehicle inspection.

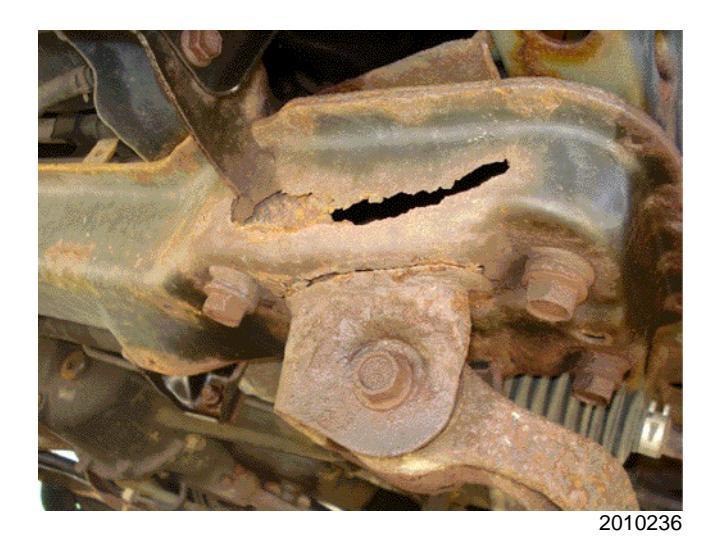
3. Carefully inspect the lower portion of the crossmember, on both the front and rear vertical surfaces, at the front lower control arm mount.

- If the metal perforates or displays a significant "dent" upon test completion, replace the crossmember. Refer to *Front Suspension Crossmember Replacement* in SI.
- If the metal does NOT perforate or display a significant "dent" upon test completion, no further action is required. Refer to the Claim section of the bulletin.
