IIS Department	Investigation:	EA 08-018			
of Transportation	Prompted by:	Consumer Complaints			
or iransportation	Date Opened:	08/28/2008	Date Closed:	06/30/2011	
National Highway	Investigator:	Kyle Bowker	Reviewer:	Jeff Quandt	
Traffic Safety	Approver:	Frank Borris			
Administration	Subject:	Front Suspension Coil Spring Fracture

ENGINEERING ANALYSIS CLOSING REPORT

<u>SUBJECT</u>: Alleged front suspension coil spring fracture.

INVESTIGATION: EA08-018

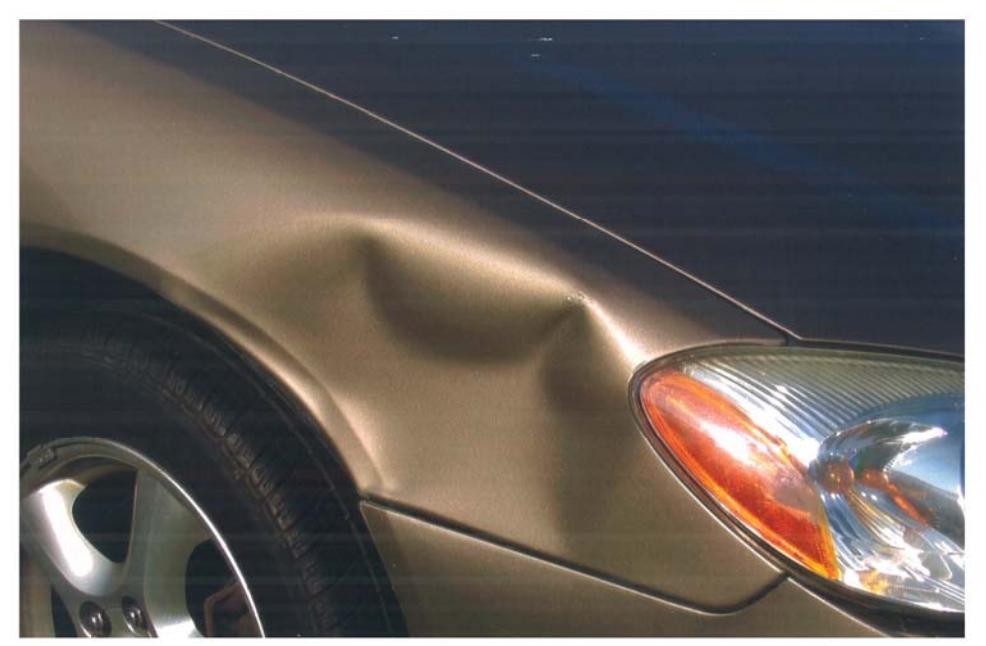
CONSEQUENCES OF THE ALLEGED DEFECT: ODI is aware of 4 reported crashes related to the alleged defect resulting in one minor injury. All 4 crashes are reportedly single-vehicle incidents involving collision with roadside objects such as guardrails, ditches, or curbs resulting in minor vehicle damage, as depicted in Figure 1 below. ODI also received 5 separate crash allegations that, upon further investigation, we do not consider to be crash incidents. Rather, the complainants described the coil spring fracture and subsequent tire puncture itself as the crash event or "accident."

Figure 1: Photograph of a subject vehicle that sustained crash damage due to the alleged defect
