DP09-001 ATTACHMENT 1

DP09-001 09V-388 consumer letter

> Safety Campaign (Special Service Campaign) - 9LG Dealer Notification on Potential Floor Mat Interference with Accelerator Pedal (Updated December 1, 2009)

S10 #: DOT/I #: RMP #: Subject: PETITION FOR ADDITIONAL INVESTIGATION INTO THE UNWANTED AND UNINTENDED ACCELERATION OF MODEL YEAR 2007 LEXUS ES350

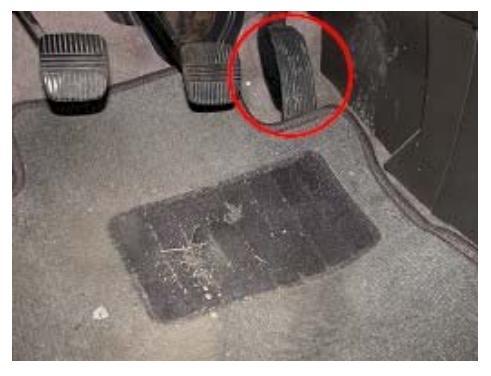
During Transport Canada's investigations of alleged sudden vehicle accelerations and stuck throttles, we frequently discover that the problem relates to some interference between the vehicle floor mats and the pedals. Typically, the interference occurs when non-original equipment floor mats are used without properly being retained to the vehicle floor. The floor mat can then move under the driver's feet and become lodged either between the pedals, on top of the pedals or under the pedals. Another common problem occurs when consumers install multiple floor mats on top of each other, reducing the clearance between the vehicle floor and the pedals.

If you have installed aftermarket floor mats in your vehicle, make certain they cannot move while driving. If you are going to install rubber mats in the winter months, when doing so, be sure that you remove the originally equipped factory floor mats. Use only one set of mats and make certain that the mats do not interfere with the gas or brake pedal before driving the vehicle.

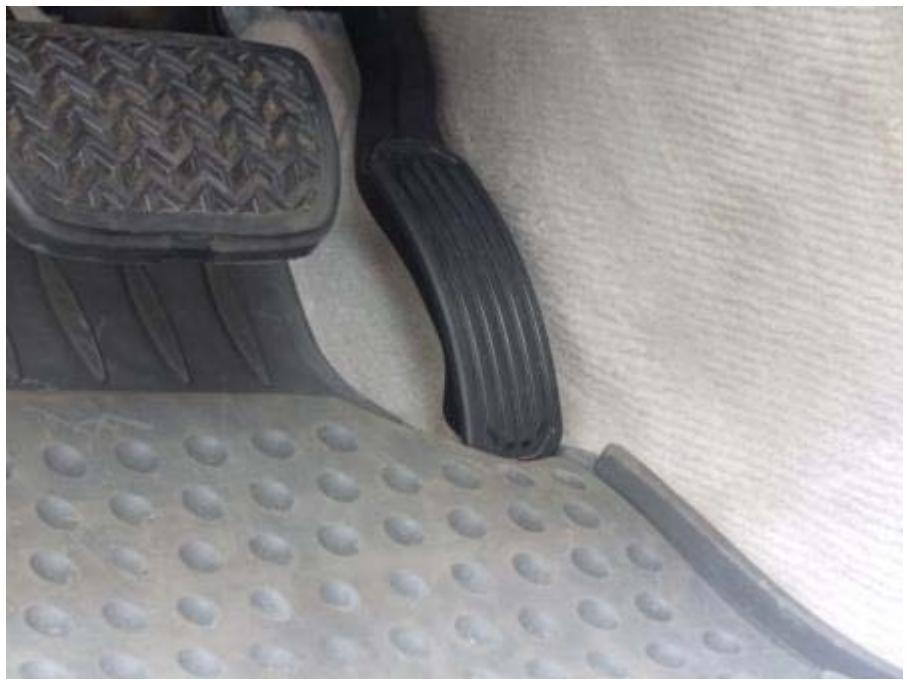
Example of an unsecured driver-side floor mat trapping the accelerator pedal in a 2007 Lexus ES350
