### GM 4/14/2010 ATTACHMENT Q 07 04-03-08-006D Steering and Front Suspension Noise Concerns

### #04-03-08-006D: Steering and Front Suspension Noise Concerns - Clunk, Thump, Rattle, Knocking, Pop, Shudder, Vibration (Diagnosis and Perform Necessary Repairs) - (Feb 24, 2009)

Models: 2005-2009 Chevrolet Cobalt (Including SS) 2006-2009 Chevrolet HHR (Including SS) 2005-2006 Pontiac Pursuit (Canada Only) 2007-2009 Pontiac G5 2003-2007 Saturn ION

### This bulletin is being revised to add Condition #3. Please discard Corporate Bulletin Number 04-03-08-006C (Section 03 - Suspension).

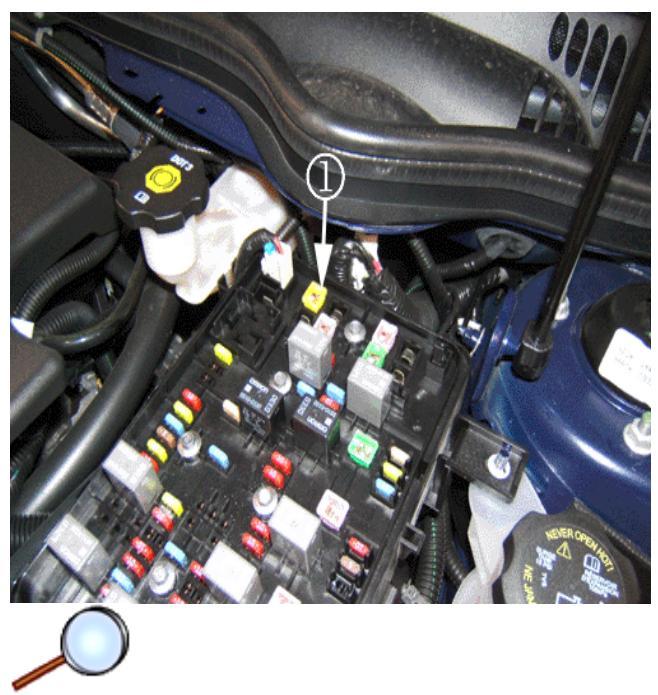
Some customers may comment on a rattle or knocking noise that is heard in the front of the vehicle while driving at low speeds 8-24 km/h (5-15 mph). This condition may be more noticeable while making a slow turn or on a loose/rough surface.

- 3. Remove the 60 amp EPS fuse (1) in the underhood fuse block.
- 4. Test the vehicle as in Step 1. Since the EPS motor is no longer powered, only the I-shaft and steering gear/rack will be loaded as you make the turn. If you hear the rattle/knocking noise during the turn, then the noise is being generated by the backlash within the steering column (assist motor gear mechanism).
- 5. Replace the 60 amp EPS fuse and repeat Steps 1 and 2 to verify that the rattle/knocking noise disappears when turning (loading steering mechanism) and can only be heard when releasing the steering wheel.

If the steering column is identified as the source of the rattle/knocking noise in the above test, replace the steering column.

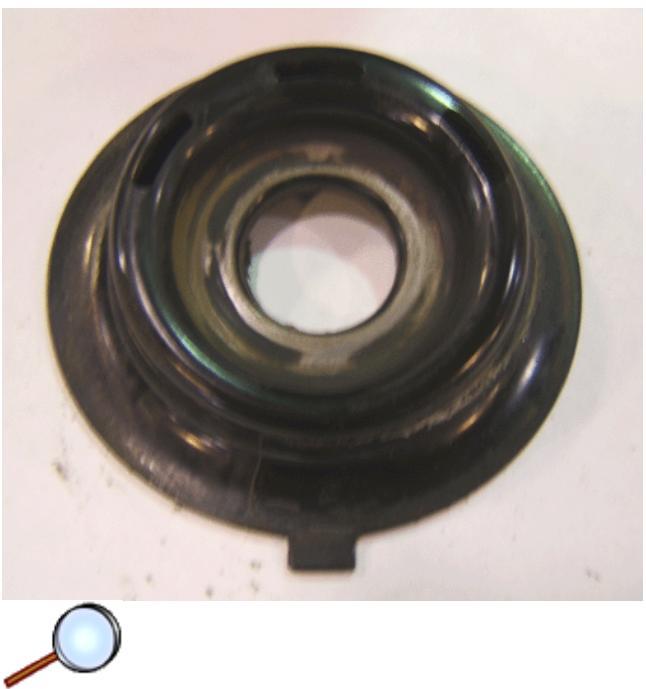
This condition may be caused by the jounce bumper slamming into the upper spring seat because it is not retained in the correct up position. The jounce bumper loses position due to oil being deposited onto its retention fingers. The oil is from the strut leaking.

Inspect the front strut(s) for evidence of oil. The leak may be slight but will still cause the concern. If oil is present, replace the affected strut, jounce bumper and dust boot (shield). Before reassembling the strut assembly, glue the new jounce bumper and new dust boot (shield) to the upper spring seat using the steps listed below. To further confirm this concern, the shield/bumper will easily slide up and down the strut shaft.

- 1. Clean the surface area of the upper spring seat using fine sandpaper.
- 2. Apply a light coat \*of 3M<sup>™</sup> Automotive Adhesion Promoter, P/N 06396, to the top of the dust boot (shield) on the inside edge and to the top of the bumper. Allow to dry 10 minutes.

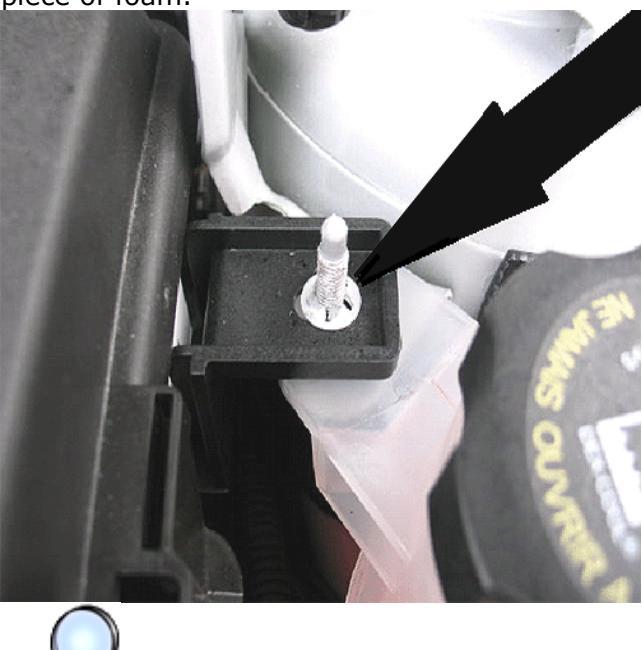
Rattles/clunks in this area of the engine compartment may be heard as coming from the steering column while driving.

2. Check that the retaining clip on the engine coolant surge tank is fully seated. If not, push down to seat.

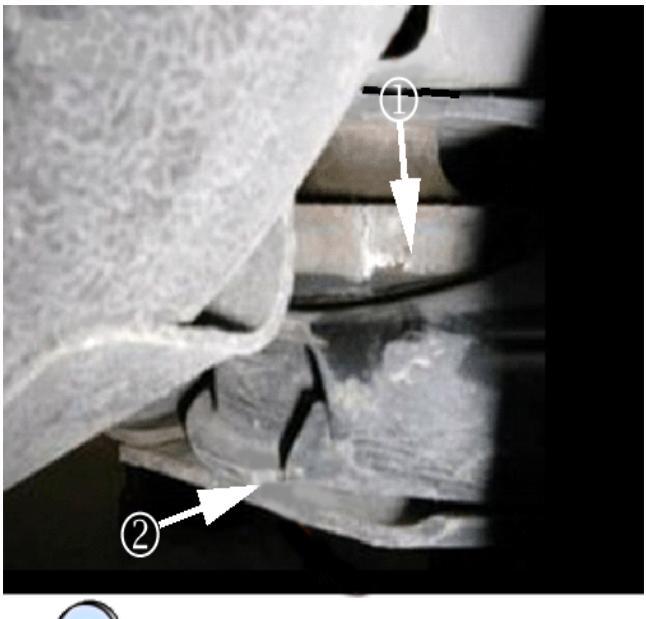
Some customers may comment on a clunk, thump or rattle noise coming from the front suspension while driving over rough road conditions or when braking.

This condition may be caused by the lower control arm rubber bushing (rear) coming out of its steel sleeve (1). This will cause the lower control arm to make hard contact (2) with the body structure. This condition may be more prevalent in regions that use road salt during the winter months.

If the rubber bushing has moved out of the steel sleeve, replace the lower control arm bushing. Do not replace the bushing if it is still centered in the steel sleeve.
