GM 12-14-2012 ATTACHMENT Q_09 2006-7 GMT360_370 DDM Function Historian 4-19-12-p

Driver Door Module Short Circuit

2006-2007 GMT360/370 DDM CA Warranty Labor Op N2117

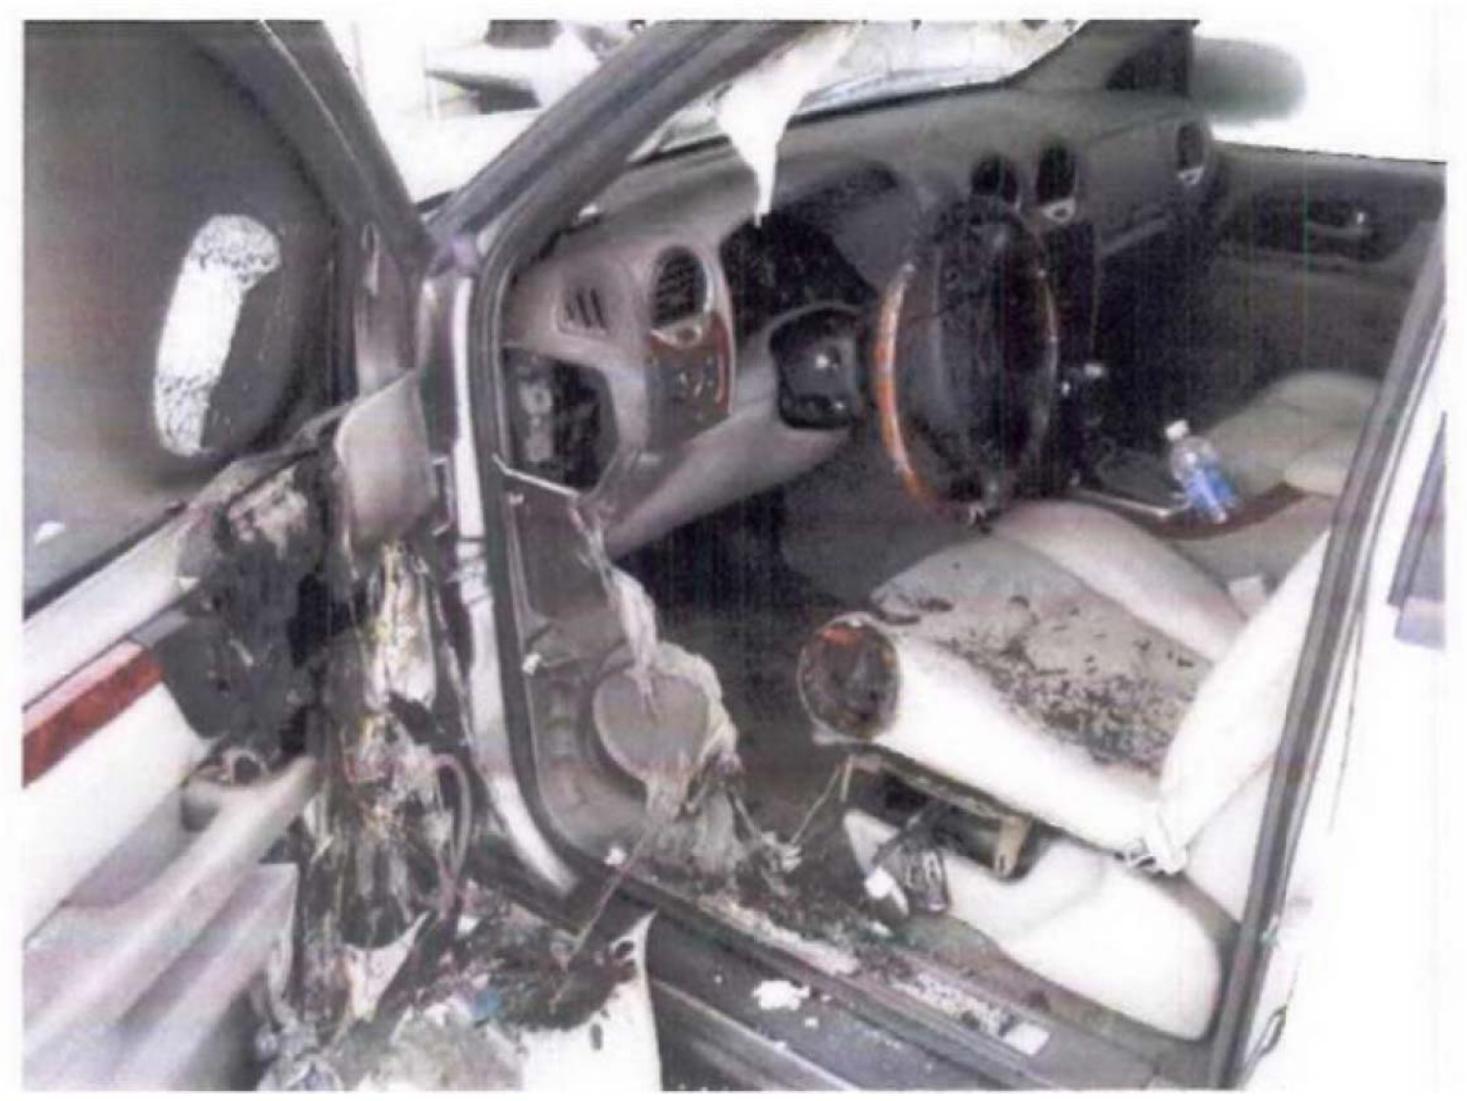
1GKET63M4622 - (723759) Incident date: 12-16-2010; Lawpack (no details on circumstances of incident, but damage is consistent with DDM)

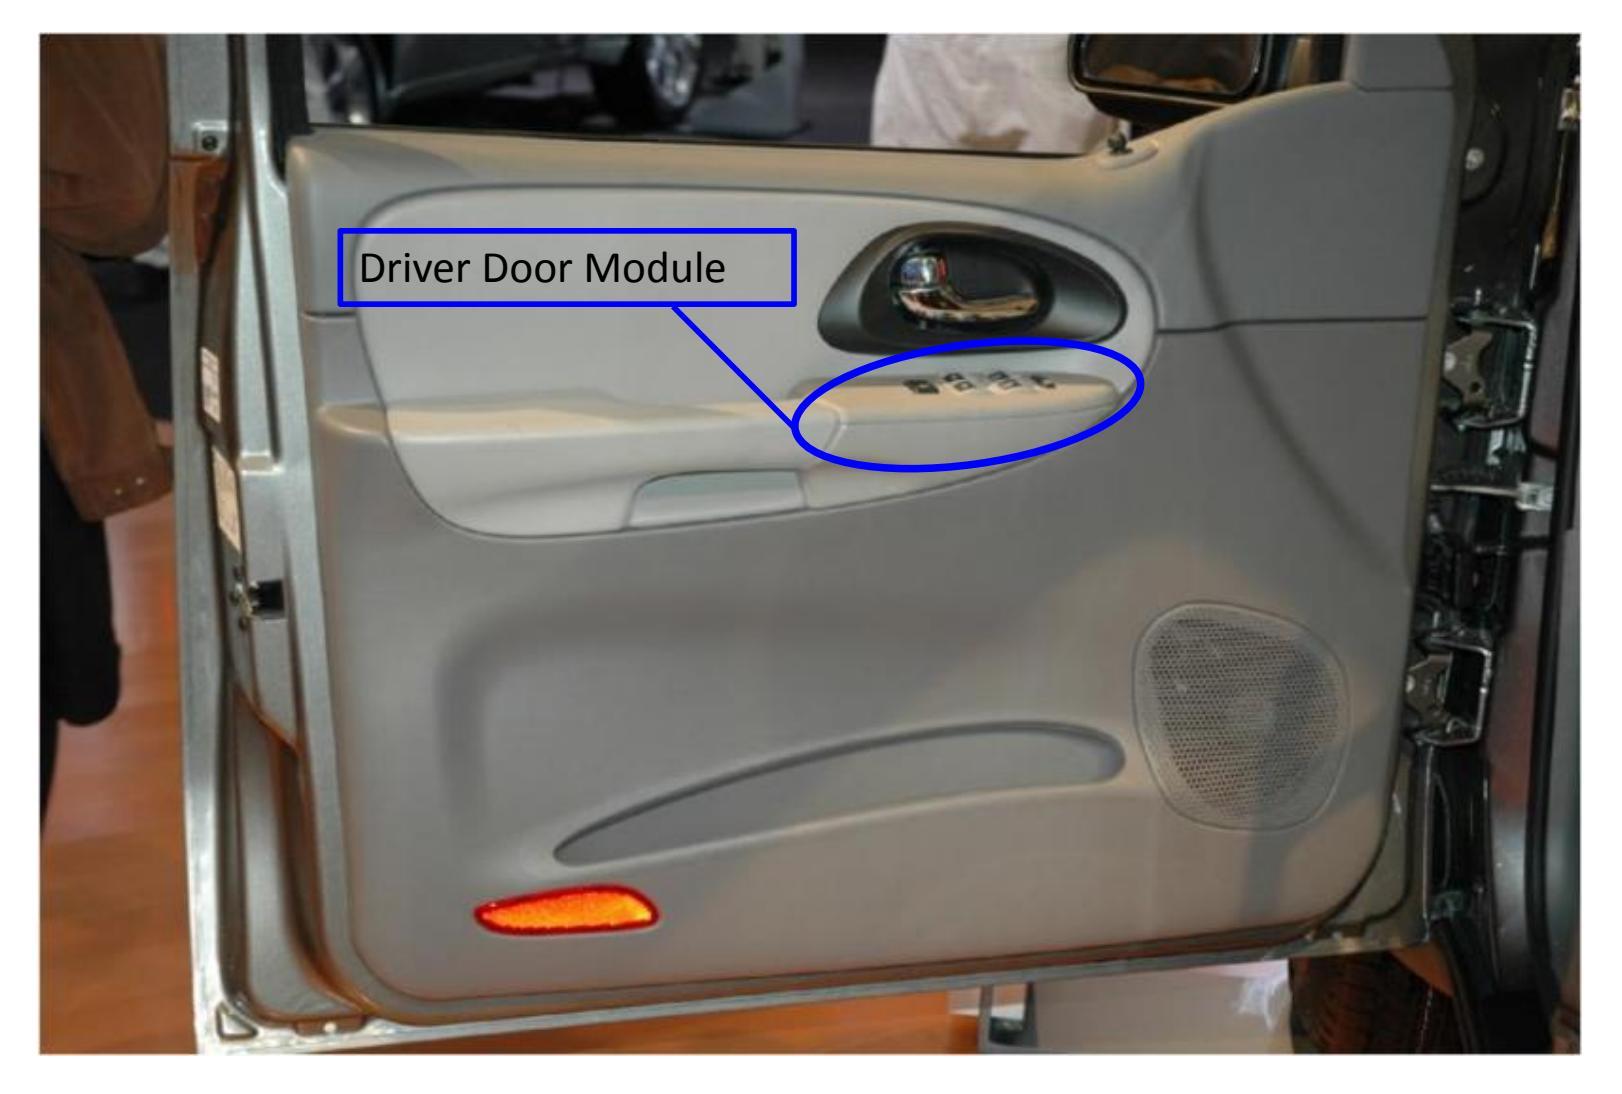
2006-7 GMT360/370 Door Trim (Chevrolet Trailblazer shown)

Technical Root Cause:

Moisture will tend to collect at the forward left corner of the module, and depending upon the amount and type of liquid intrusion into the DDM, corrosion of the printed circuit board traces may occur and current flow may be compromised.

Potential Field Remedy: Treat DDM to prevent short circuits (not currently validated) or replace DDM.

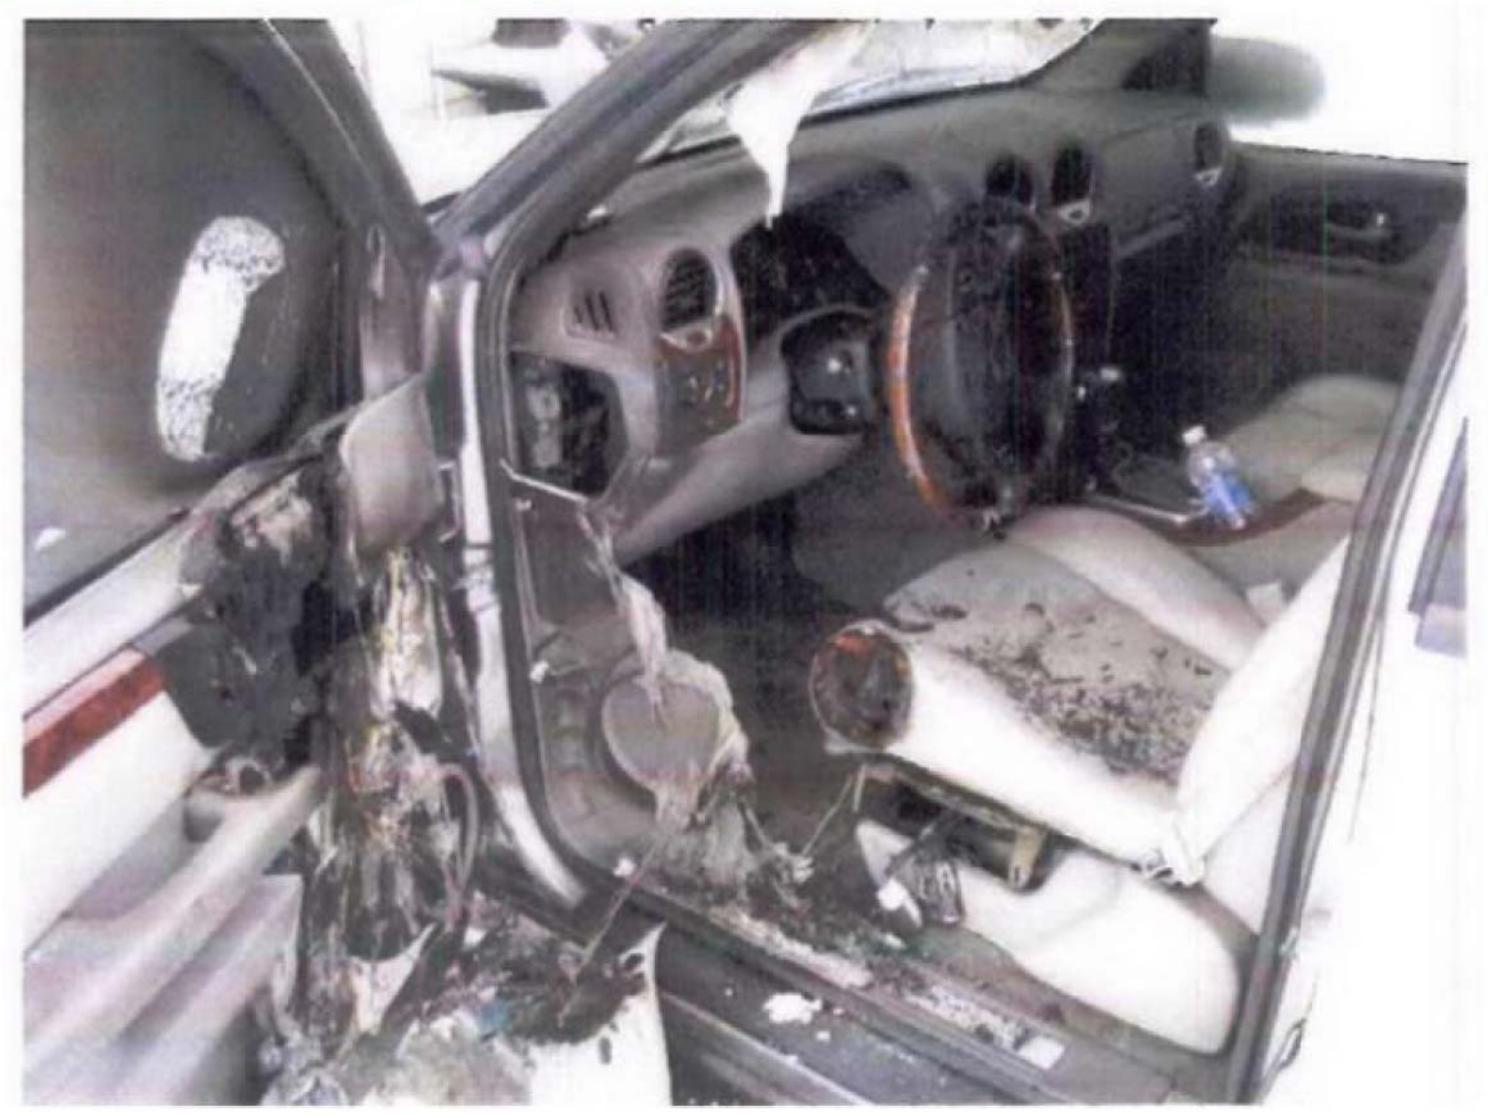
1GKET63M462 (no details on circumstances of incident, but damage is consistent with DDM)

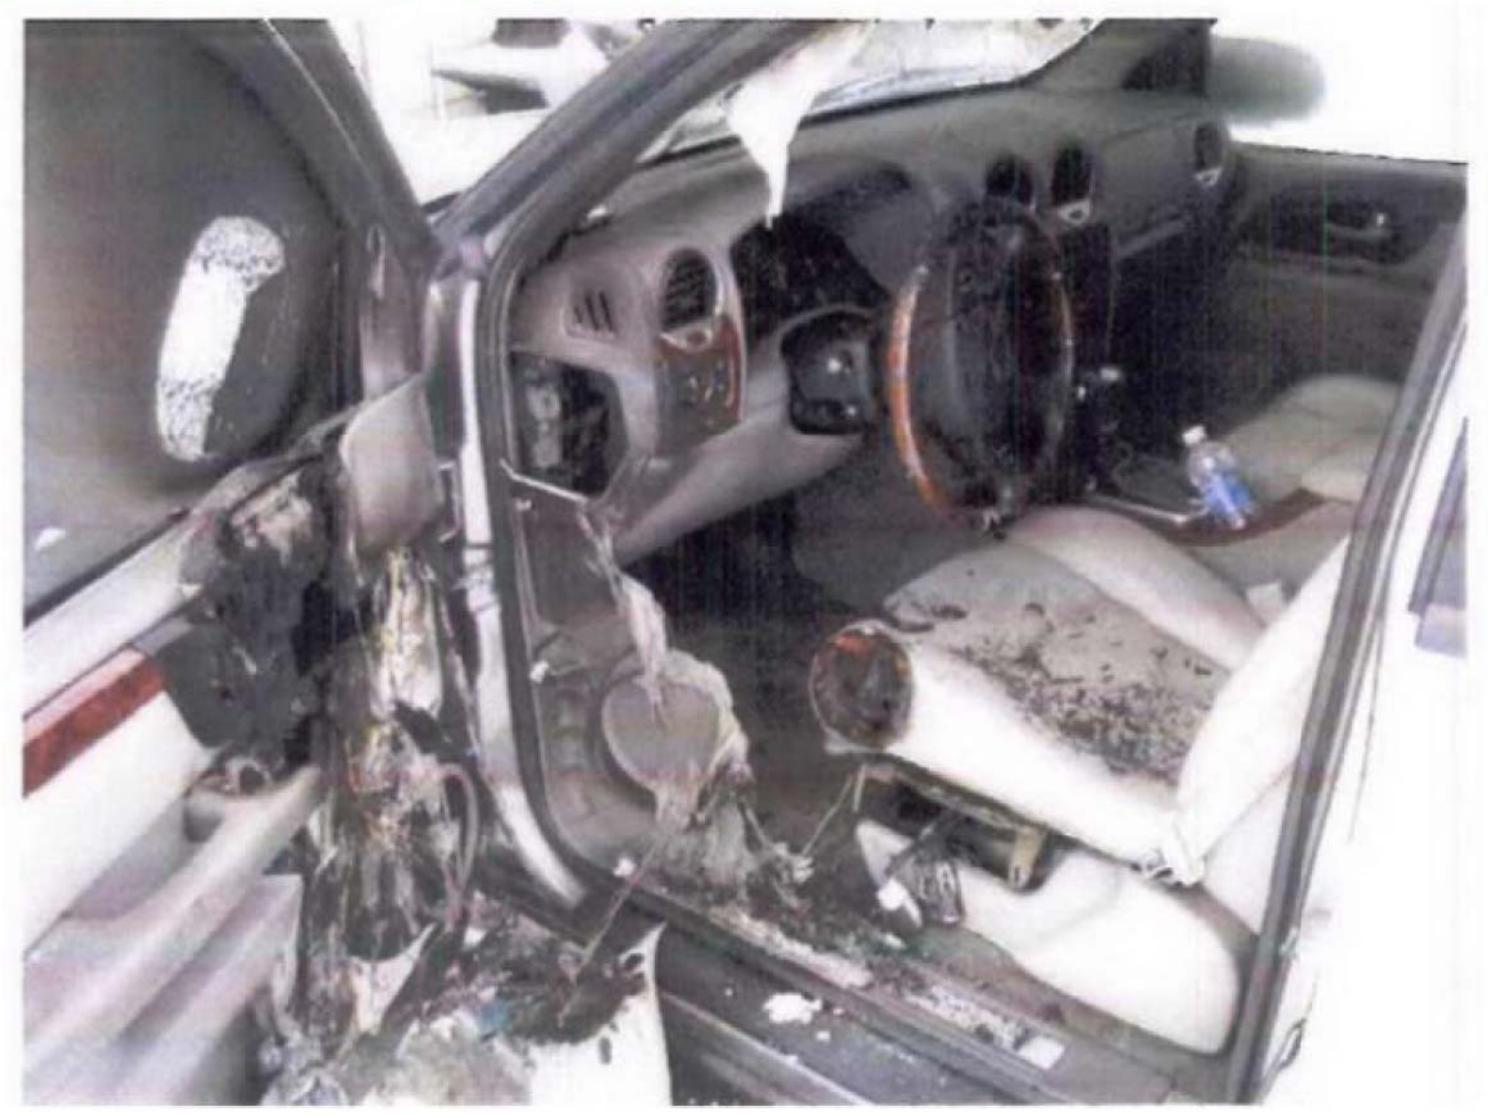
1GKET63M462 (no details on circumstances of incident, but damage is consistent with DDM)

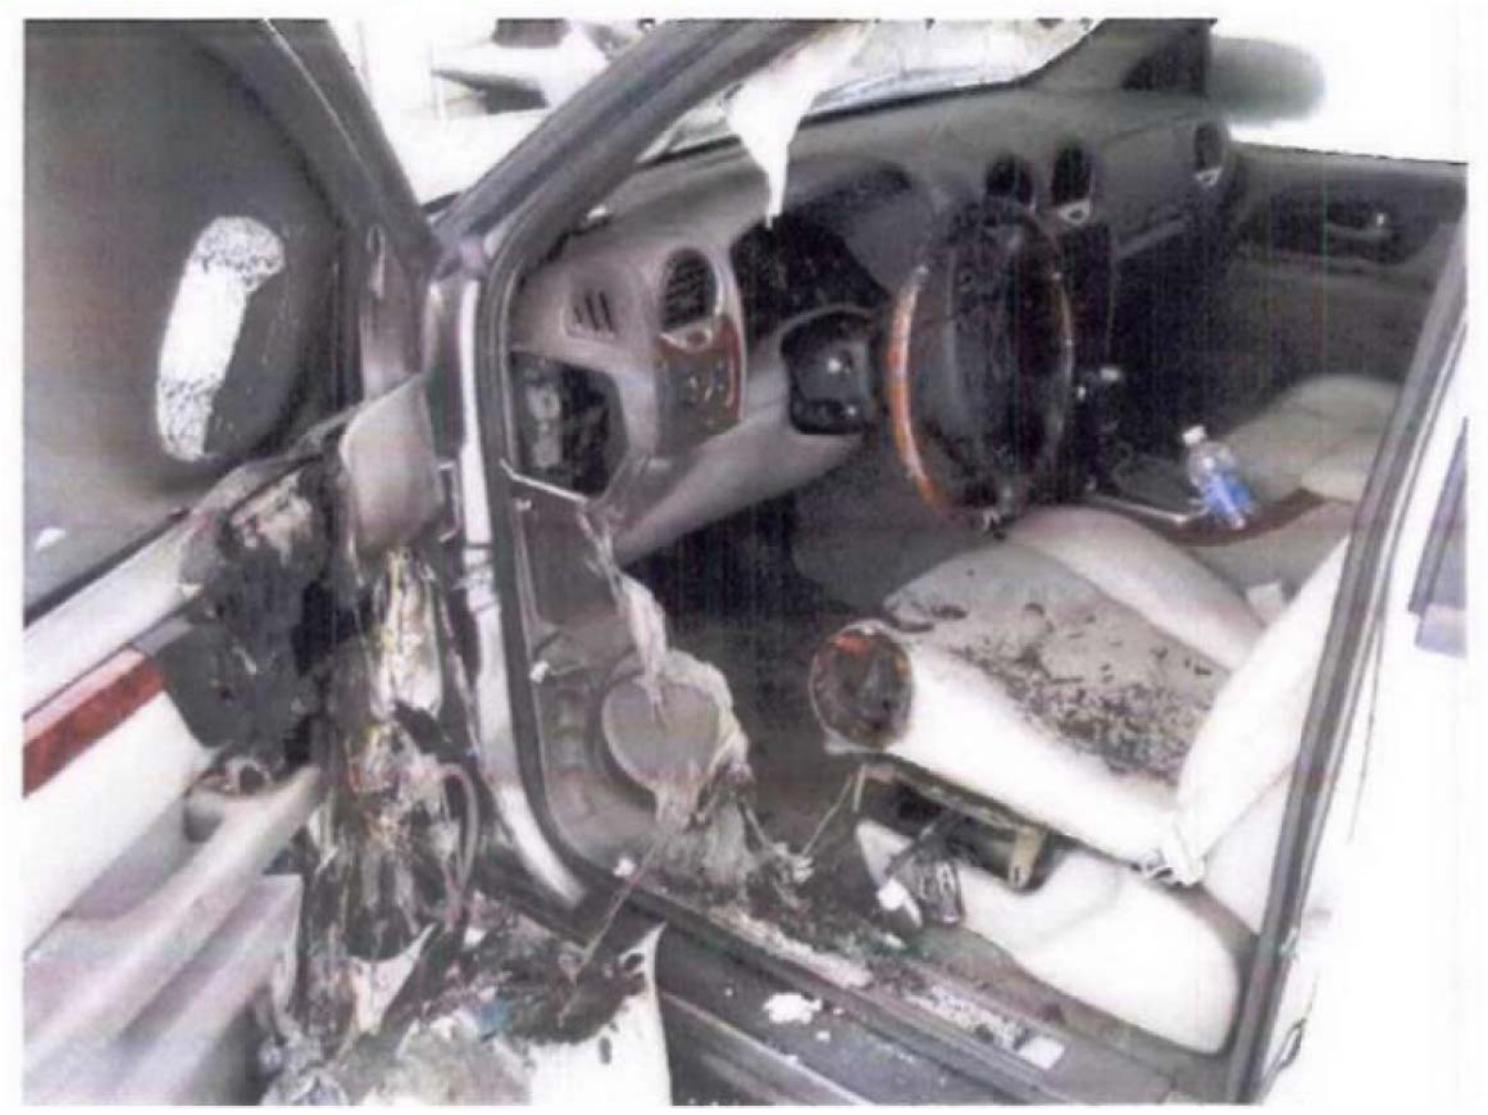
1GKET63M462 (723759) Incident date: 12-16-2010; Lawpack (no details on circumstances of incident, but damage is consistent with DDM)

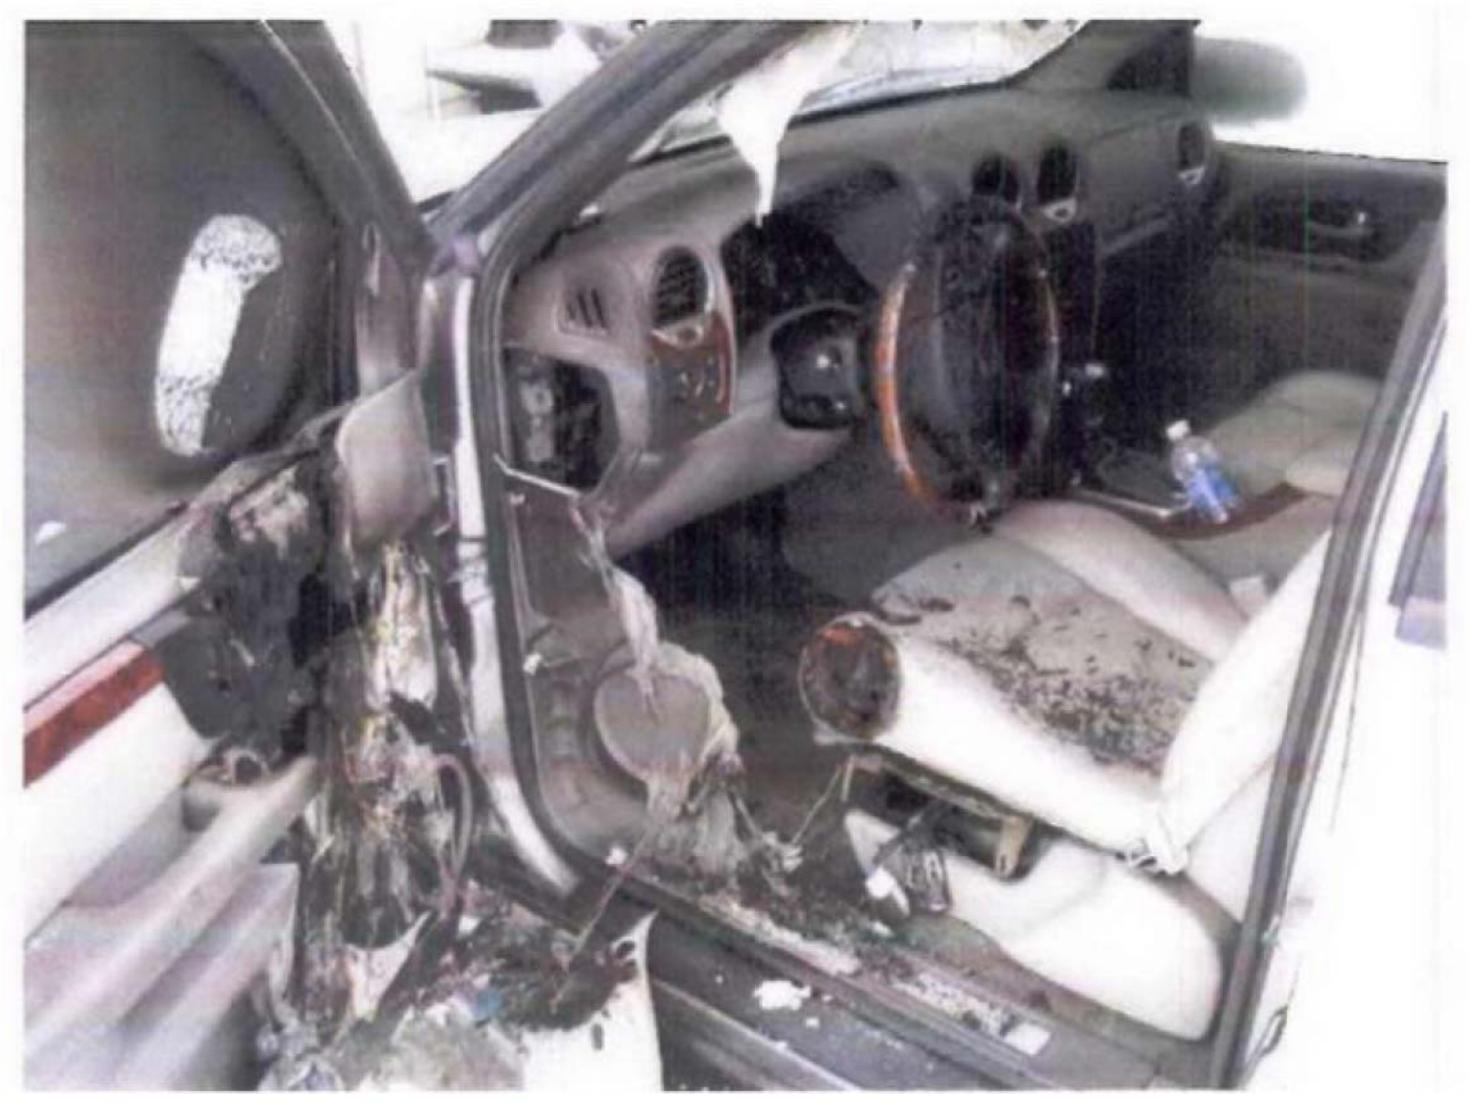
1GKET63M4622 - (723759) Incident date: 12-16-2010; Lawpack (no details on circumstances of incident, but damage is consistent with DDM)

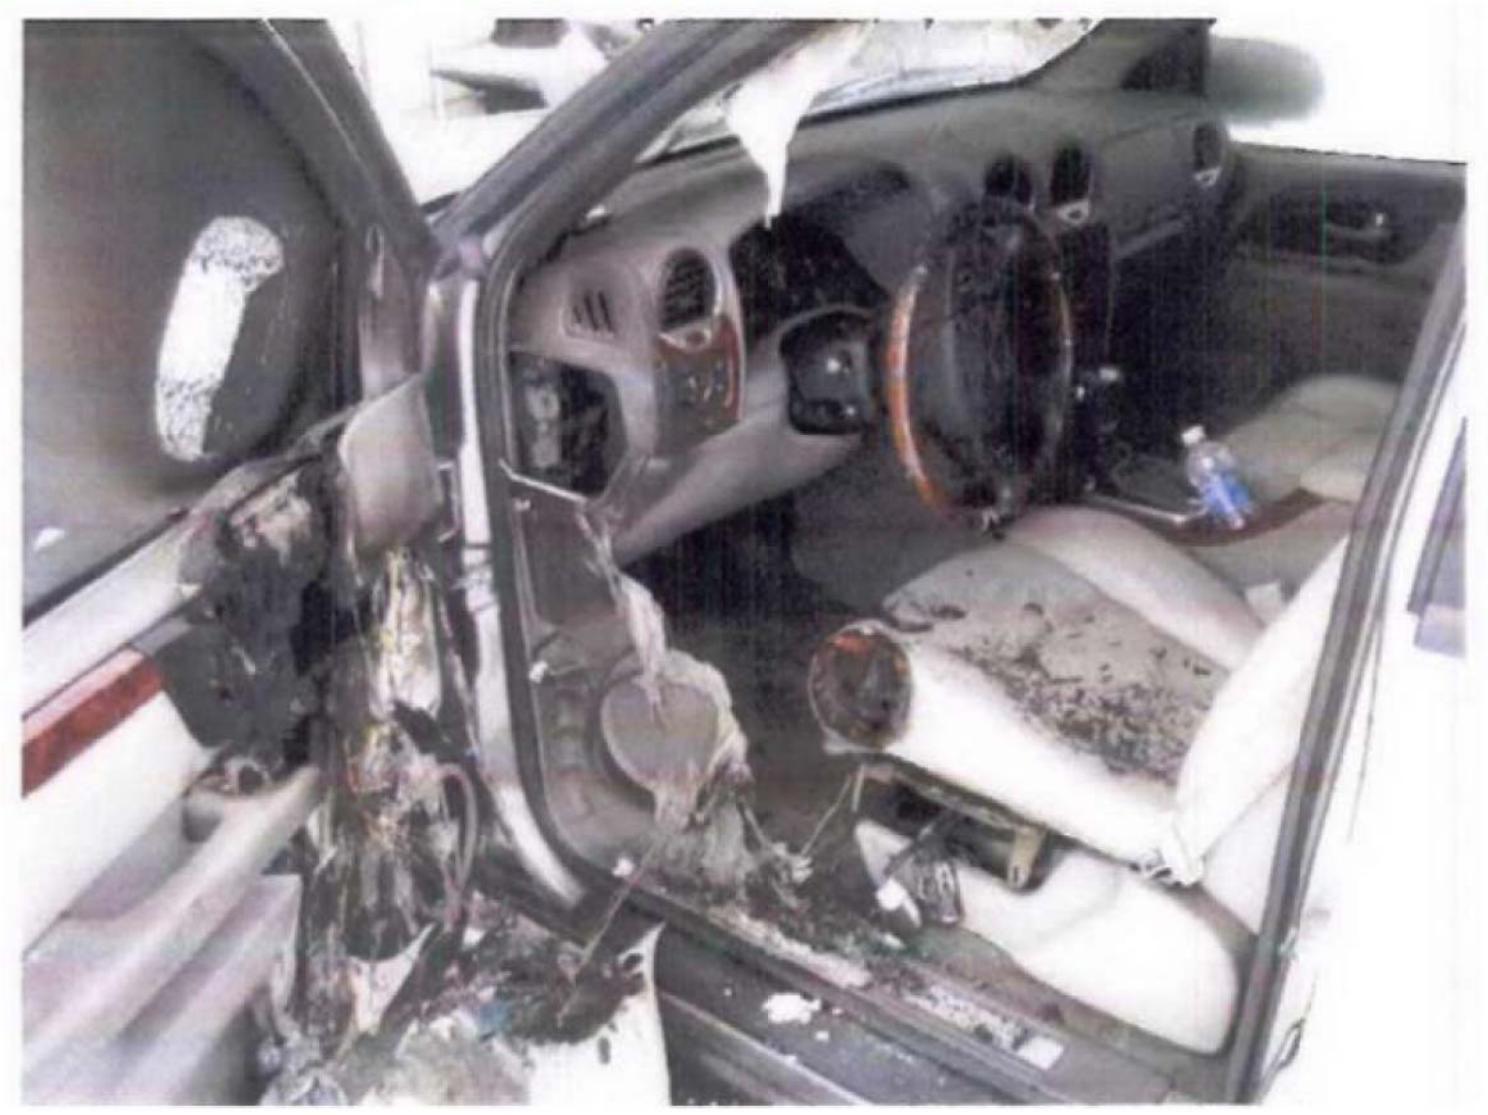
1GKET63M462 (723759) Incident date: 12-16-2010; Lawpack (no details on circumstances of incident, but damage is consistent with DDM)

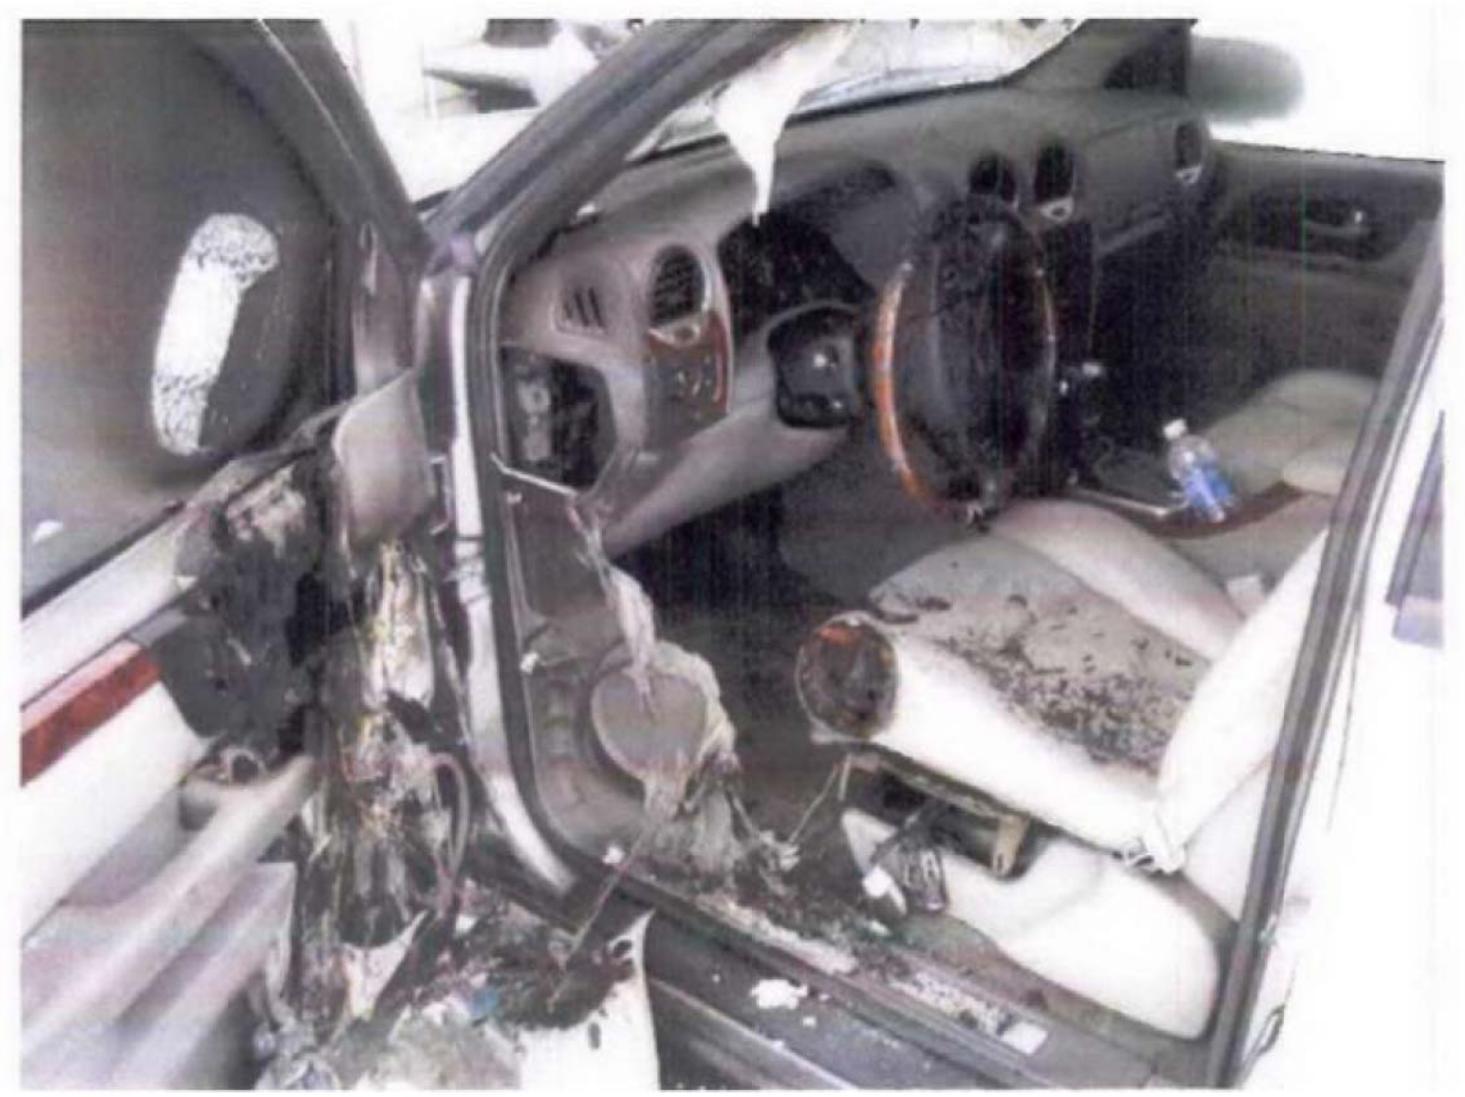
1GKET63M462 - Control (723759) Incident date: 12-16-2010; Lawpack (no details on circumstances of incident, but damage is consistent with DDM)

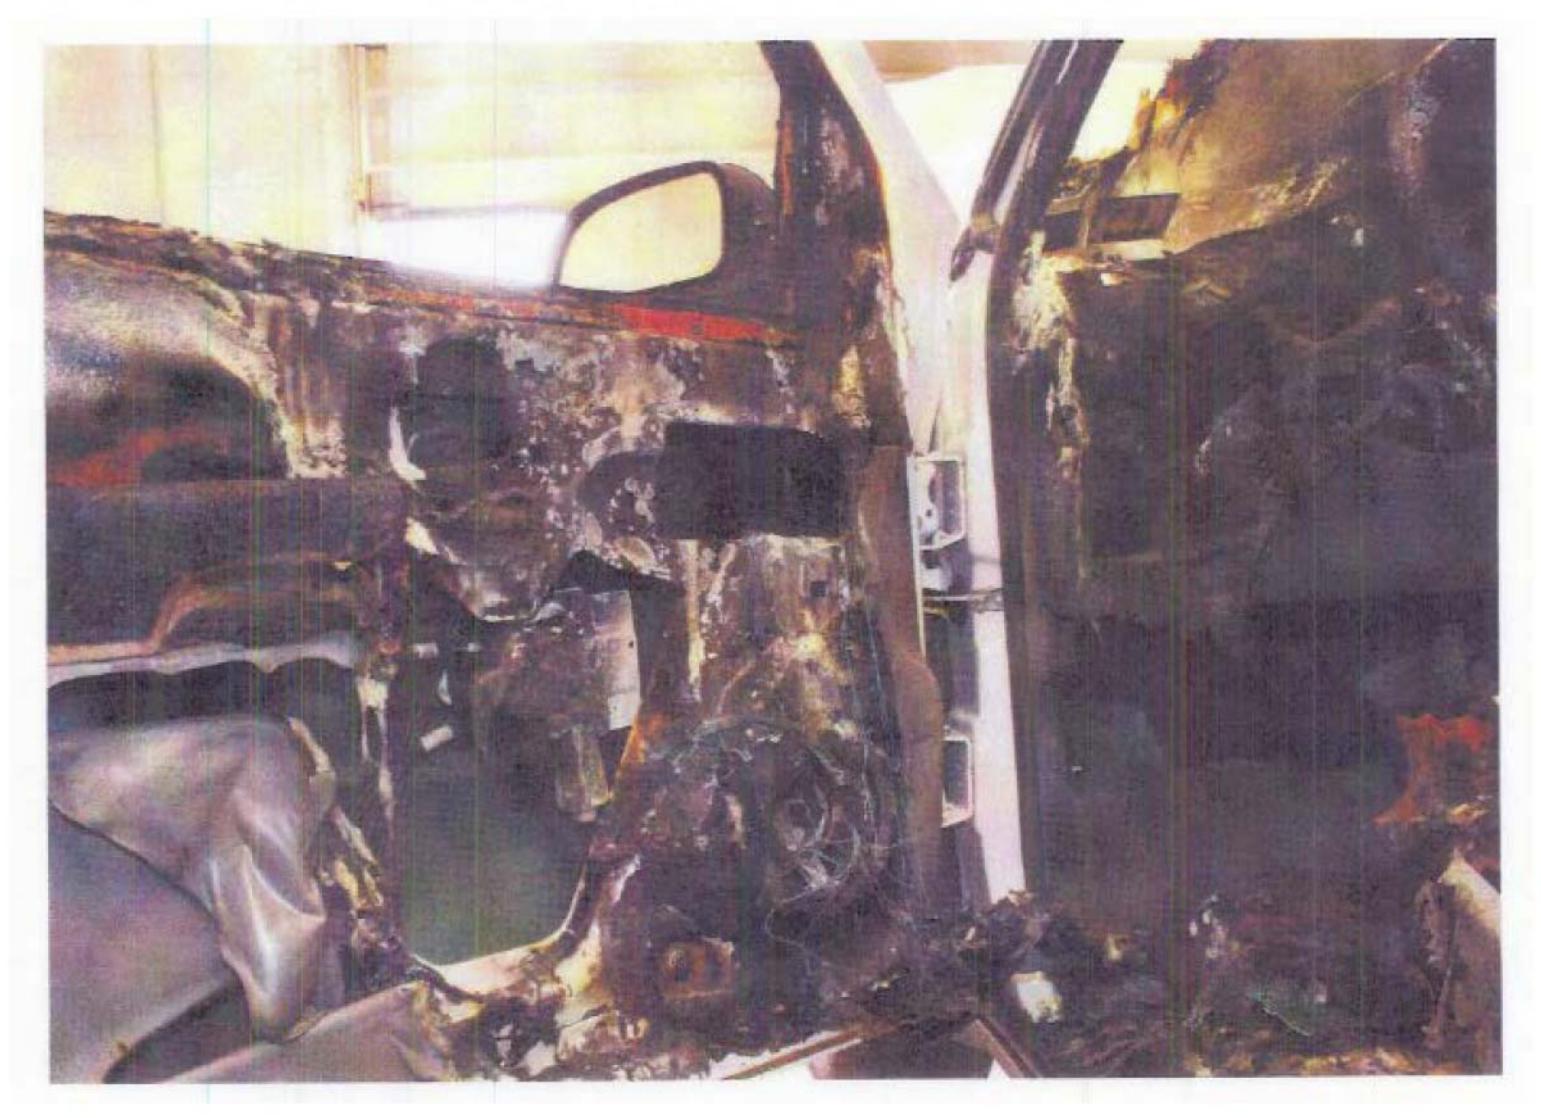
1GNDT13S362 (663106) Incident date: 10-29-2008; Estimated mileage: 50,000 miles; Fire in driver door while the s/v was parked and unattended.

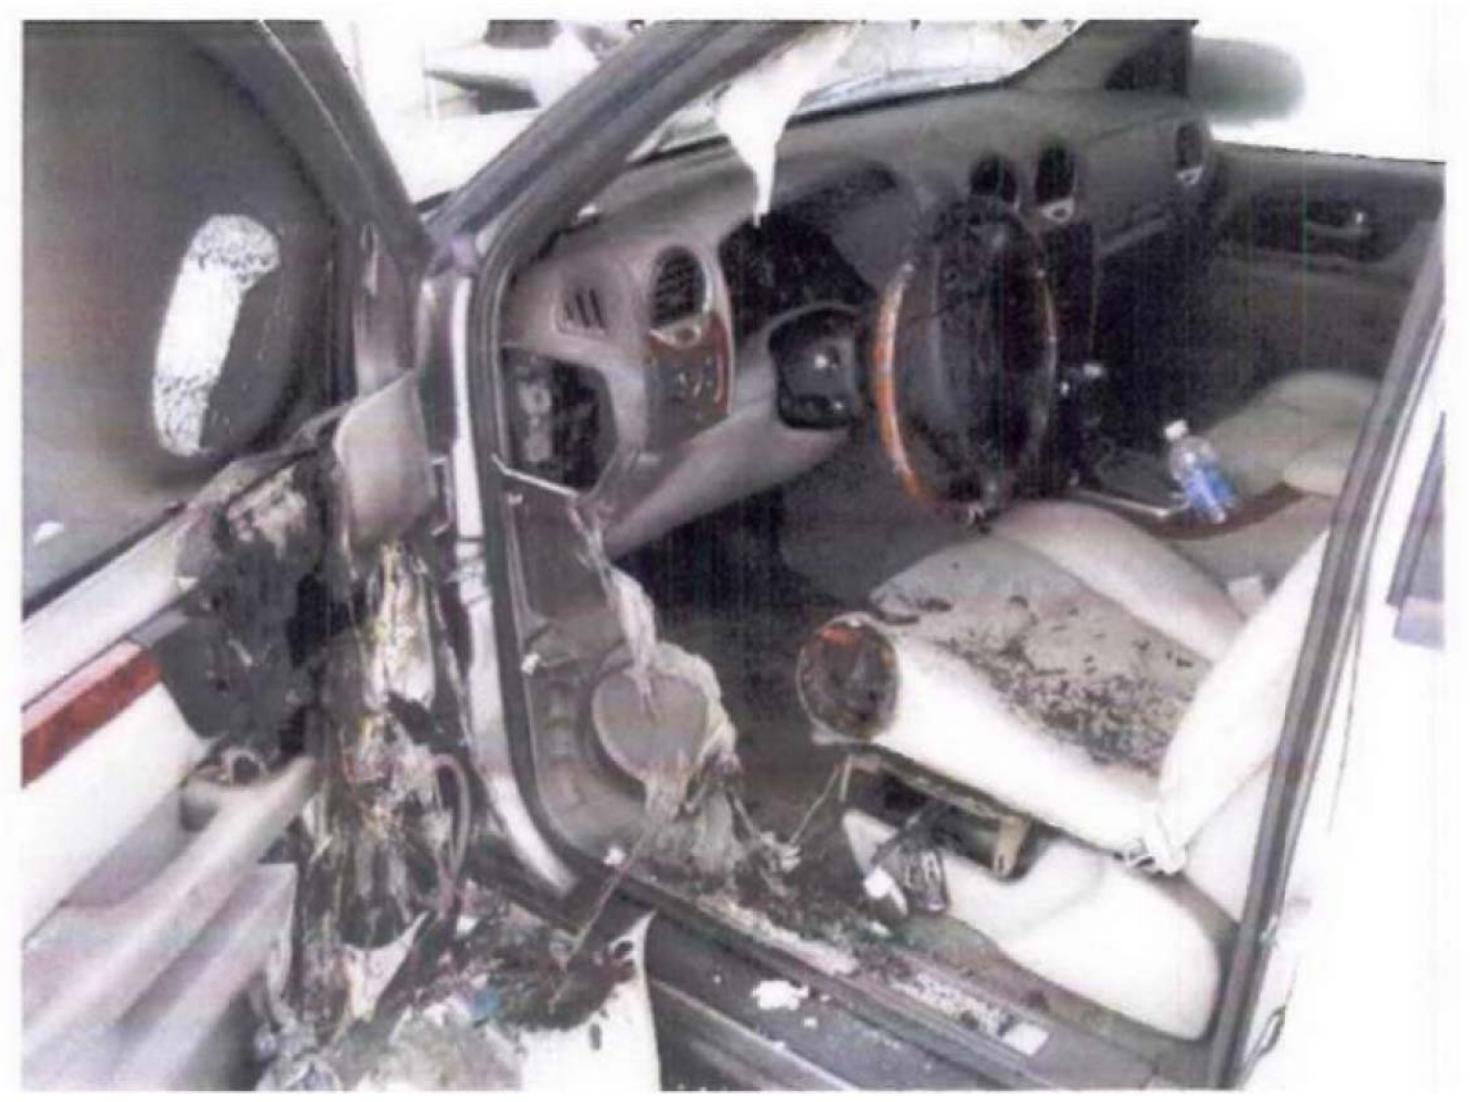
1GKET63M4622 - (723759) Incident date: 12-16-2010; Lawpack (no details on circumstances of incident, but damage is consistent with DDM)

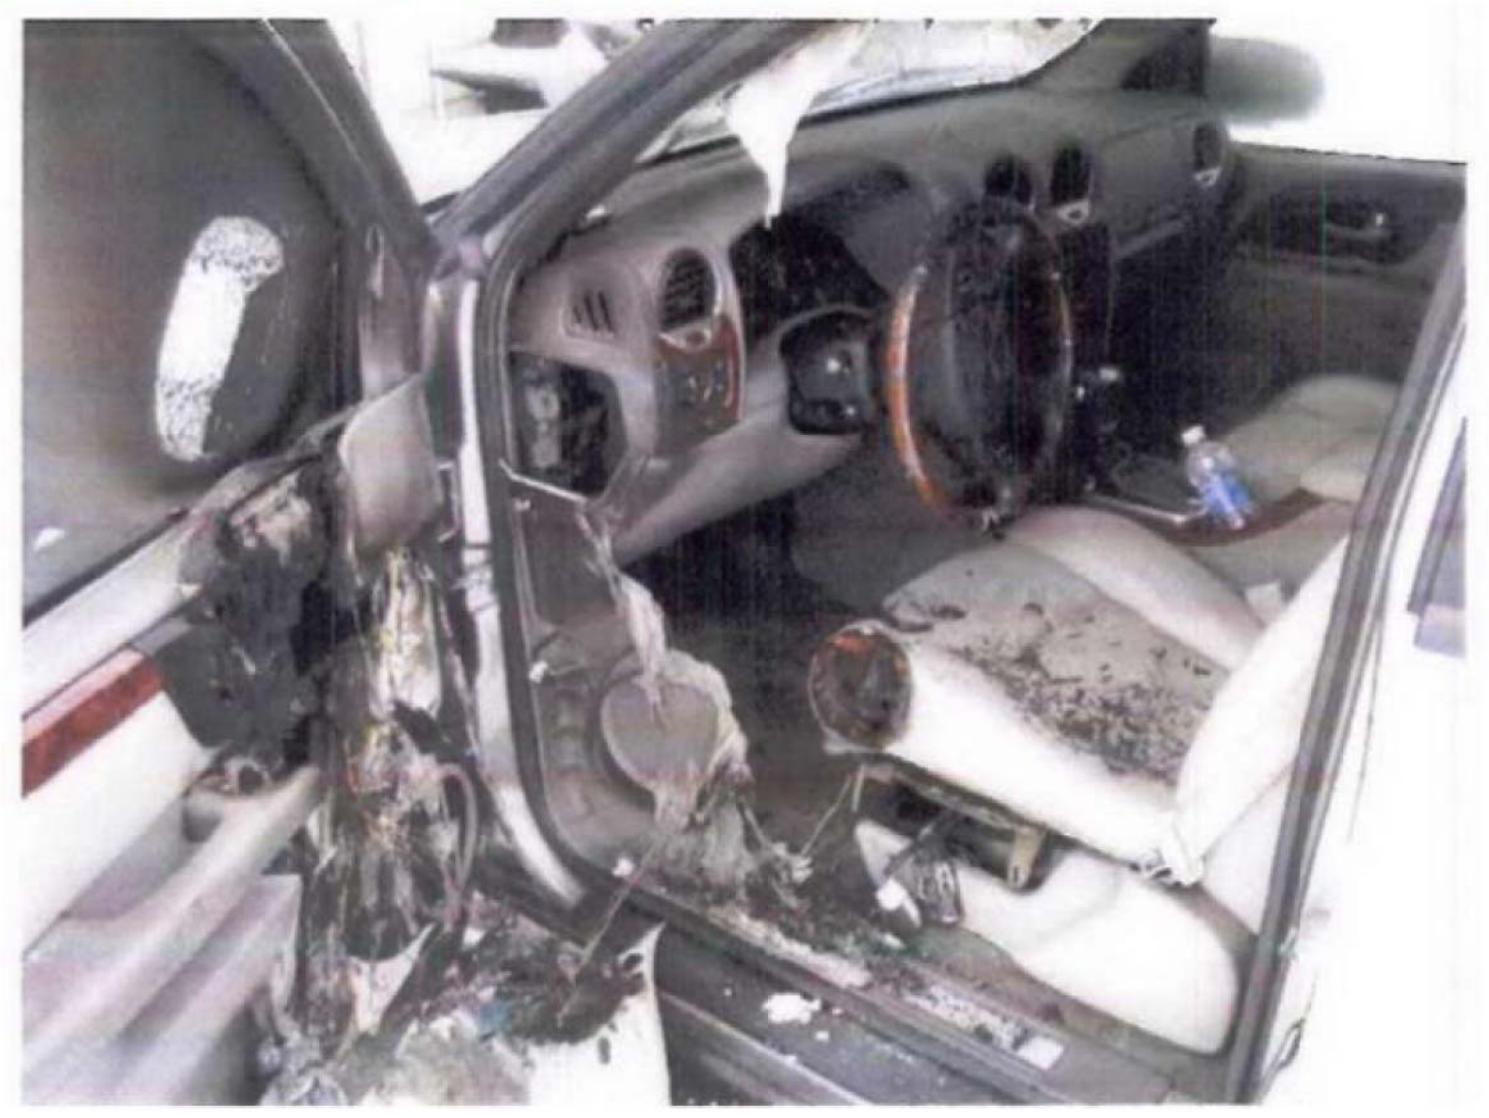
1GKET63M462 (no details on circumstances of incident, but damage is consistent with DDM)

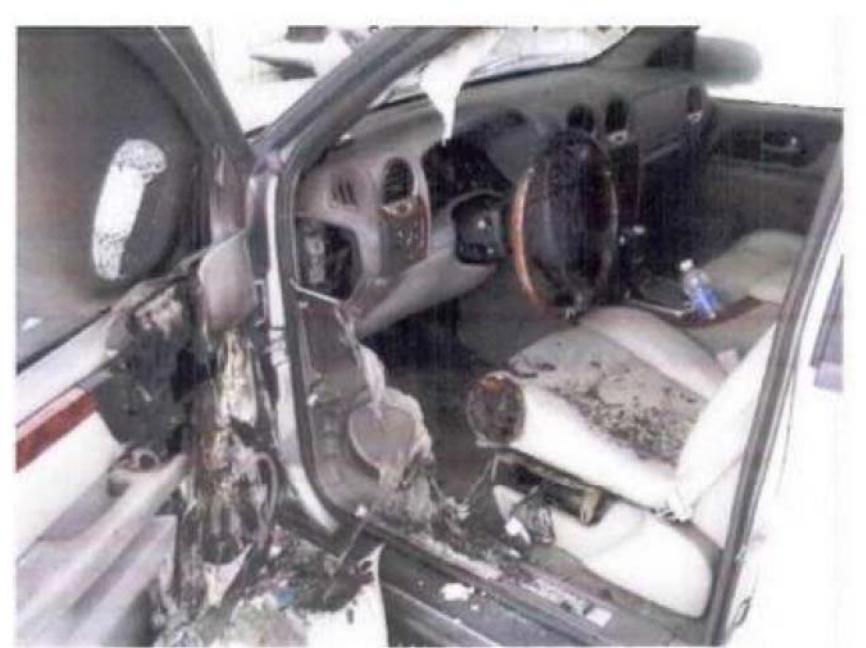
Figure 5 - 1GKET63M462 (723759) Incident date: 12-16-2010. No detail on circumstances of incident, but damage is consistent with DDM.
