Inspections and Tests of Engine-Coolant Radiators with Integrated ATF-Temperature-Stabilizing Cylinders from 2005-10 Nissan Light Trucks

Four Nissan radiators were procured, inspected and tested by the Defects Analysis Group at the Vehicle Research and Test Center (VRTC), East Liberty, Ohio, in response to a request to support the Office of Defects Investigation (ODI) on Defect Petition DP12-004. This defect petition was requested by the North Carolina Consumers Council, Inc. (NCCCI). The ODI opening resume¹ listed 512 Vehicle Owner's Questionnaire (VOQs) complaints between late 2005 and early 2012. The ODI and NCCCI complaints allege repeated unexpected slow acceleration, various transmission malfunctions, and other safety concerns due to the engine coolant mixing with the automatic transmission fluid (ATF).

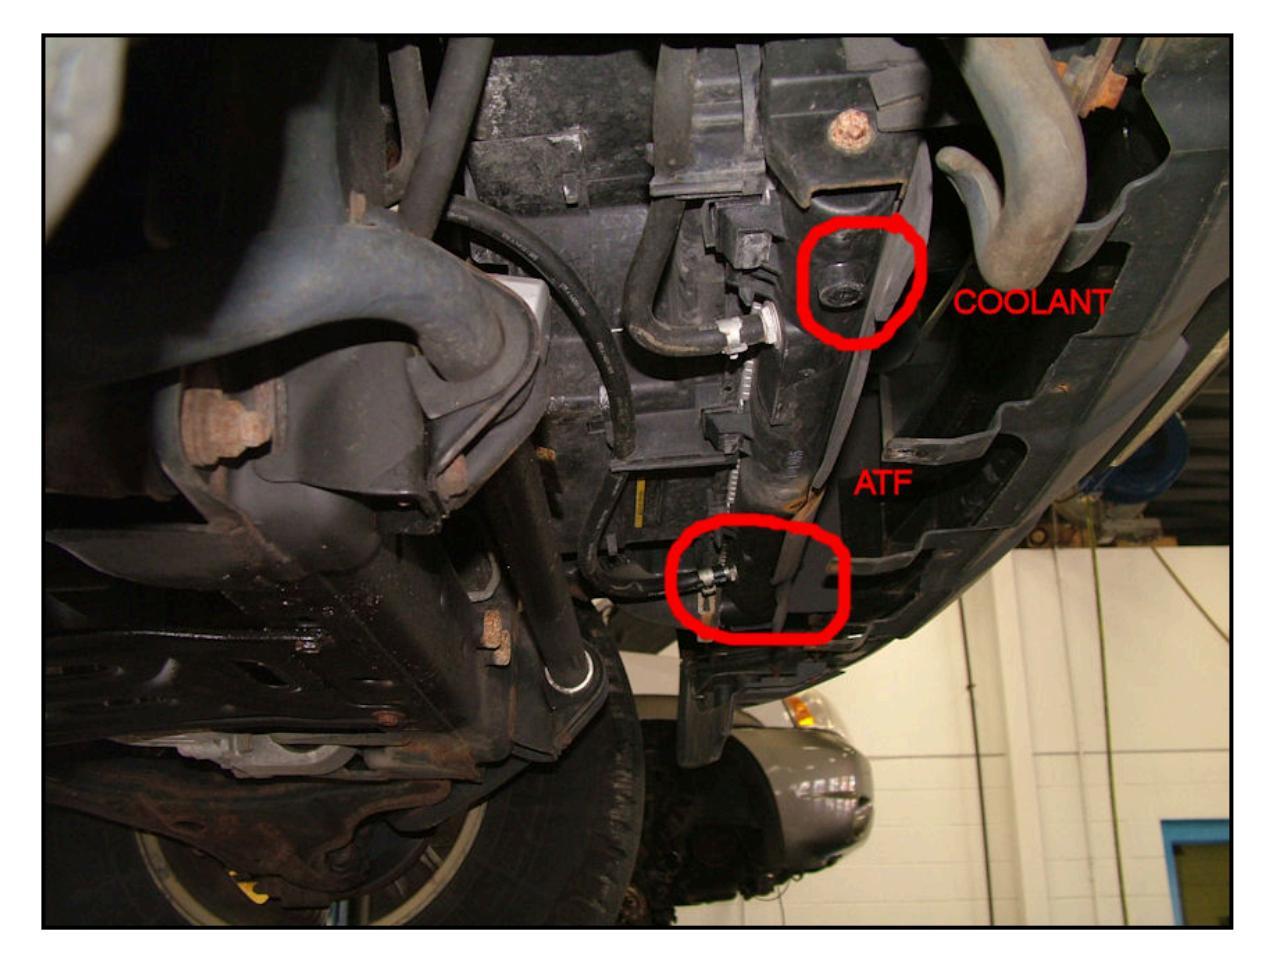
Figure 13 – Drain Points for Fluid Collections from NF1

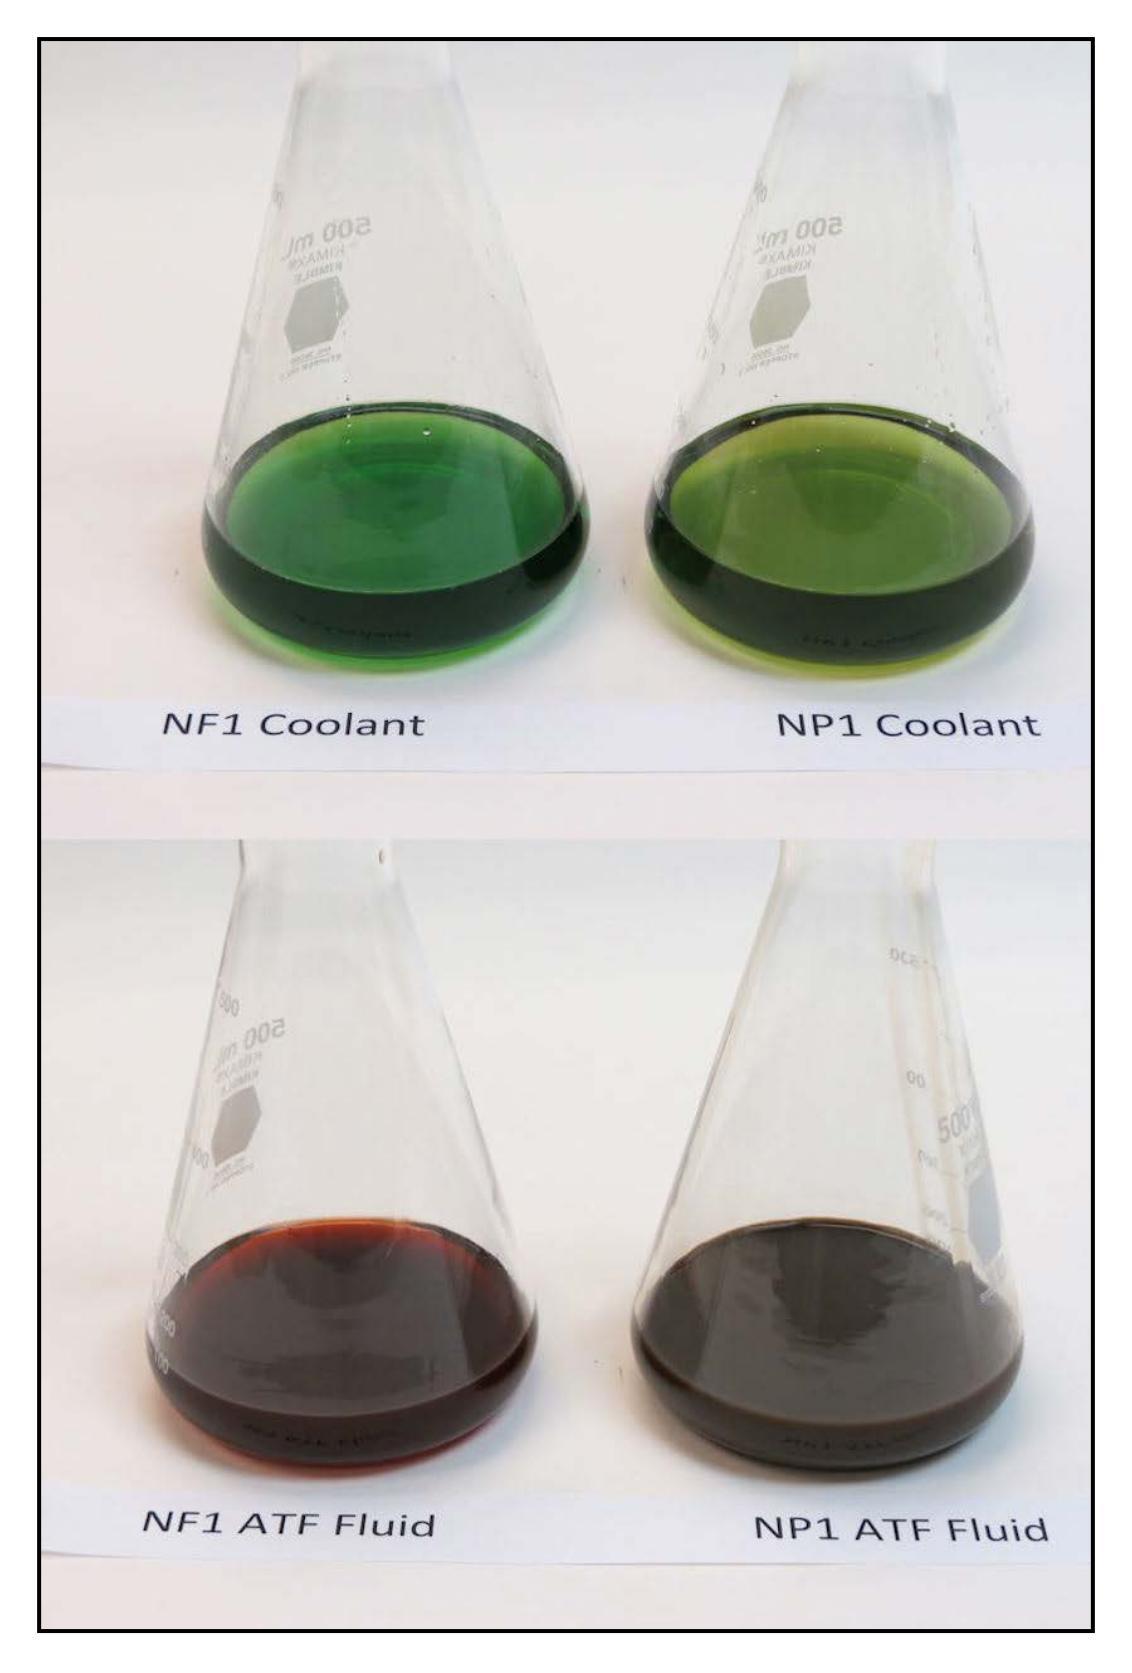
Figure 14 – Engine Coolant and ATF Samples from NF1 and NP1

[The fluids from NF1 were Deemed Normal, While Fluids from NP1 were Considered Abnormal]

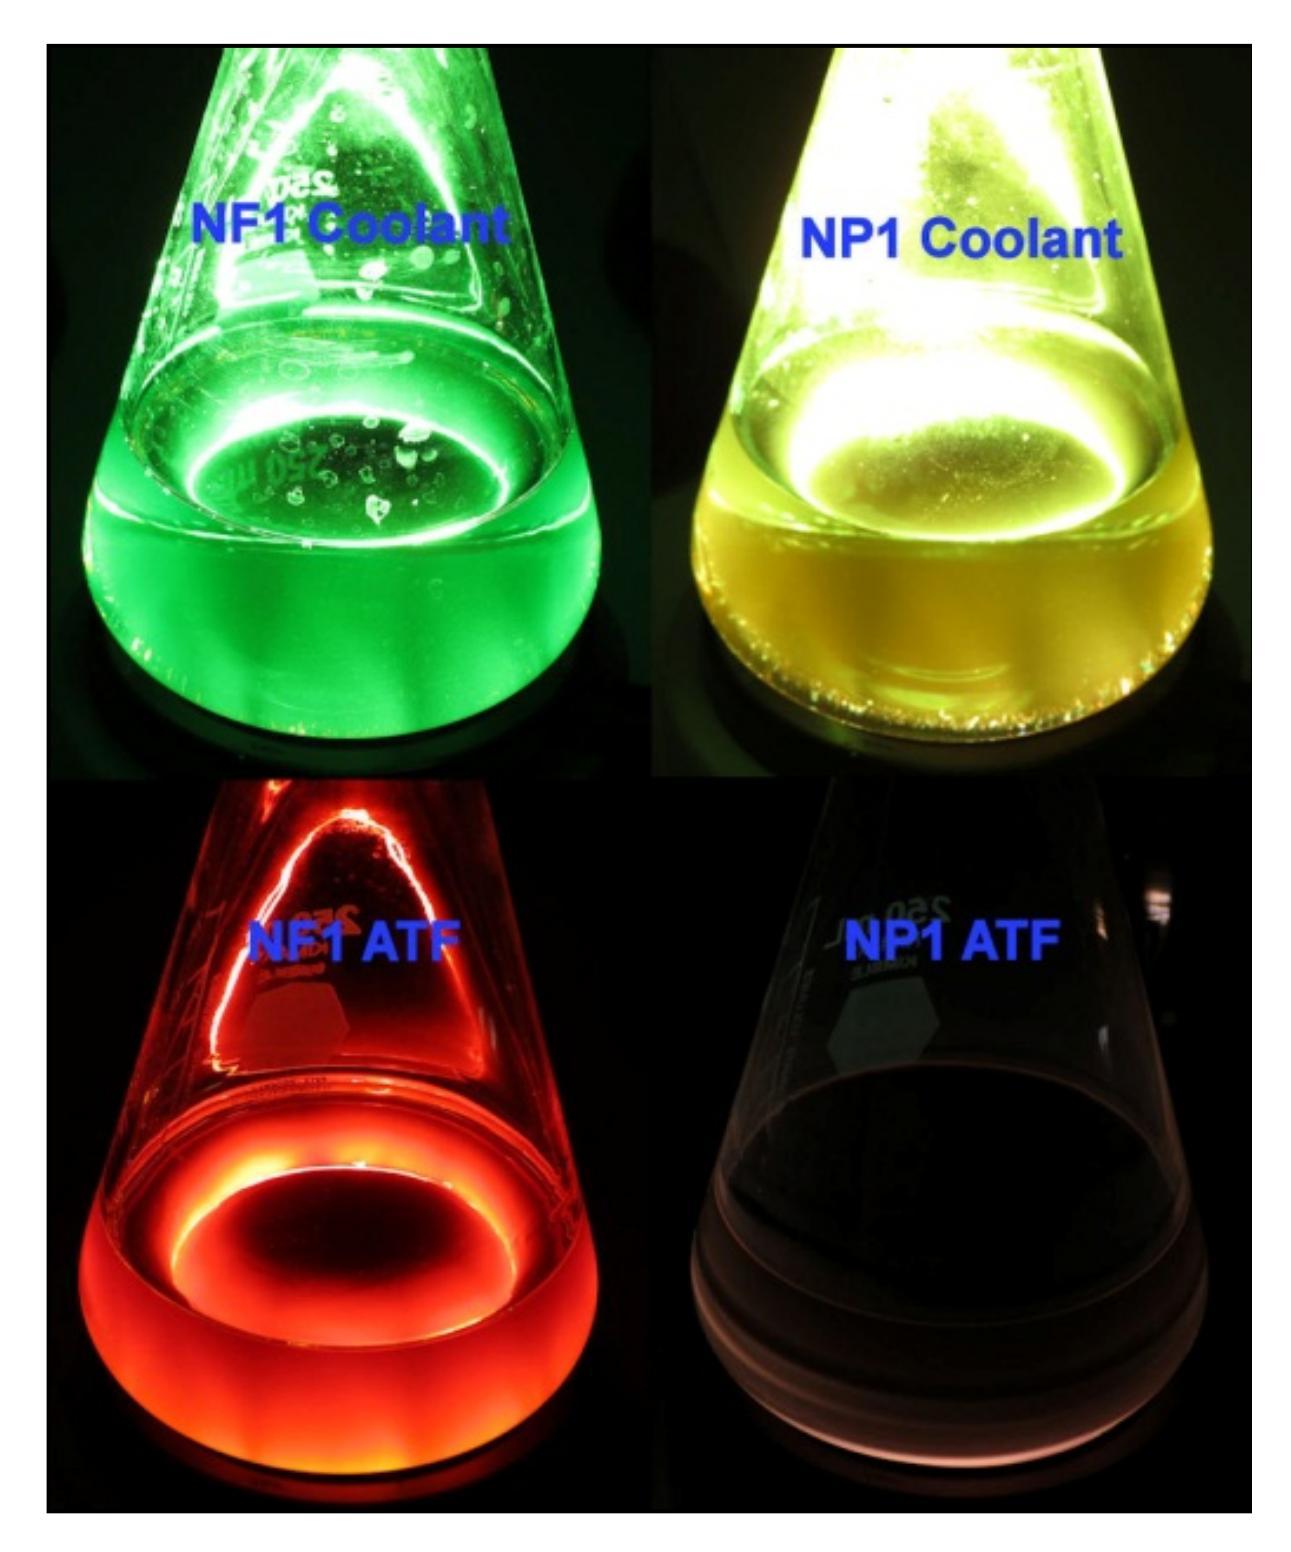
Figure 15 – Engine Coolant and ATF Samples from NF1 and NP1 with Lighting from Below to Show the Differences in Colors

[The fluids from NF1 were Deemed Normal, While Fluids from NP1 were Considered Abnormal]

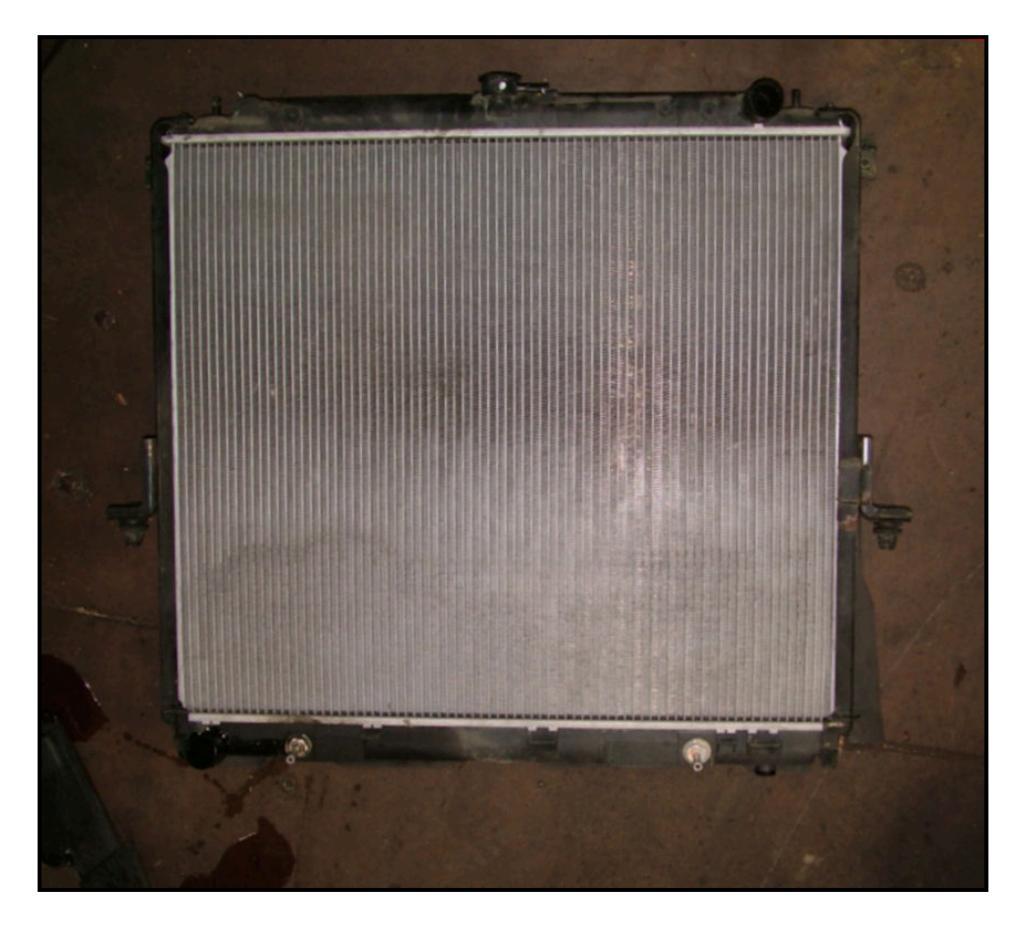
Figure 16 – The Radiator after Removal from NF1

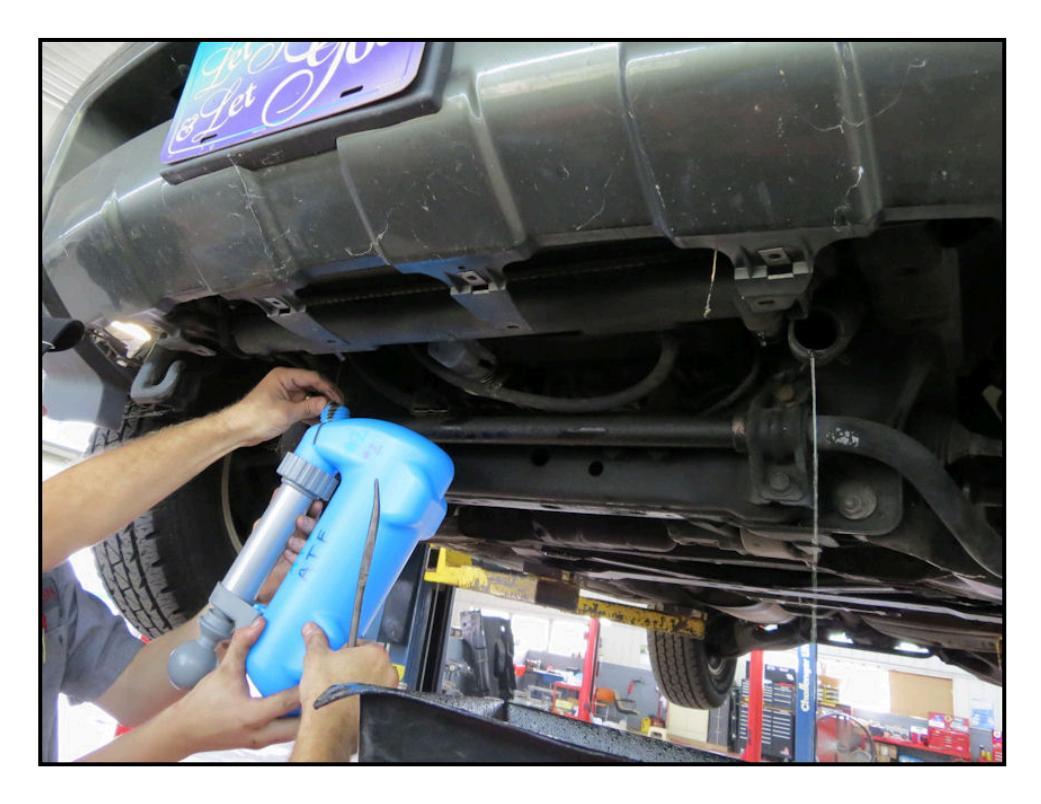
Figure 23 – Fluid Collections from NP1

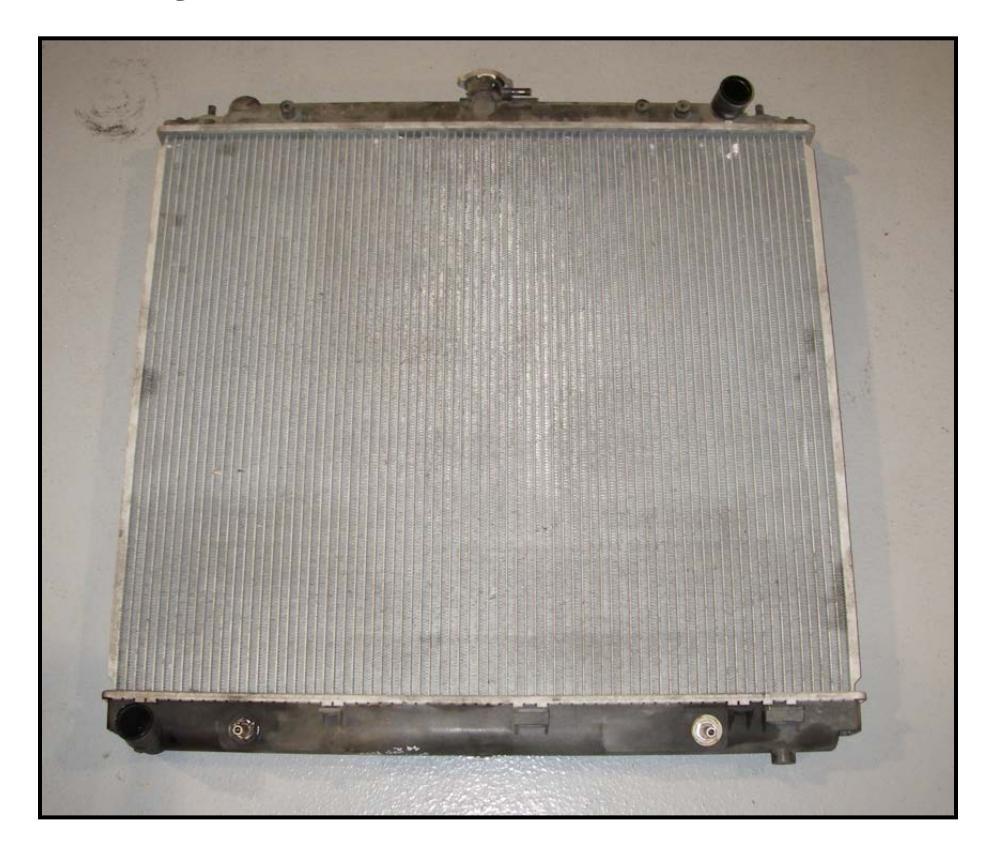
Figure 24 – The Radiator after Removal from NP1

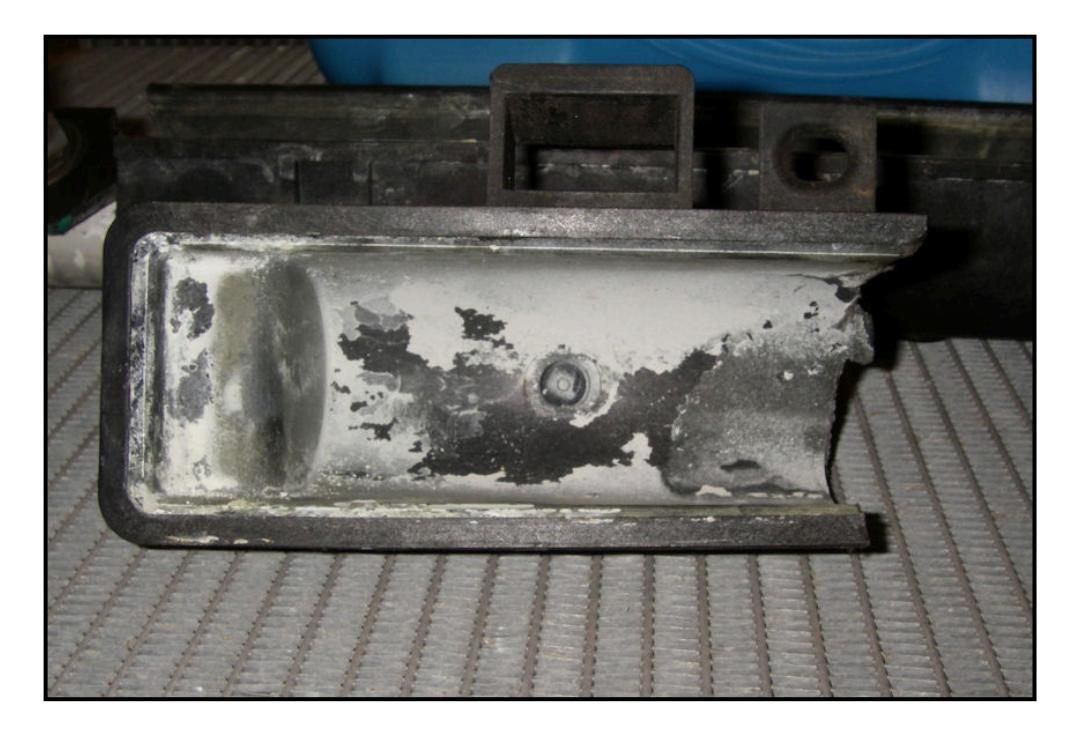
Figure 31 – Radiator SY1 Lower End Cap with Powdery Deposits

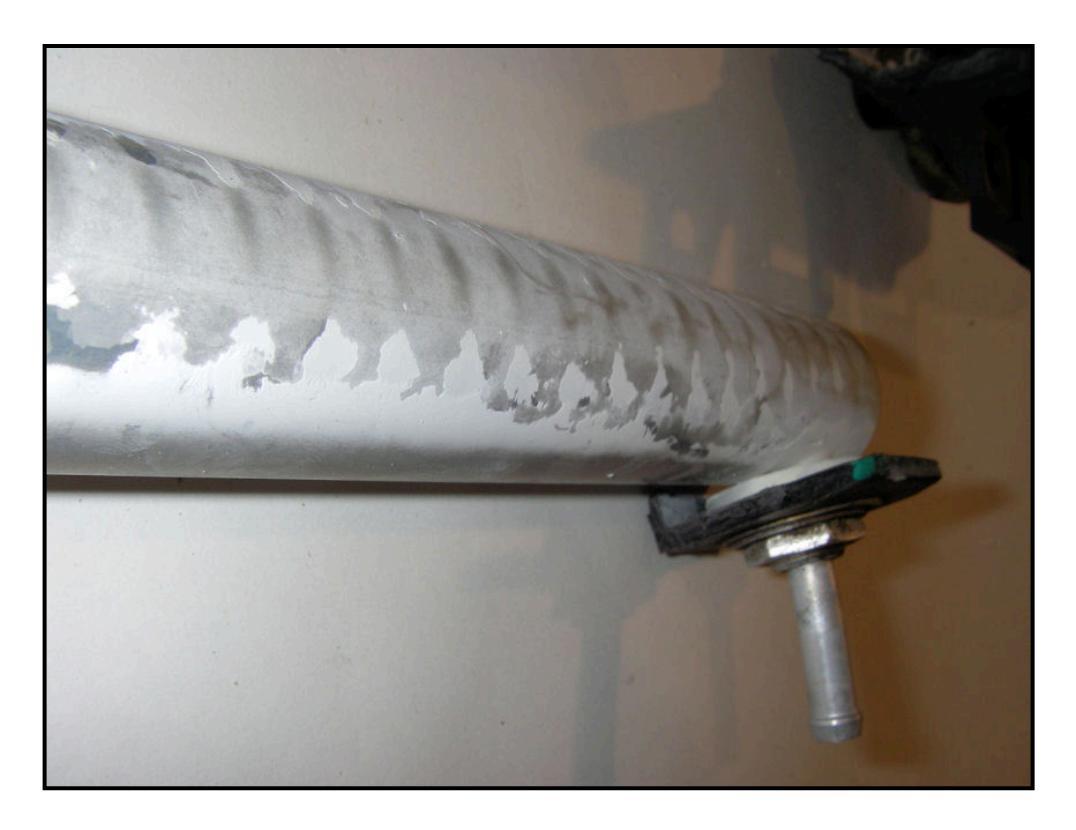
Figure 32 – Radiator ATF Cylinder SY1 with Powdery Deposits

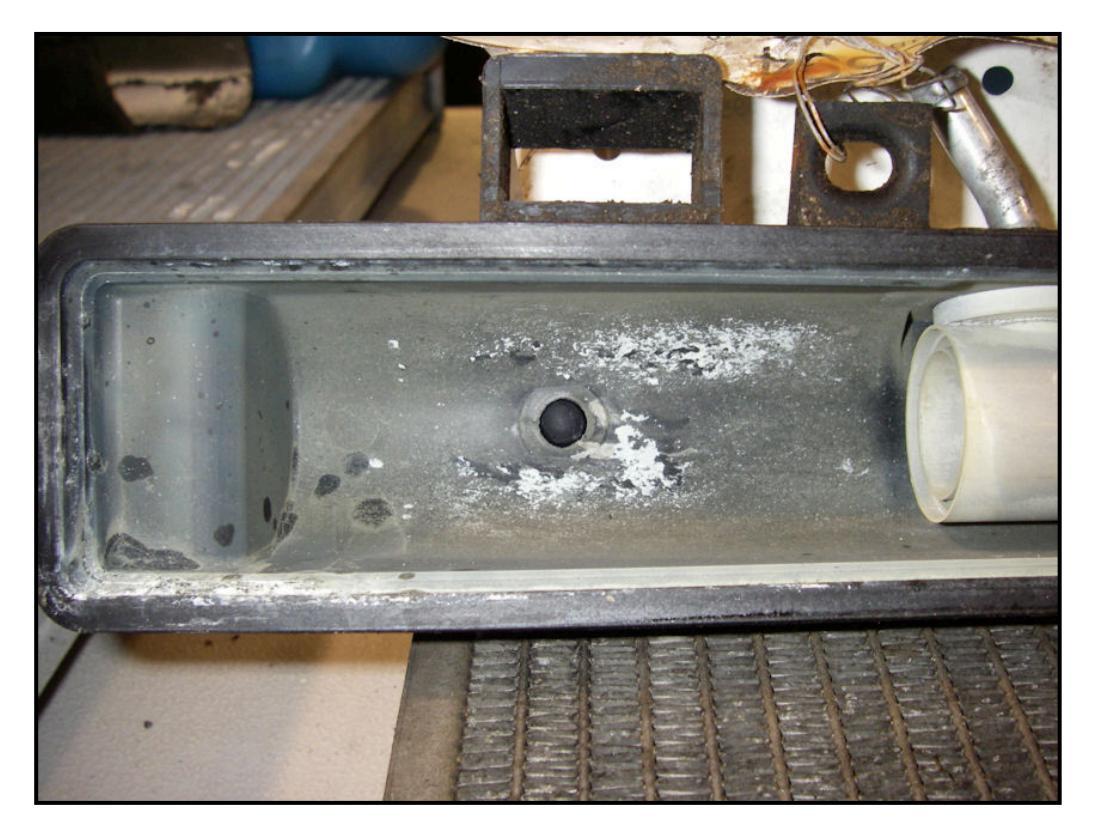
Figure 33 – Radiator SY2 Lower End Cap with White Flaky Deposits

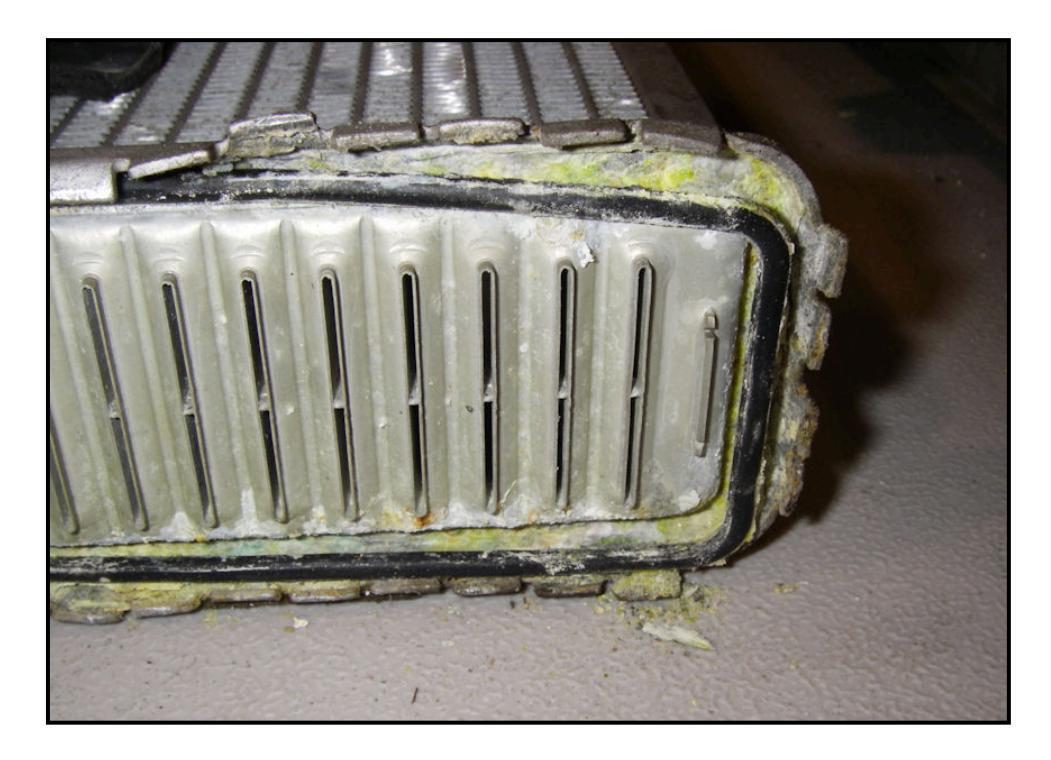
The salvage-yard radiators were examined for corrosion. One theory, proposed by the service writer/technician at a field visit, was that the radiators were being damaged due to lack of maintenance. The anti-corrosives in the coolant are depleted over time, and if the coolant is not changed, corrosion of the radiator components could result. Inside both salvage-yard units, there were light flaky deposits on the interior of the lower end cap and similarly colored powdered deposits on the ATF cylinder, as shown in Figures 31 to 33. There was also corrosion on both salvage-yard radiators along the crimp tabs and O-ring seal between the coolant core and the lower plastic-end cap, as shown in Figures 34 and 35. No leaks were observed at these locations in the submersion tank.

Figure 34 – Radiator SY1 with Corrosion on the Radiator Core at the Lower End Cap Attachment O-Ring

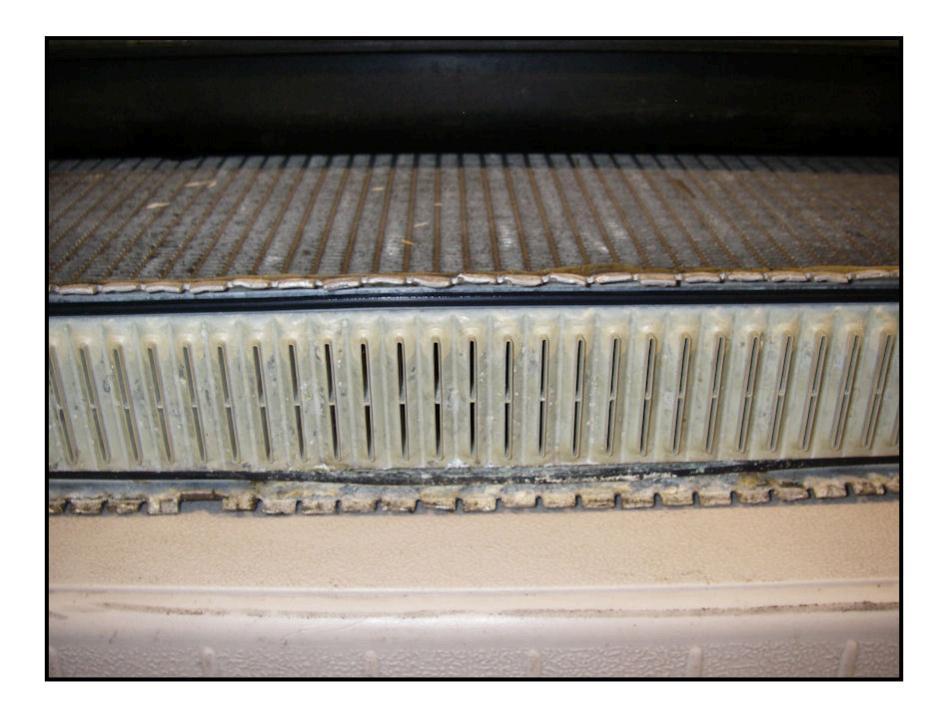
Figure 35 – Radiator SY2 with Corrosion on the Radiator Core at the Lower End Cap Attachment O-Ring

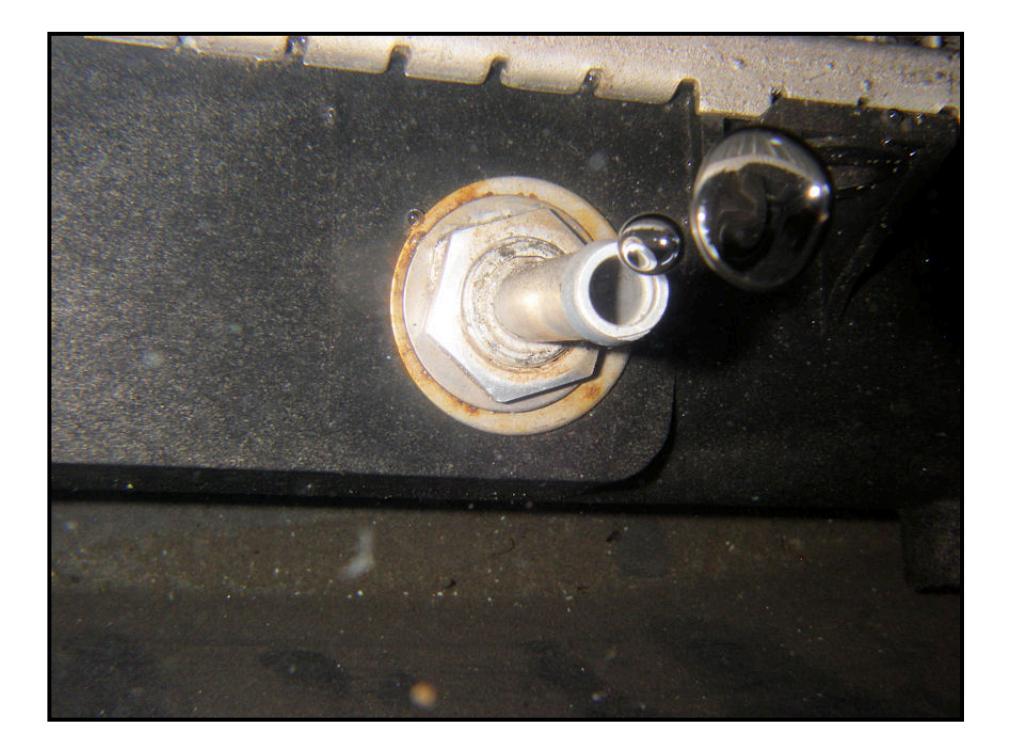
The radiator retrieved from NP1 was sealed, pressurized, and submerged in the water tank. The radiator bubbled slowly but steadily from the open ATF ports. Two bubbles, one large and one small, were emitted approximately every 10 seconds from one ATF port, as shown in Figure 36. These bubbles indicated a crossover leak between the two fluid systems. The 20-psi pressure was trapped in the radiator by closing the valve, and the pressure dropped slowly to 12 psi over four hours. At the end of the four-hour period, it was also noticed that the radiator core had started to leak air externally along the lower plastic-end cap in the middle with a steady stream of very small bubbles.

Figure 36 – Complete Radiator NP1 Submerged with Crossover Leak from the ATF Cylinder Port

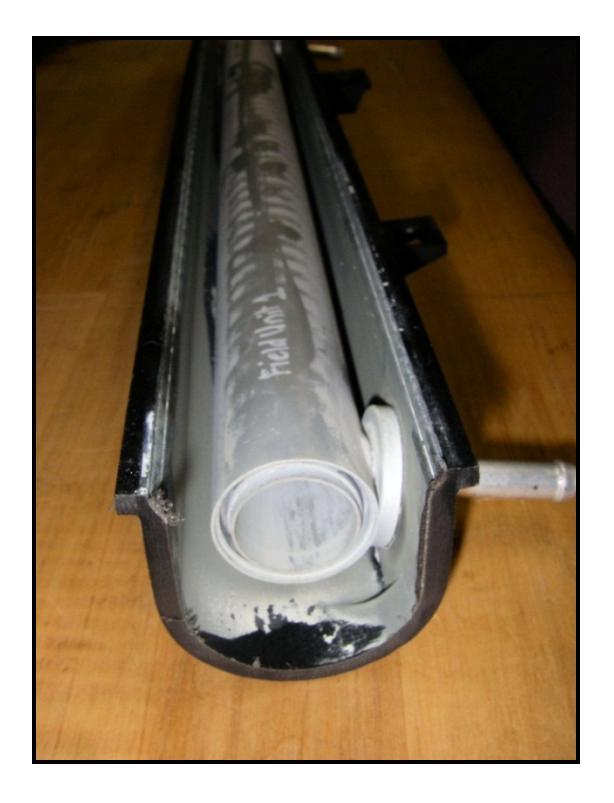
Figure 37 – Lower End Cap Removed from Radiator NF1 with Left Side White Powdery Deposits

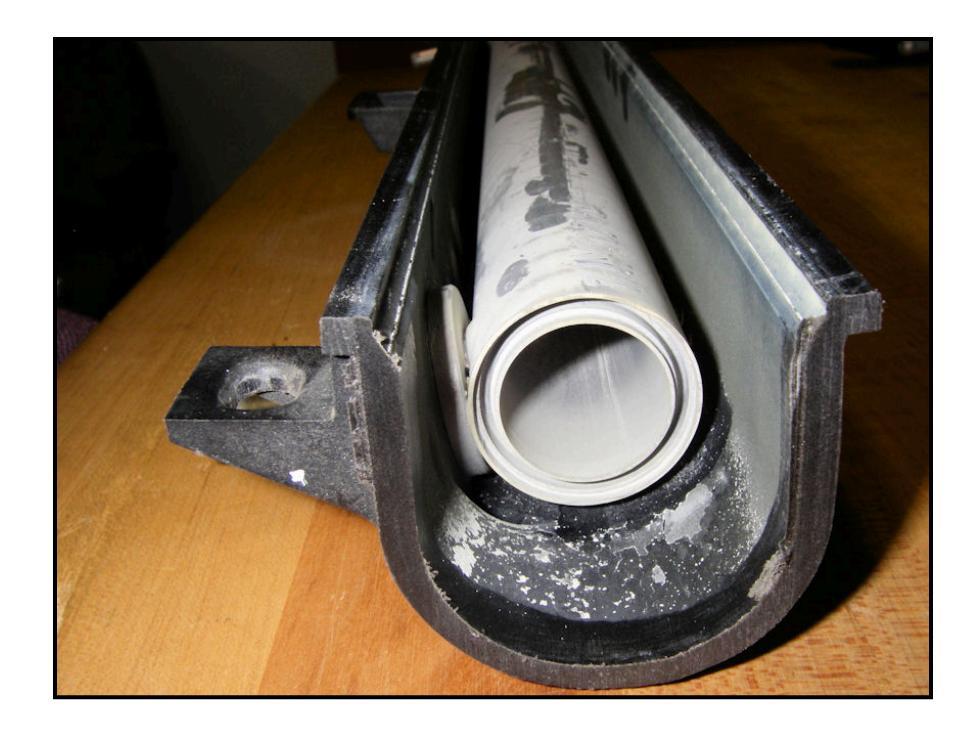
Figure 38 - Lower End Cap Removed from Radiator NF1 with Right Side White Flaky Deposits

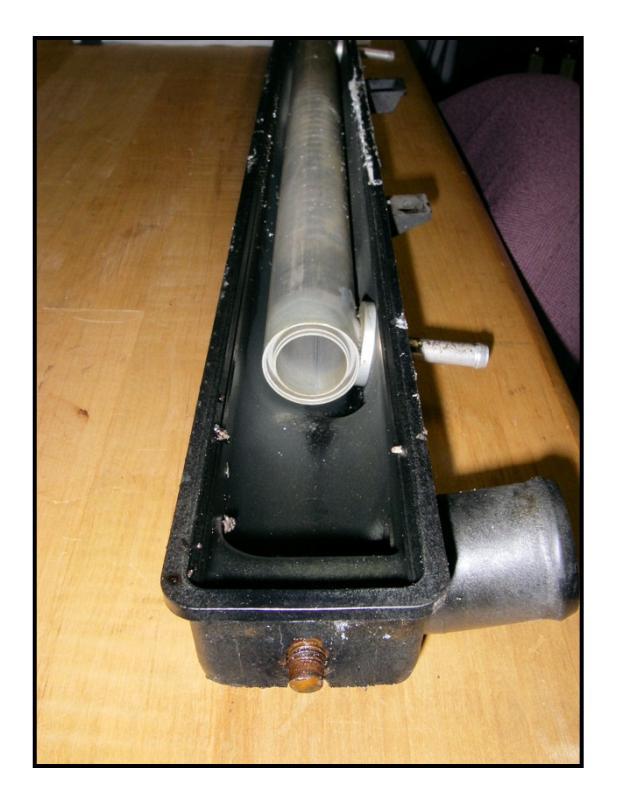
Figure 39 - Lower End Cap Removed from Radiator NP1 with Left Side Showing No Deposits

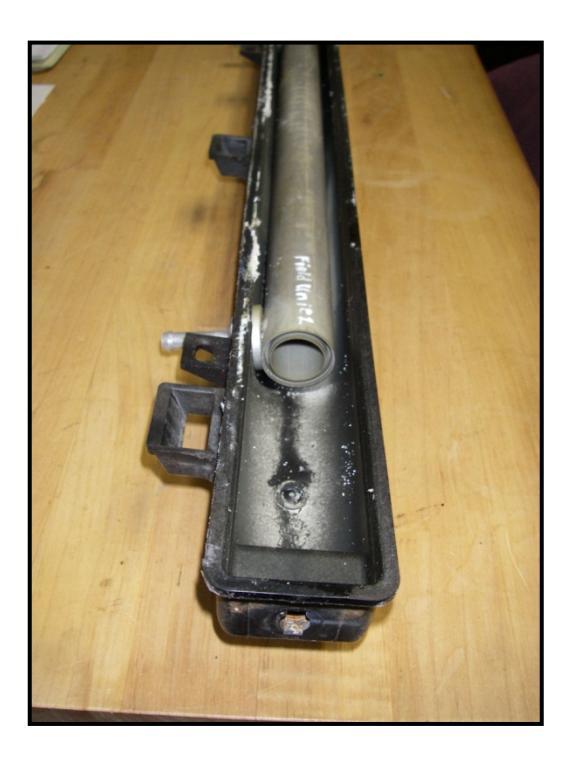
Figure 40 - Lower End Cap Removed from Radiator NP1 with Right Side Showing Light Deposits

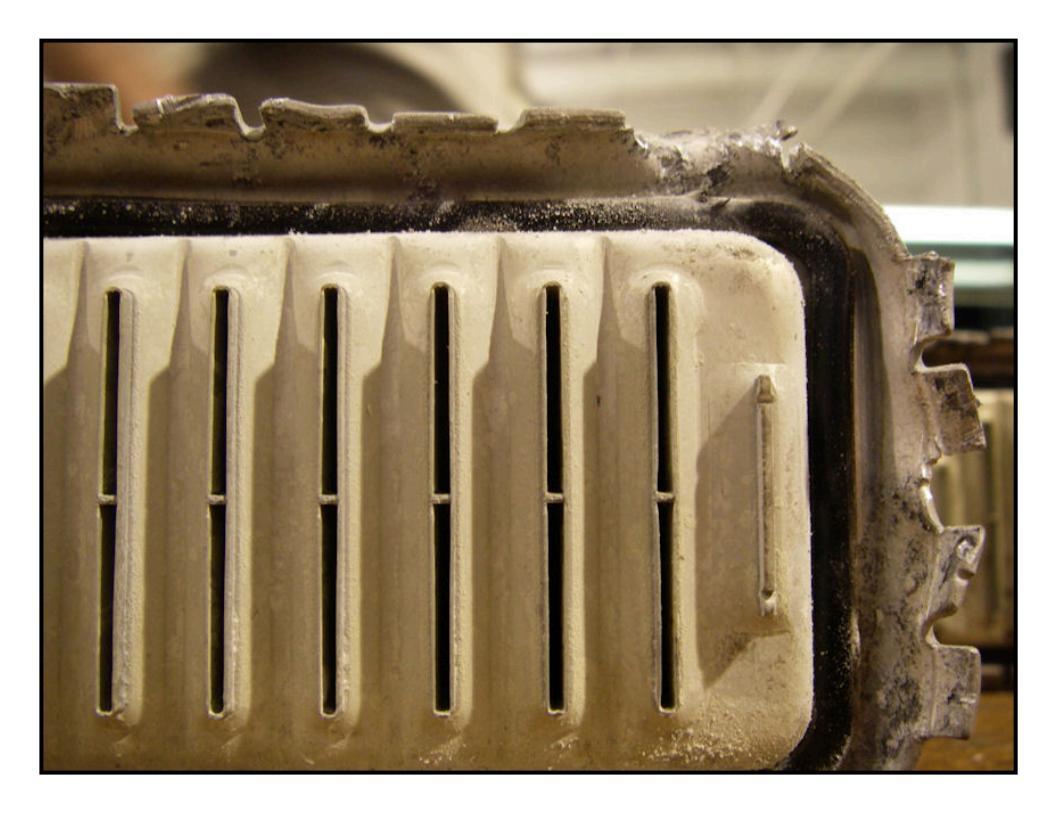
Figure 41 - Radiator NF1 with Corrosion on the Radiator Core at the Lower End Cap Attachment O-Ring

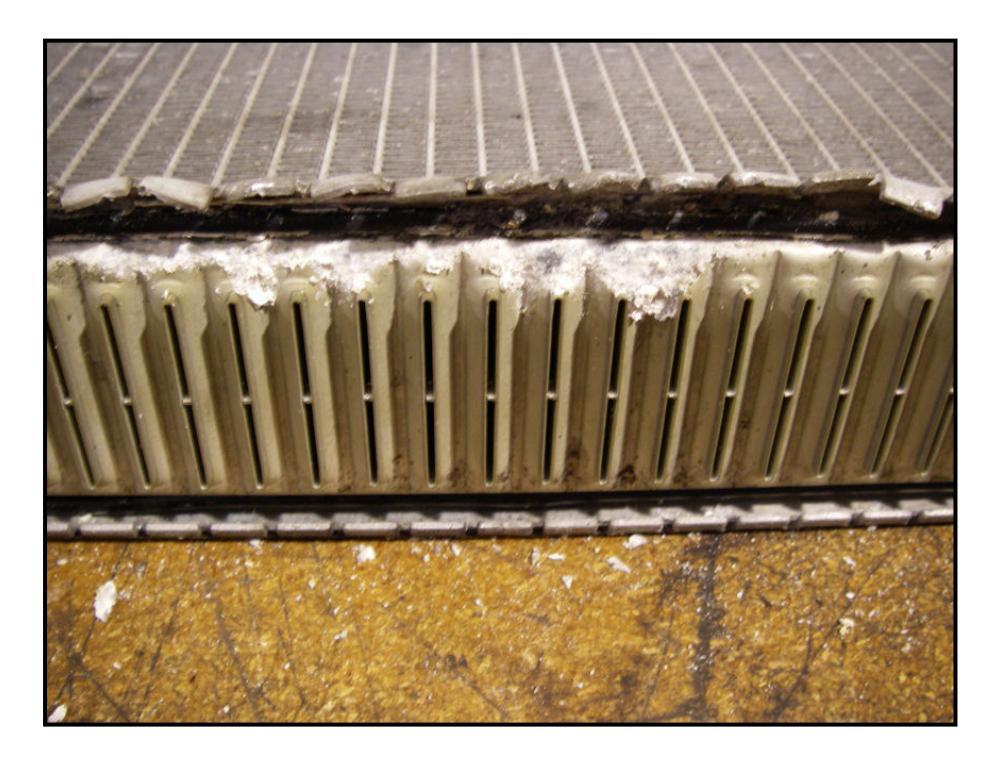
Next, the lower plastic-end caps were removed from both complaint radiator cores. The internal ATF cylinders were examined and are shown in Figures 37 to 40. The complaint radiator retrieved from NF1 had light deposits inside the plastic-end cap and on the cylinder similar to the salvage yard units. There was light corrosion at one corner of the radiator core, as shown in Figure 41. The radiator retrieved from NP1 did not have those deposits, but it did have significant corrosion along the middle section of the radiator core where the slow leak developed late in the four-hour pressure hold test, as shown in Figures 42 to 44.

Figure 42 - Radiator NP1 with Corrosion on the Radiator Core Along the Middle at the Lower End Cap Attachment O-Ring

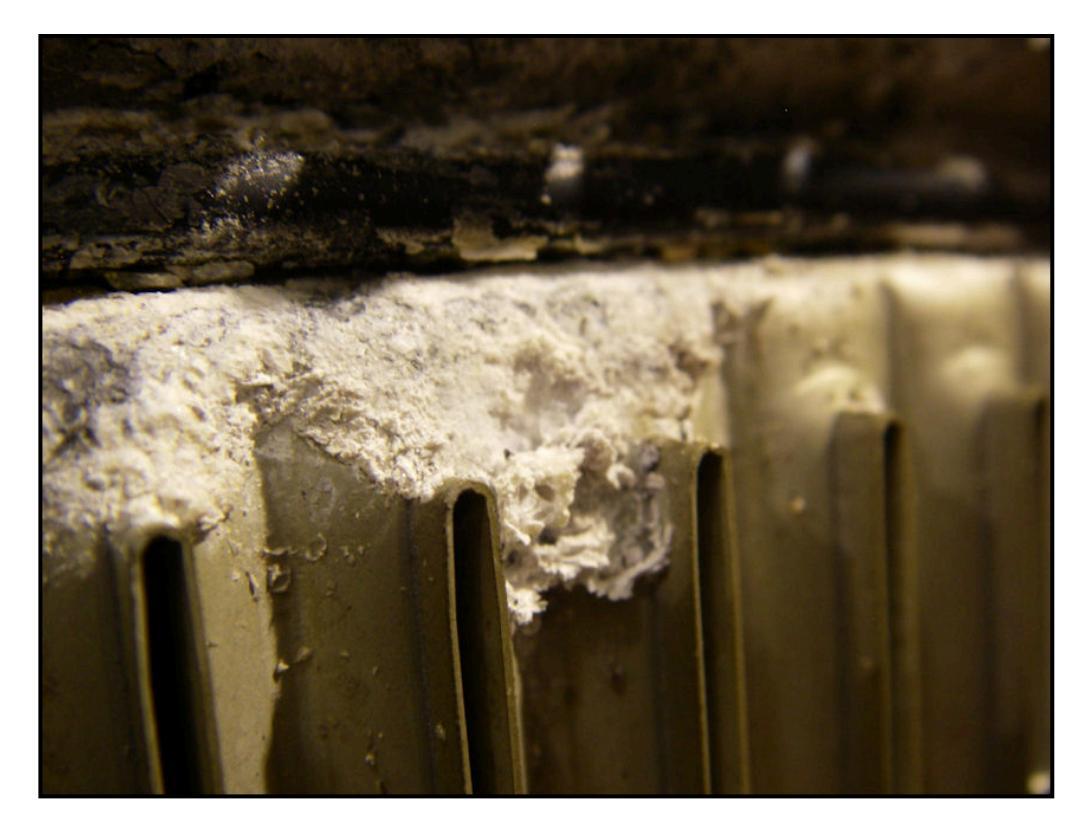
Figure 43 – Close-up of Radiator NP1 with Corrosion on the Radiator Core Along the Middle at the Lower End Cap Attachment O-Ring

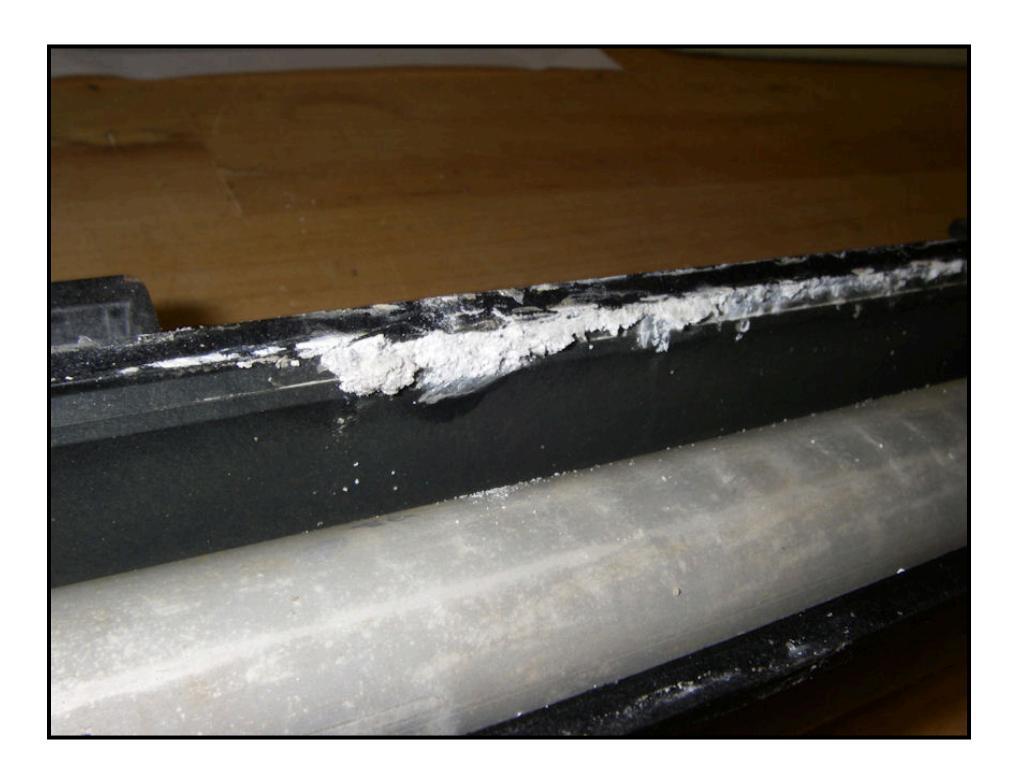
Figure 44 – Close-up of the Lower End Cap of Radiator NP1 with Corrosion Deposits at Interface to the Radiator Core

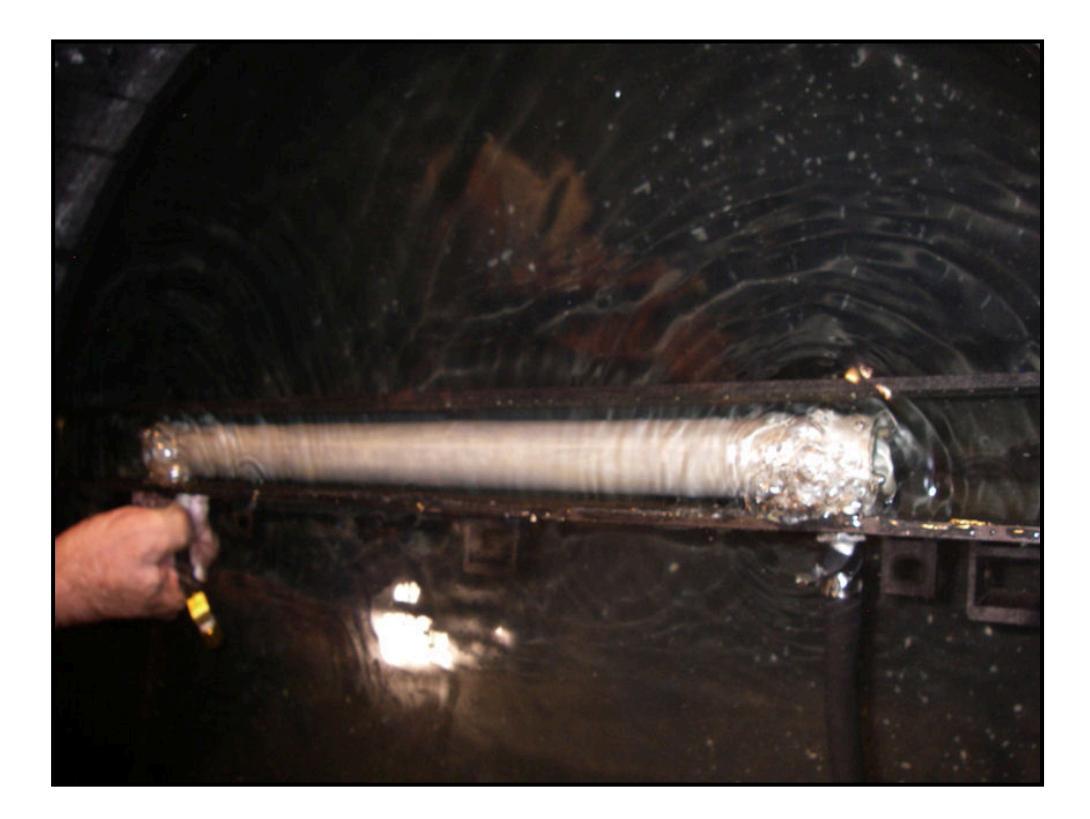
The ATF cylinder from NP1 was pressure tested while still installed in the lower plastic-end cap, and it leaked from both ends near the ATF ports, as shown in Figure 46, with only 1-psi of

Figure 46 – The Submerged ATF Cylinder NP1 Inside the Lower End Cap was Found to Leak Near Both ATF Ports

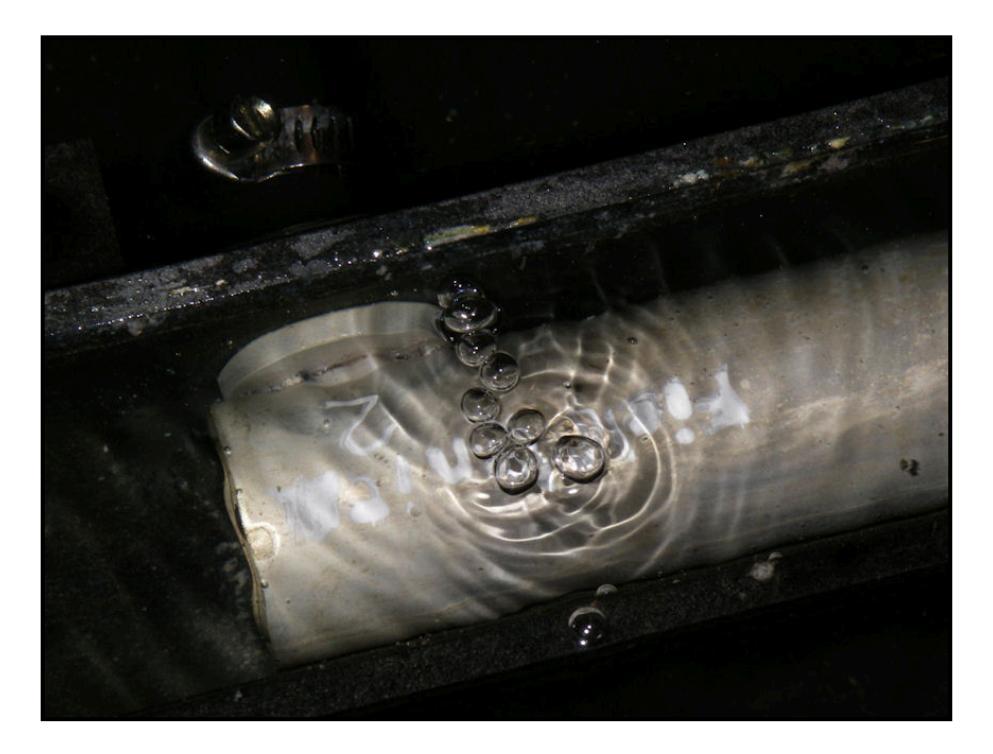
pressure. Upon a closer look, it was noted that both ends were leaking from an area just inboard of the ports near the point where the mounting disk of the port met the cylinder, as shown in Figure 47. The lower end plastic-cap was then cut away by hand with a hacksaw to avoid loading the port area by unscrewing the mounting nuts, as had previously been discussed with the salvage yard unit. The ATF cylinder was again submerged, and there was more visibility in the area of the leak. The right and left sides had identical leak points immediately inboard of the port mounting disks, as shown in Figures 48 and 49. The remaining plastic section of the lower-end cap was then clamped in a vise (to avoid loading the port mounting disks at the attachment points to the ATF cylinder) and the original mounting nuts removed. Both sides had significant corrosion debris under the exterior mounting nuts, as shown in Figure 50. The ATF cylinder was again submerged to inspect the leak points. The trail of bubbles was clearly from the inner contact point of the inlet and outlet port disks and the cylinder, as shown in Figures 51 and 52. The ATF cylinder was pressurized to 20 psi, and the shutoff valve was actuated. The ATF cylinder leaked to 0-psi pressure in 11 seconds. This expansive-force-pressure test leaked at a much higher rate than the previous compressive-force-pressure test conducted with the entire radiator.

Figure 47 – Close-up of The Submerged ATF Cylinder NP1 Inside the Lower End Cap Showing the Leak Near the Right ATF Port

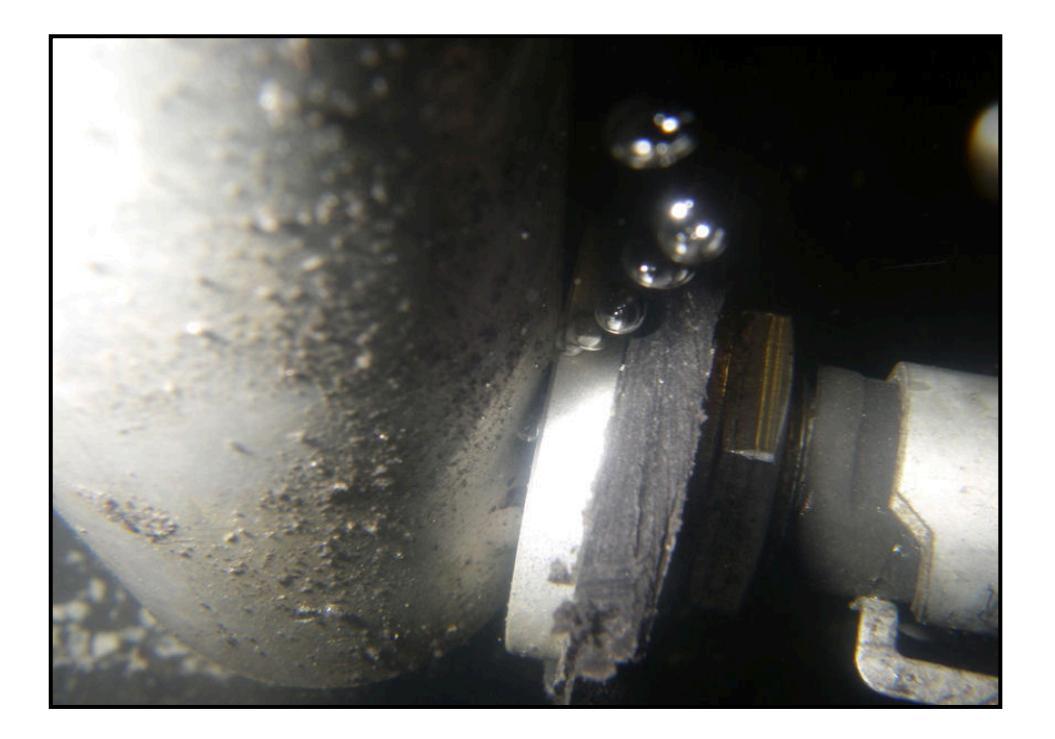
Figure 48 – The Submerged ATF Cylinder NP1 After Cutting Away the Lower End Cap without Removing the Nuts Showing the Leak at Left ATF Port

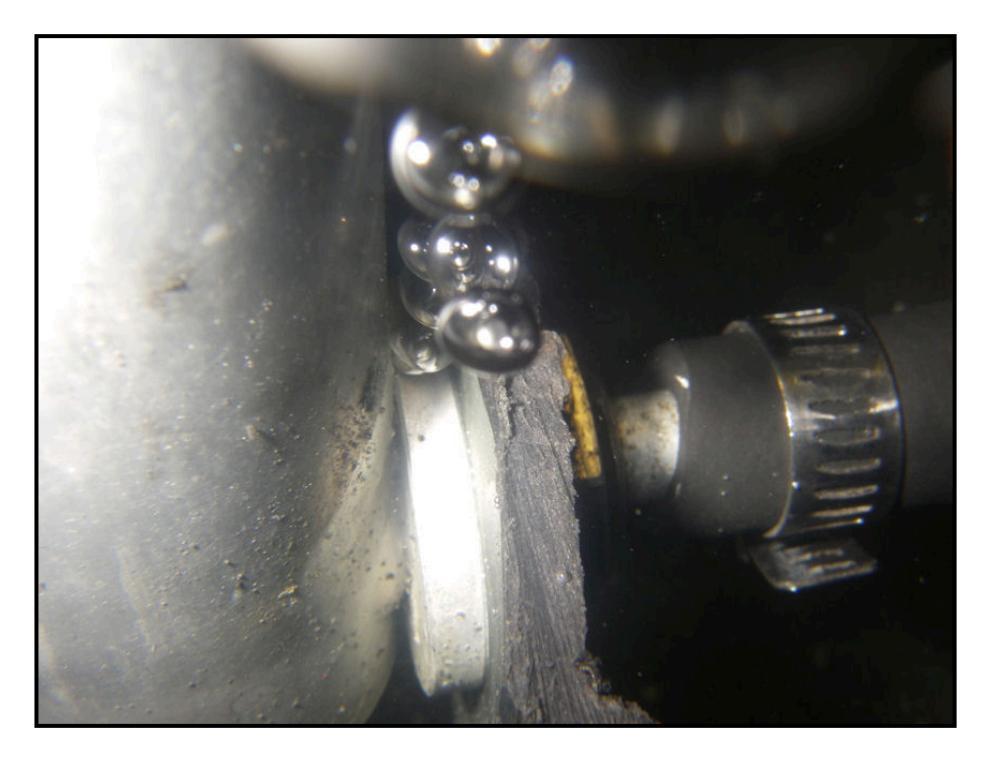
Figure 49 – The Submerged ATF Cylinder NP1 After Cutting Away the Lower End Cap without Removing the Nuts Showing the Leak at Right ATF Port
