Inspections and Tests of Engine-Coolant Radiators with Integrated ATF-Temperature-Stabilizing Cylinders from 2005-10 Nissan Light Trucks

Four Nissan radiators were procured, inspected and tested by the Defects Analysis Group at the Vehicle Research and Test Center (VRTC), East Liberty, Ohio, in response to a request to support the Office of Defects Investigation (ODI) on Defect Petition DP12-004. This defect petition was requested by the North Carolina Consumers Council, Inc. (NCCCI). The ODI opening resume¹ listed 512 Vehicle Owner's Questionnaire (VOQs) complaints between late 2005 and early 2012. The ODI and NCCCI complaints allege repeated unexpected slow acceleration, various transmission malfunctions, and other safety concerns due to the engine coolant mixing with the automatic transmission fluid (ATF).

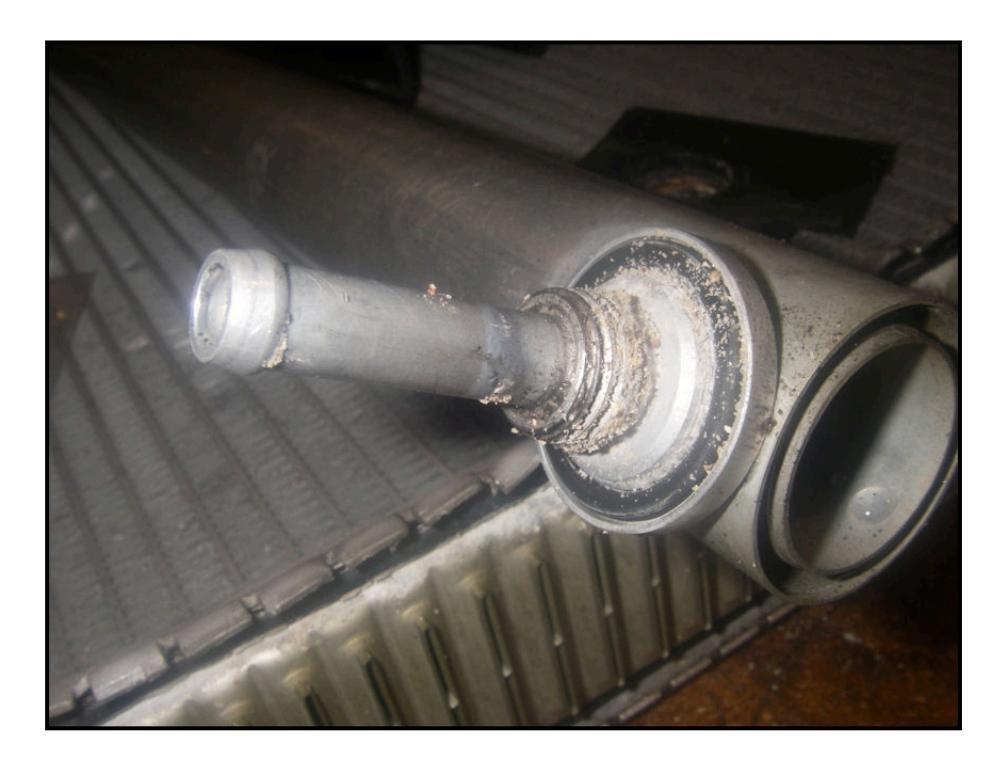
Figure 50 – The ATF Cylinder NP1 After Removing the Retaining Nuts Showing the Corrosion that was Present at Both ATF Ports

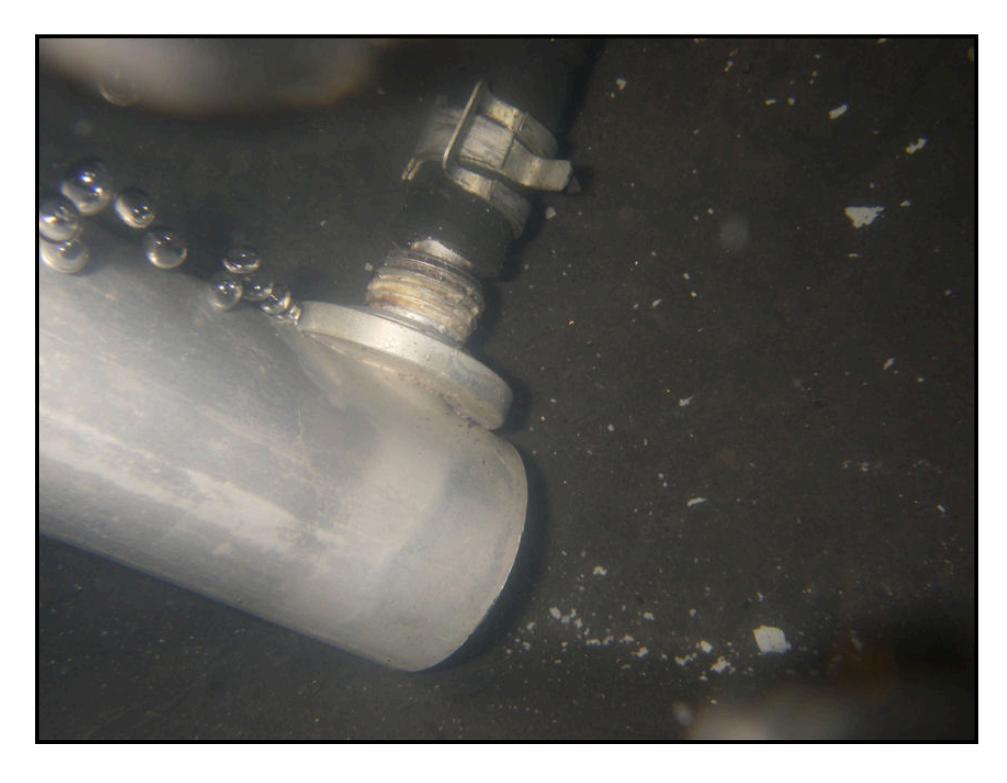
Figure 51 – The Submerged ATF Cylinder NP1 After Complete Removal from the Lower End Cap Showing the Leak at Left ATF Port

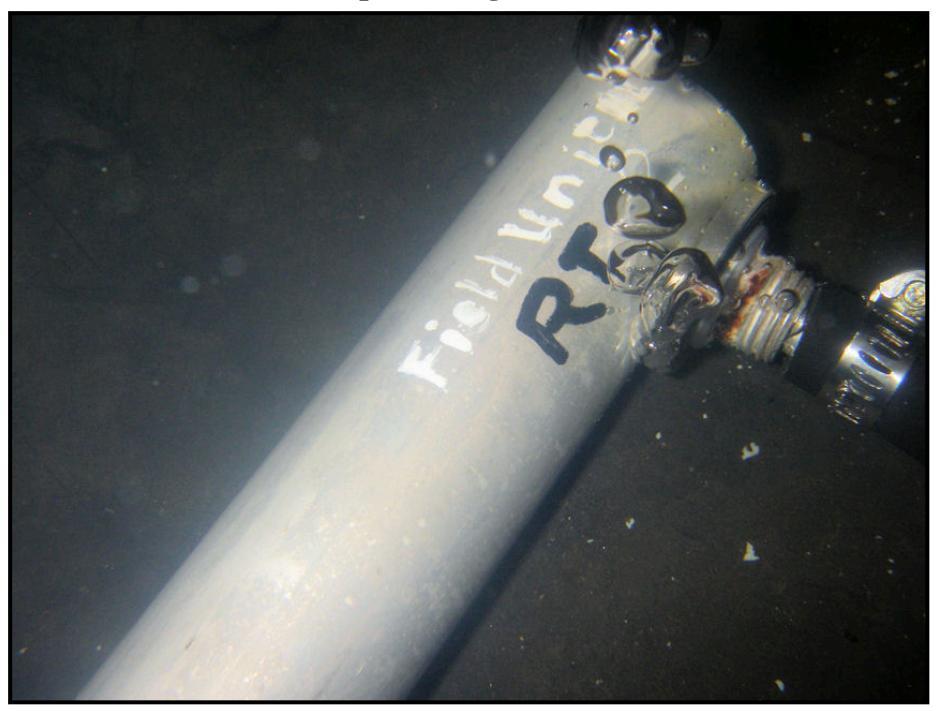
Figure 52 – The Submerged ATF Cylinder NP1 After Complete Removal from the Lower End Cap Showing the Leak at Right ATF Port

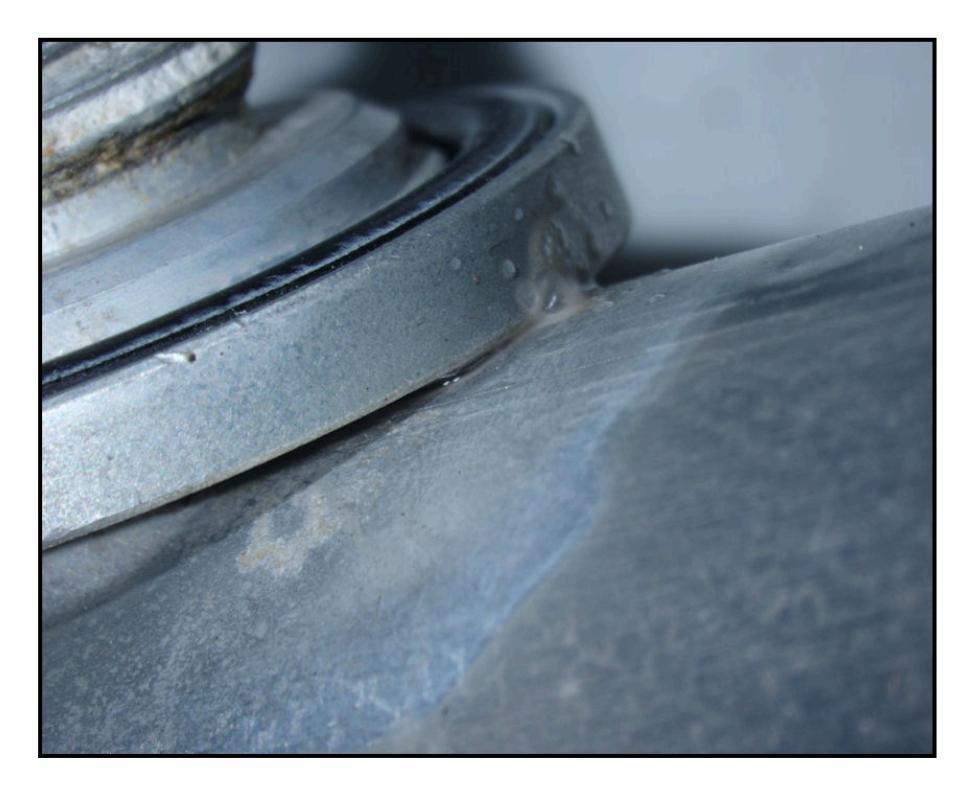
The NP1 ATF cylinder was dried, and the left port area was observed under the stereo microscope. The tube was lightly pressurized, and small milky bubbles appeared at the intersection of the left port disk and the cylinder, as shown at a magnification of 5X in Figure 53. Then a slight vacuum was applied to the cylinder to remove the liquid from the area of interest, as shown at 15X in Figure 54, revealing a fracture in the thin-walled cylinder. A closer view of this area, at 25X, showed additional radial cracks in the cylinder surface emanating away from the central tear, as shown in Figure 55. This fracture appeared to be the result of normal hoop stress on the cylinder in an area that was restrained by the port disk that resulted in a stress concentration and a fatigue fracture. Next, the right port area was examined, as shown in Figure 56 at a magnification of 3X, and the cylinder wall appeared to be intact. The fracture became apparent under a magnification of 10X, as shown in Figure 57. A close-up of the area is shown at a magnification of 50X in Figure 58, and the thin cylinder wall was again separated along the line of the filler alloy of the weld.

Figure 53 – The ATF Cylinder NP1 Under the Stereo Microscope at Magnification 5X with Slight Pressurization Showing the Leak Point Near the Left ATF Port

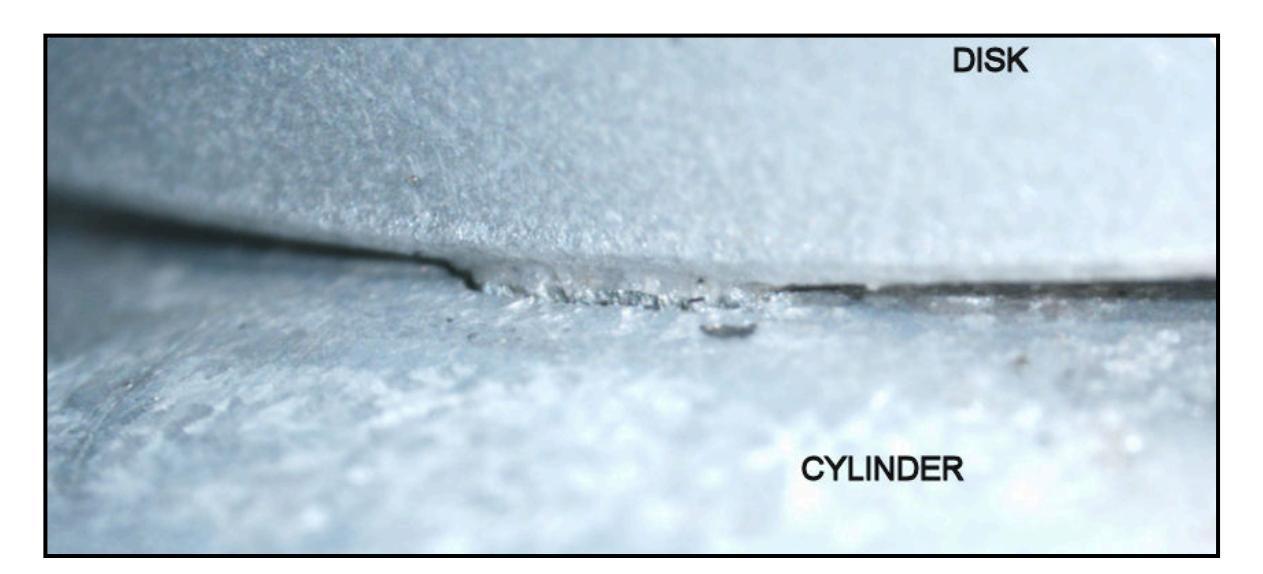
Figure 54 – The ATF Cylinder NP1 at 15X Showing a Fracture in the Thin-Walled Tube at the Disk of Left ATF Port

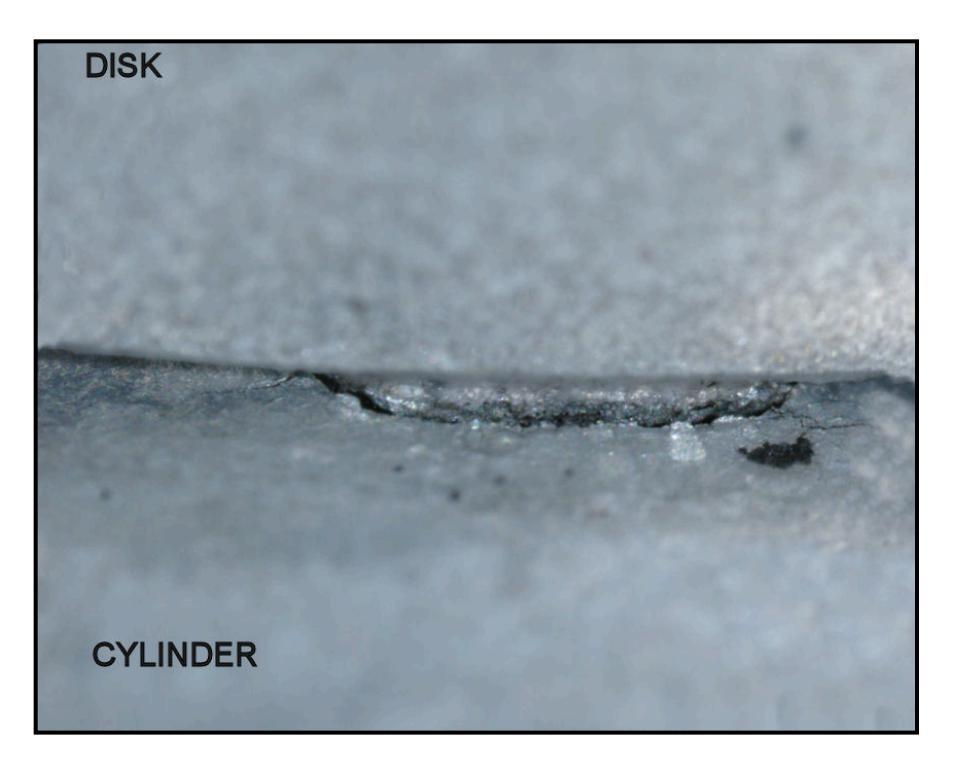
Figure 55 – The ATF Cylinder NP1 at 25X Showing a Fracture in the Thin-Walled Tube at the Disk of Left ATF Port

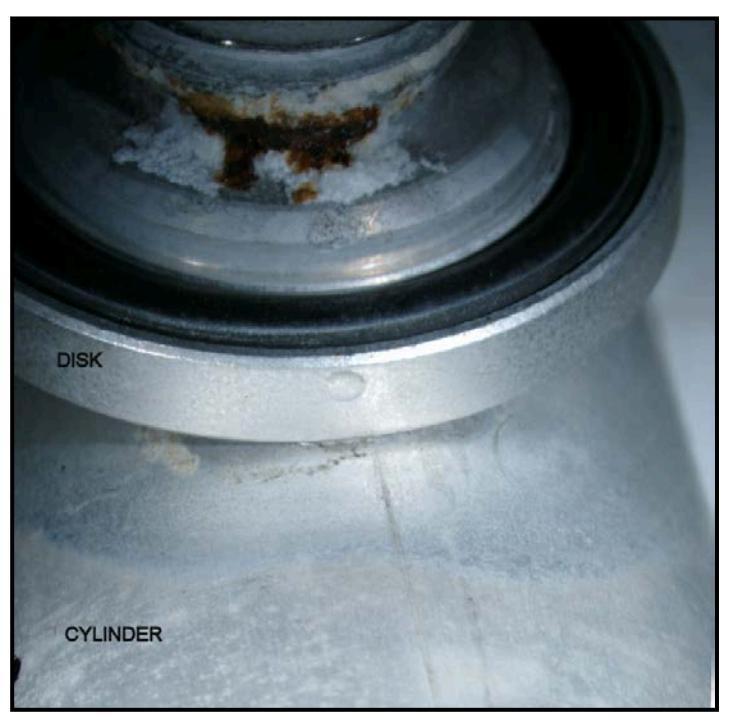
Figure 56 – The ATF Cylinder NP1 at 3X Showing Area of Leak at the Disk of Right ATF Port

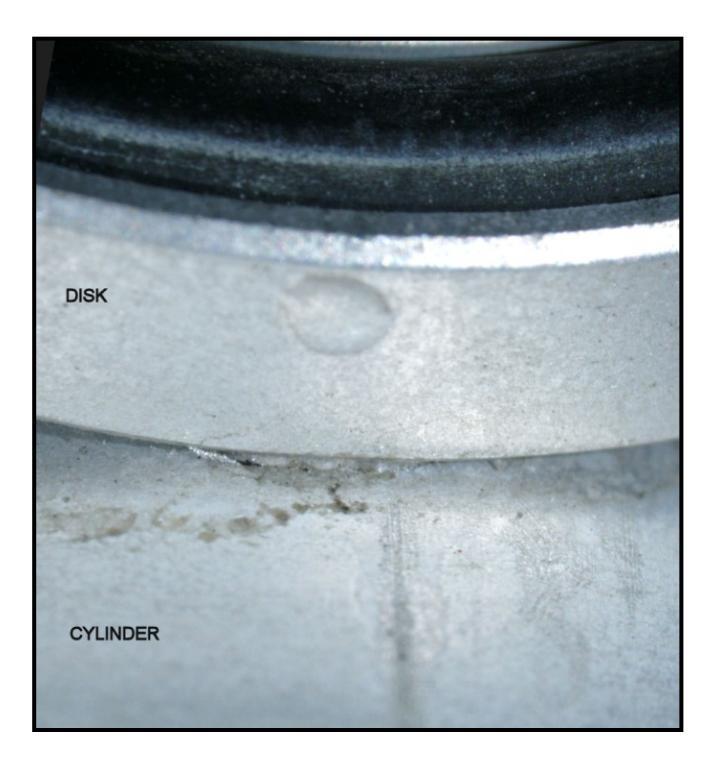
Figure 57 – The ATF Cylinder NP1 at 10X Showing a Fracture in the Thin-Walled Tube at the Disk of Right ATF Port

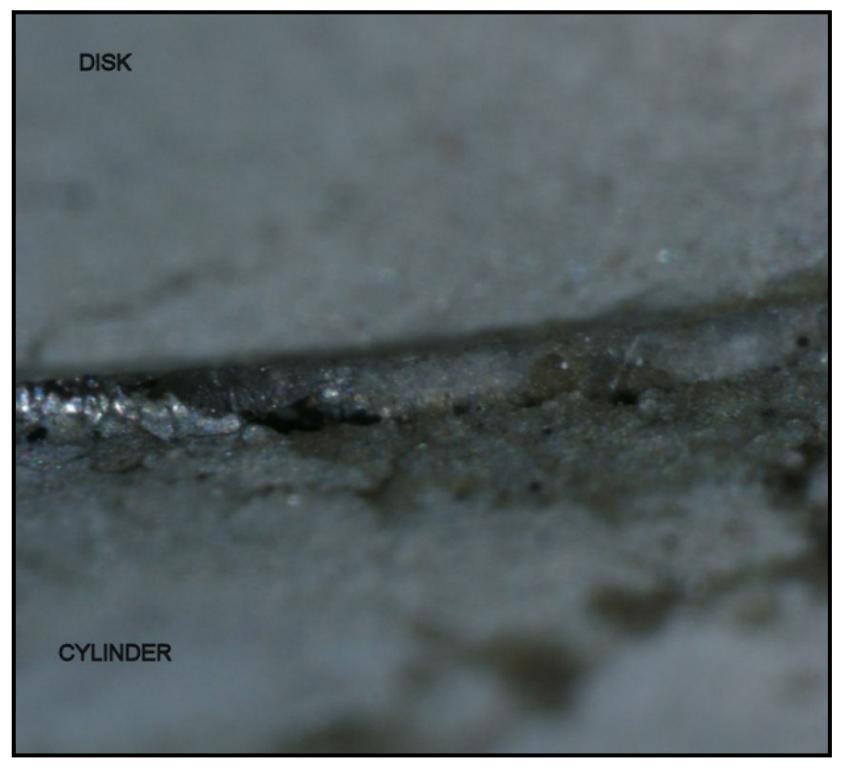
Figure 58 – A Close-up Showing the Fracture in the ATF Cylinder NP1 at 50X at the Disk of Right ATF Port

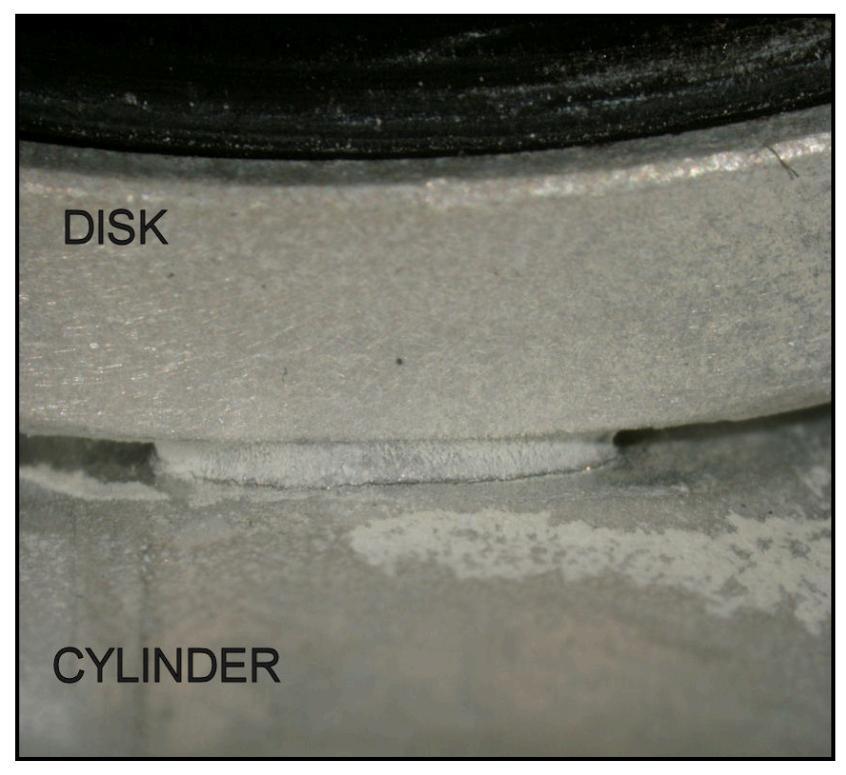
The NF1 ATF cylinder was inspected with the stereomicroscope in the area of the failure of the NP1 ATF cylinder. It was observed to have a wider attachment weld-filler alloy area and cracks along the same surface on both ends, as shown in Figures 60 to 63. The two salvage-yard ATF cylinders were inspected at each end, and it was found that three of the four ends also had

Figure 60 – The ATF Cylinder NF1 at 10X Showing a Wider Weld and a Crack at the Disk of Left ATF Port but No Leak was Observed

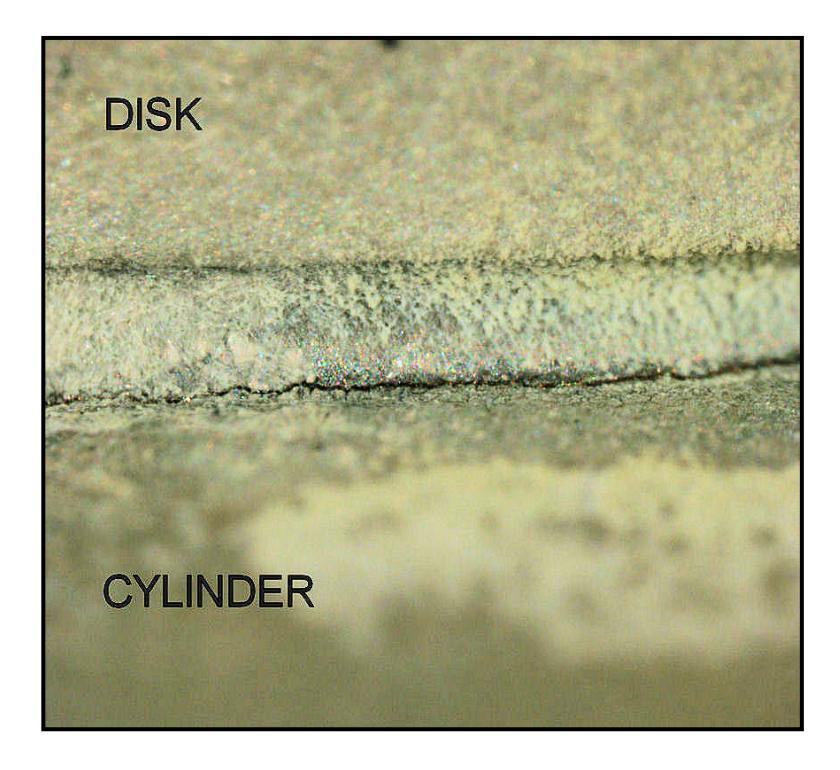
Figure 61 – The ATF Cylinder NF1 at 30X Showing a Crack at the Disk of Left ATF Port but No Leak was Observed

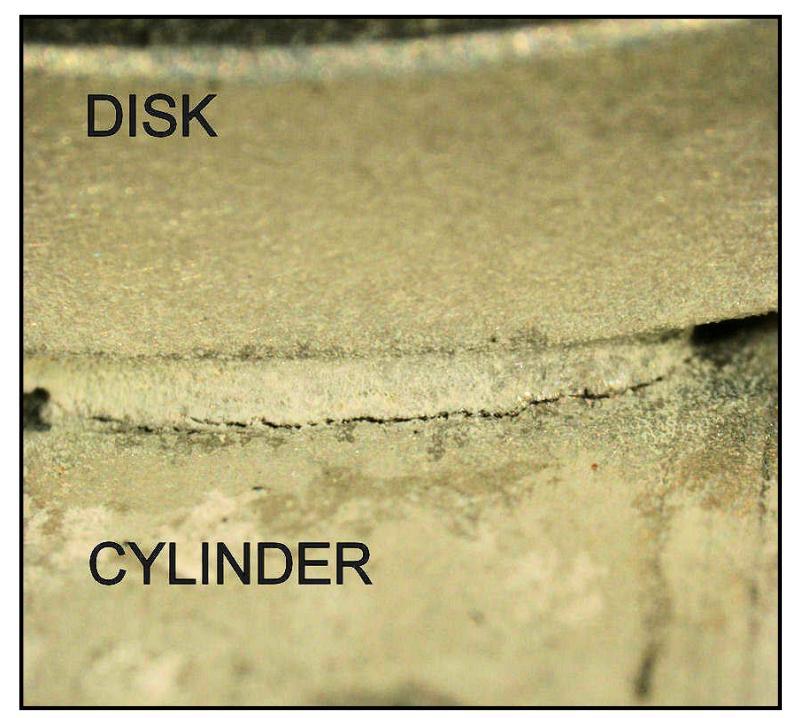
Figure 62 – The ATF Cylinder NF1 at 15X Showing a Crack at the Disk of Right ATF Port but No Leak was Observed

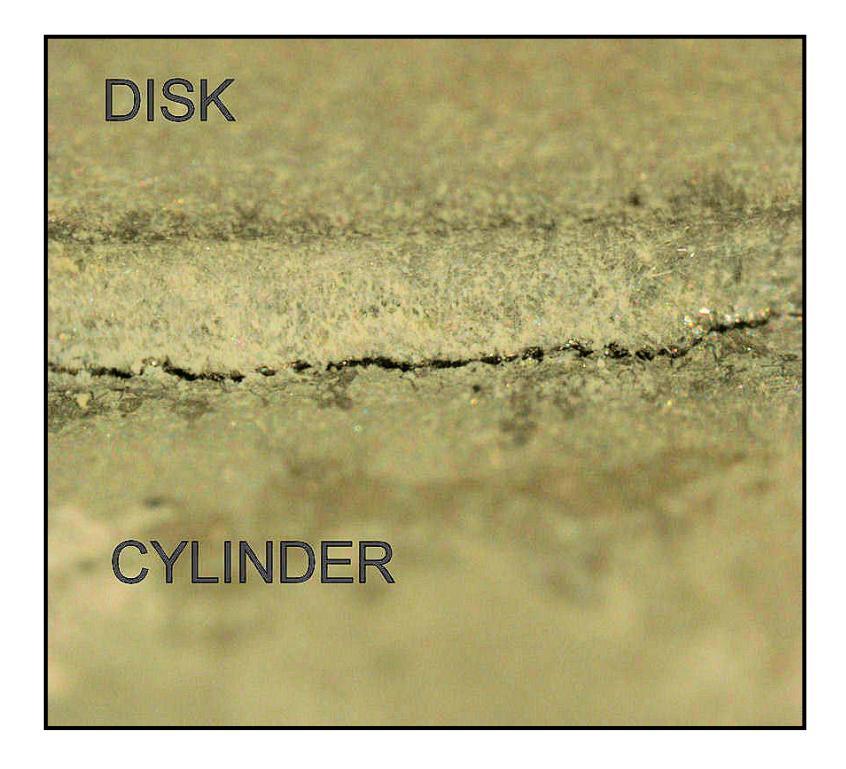
Figure 63 – The ATF Cylinder NF1 at 30X Showing a Crack at the Disk of Right ATF Port but No Leak was Observed

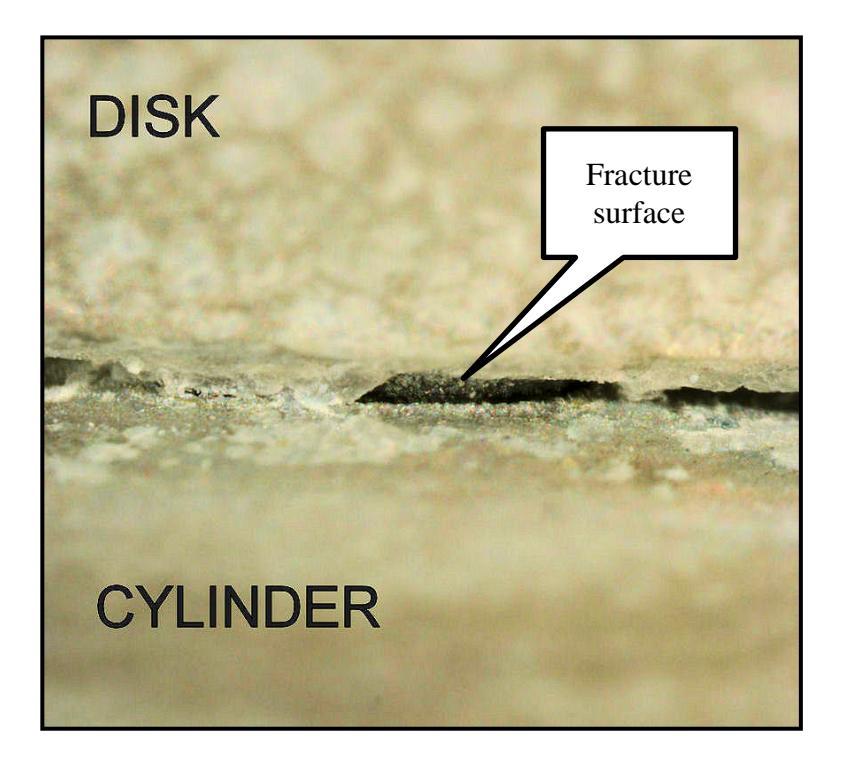
Figure 67 – ATF Cylinder SY#1 at 30X After Cleaning Showing a Fracture In the Cylinder Under the Disk of Right ATF Port, but No Leak was Observed

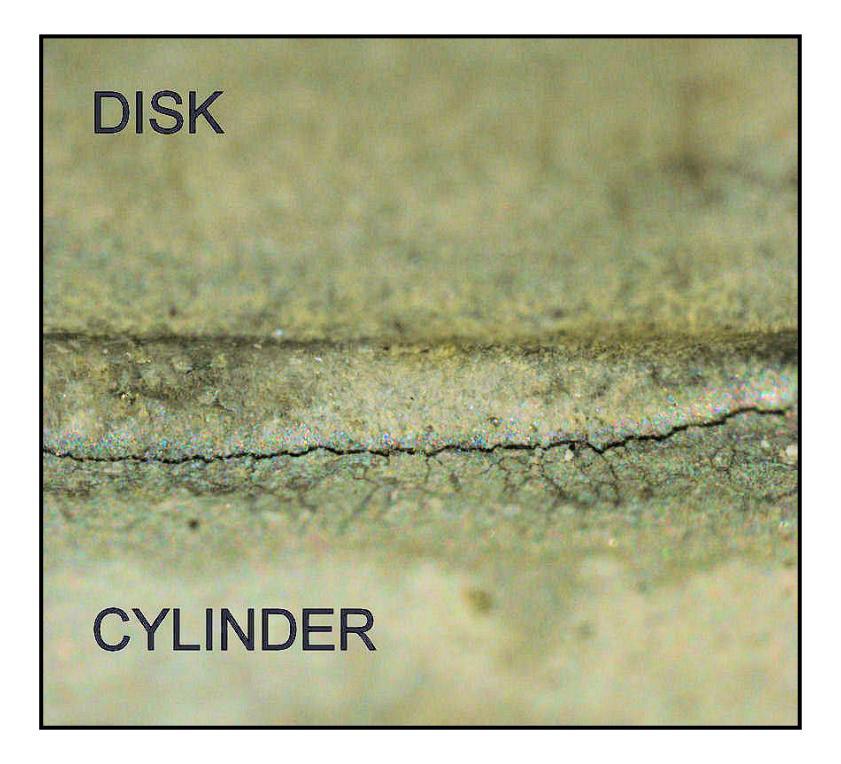
Figure 69 – The ATF Cylinder SY#2 at 35X Showing a Crack in the Weld at the Disk of Left ATF Port, but No Leak was Observed

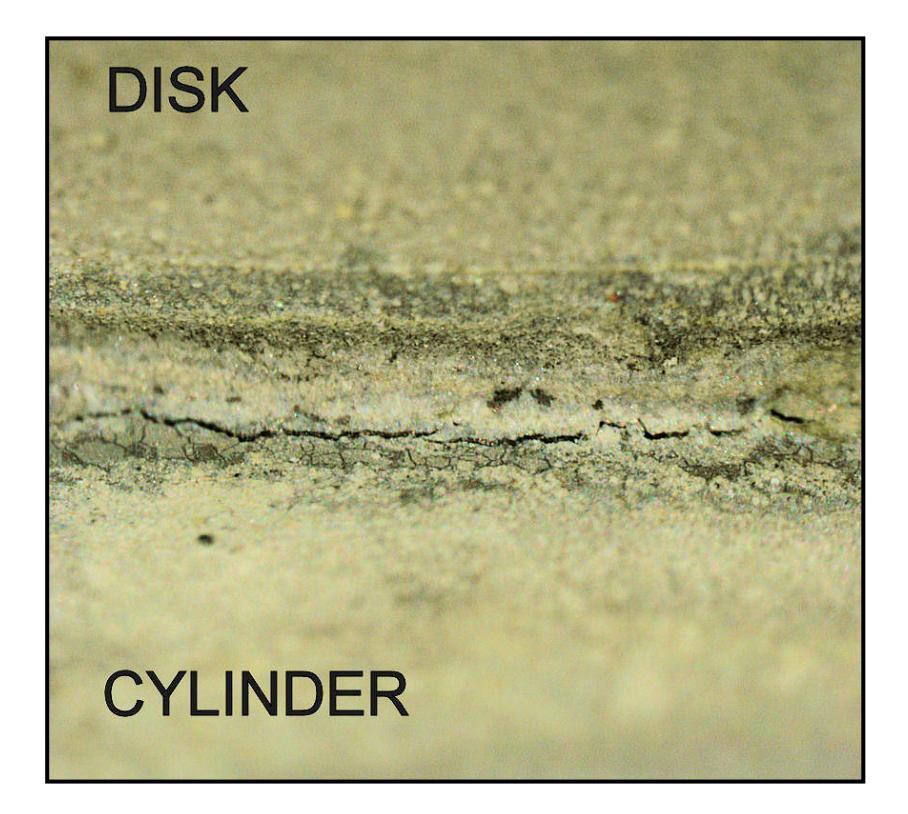
Figure 71 – The ATF Cylinder SY#2 at 30X Showing a Crack in the Weld at the Disk of Right ATF Port, but No Leak was Observed
