From: [REDACTED]
Sent: Wednesday, May 14, 2014 8:39 AM
To: [REDACTED]
Subject: FW: Follow-up & Ford Focus BEV vehicle VIN - Quebec

From: [REDACTED]
Sent: Thursday, May 15, 2014 4:31 PM
To: [REDACTED]
Subject: RE: Warranty Return

From: [REDACTED]
Sent: Monday, May 05, 2014 10:48 PM
To: [REDACTED]
Cc: [REDACTED]
Subject: Re: Power Xpress coupler and vehicle inlet photo's
Attachments: Focus Charge Port2.zip

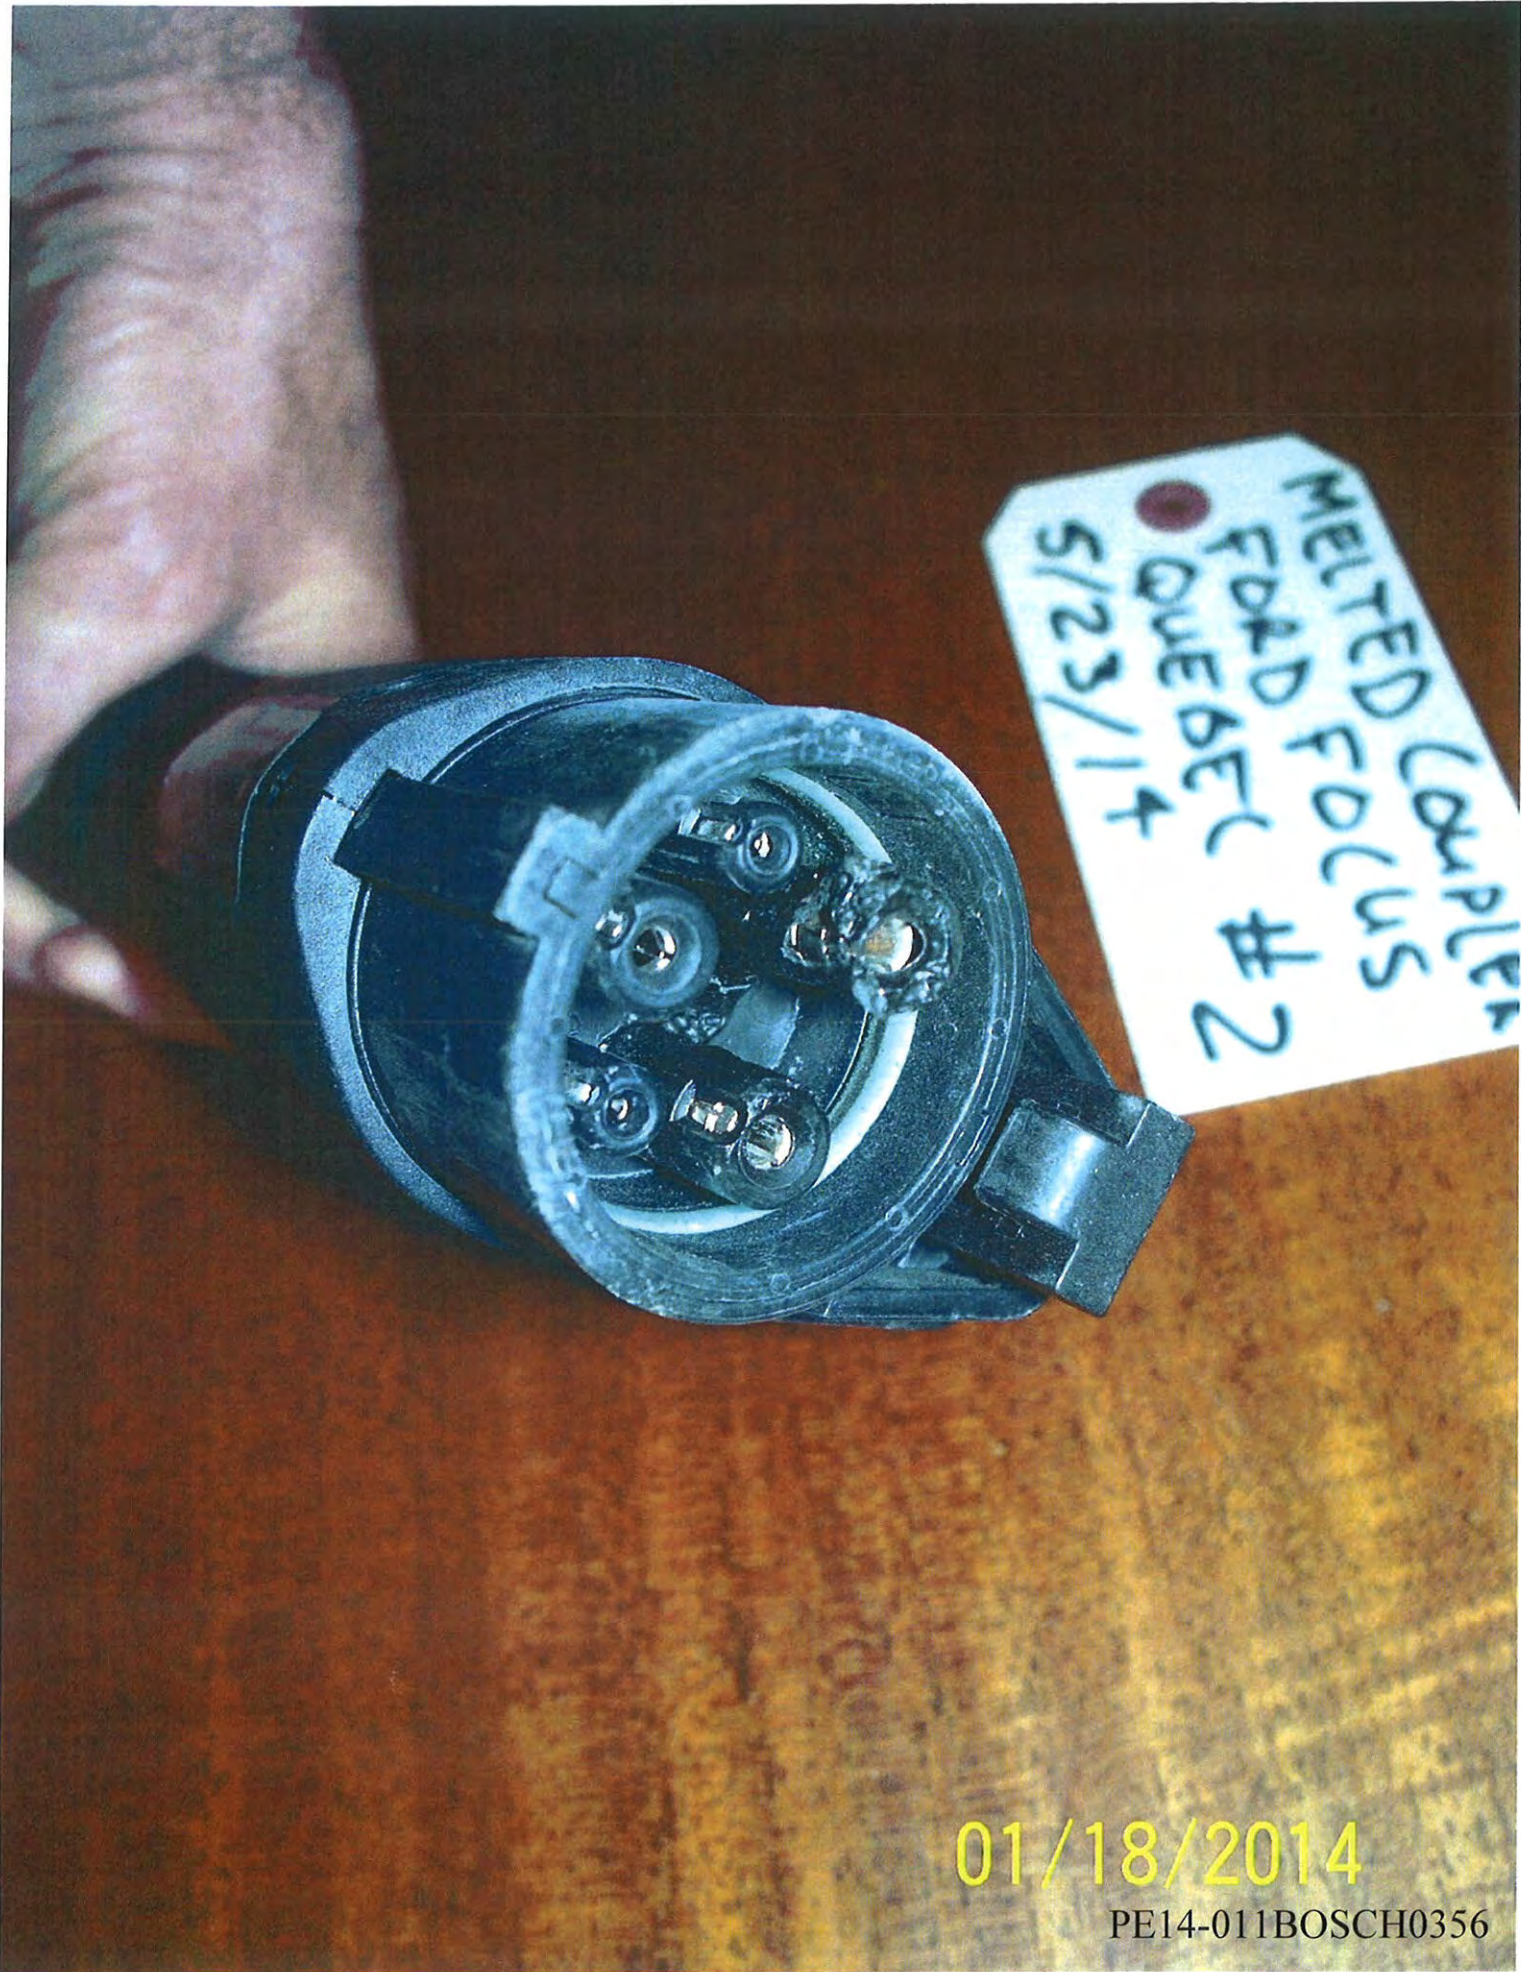
MELTED COUPLER
FOARD FOCUS
● QUEBEL #2
5/23/14

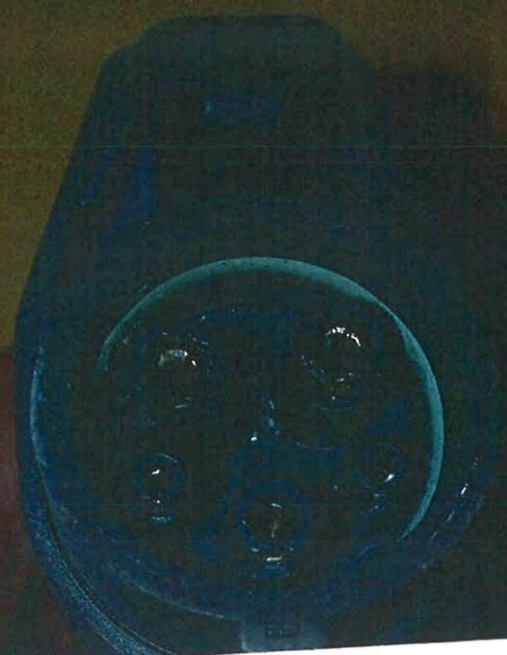
MELTED COUPLER
FORD FOCUS
• QUEBEC #2
5/23/14

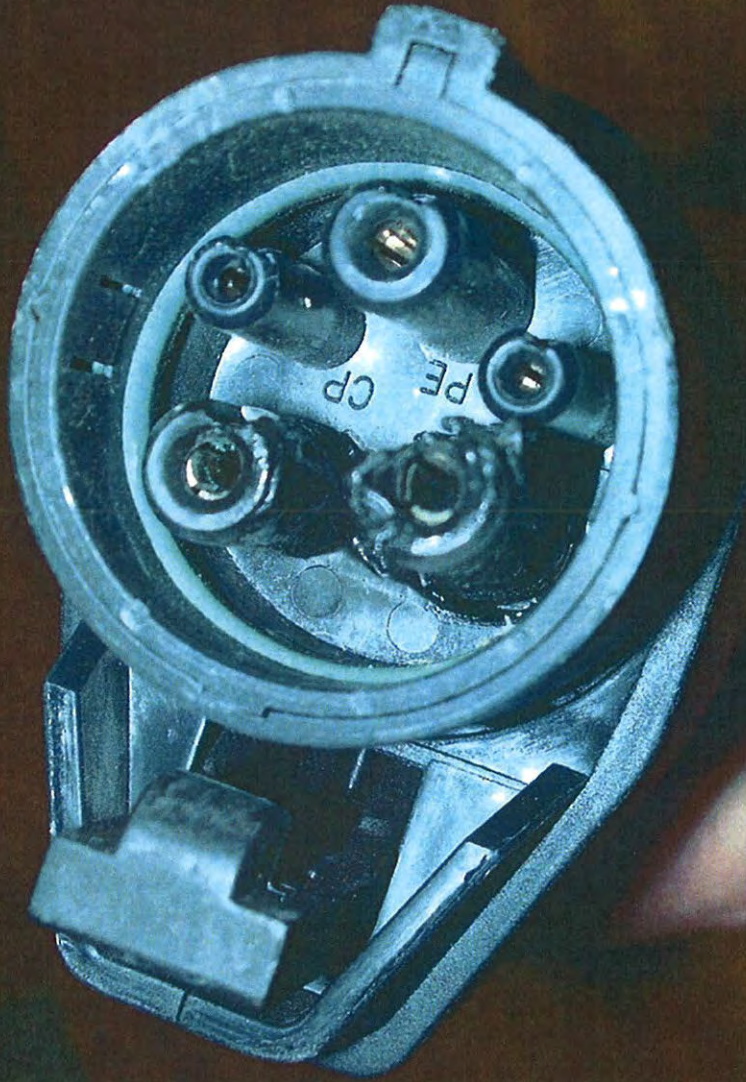
PE14-011
BOSCH0359

MELTED COUPLER
FORD FOCUS
QUEBEC #2
5/23/14

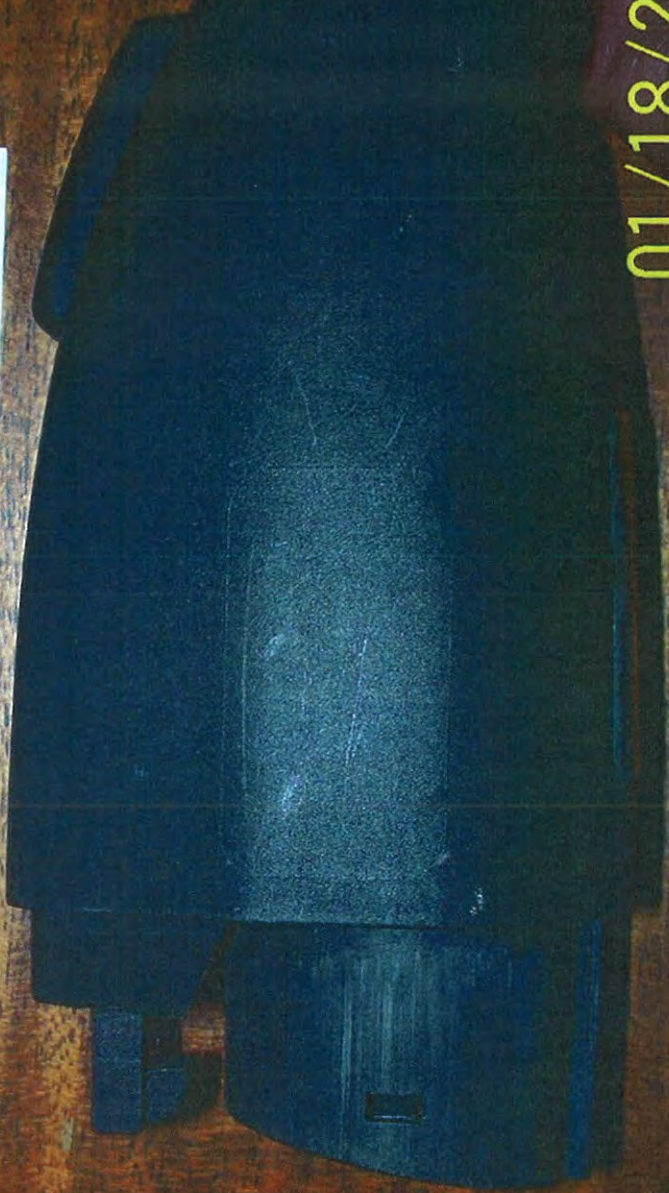
MELTED COUPLER
FORD FOCUS
QUEBEC #2
5/23/14

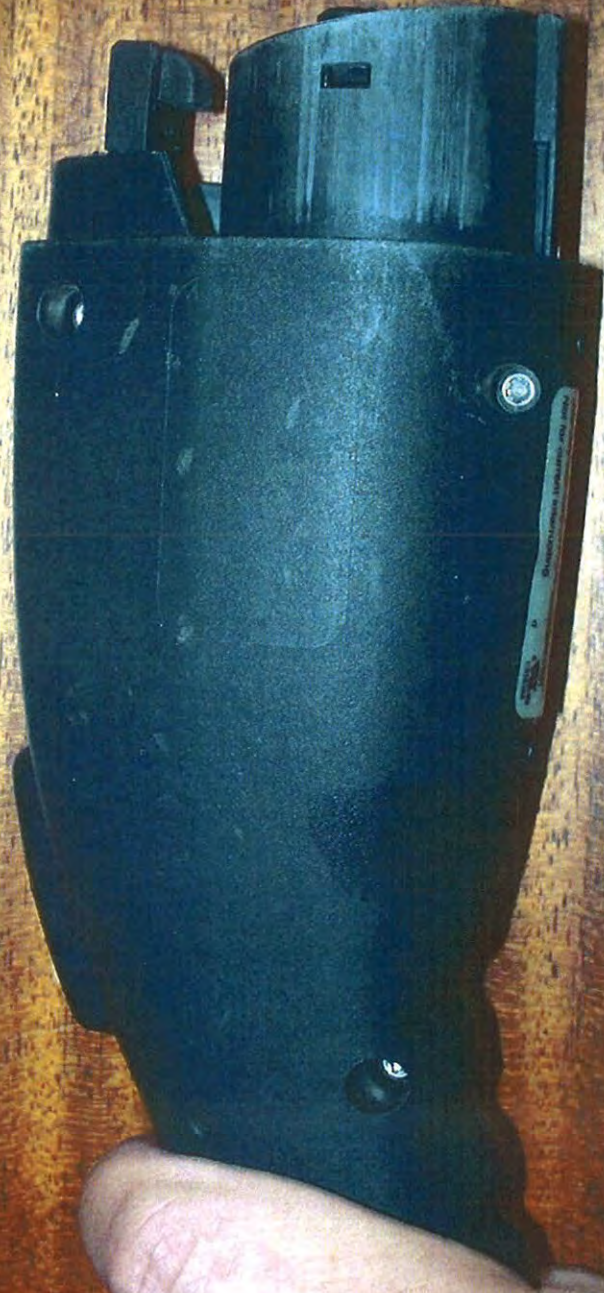
MELTED (ouplar
FORD FOCUS
QUEBEC # 2
5/23/14

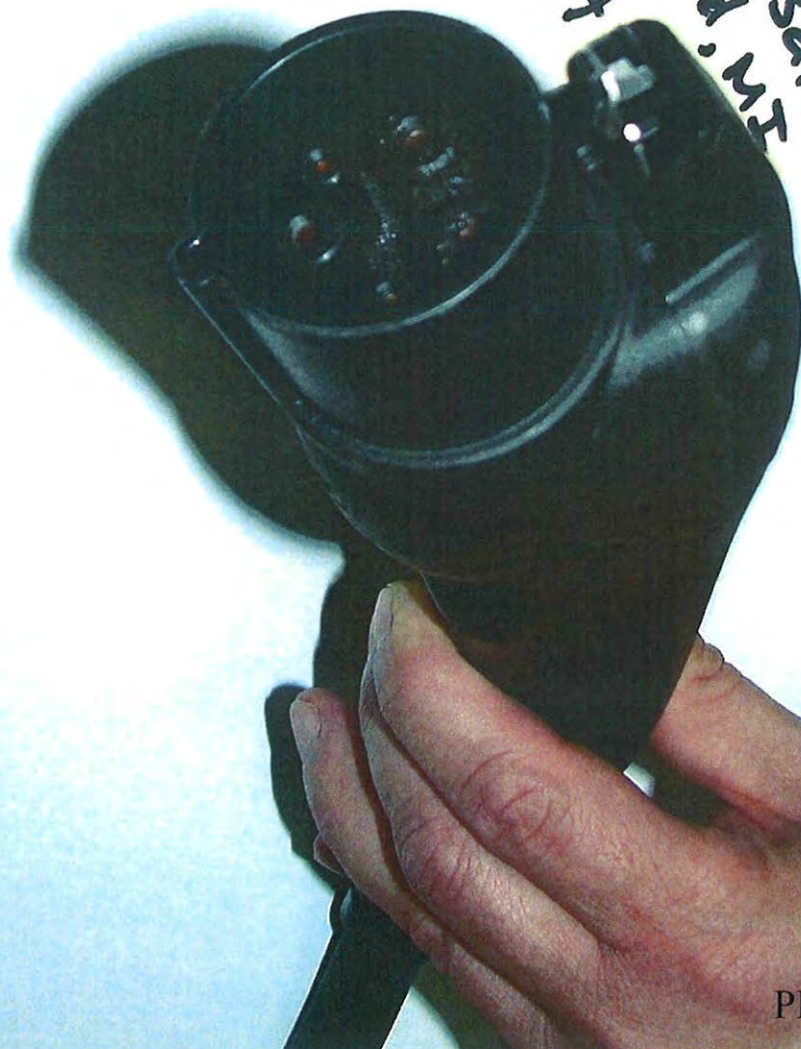
MELTED Nissan
Hartland, MI
5/23/14 #3

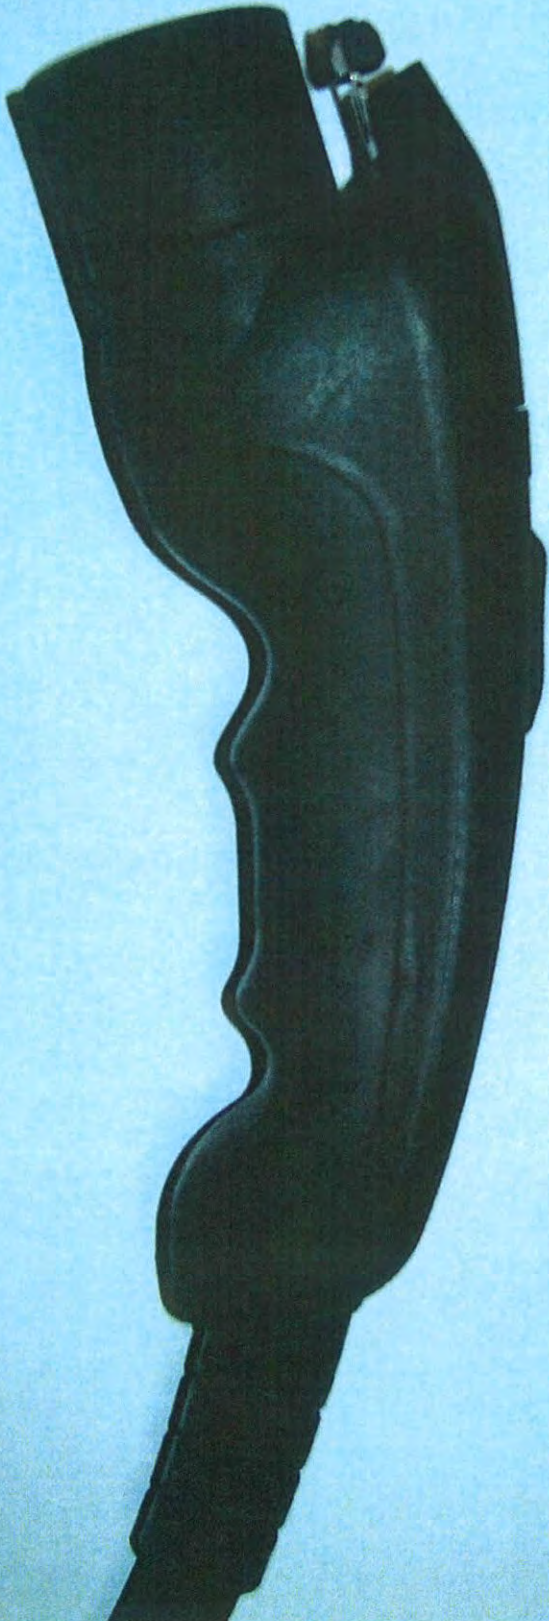
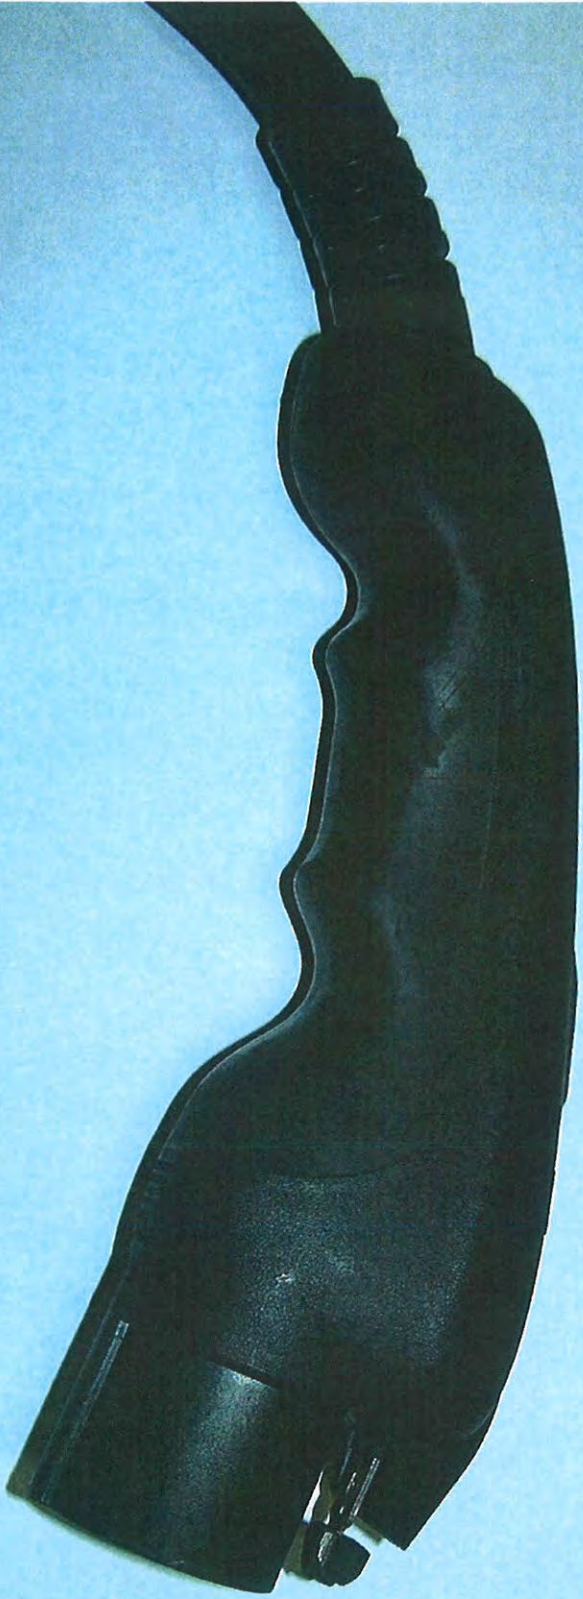
MELTED NISSAN
Hartland, MI
5/23/14 #3

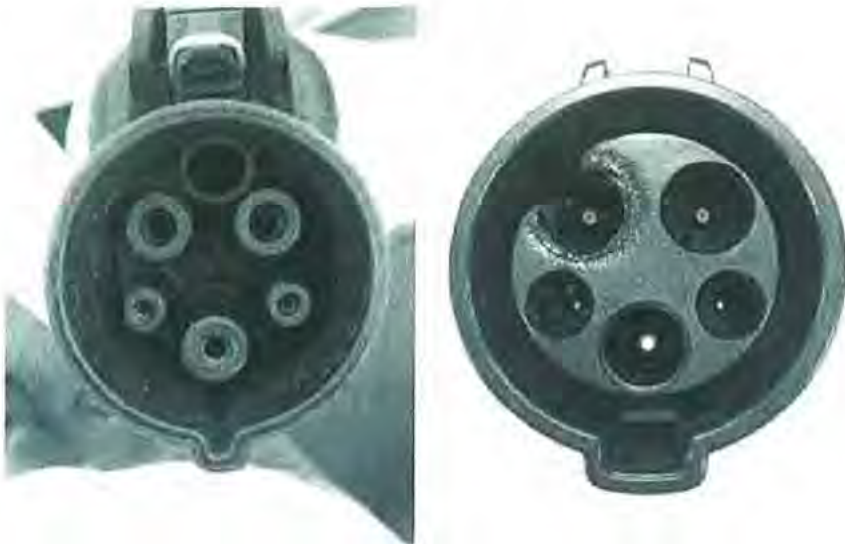
- The event has occurred twice on a single Tesla
- Each of the two events occurred on a different Bosch charger
- Each occurrence was in multi-hour charging session
- The customer has not used the adapter in multi-hour charging sessions at other chargers
- While the event did repeat, it is not deterministically repeatable (customer has completed other long-duration sessions on Bosch charger with the adapter without incident)
- The adapter itself is melted on the upper left of the left power pin, and that pin does not appear loose or mis-aligned (See pic)
- The J1772 Coupler was not melted in the incident (see pic)

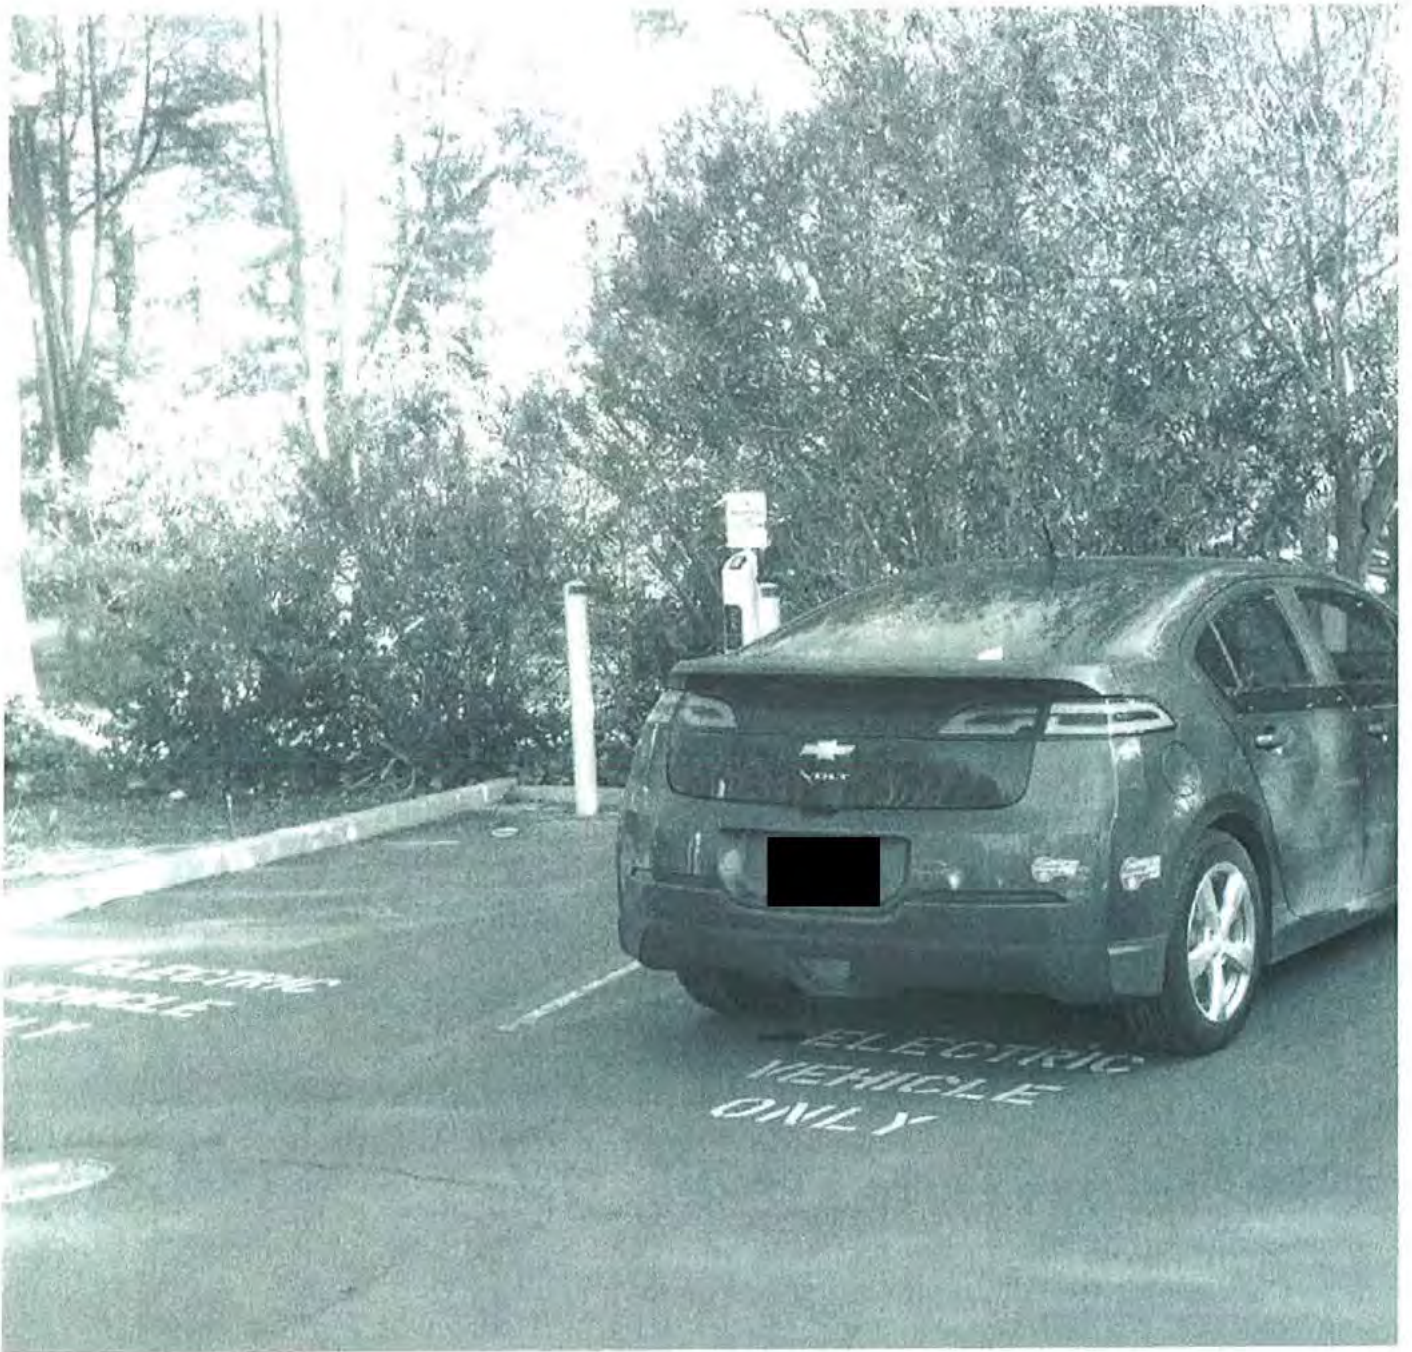
Pictured is David's Roadster, but this happened with my Model S. The arrow indicates which charger showed the problem.

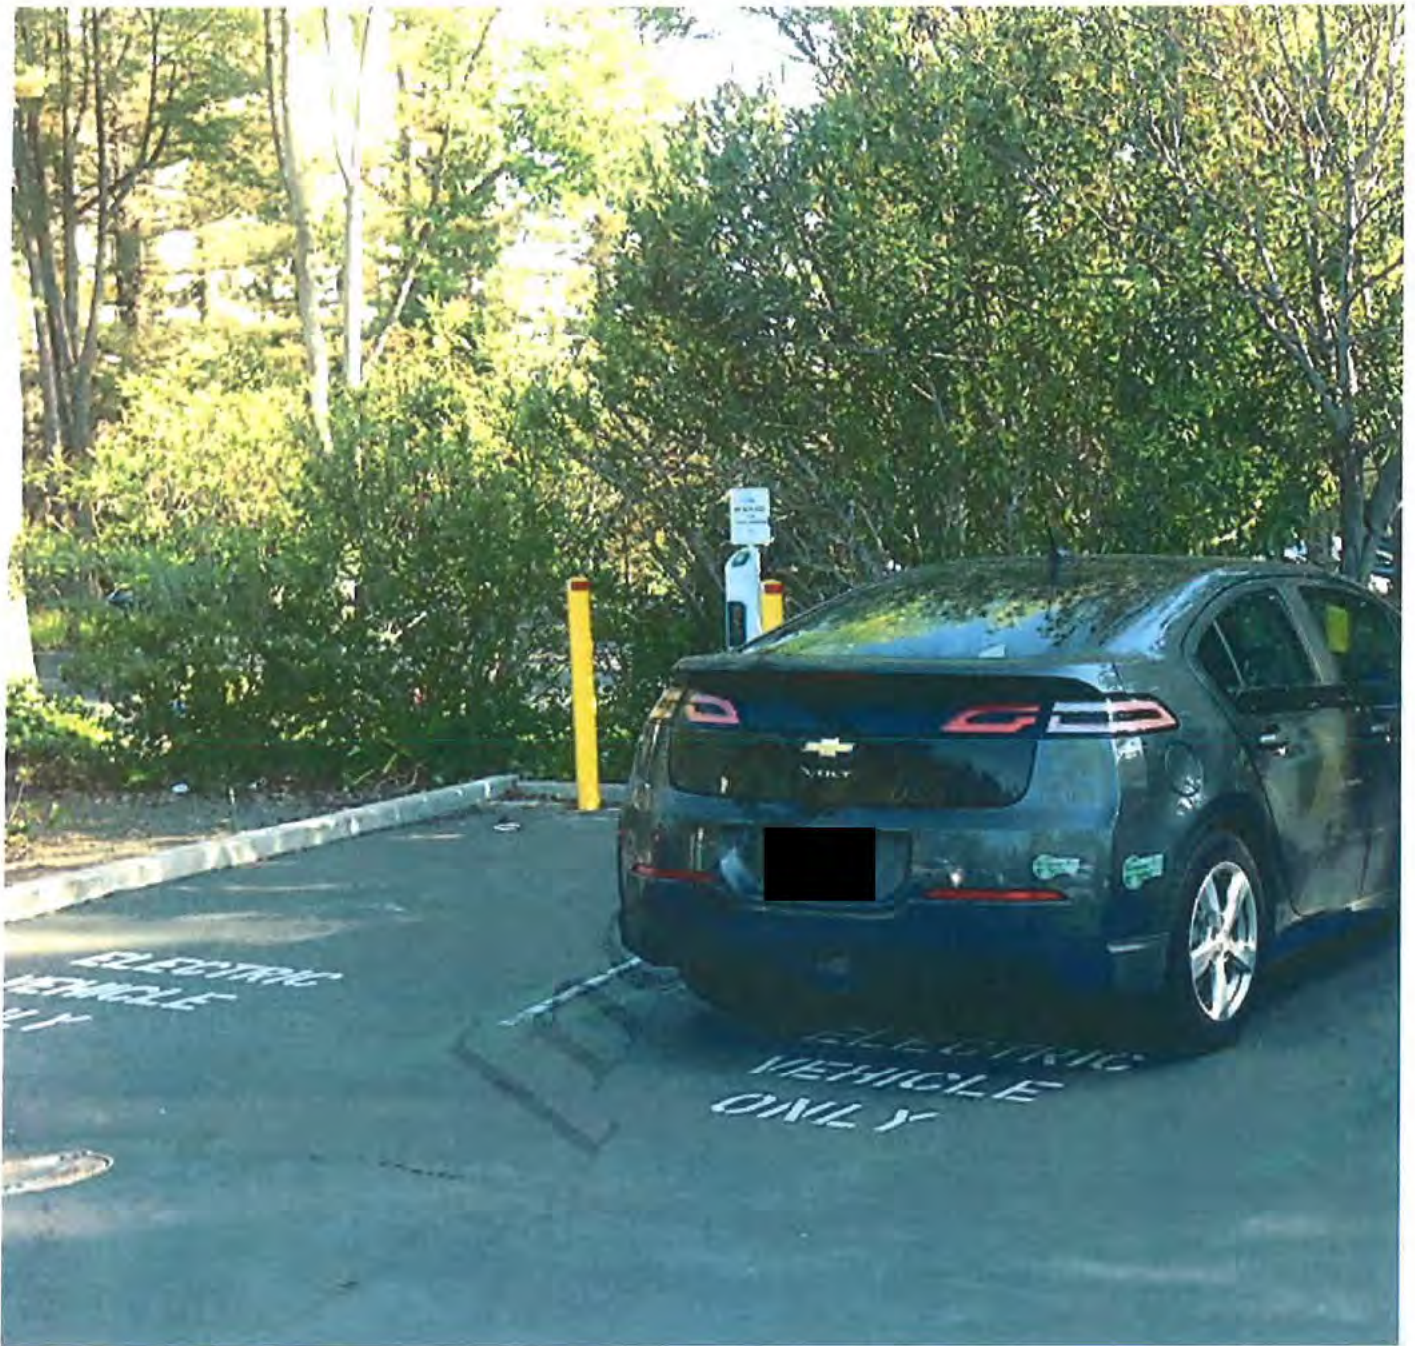
Pictured is [REDACTED] but this happened with my Model S. The arrow indicates which charger showed the problem.

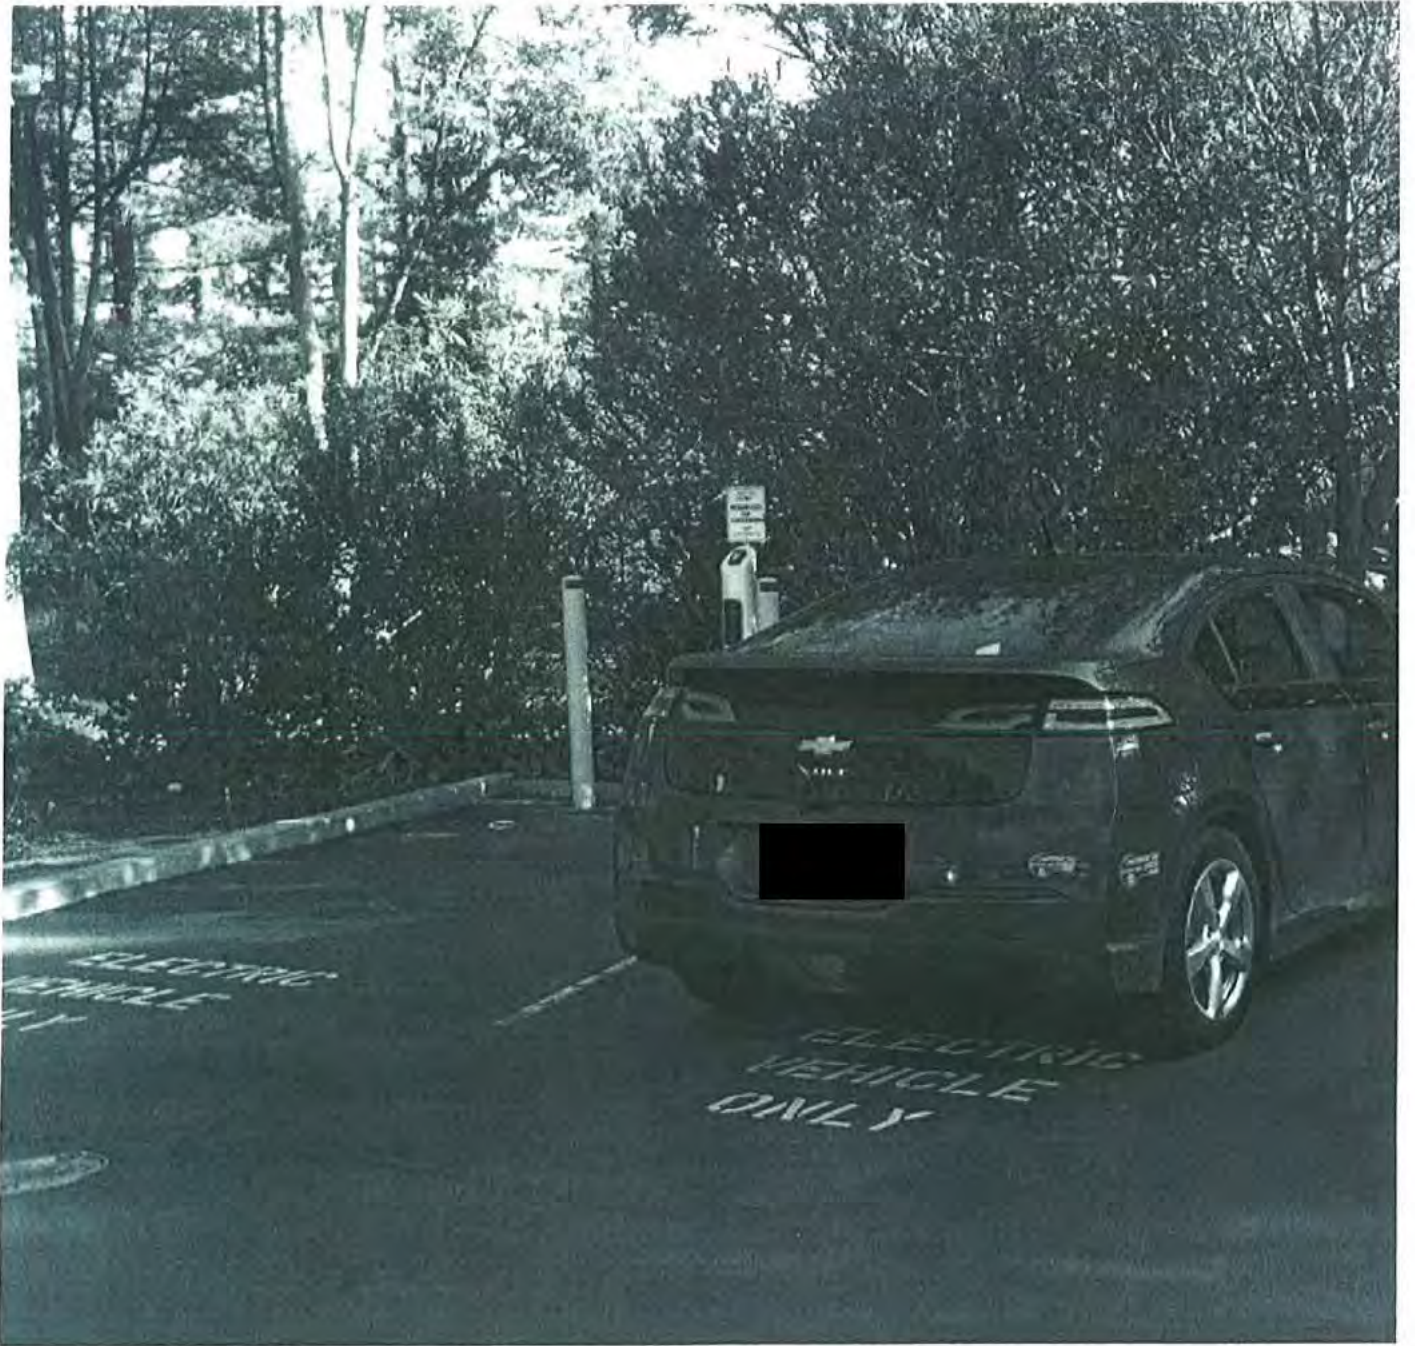
Pictured is [REDACTED] but this happened with my Model S. The arrow indicates which charger showed the problem.

[REDACTED]
As we discussed, I have shipped a replacement unit (rev 4 firmware with UART) to your installer. Tracking number is 1z4518850154 [REDACTED]. I included in the box a prepaid return shipping label to send the defective unit back so that we can perform a detailed engineering analysis. We will let you know of our findings when available.
