U.S. Department  
of Transportation

**National Highway  
Traffic Safety  
Administration**

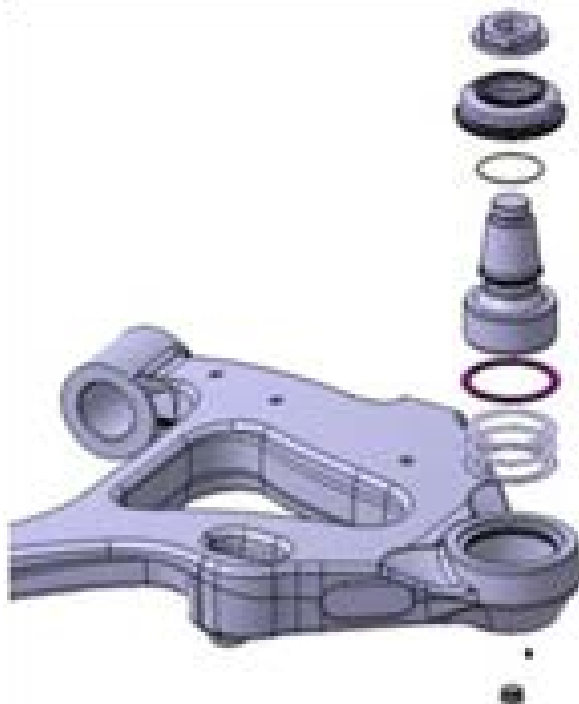
During the course of the investigation Pierce informed ODI that the TAK-4 suspension had been equipped with two different design ball joints since its inception. The first generation ball joint (Figure 2.) was installed on the subject vehicles from MY 2004 to MY 2013 and was designed to be serviceable. This design allowed maintenance personnel to adjust ball and socket endplay with stack-up shims. Starting MY 2014, a second generation ball joint was installed that implemented a sealed, pre lubricated, one piece, maintenance free design.

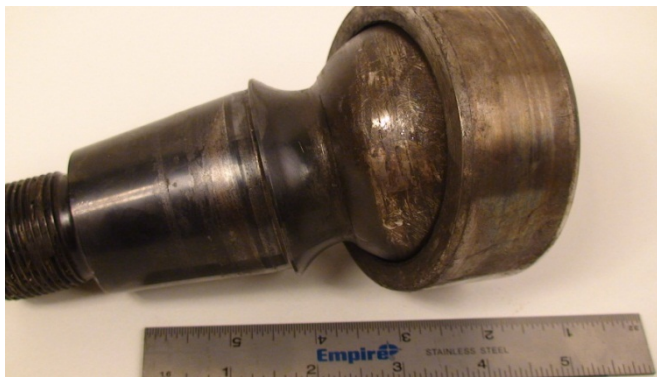
The photograph below (Figure 3) shows a first generation ball joint (removed from a subject vehicle) that demonstrates the premature wear that can result from a torn boot.
