Conditions Necessary to Create Elevated CO Levels Within the Cabin of the Subject Vehicles

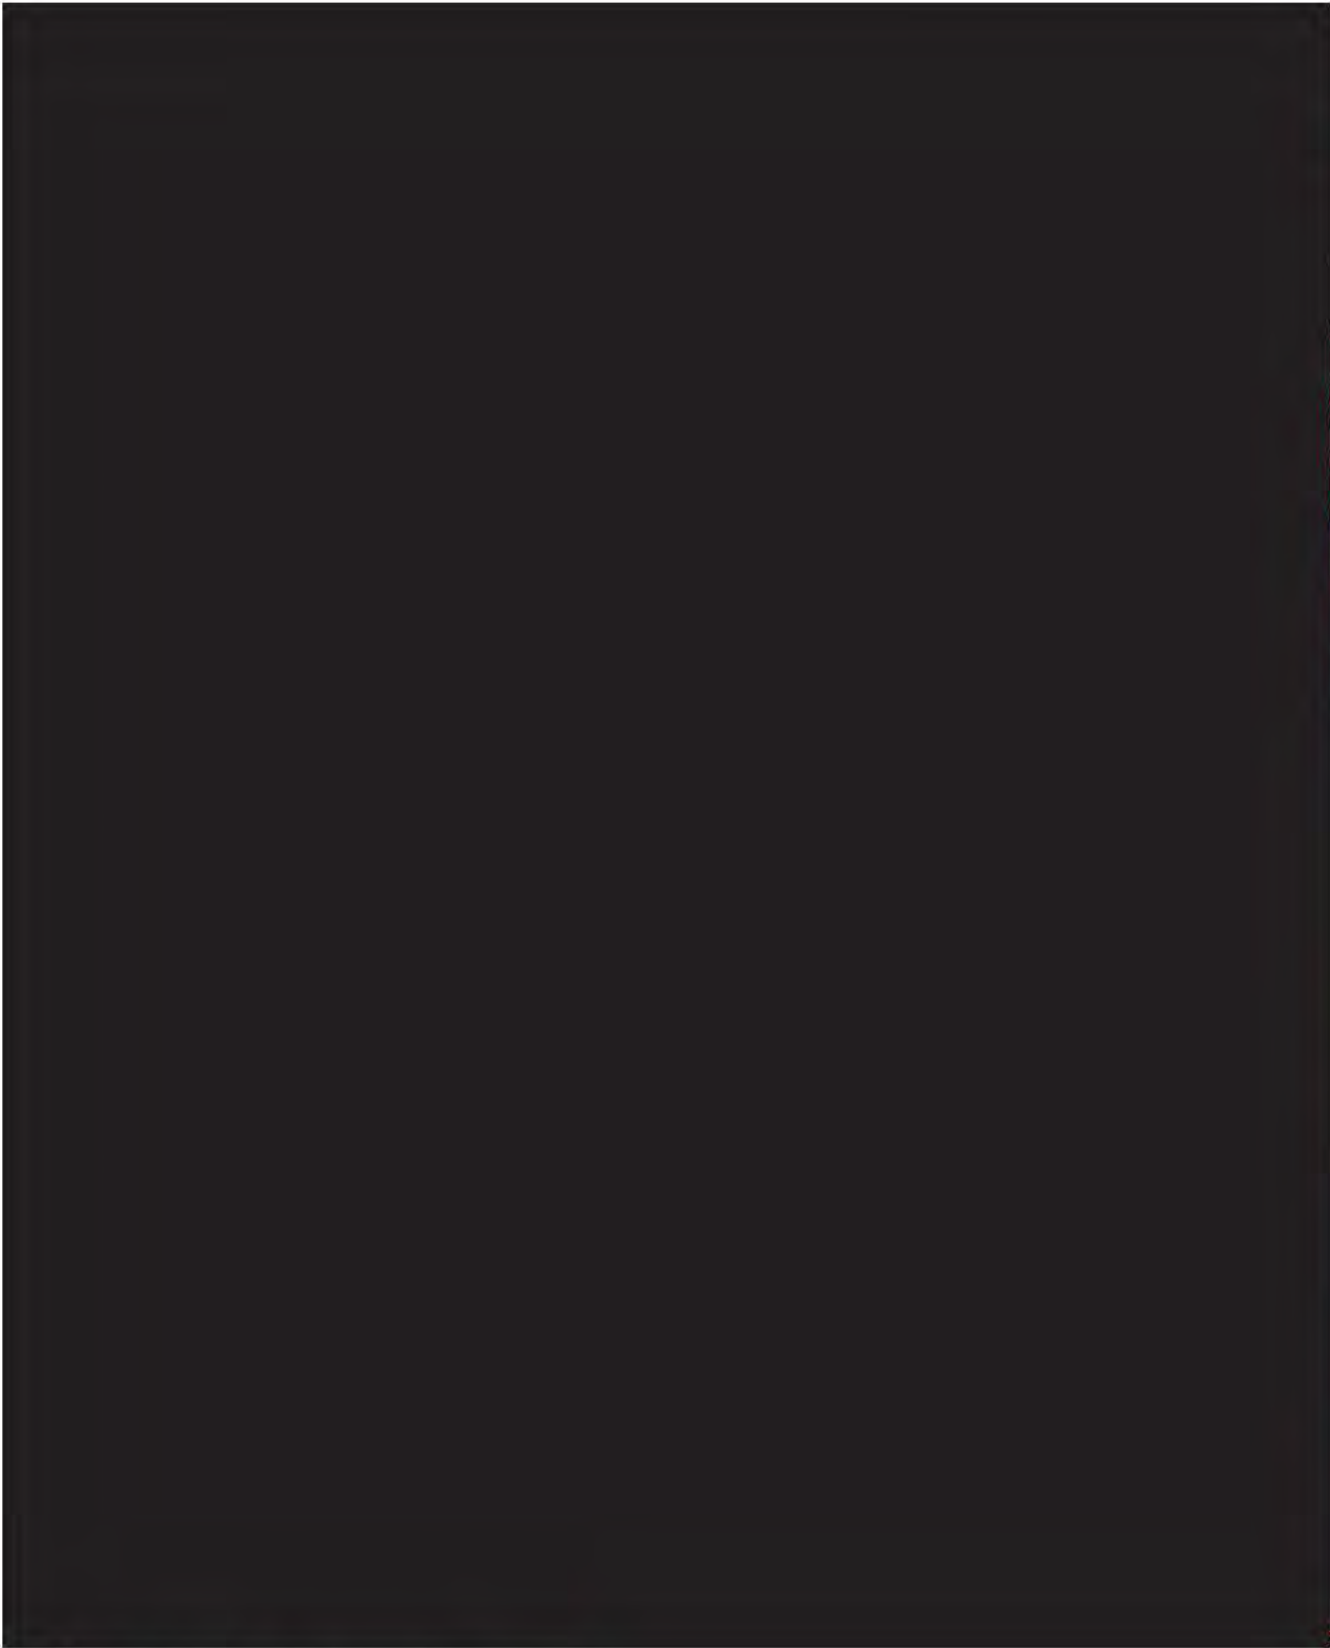
⁶ Similar SUVs will be discussed later in the report.
⁷ <https://www.youtube.com/watch?v=WYwiMhBXIL8>

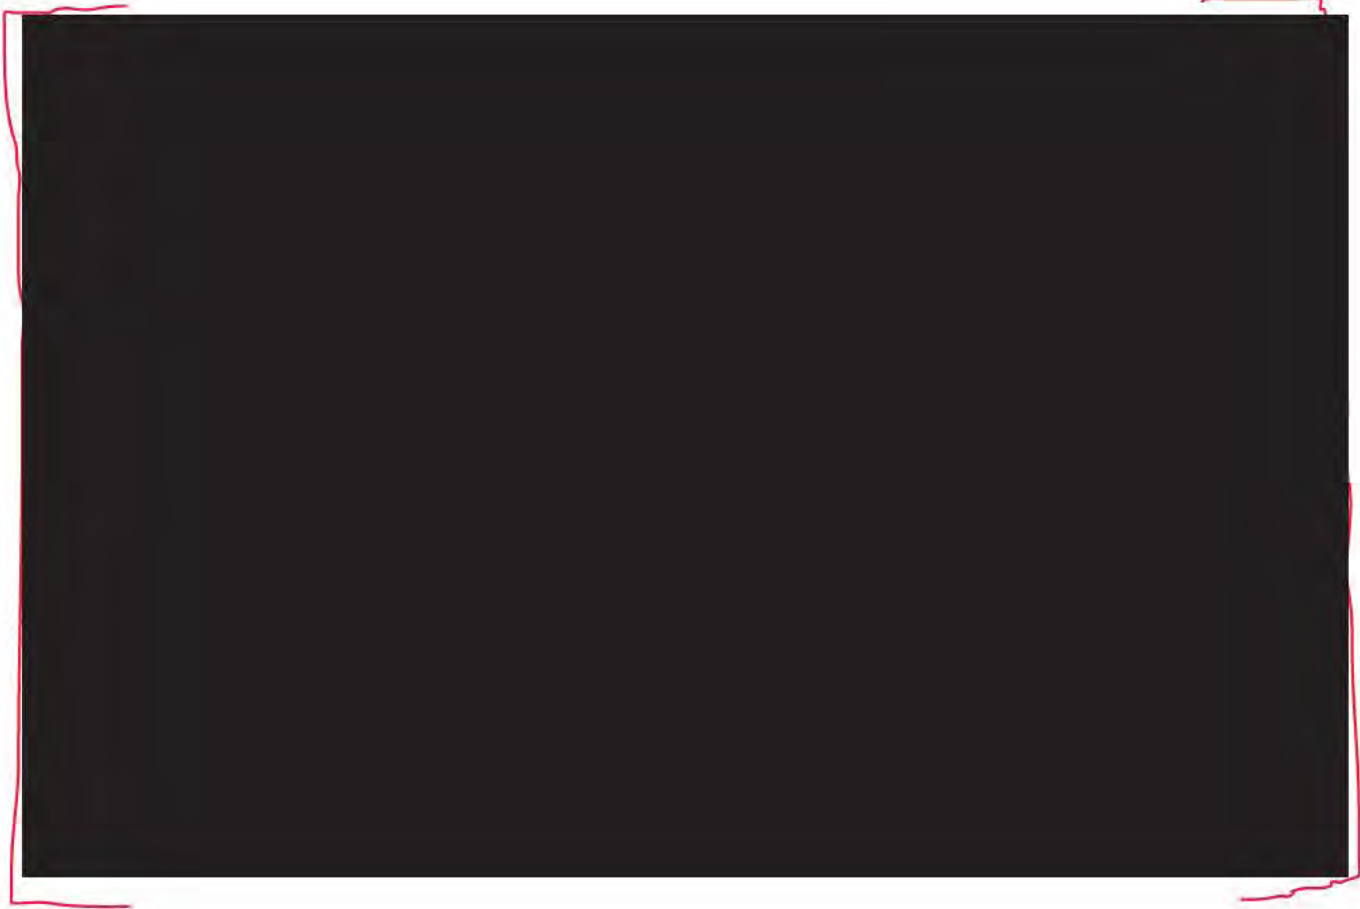
³⁹ Police Interceptor Utility vehicles have the characters "K8A" in positions 5-7 of the VIN.

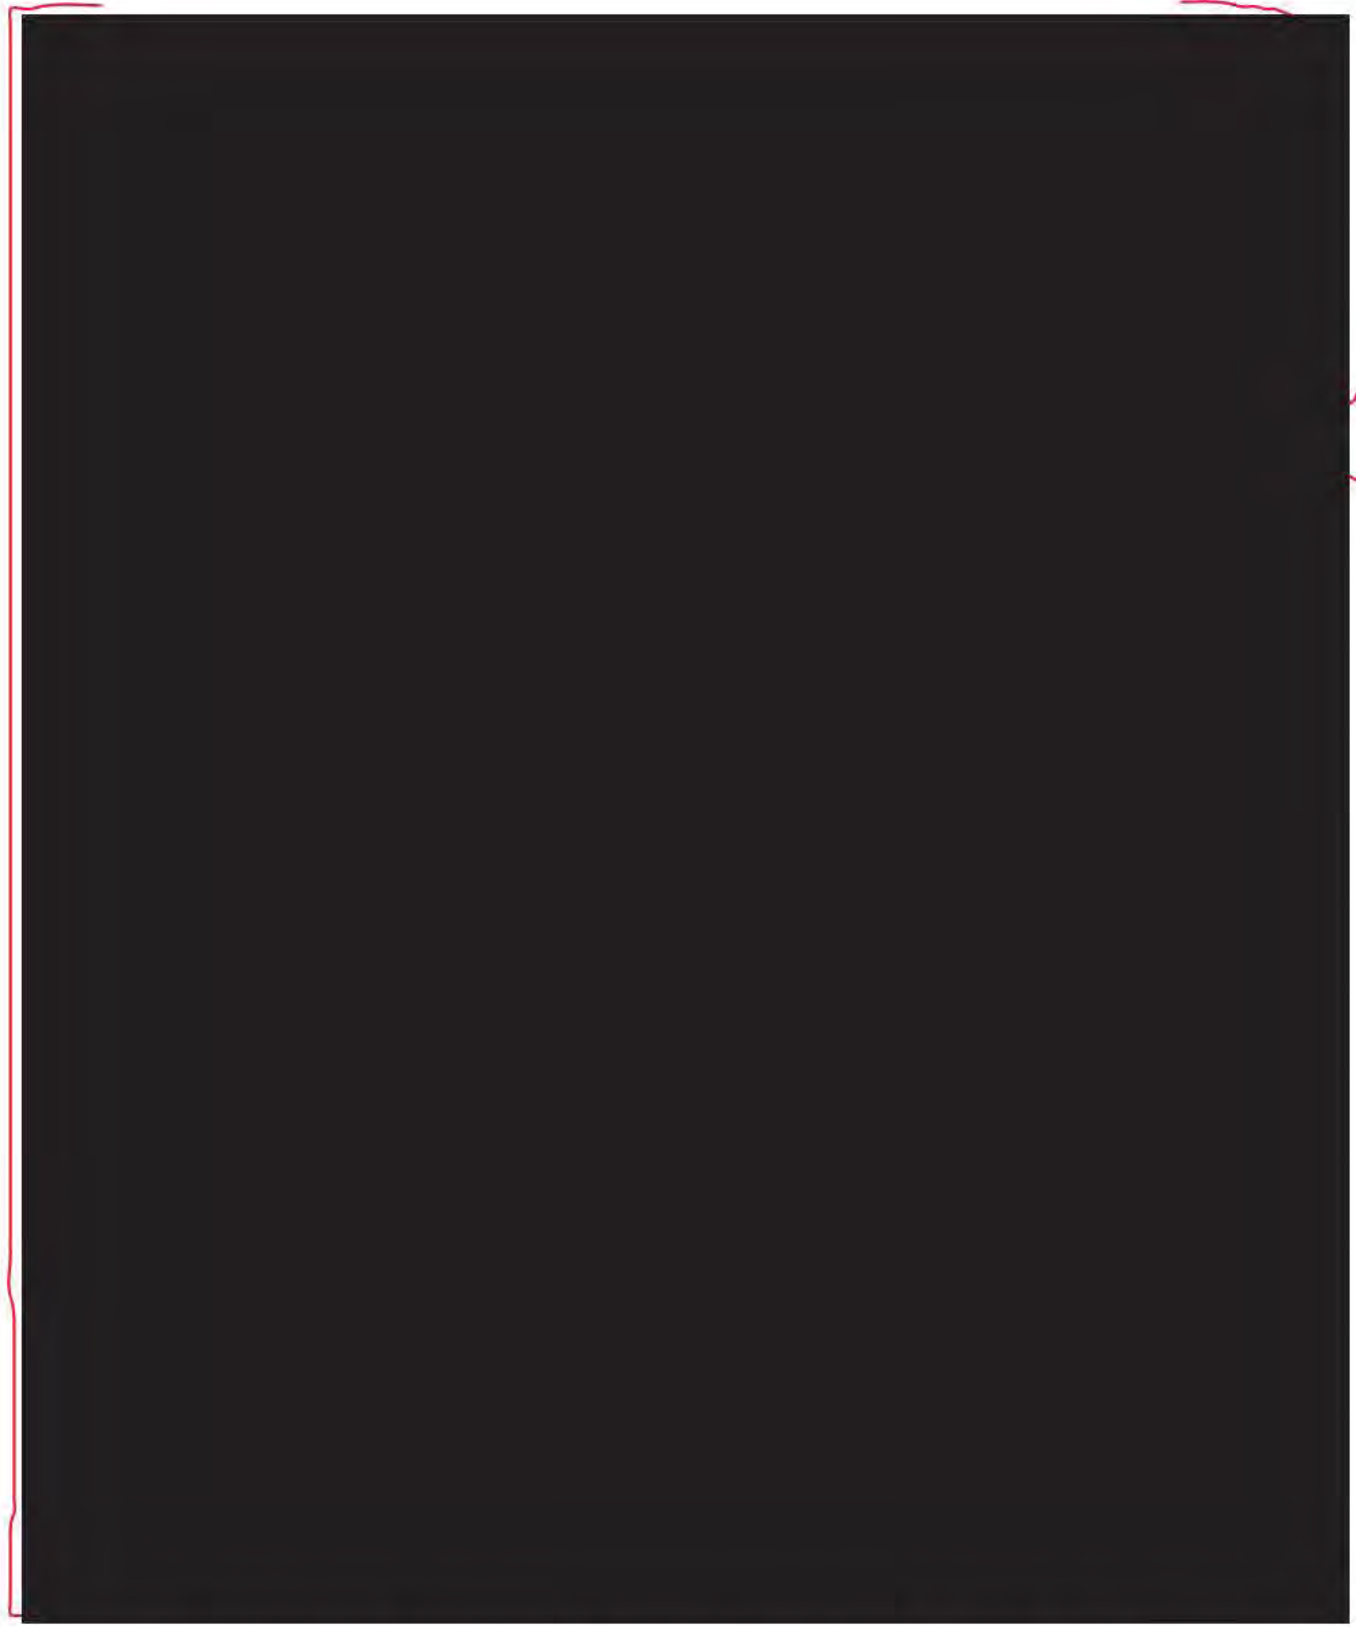
⁴⁰ The term “potentially relevant” is used because as discussed, not all the repairs identified by the search strategy related to exhaust odor/CO in the cabin from the Subject Concern. See Exhibit D for a further discussion.

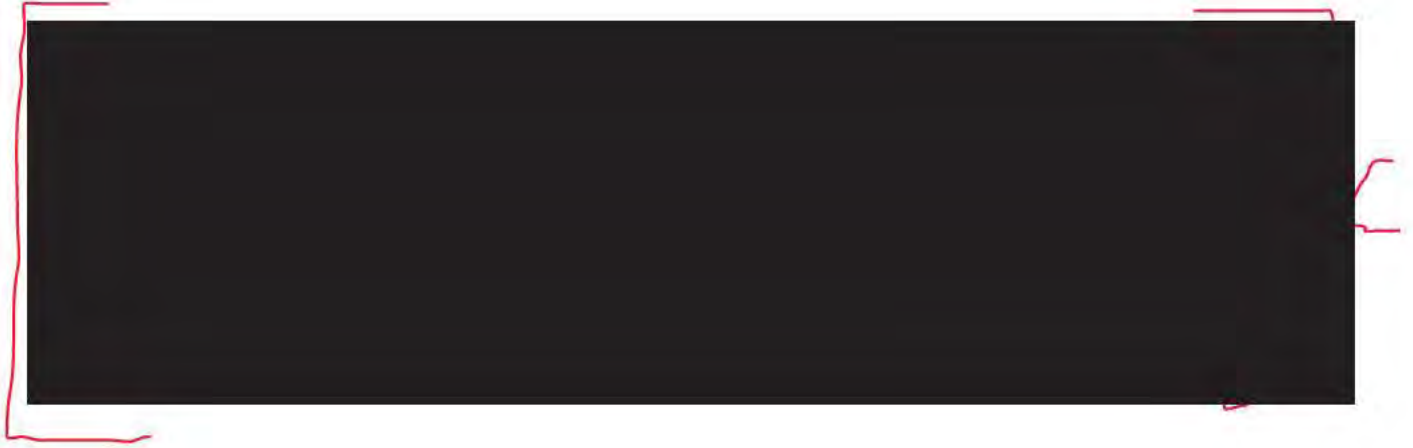
Experiences of the Three Named Plaintiffs

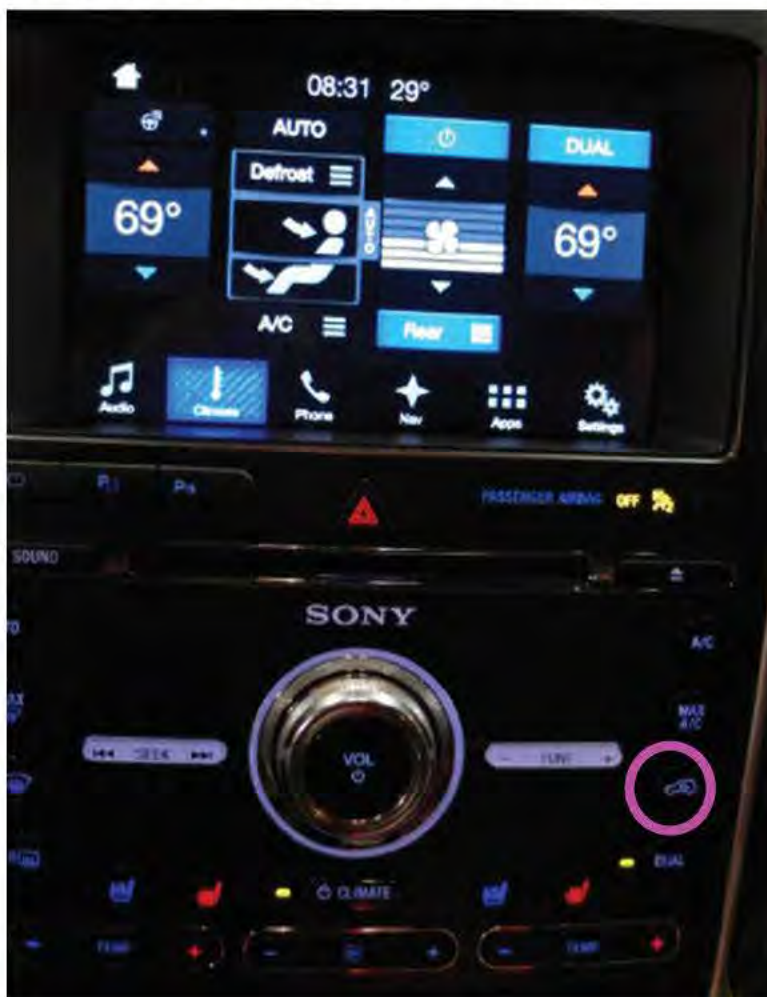
Figure 9. Settings of the ██████ HVAC system upon receipt of the vehicle.

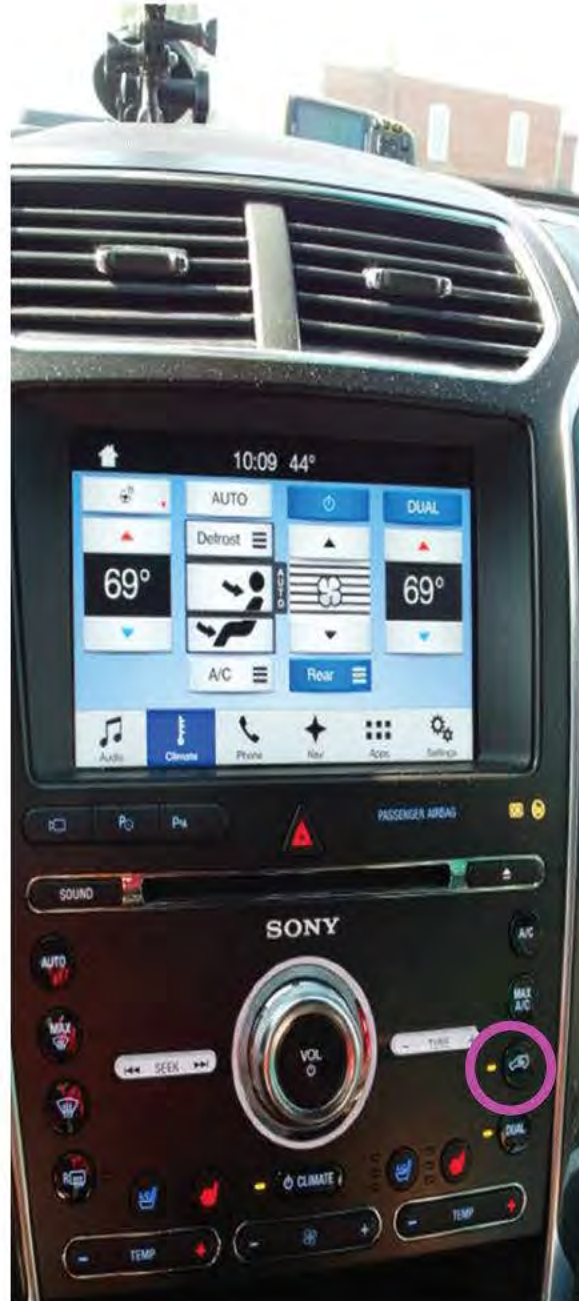
Figure 12. HVAC settings for the inbound trip showing Recirculation mode and full fan speed.

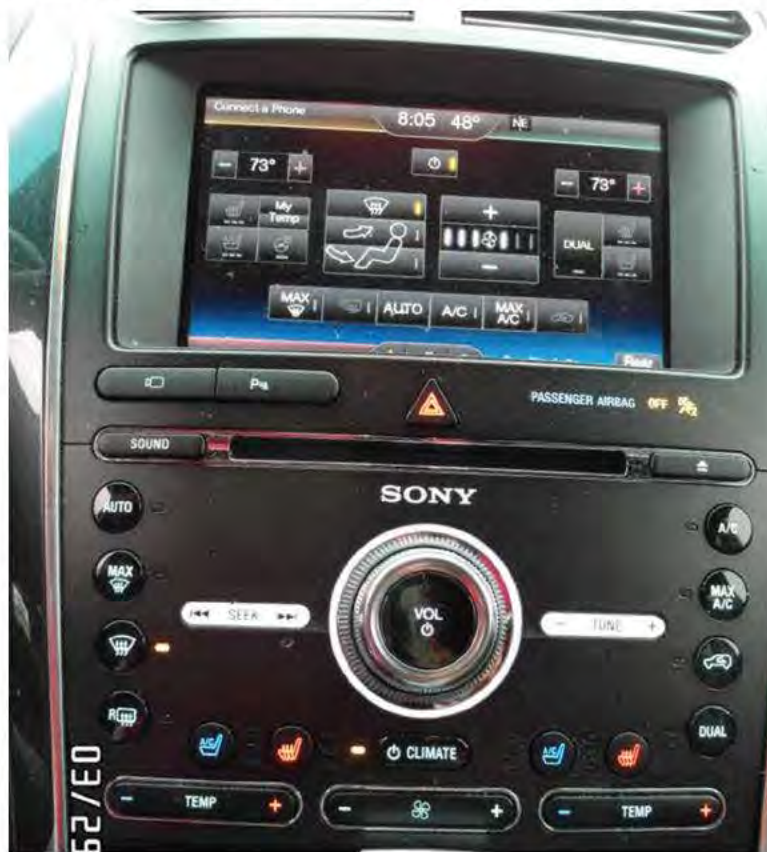
Figure 13. HVAC settings on the [REDACTED] vehicle as received.

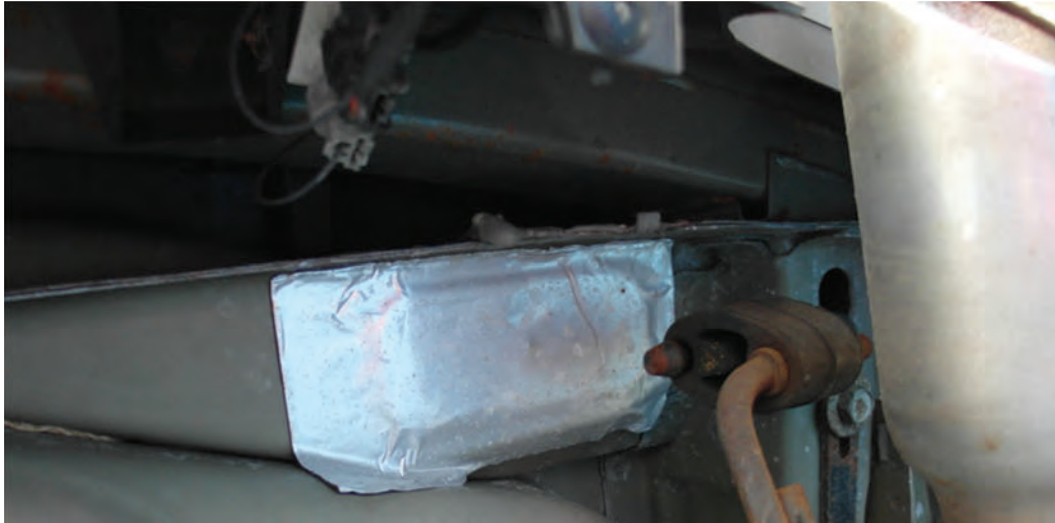
Figure 14. Mastic patch applied to underside of Explorer as part of CSP 17N03 repairs.

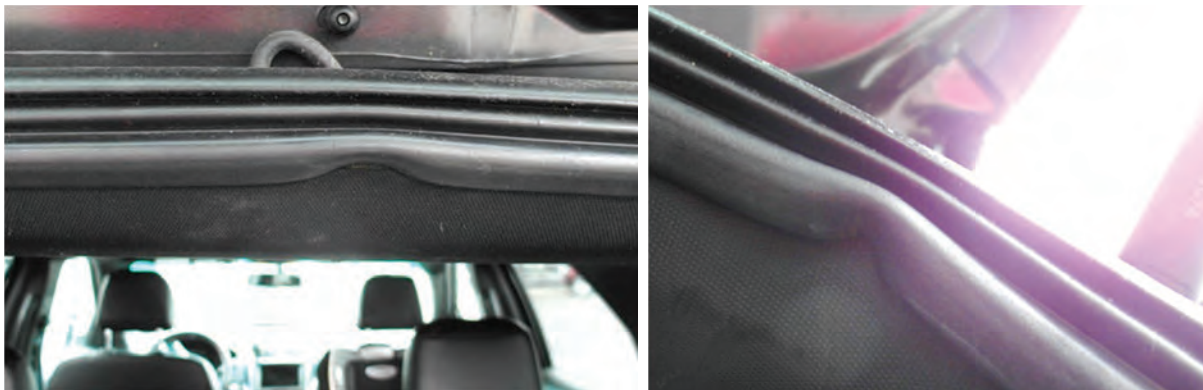
Figure 15. Two locations where the liftgate seal was not properly in position.

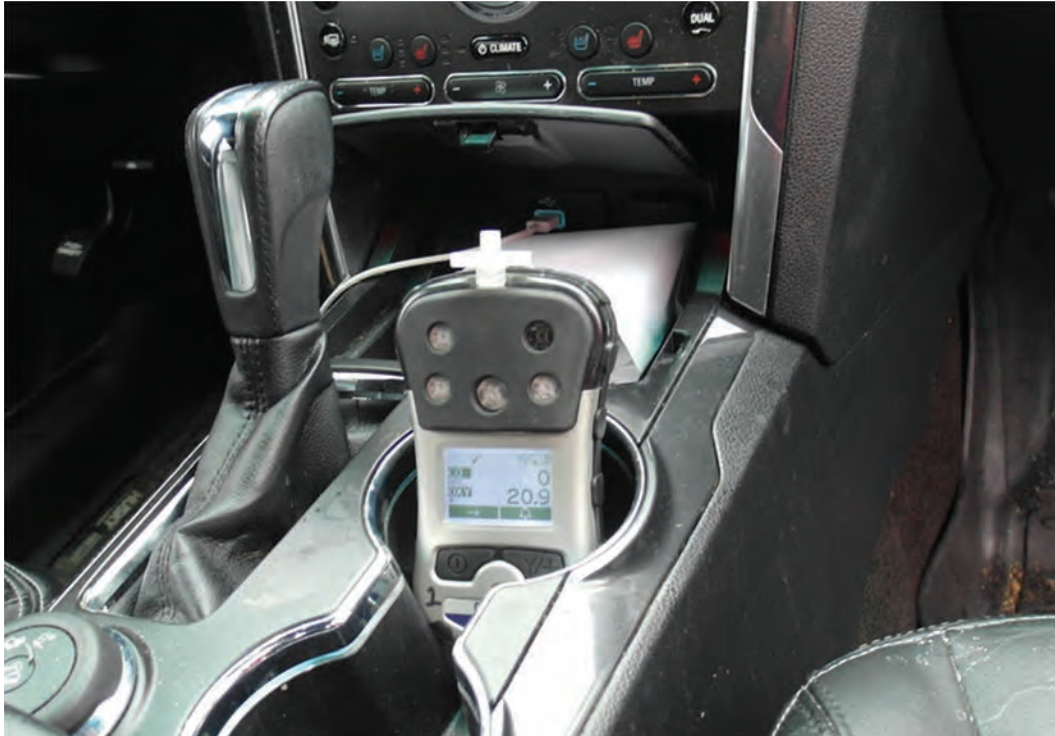
Figure 16. Location of the front CO sensor.

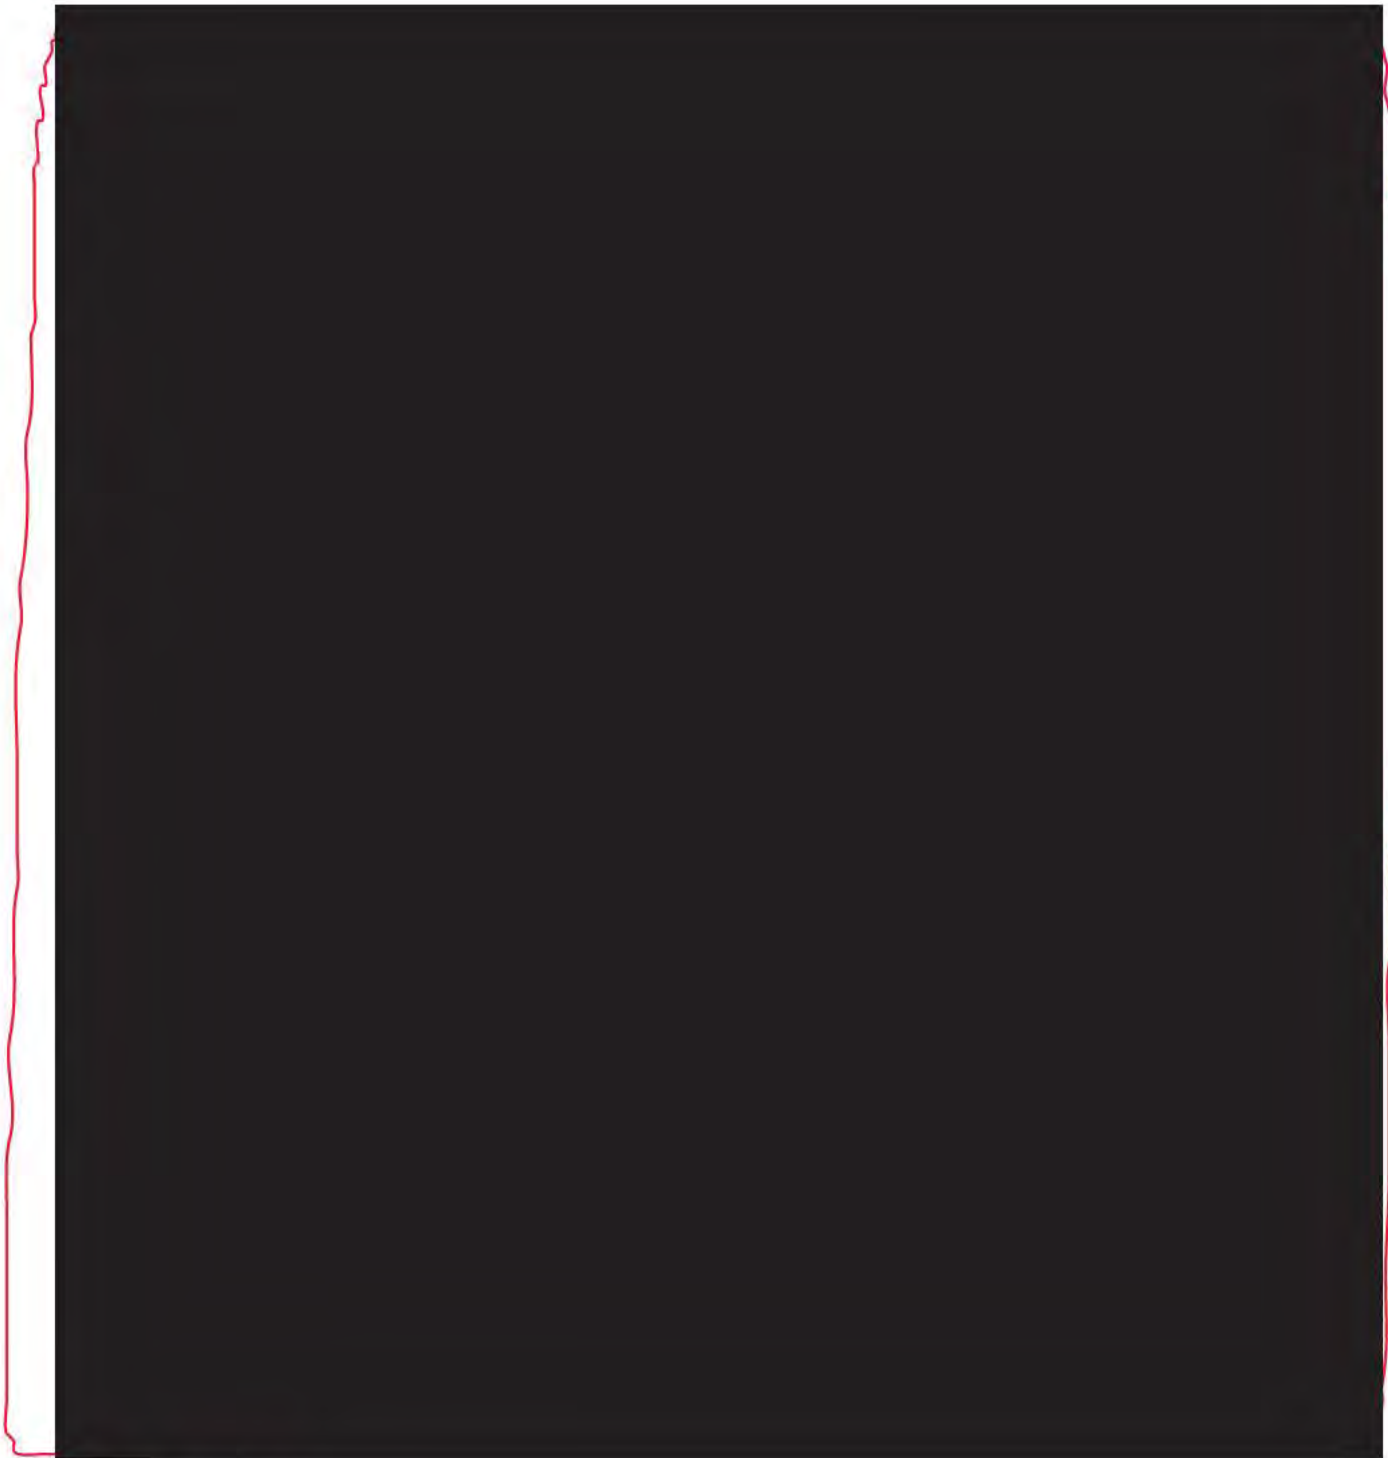
¹³² Galastis report, Exhibit 3C.
