Driveline Maintenance Tips

REFERENCE BOOK AND TECH NEWS
December 2015

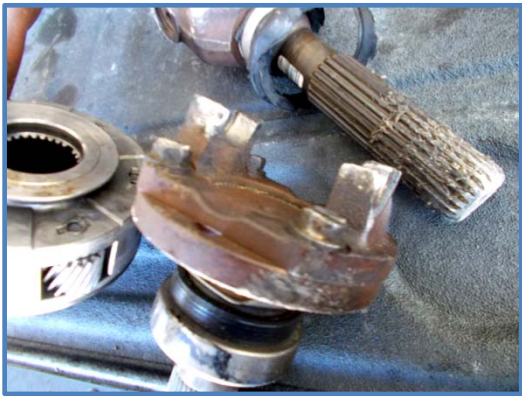
Figure 1: Expensive, broken universal joint

The first lesson addresses a maintenance issue with some Ram 2500 through 5500, four-wheel drive universal joints. This is a case where skipping a small maintenance task can cause some very expensive damage (Figure 1).

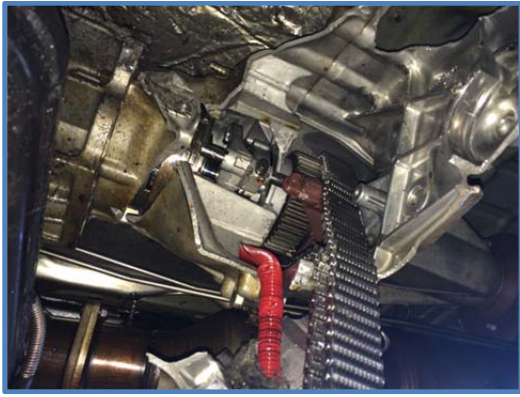
Recently, there has been an increase in failures of the double cardan universal joints (“u-joints”) on certain heavy-duty Ram’s front drive shafts. In some cases, catastrophic failures have caused extensive damage to vehicles and tremendous customer dissatisfaction. Failures at highway speeds may damage the transfer case, front driveshaft and axle, and the floor pan, leading to repair costs approaching \$20,000 (Figure 2).

Figure 2: Destroyed transfer case

The root- cause of the u-joint failures is a lack of lubrication. The u-joints are simply overlooked during scheduled maintenance; and, as the affected trucks get older, more failures are showing up.

- 2003 through 2013 heavy-duty, four-wheel drive Rams do not use front axle disconnects. Therefore, the front driveshaft always spins when the vehicle is moving.
- The increased ride height (from 2007 on) leads to a more severe working angle, which further stresses the u-joints.
- Failures are more common on fleet vehicles.

Proper maintenance can prevent failure of the u-joints. Lubricate all double cardan joints at every oil change using Mopar type MS-6560 lithium based grease or an equivalent. Lubrication requirements are detailed in service information and the owners' manual. Also, there is a reminder sticker on the left front fender.

To reduce future failures, inspect the double cardan joints and the transfer case (near the front output shaft) during service, because vibration from a failing u-joint can induce stress cracks in this area. In addition, failing u-joints may show signs of distress, including gaps in the bearing area, and rusty powder on the yoke surfaces.

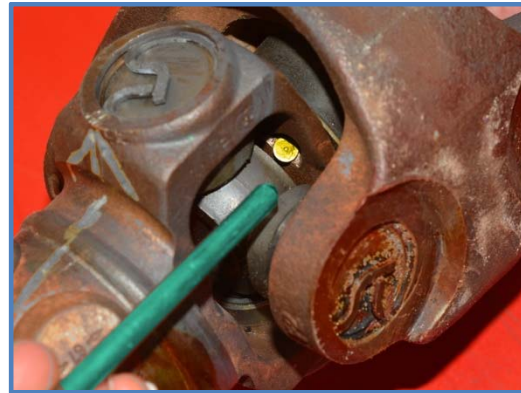
Many u-joints use “flush” or “midget” fittings, which require using a needle adaptor, while other units are equipped with conventional Zerk fittings (Figure 3).

Figure 3: Grease needle and flush fitting

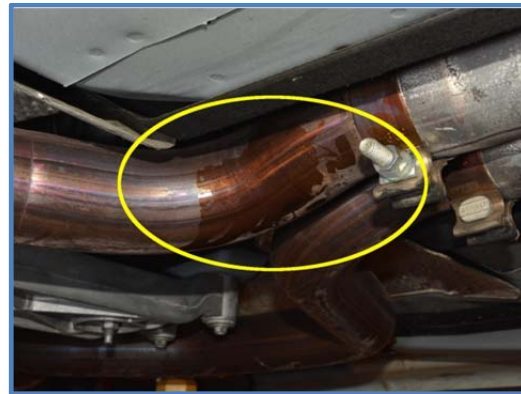
If a driveline unit is overfilled, lubricant may spray out of the vent. If it sprays on a hot exhaust system, it will smoke, smell, and could possibly ignite (Figure 6). Also, lubricant may be forced out of the seals.

Figure 6: Lubricant on exhaust pipe

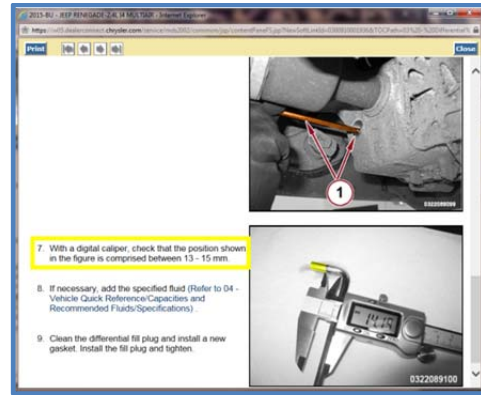
Also, checking the level requires following a very strict procedure; and the unit is NOT filled to the bottom of the inspection plug (Figure 9).

Figure 9: Special level check from service information

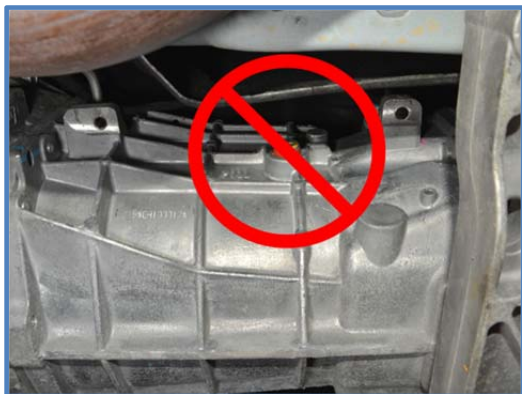
Figure 12: Do not remove the "level" plug!

The Hellcat TR6060 has a fill/level check plug, but the plug is useless on the cooler equipped version of this transmission. If the plug is removed, and fluid is allowed to drop to the level of the hole, the transmission will be under filled by about 20% (Figure 12).

As discussed earlier, under filled transmissions fail, probably starting with a destroyed second gear, causing very unhappy customers.

Since there is no way to check the fluid level, the only way to verify the amount of fluid is to drain and refill the transmission. The transmission cannot be "topped-off." To ensure the correct fill level:

- Consult the newly updated procedure in service information, which explains how to drain and purge the transmission, cooler, and lines, using low-pressure compressed air.
- Measure out the correct amount of ATF+4.
- Remove the upper cooler line from the transmission.
- Use a suitable transfer pump to fill the transmission through the upper cooler line fitting.
- Reinstall the transmission line.
