STAR CENTER NEWS

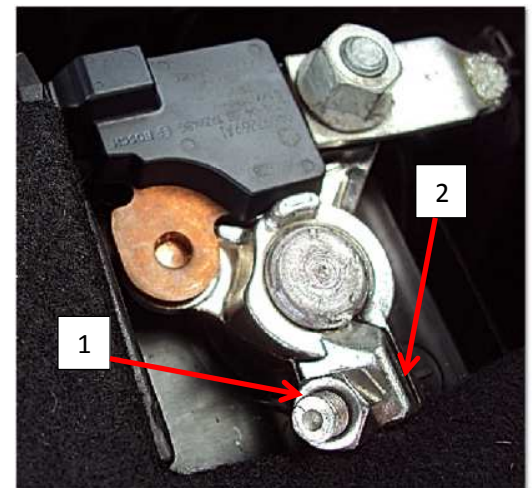
Due to incidences of damage to the IBS module occurring during the performance of service procedures, please be sure to adhere to the following recommendations when removing and installing the negative battery cable/IBD module.

1. Loosen M6 captive hex nut (1) without removing.
2. Insert medium-sized flat end of screwdriver in pole clamp slot (2).
3. Lightly tap screwdriver to open pole clamp slot to 3mm max.
4. Carefully lift IBS module upward to remove it from the negative battery post.

1. Place IBS module onto negative battery post and push down to ensure it is properly seated.
2. While applying downward force (20N max) on IBS module to prevent rotation, tighten M6 captive hex nut to 7Nm +/- 1Nm.

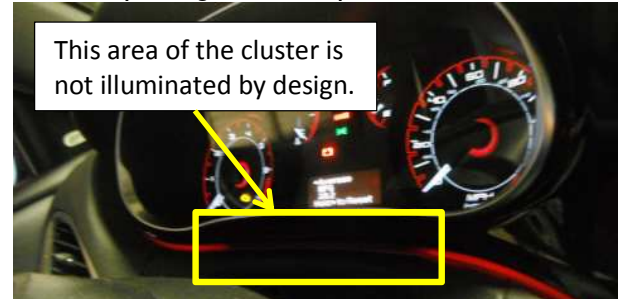
The lighted feature on the cluster bezel for the PF is not lit in the area above the steering wheel shroud by design (area in yellow below).

If a customer notes this, explain that it is by design intent and that all Darts equipped with the lighted bezel feature have this appearance. Comparison to another PF that is similarly equipped may be helpful.

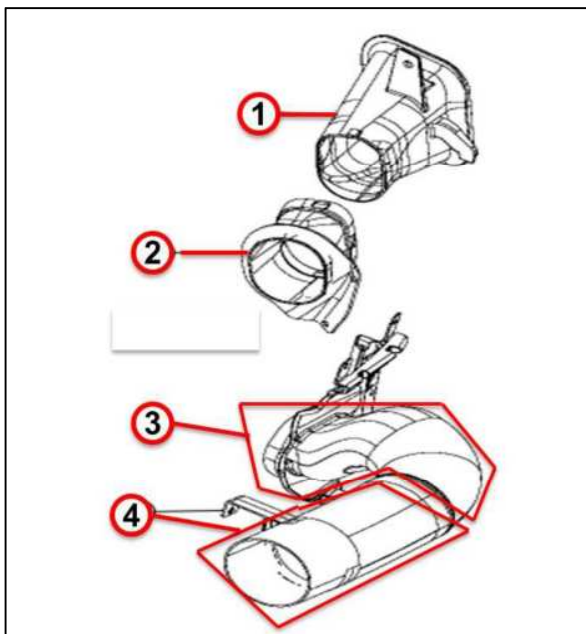
Some customers may experience a premature "Service Air Filter" message displayed on the EVIC. The mil may also be illuminated when this occurs. If the MIL is on, fault code P2280 - AIR FLOW RESTRICTION / LEAK BETWEEN AIR CLEANER AND MAF is likely to be set in the PCM. This condition may occur on vehicles with relatively low mileage.

The message in the EVIC as well as the DTC is intended to inform that the air filter has become restricted, requiring replacement. However, other inlet restrictions may also trigger the message and fault. Other possible causes are:

1. Debris blocking the Air Inlet Adapter or Ambient Air Duct (1) and (2).
2. Blocked air intake shield plastic tube (3).
3. Collapsed air intake shield porous tube (4).

Before replacing the air filter, make sure to remove the inlet shield ducting (3 and 4) to the lower portion of the air box.

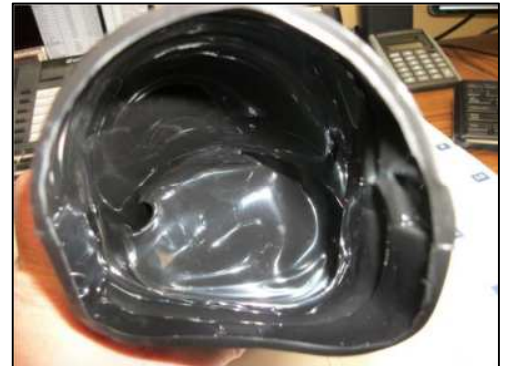
Inspect for signs of flashing material in the air intake shield plastic tube (3) (see photo below).

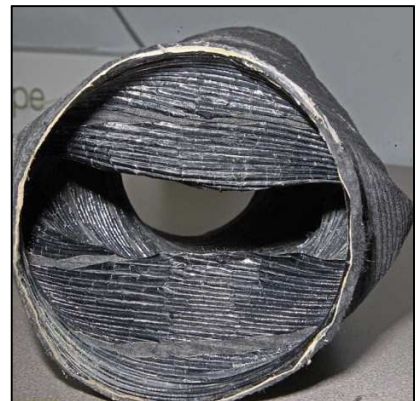
Also inspect for a collapsed air intake shield porous tube (4) (if equipped) (see photo below).

If both pieces have no problem found, replace the air filter.

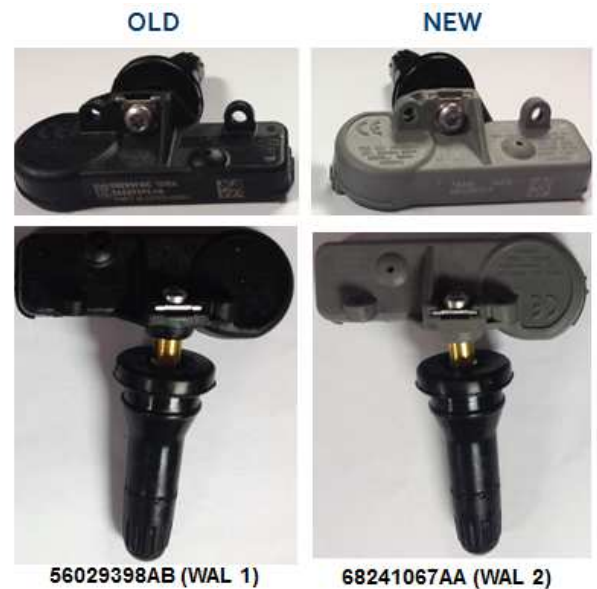
The old sensor, a Schrader WAL I model, is black. The new sensor, a Schrader WAL II, appears identical in shape to the WAL I but is colored gray to distinguish it from the old sensor.

New MY2016 production will use the new gray sensor and, as Mopar inventories are depleted, the gray sensor (68241067AB) should be ordered and used in place of the black sensor (56029398AB). Please, always refer to STAR PARTS to check for part supersedence. There is no change in installation procedures and the new sensor is interchangeable with the old sensor. Gray and black sensors can be mixed on the same vehicle. All four wheels do not need to use the same color sensor.

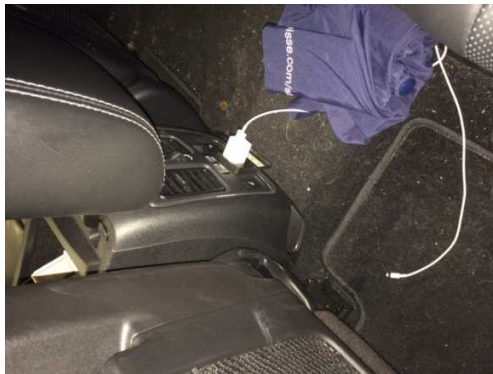
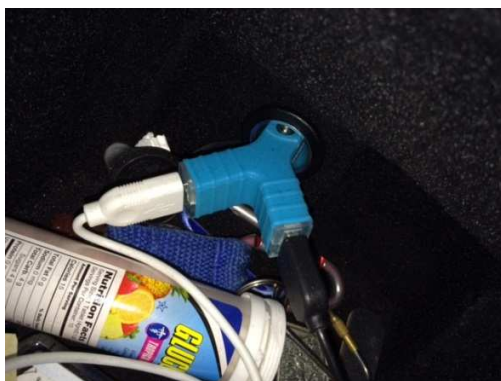
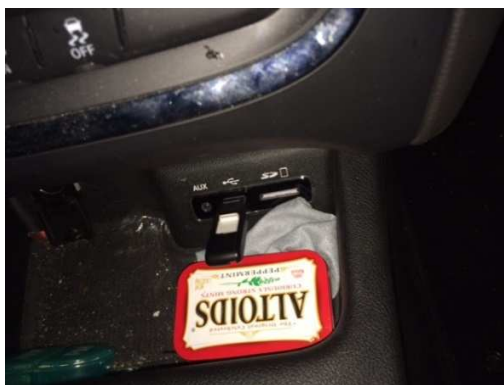
Our field technicians have been experiencing intermittent problems, ranging from the RKE not working to the Keyless Go indicating “KEY HAS LEFT THE VEHICLE”, that are being caused by RFI from various charging and USB interface devices for portable electronics.

Examples of such devices are displayed below:

Depending on the system involved, these devices can generate a strong enough RFI signal in the various send and receive frequency bands.

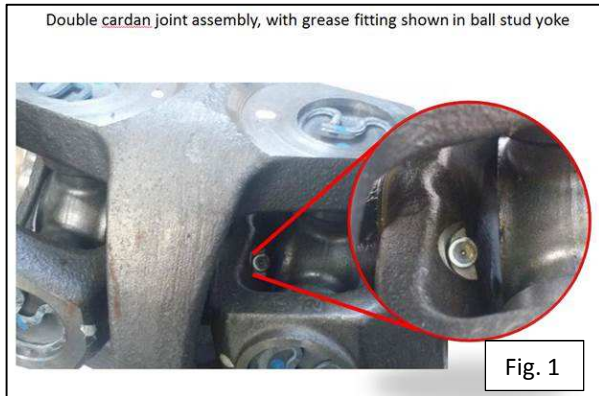
The assembly has a small grease fitting in the middle of the joint (Fig. 1).

The fitting on the joint is not the typical Zerk fitting that is common on front suspension components.

The fitting is actually a conical depression in the joint that has a small steel check ball at the bottom.

As a reminder, these double cardan joints require lubrication periodically.

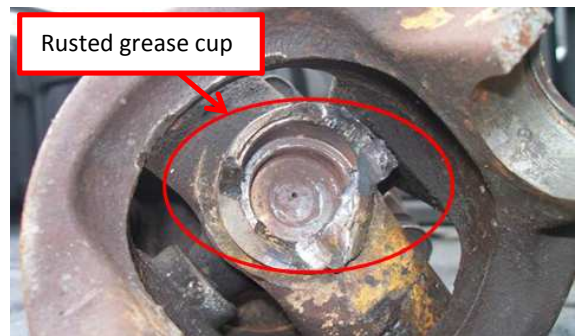
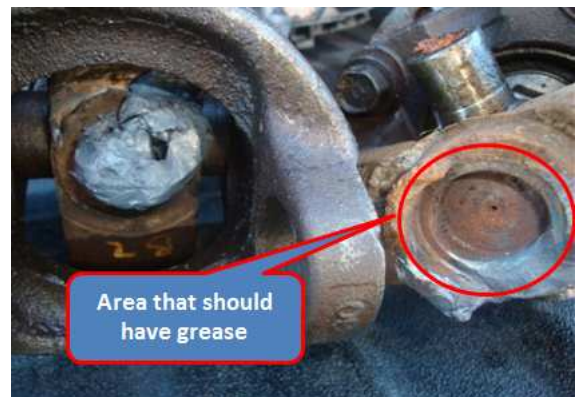
As pictured below, failure to lubricate this joint may lead to premature front propeller shaft joint wear and failure.
