Analysis of EDR Data

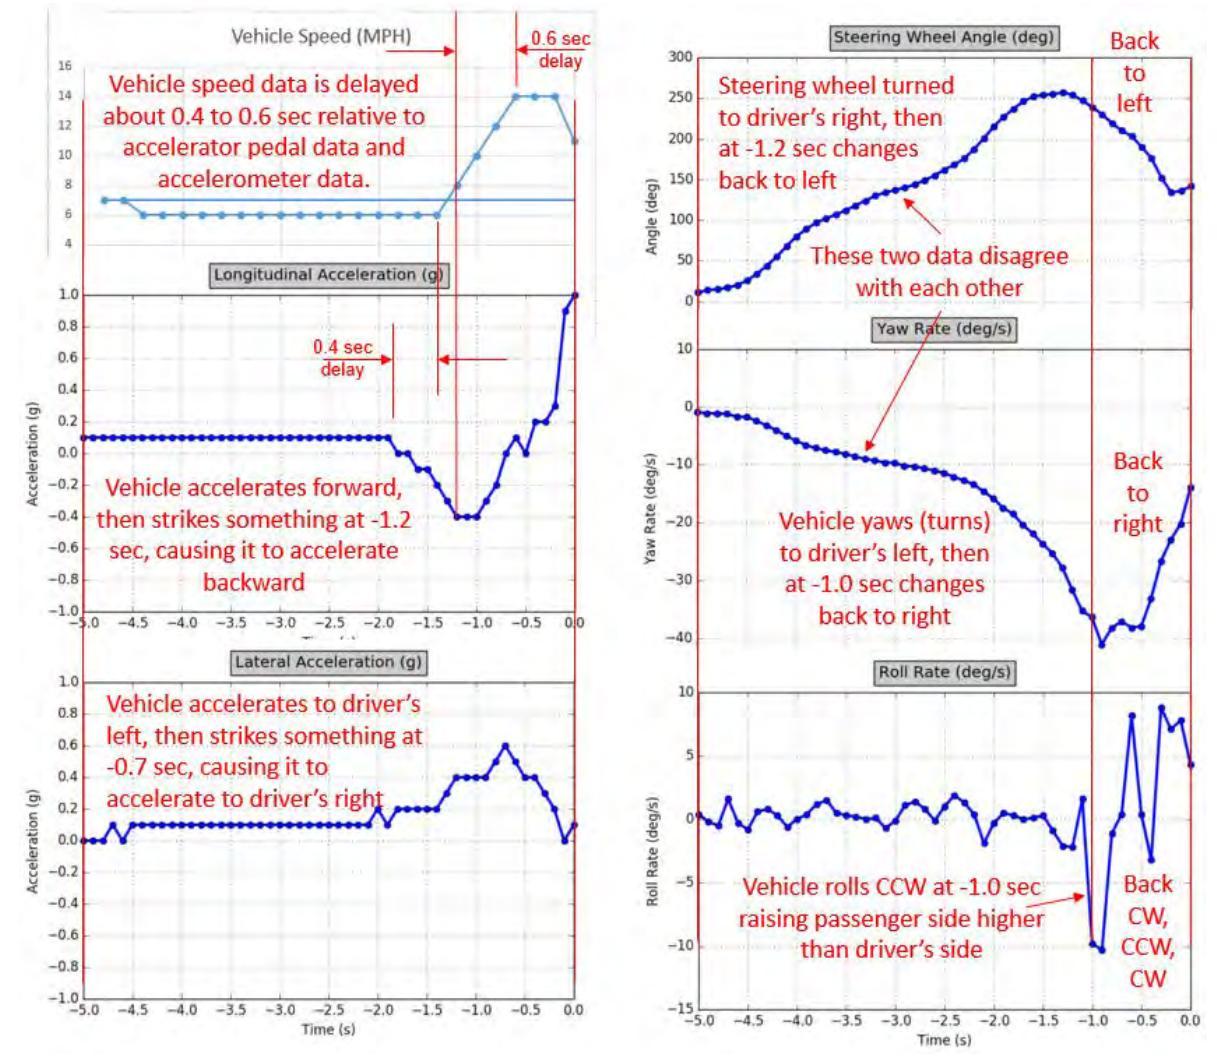
Figure 1. Pre-crash accelerometer data plots

Figure 1 shows plots of all the pre-crash accelerometer data obtained from the EDR report of 2019/07/25 22:44:10 (UTC), along with the plotted vehicle speed data. Analysis of the data provides three major conclusions:

- 1) The steering wheel angle data and the yaw rate data are not consistent with each other.
- 2) If the sign of the steering wheel angle data is changed, then all the accelerometer data become consistent with each other, showing that the vehicle veered to the left as shown in Figure 2, in agreement with the driver's testimony and with the damage to the right front corner of the vehicle as supported by repair records.
- 3) All accelerometer data plots show a change in the sign of the acceleration at around -1.0 seconds before the final crash, indicating possible contact with a crushable object before contact is made with a more impenetrable wall at 0.0 sec.

- 1. <u>Steering wheel angle data and yaw rate data are not consistent with each other</u>. By definition, yaw is the rotation of a vehicle about a vertical axis, with positive yaw values indicating a rotation to the driver's right. Therefore, the negative yaw values in the yaw rate data of Figure 1 indicate a rotation of the vehicle to the driver's left with the rate of rotation increasing with time, and then decreasing again. This is incompatible with the steering wheel angle data, which shows positive values indicating a turn of the steering wheel to the right and then back to the left. What this means is that one of these plots has the wrong sign, indicating that one of the plots does not conform to the SAE 211 / SAE J670 standards mandated by NHTSA in its Part 563 EDR rule dated Sept 2012. Why this wrong sign exists is unknown, and may indicate a mistake by Tesla when designing the EDR system.

- a. the vehicle accelerated forward as shown by the longitudinal acceleration data showing a forward acceleration followed by a rearward acceleration caused by crashing into an object. The acceleration caused by the crash reached a value of 1g, triggering the recording of the EDR data, but not the excitation of the air bags.

- b. the vehicle veered to the left before the crash as shown in Figure 2. This is supported by:
 - 1) the revised steering wheel angle data now agreeing with the yaw rate data,

- 2) the lateral acceleration data showing that the vehicle accelerated first to the left and then to the right, and
 - 3) the driver's testimony,
 - c. the vehicle struck an object with the right front fender as supported by:

- 1) the lateral acceleration data showing that the vehicle first accelerated to the driver's left and then back to the driver's right,
 - 2) the roll rate data, showing that the vehicle first rolled counterclockwise (CCW), raising the passenger side higher than the driver's side, and then back clock-wise (CW) again, followed by an additional CCW and CW rotation,

- 3) the driver's testimony,
 - 4) repair records indicating damage to the right front fender area.
 - 3. <u>The vehicle may have made contact initially with a crushable object (like a garbage can, a planter, or something similar) before final contact was made with a more impenetrable object like the garage structure between the two garage doors. This is inferred from the observation that all accelerometer data plots show a change in the sign of the acceleration values at around -1.0 seconds before the final crash, with the reverse accelerations reaching their highest values at 0.0 seconds.</u>

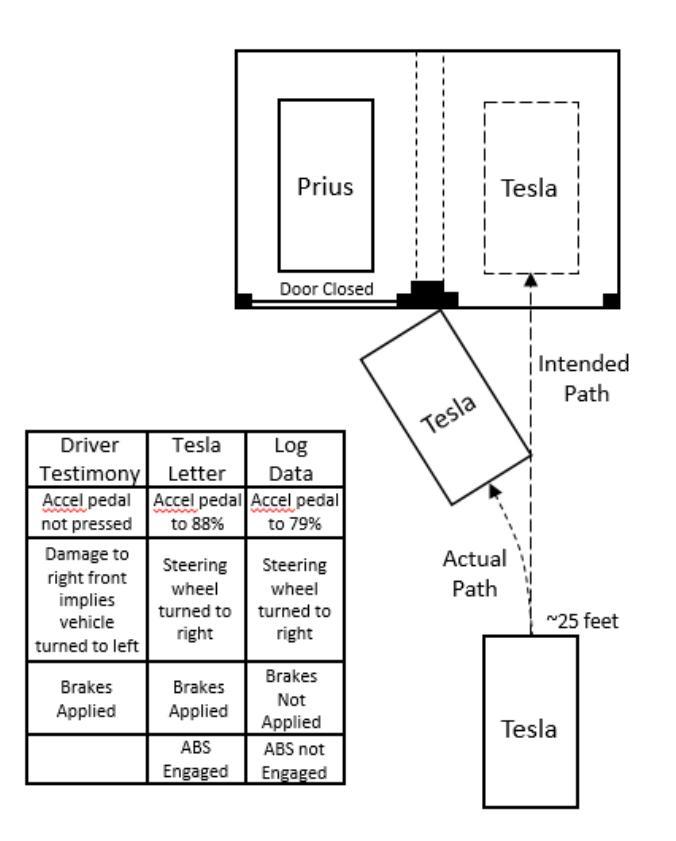
Figure 2. Vehicle path for the incident along with a table showing inconsistencies between the driver's testimony, the EDR data as interpreted by Tesla, and Tesla's letter to the driver. This report shows the EDR data is consistent with the driver's testimony.

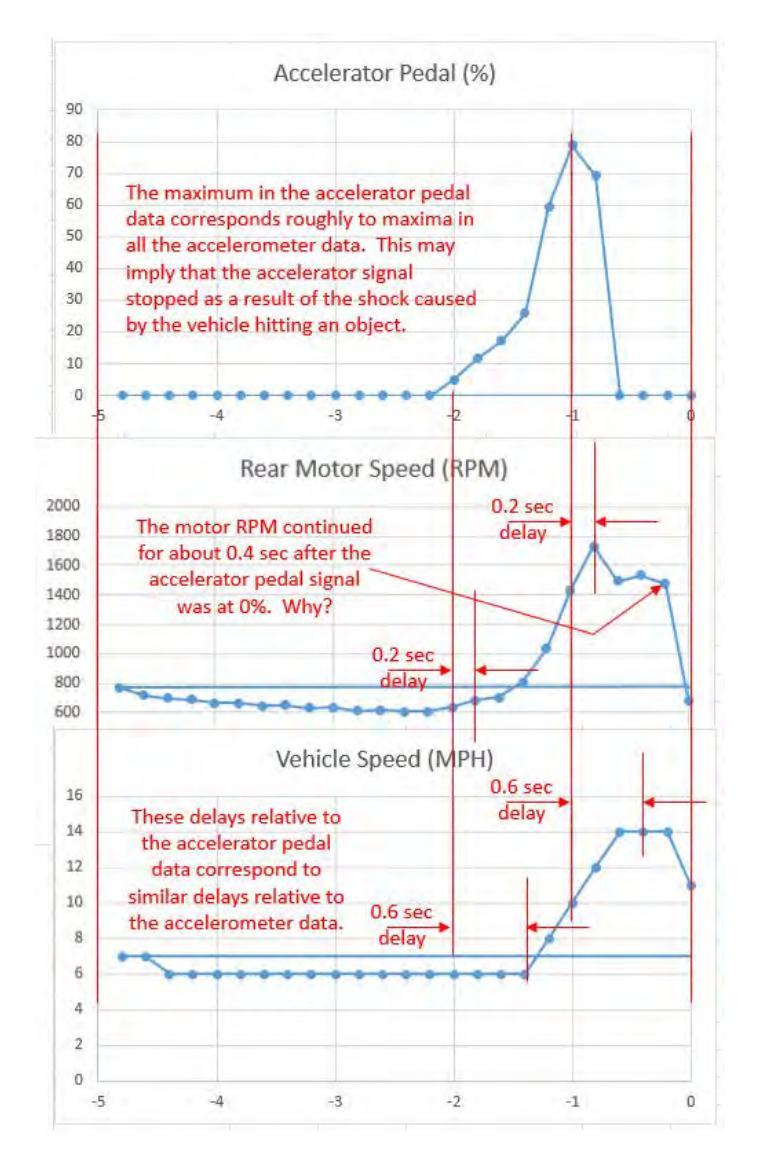
Figure 3 shows plots of the pre-crash data values of accelerator pedal depression (%), rear motor speed (RPM), and vehicle speed (MPH). One can make the following three inferences from these plots:

- 1. The maximum in the accelerator pedal data at -1.0 seconds corresponds roughly to the maxima in all the accelerometer data at about -1.0 seconds. This appears to show that the driver released the accelerator pedal after the vehicle initially made contact with a crushable object, but before the vehicle finally came to rest at 0.0 seconds. But this inference is merely an assumption until Tesla can prove that the recorded accelerator pedal data is actually obtained by storing the accelerator pedal sensor voltage values, and not some signal derived from the voltage data but possibly affected by other events occurring in the vehicle. Therefore, the dropping of the accelerator pedal data to a zero value may also imply that an accelerator-related signal derived from the accelerator pedal voltage stopped as a result of the shock caused by the vehicle hitting an object, which changed a related event. This possibility allows for events other than the accelerator pedal sensor value to influence the vehicle motion.

- 2. The rear motor speed (RPM) and the vehicle speed (PMH) are offset from the accelerator pedal (%) data by 0.2 seconds and 0.6 seconds, respectively. While some delay in these two responses may be expected, a delay of 0.2 seconds

between the accelerator pedal and the motor speed is quite large and should be detectable by the driver as a noticeable lag in accelerator response. It is not known if this is a normal lag value for the Tesla motor, or if this large value indicates that some non-normal process is at work in this incident. It is known, however, that in vehicles with internal combustion engines this delay is kept as far below 100 milliseconds as possible (typically about 30 to 70 milliseconds) to avoid the driver experiencing a lag in accelerator response.

3. The rear motor speed (RPM) plot shows that the motor RPM continued at about 1500 RPM for about 0.4 seconds after the accelerator pedal data went to zero. This is not a result of the 0.2 second delay of the motor RPM relative to the pedal data, but is in addition to the delay. The cause of this continuation in motor RPM is unknown at this time. It may imply that some other process is in control of the motor RPM in addition to the accelerator pedal data.
