Subject: Safety Recall Notice No. "NB" (Forenza/Reno Splice Pack)

Section Title: Body, Cab & Accessories TSB No. TS 11 10057

SUBJECT:SAFETY RECALL CAMPAIGN "NB" LOW BEAM HEADLIGHT AND
DAYTIME RUNNING LIGHT (DRL) SPLICE PACK REPAIR
FORENZA SEDAN/WAGON, RENO (RQ420)

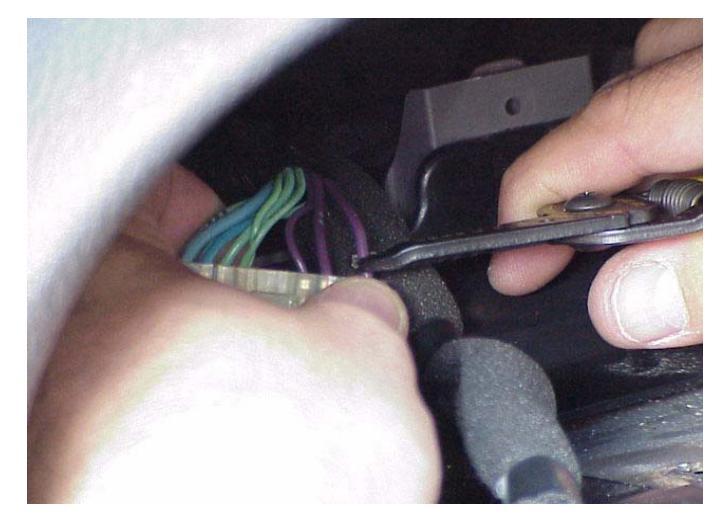
7. Back up at the instrument panel opening, pull the splice pack out from in between the A/C duct and dash support structure. Inspect the splice pack for the three violet wires shown. If present continue to step 8. If they have been cut off, a repair attempt has been made which will have to be removed and then repaired as described starting with step 8.

With the splice pack anchor facing you as shown, the three violet wires will be on top.

8. Cut the three violet wires just behind any heat damage if it exists. If a repair has already been attempted remove the repair by cutting the wires as close to the repair as possible.
