June 6, 2012

## SUBJECT: Safety Recall 11S24

Certain 2001-2002 Escape Vehicles Equipped with an Anti-Lock Brake System (ABS) Fused Relay Installation and Brake Master Cylinder Reservoir Cap Replacement

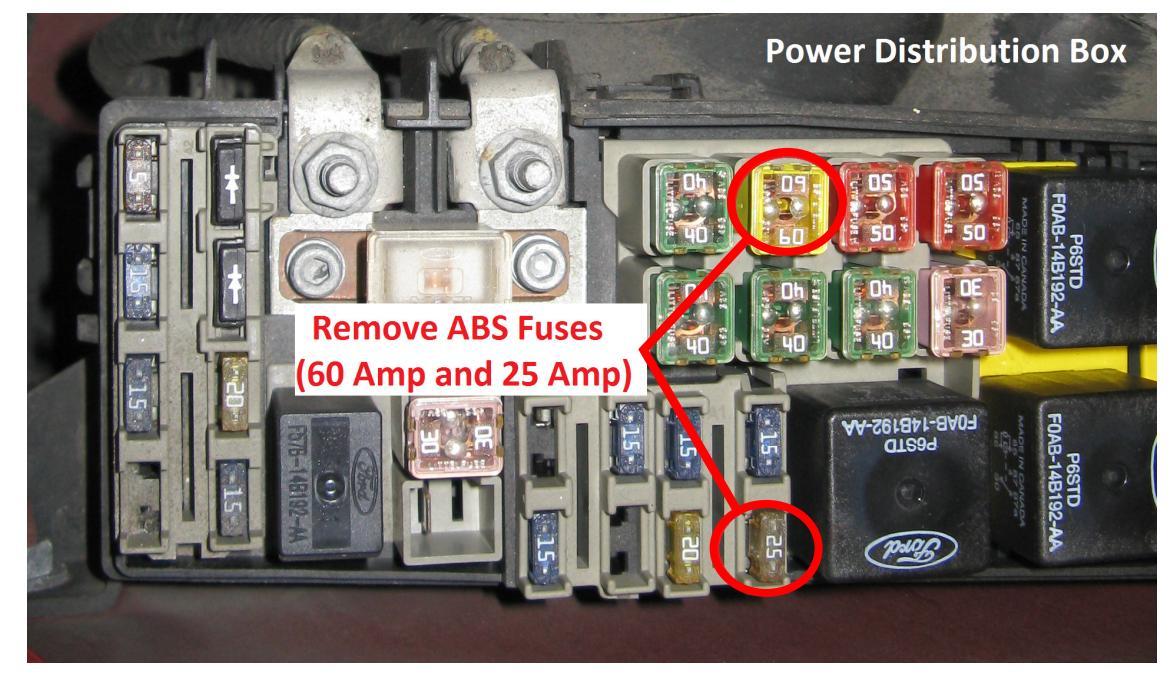
- Check to see if the ABS warning light is illuminated.
  - If illuminated, advise the customer of the condition and ask if they want the dealership to diagnose the concern. The customer should be informed that the likelihood of the illuminated ABS warning light being related to the recall is VERY rare and that it will most likely not be covered under this recall.
- Have dealership personnel remove both ABS fuses (60A and 25A) from the Power Distribution Box (PDB) in the engine compartment to prevent the possibility of an unattended fire. Reference illustration below. Do not instruct customers to pull the fuses before arriving at the dealer as this will disable the ABS. The fuses can only be removed once the vehicle won't be driven on the road. ABS function will be restored with the completion of this recall.

**NOTE:** If the customer would like to have the ABS warning light diagnosed, Diagnostic Trouble Codes (DTCs) should be retrieved <u>prior</u> to fuse removal. By removing the ABS fuses, all stored DTCs associated with the ABS will be cleared.
