12-01-020

**Technical Service Bulletin**

Santa Fe (CM/A)

#### SRS PODS ECU SOFTWARE UPDATE (CAMPAIGN 105)

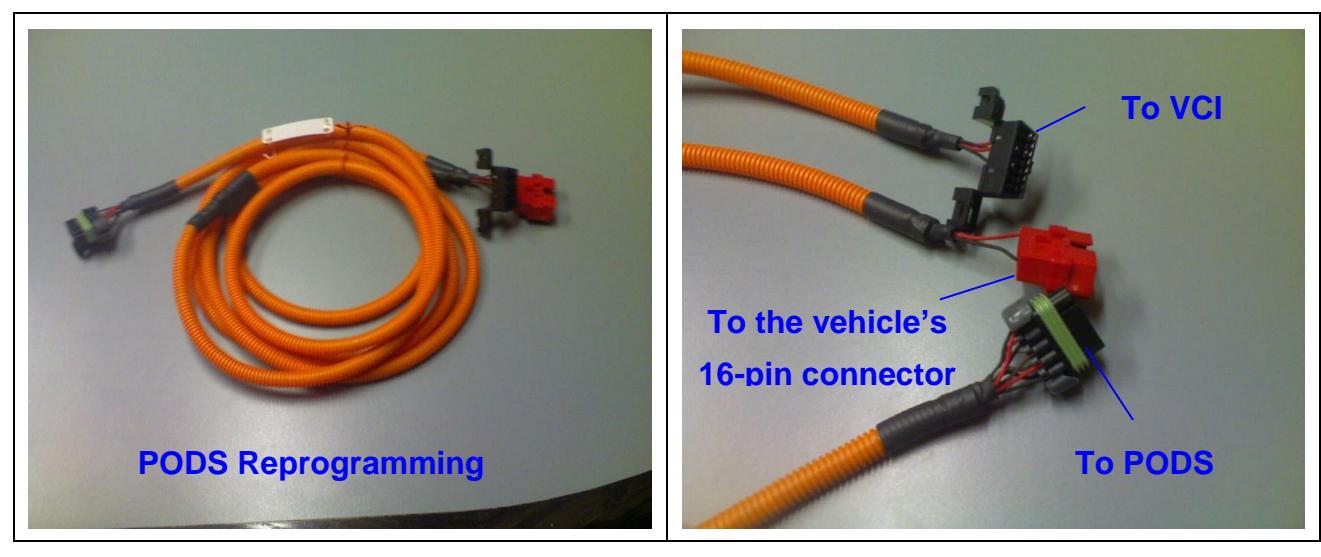
**4.1** The PODS Reprogramming cable shown here will be sent to each dealer to be used for the PODS ECU UPDATE. Additional cables (P/N 00305-88020) can be ordered through the PDC.

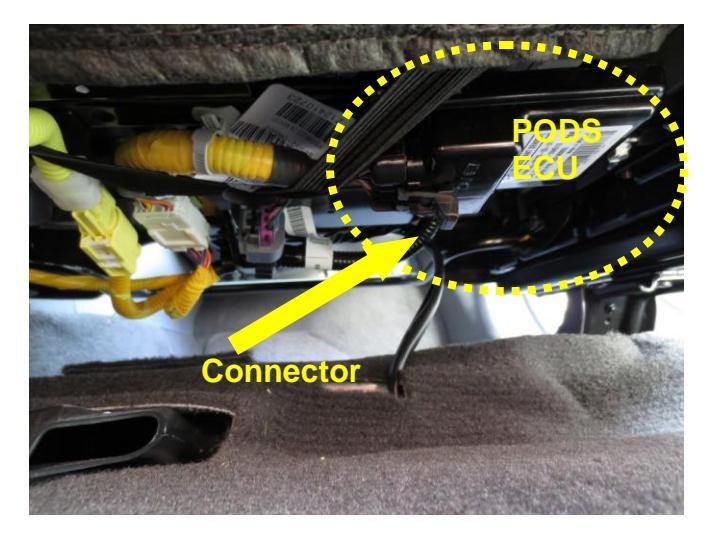
Slide the passenger seat forward. From the rear right door area, access the underside of the passenger seat to unclip the connector.

8) Disconnect the PODS ECU connector.
