Re: 49 CFR Part 573; Recall of Mercedes-Benz Fuel Filter Flange

Manufacturer's Campaign Identification Number 2013020002

NHTSA Recall Number 12V-557

SUBJECT: Models X204, 204, 207, 212, 216, 221, Model Years 2011- 2012 Replace Fuel Filter

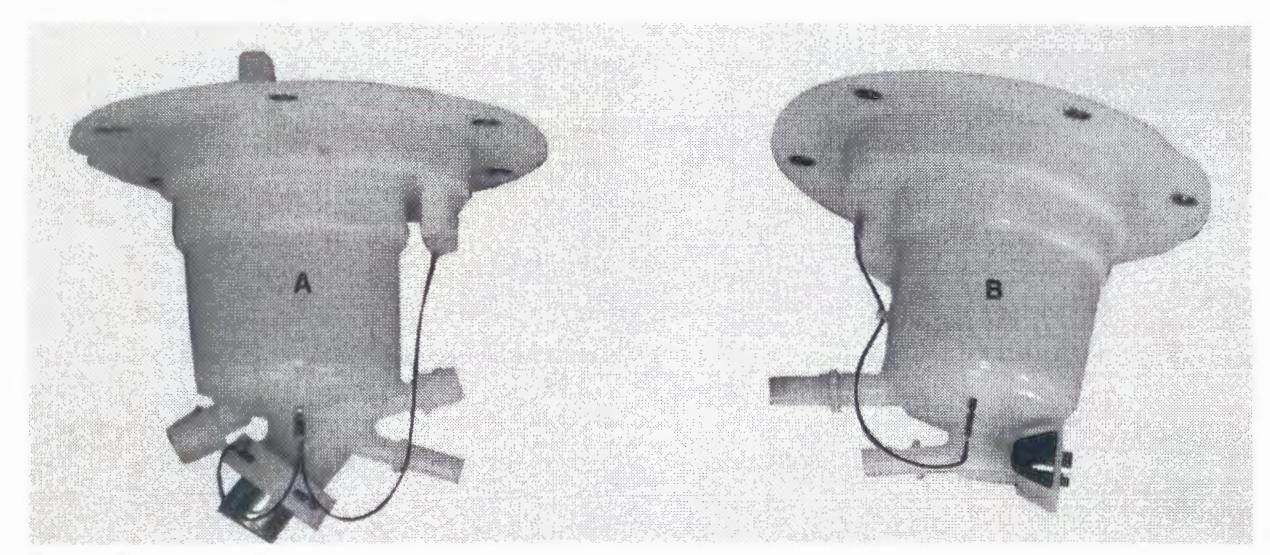
Figure 4

- Fuel filter (A, Figures 3, 4) for models 204.0/9, 212, 207, 216.376, 221.171/186/ 176/195/179 is equipped with 3 fuel line fittings.
- Fuel filter (B, Figure 4) for models: 216.374/394, 221.173/194/174 is equipped with 2 fuel line fittings.

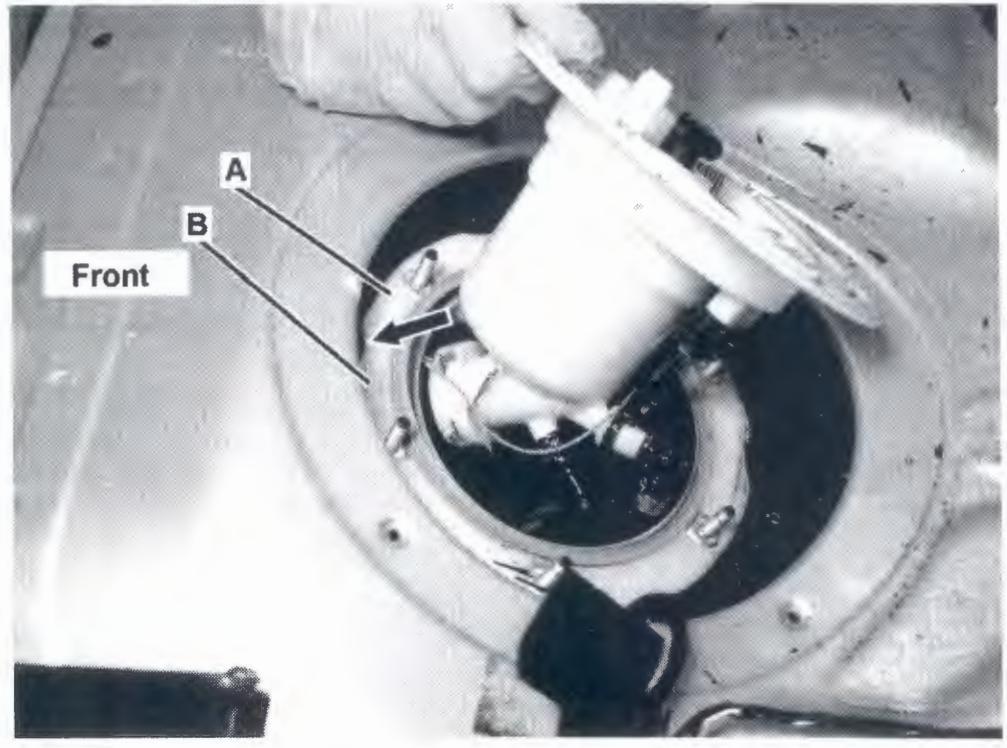
Figure 8

A: Spacer ring B: Location of "Top" marking on spacer ring Arrow: Location of top notch on spacer ring

- Spacer ring (A, Figure 8) is installed with side marked "Top" (B) facing up.
- Tabs on spacer (A) are facing up.
- Torque sequence is observed (Figure 9)
- 9. Start vehicle and check fuel system for leaks.

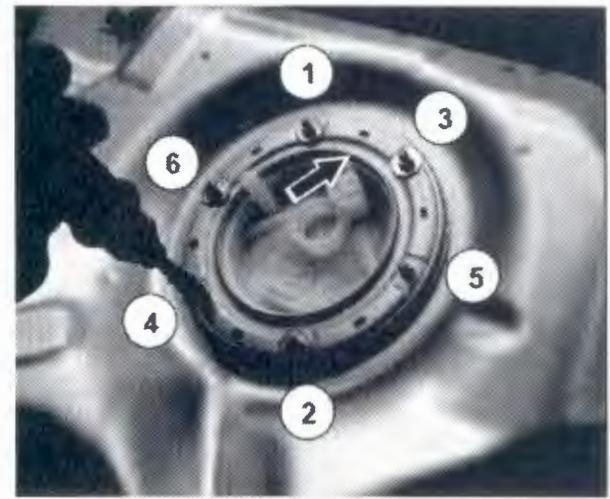
Figure 8

(Fuel tank shown out of vehicle, **arrow** indicates notch on fuel filter)
