TMS-NTC-13178 July 23, 2013

Re: Toyota Safety Recall 13V-235 Dealer Notification - Remedy

Subject: Safety Recall DLD - Remedy Available Certain 2010 Model Year HS 250h Vehicles Brake Booster Pump Assembly (Accumulator)

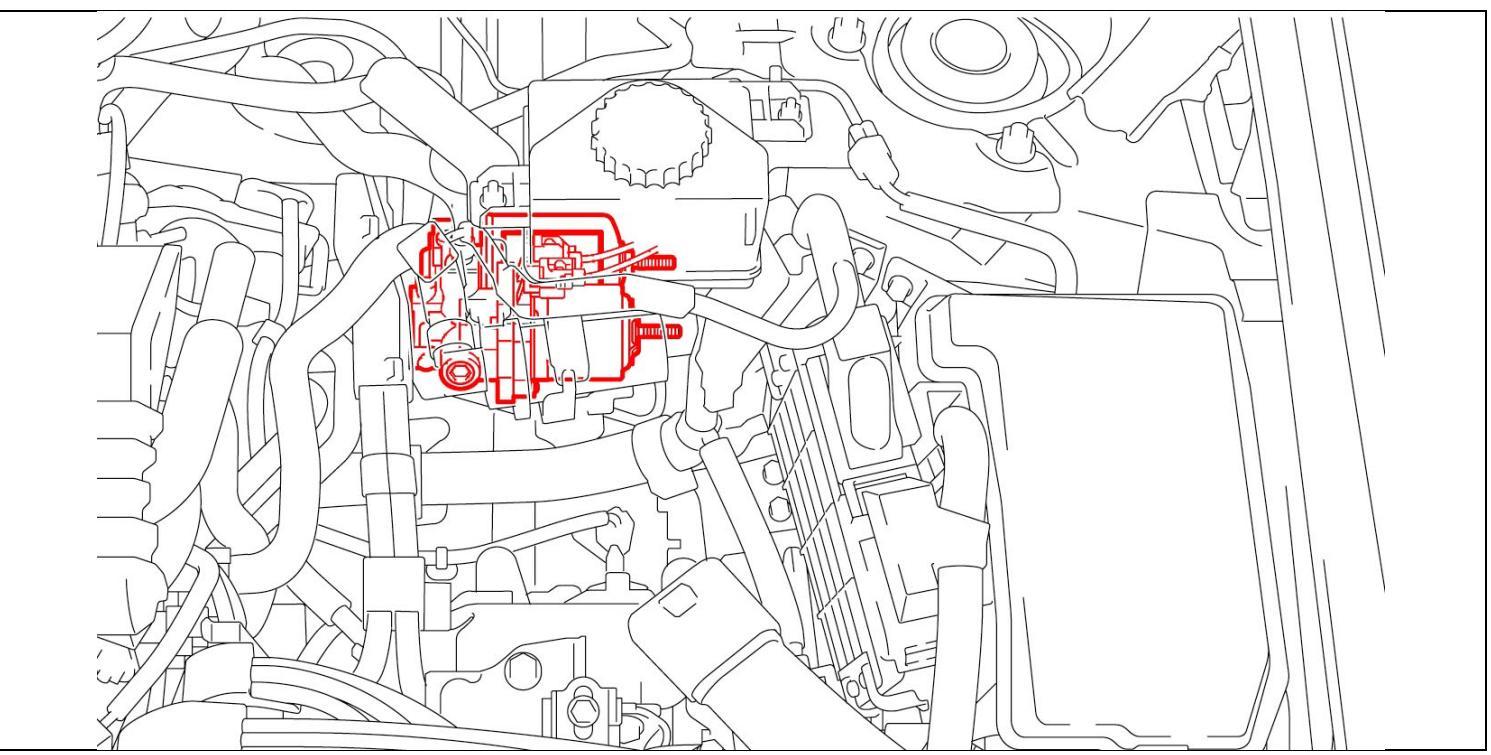
7. INSPECT THE ORIENTATION OF THE ACCUMULATOR CAUTION LABEL

a) Inspect the orientation of the caution label to determine if the accumulator requires replacement.

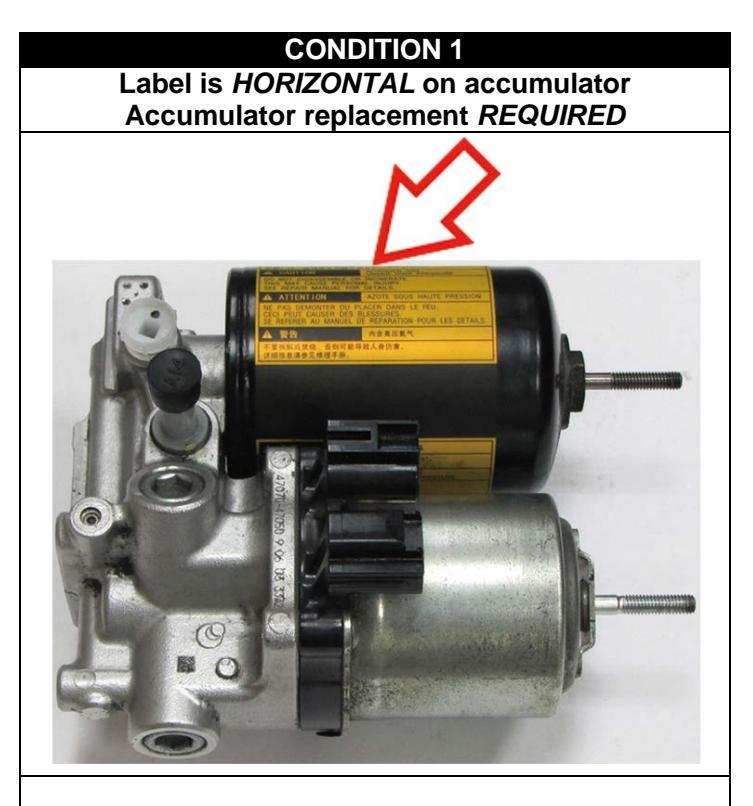
The accumulator is affected and replacement is required. Proceed to **SECTION VIII.** To determine if additional parts require replacement.

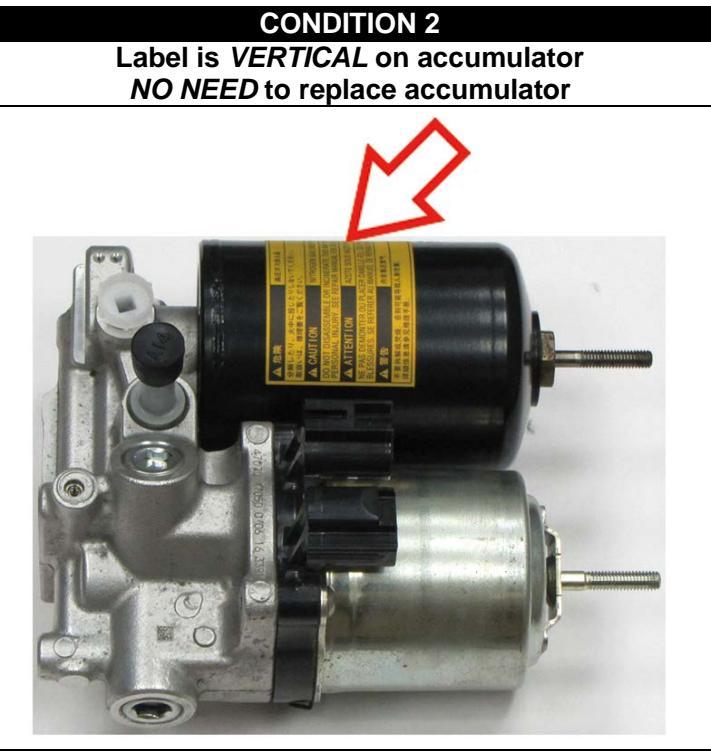
The accumulator *IS NOT* affected and *DOES NOT* need to be replaced. Reassemble the vehicle, then proceed to **SECTION XIII.** for instructions on ISC initialization.
