## PRODUCT RECALL

### TECHNICAL BULLETIN

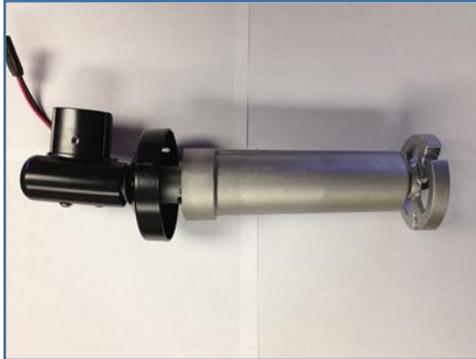
Awning Motor  
Pre February 13, 2013. This motor is **not** affected by the product recall.
