Automotive Division Restraints	Technical Service Bulletin Bulletin No. TS 03 04284	May 19, 2014

SUBJECT:Safety Recall Campaign "VD";
Front Passenger Side Bottom Seat Cushion ReplacementMODEL(S):SX-4 (RW420)YEAR:2007~2011VIN LIST:For a quick reference to affected VINs and, a specific VIN associated Service
Part part number, please click this link.

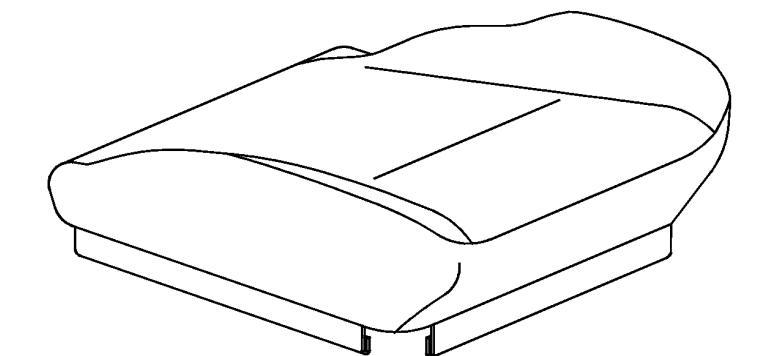
Trim Sub-Assembly

- CONDITION: The Occupant Classification System (OCS) may develop an electrical circuit disconnection within the front passenger sensing system sensor mat that is built into the front passenger seat bottom cushion. The disconnection is due to repeated flexing of the sensor mat from use of the front passenger seat. If this condition occurs, the "AIR BAG" light in the instrument cluster and, the front passenger's seat belt reminder light will come on. Also, the "PASS AIR BAG OFF" indicator light will remain off because the front passenger air bag will remain enabled. In a frontal impact of significant magnitude, the front seat. Air bag deployment with a child or small adult in the front passenger seat increases the risk of severe injury or death to that occupant.

- CAUSE: Suzuki has determined that an electrical circuit disconnection (OPEN) can develop within the Front Passenger Occupant Classification System (OCS) sensor mat that is built into the front passenger seat bottom cushion, due to repeated flexing of the mat from use of the seat.

- CORRECTION: Authorized Suzuki Service Providers will replace the front passenger bottom seat cushion at no charge to the customer on affected vehicles.
