NISSAN BULLETIN 2015 Armada Seat Belt Buckle Voluntary Safety Recall Campaign

Reference: PC385 Date: August 6, 2015

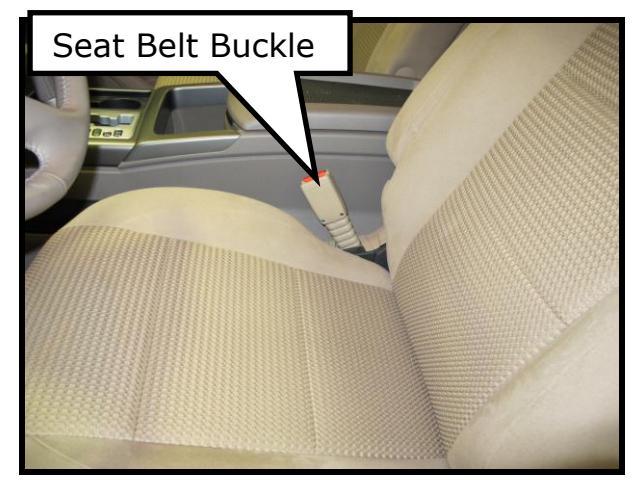
Figure 1

- 1. Open left front (Driver) door.
- 2. Locate left front (Driver) seat belt buckle as shown in Figure 1.

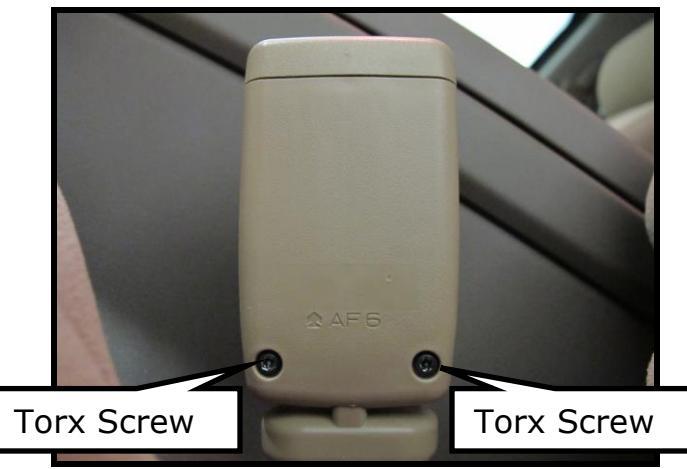
Figure 2

3. Remove (2) T-10H (tamper proof) Torx screws on the left front seat belt buckle, refer to Figure 2.

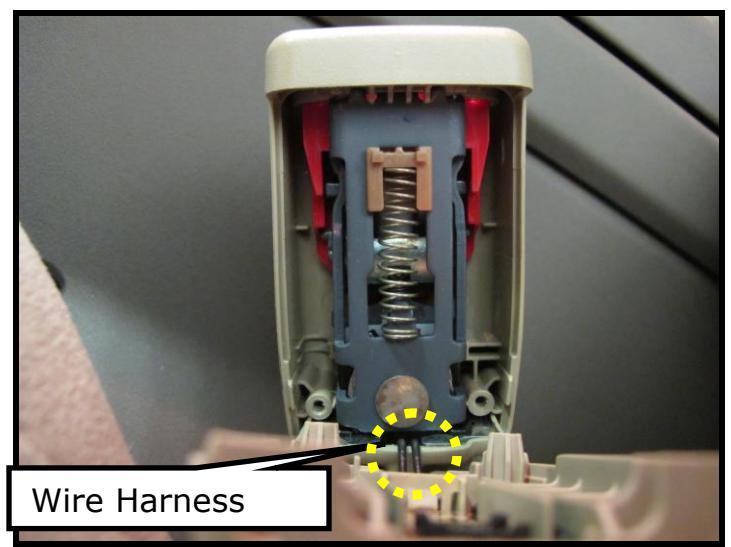
Figure 4

- 4. Open the buckle cover to inspect buckle latch mechanism.
 - Gently pull cover out from the bottom, then push down to release the buckle cover, refer to Figure 3.
 - Pivot the top of the buckle cover out leaving the bottom still touching the buckle due to the wire harness inside as shown in Figure 4.

Take care to not damage the wire harness at the bottom of the buckle cover as shown in Figure 4.

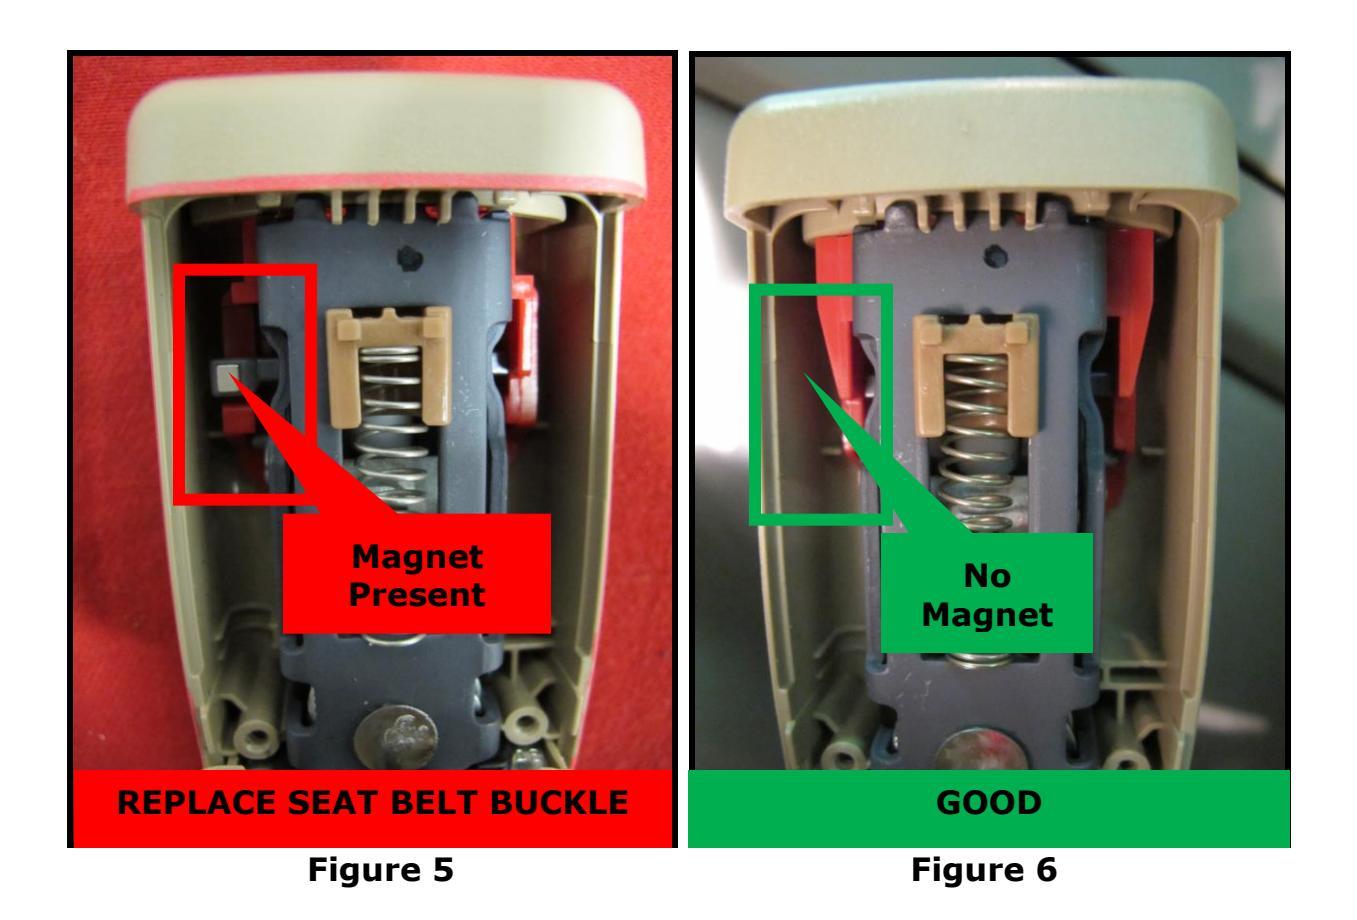
- Inspect the buckle latch mechanism for presence of a magnet. See Figures 5 and 6 below.
- 6. Repeat inspection (Steps 1-5) for right front (Passenger) seat belt buckle.

- 8. If a magnet **IS** present in either front seat belt buckle mechanism as shown in Figure 5, then replace the affected front seat belt buckle.
 - Refer to the 2015 Armada Electronic Service Manual (ESM). Section SB-Seat Belts, for seat belt buckle replacement procedures.
 - **CAUTION:** Before replacing a Seat Belt Buckle (SRS system), turn ignition switch off, disconnect both battery terminals and wait at least three minutes. Refer to ESM PG-81, "<u>Removal and Installation</u>".
