Recall Campaign Bulletin

Campaign No. 2015030004, April 2014

SUBJECT: Model 205 (C-Class), Model Year 2015 Fuel Tank Sender Cover

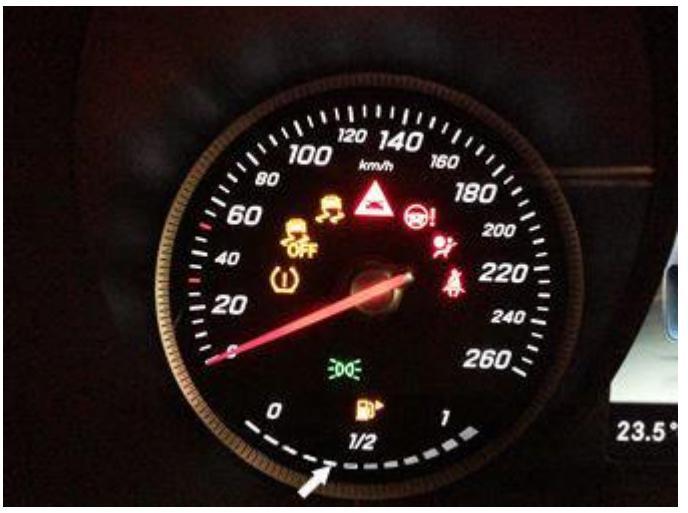
Figure 1 (Non-US speedometer shown)

INote: The fuel tank should not be more than ½ full (Figure 1). Check fuel level and pump out fuel if necessary, refer to WIS: AR47.10-P-4001LW.

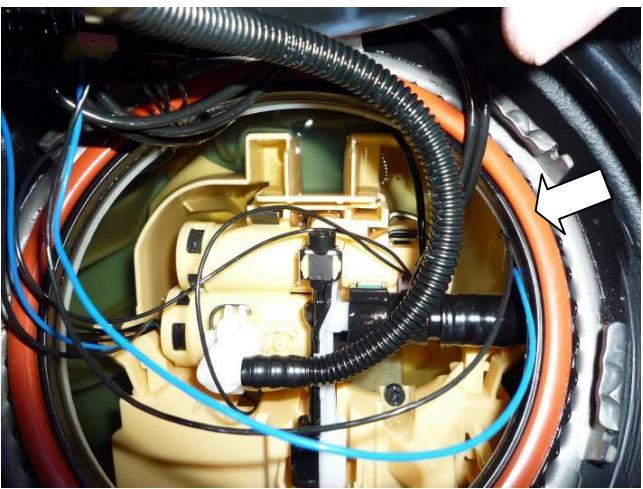
Figure 4

4. Check **all** visible electrical wires (Figure 4) on fuel tank and fuel feed module for damage.

I Note: A pinched wire **is not necessarily** damaged. A pinched wire is not damaged unless **wire strands are exposed**.

- If electrical wires on fuel tank are damaged (Not OK): Proceed to Subject B.
- If electrical wires on fuel feed module are damaged (Not OK): Proceed to Subject C.
- If electrical wires on fuel tank and fuel feed module are **not** damaged **(OK)**: Continue with steps 5 10.
- 5. Replace O-ring (arrow, Figure 4) on feed unit flange:
- During assembly, use the lubricating paste as described in WIS: AR47.20-P-5710LW.
- The O-ring (arrow) must be inserted into the groove on the fuel tank.
