SUBJECT:			No:	SR-15-003
-	NT BLOWER MOTO	-	DATE	June, 2015
SAFE	TY RECALL CAMP	AIGN	MODE	EL: See Below
CIRCULATE TO:	[X] GENERAL MANAGER	[X] PARTS MANAGER		[X] TECHNICIAN
[X] SERVICE ADVISOR	[X] SERVICE MANAGER	[X] WARRANTY PROCES	SOR	[X] SALES MANAGER

## PURPOSE

Due to a manufacturing error, the shaft and bearing inside the front blower motor on affected vehicles may have been improperly centered. If use continues under this condition, the shaft and bearing could ultimately seize resulting in total loss of blower performance.

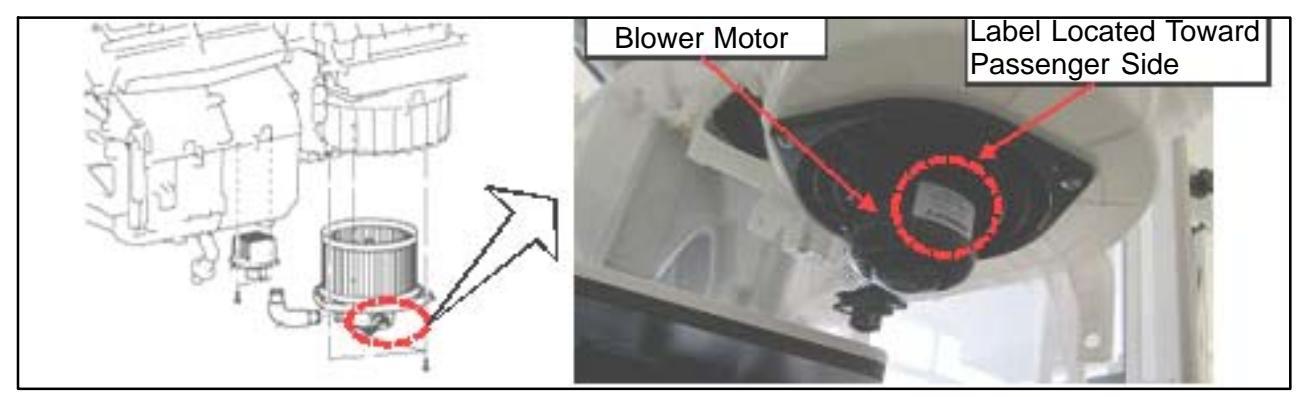
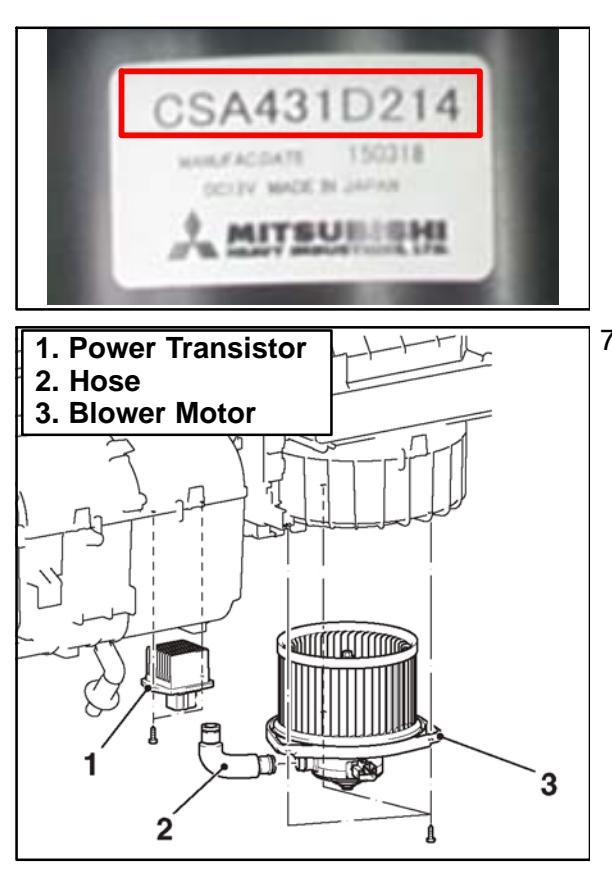
- 1. Turn the ignition switch to the "ON" position or press the engine start/stop switch twice until the LED indicator illuminates green.
- 2. Turn on the blower motor to the "MAX" position. Notate if the blower motor is able to achieve "MAX" performance.
- 3. Turn the vehicle "OFF."
- 4. Move the front passenger seat to the full rearward position and remove the front passenger side floor mat (if equipped).
- 5. Remove the passenger compartment bottom cover assembly (located below glove box).
- 6. With a flashlight, inspect the part number label on the blower motor.

- a. If the part number <u>is not CSA431D214 or</u> <u>CSA431D214A</u>, inspection is complete. <u>Re-</u> <u>placement is not required</u>. Reinstall the passenger compartment bottom cover assembly and front passenger floor mat (if removed) and return vehicle to customer.
- b. If the part number <u>is CSA431D214 or</u> <u>CSA431D214A</u>, proceed to the next step.
- 7. Replace the blower motor with the corresponding part indicated in the **Parts Information** section.
