RECALL CAMPAIGN BULLETIN

Reference: NTB15-074 Date: August 17, 2015

VOLUNTARY SAFETY RECALL CAMPAIGN 2015 ARMADA FRONT SEAT BELT BUCKLE

CAMPAIGN ID #: PC385 APPLIED VEHICLES: 2015 Armada (TA60)

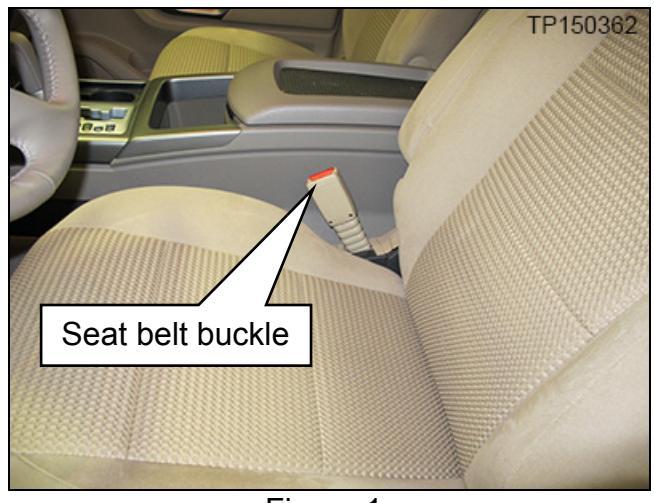
Figure 1

- 1. Open the door on the side of the seat belt buckle that is being inspected.
 - Both sides will be inspected, one at a time.
- 2. Locate the seat belt buckle as shown in Figure 1.
 - Driver's side shown. Passenger side is similar.

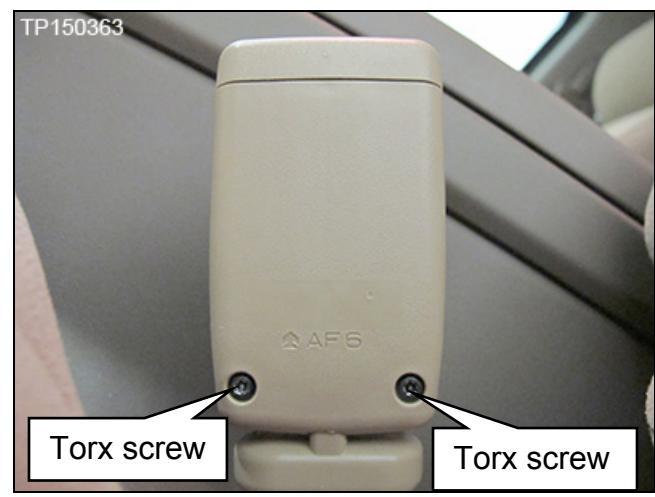
Figure 2

3. Remove two Torx_® (T-10H, tamper proof) screws from the seat belt buckle.

(Figure 2).

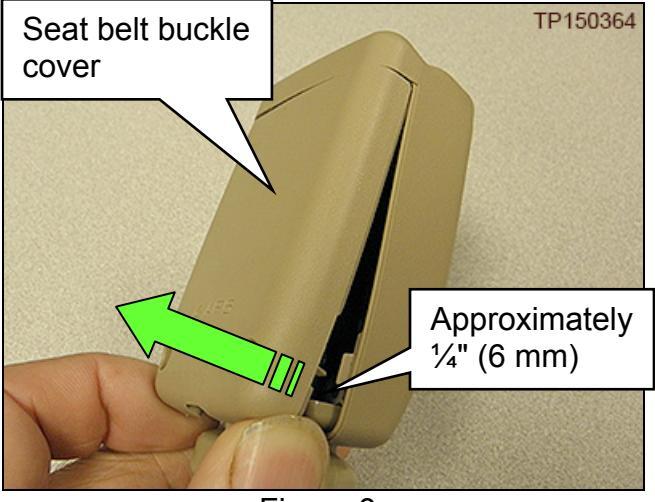
Figure 3

- Open the seat belt buckle cover to inspect seat belt buckle latch mechanism as follows:
 - a. Gently pull the "seat belt buckle cover" (buckle cover) away from the bottom of the "seat belt buckle" (buckle); approximately ¼" (6 mm) (Figure 3).

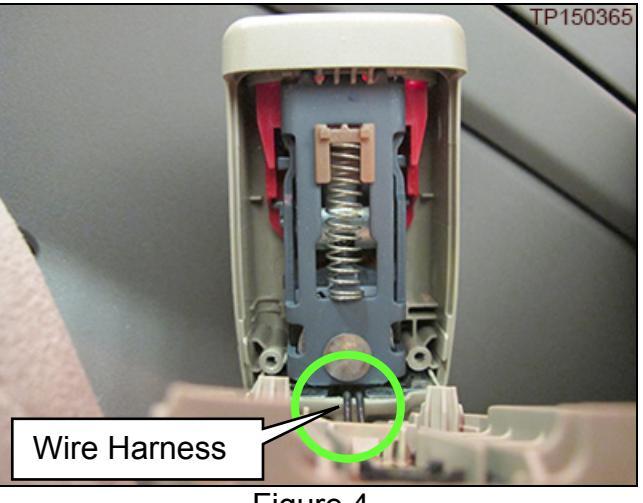
Figure 4

IMPORTANT: Only pull away far enough to allow the buckle cover to slide down, to prevent damage to the wires connected to the buckle cover (see Figure 4).

IMPORTANT: Take care to not damage the wire harness at the bottom of the seat belt buckle cover shown in Figure 4.

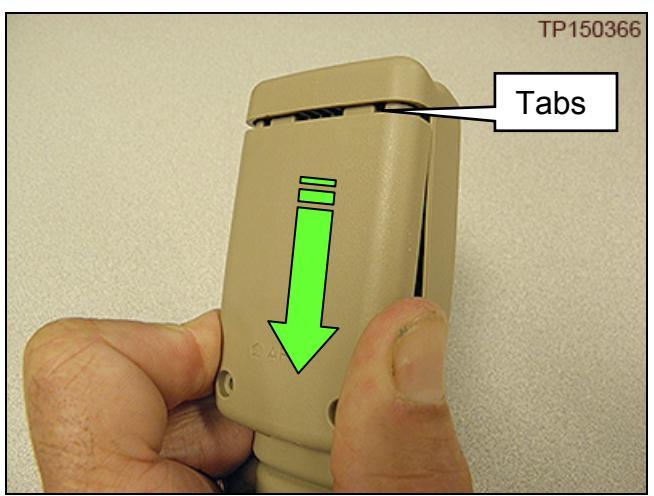
Figure 5

b. While the bottom of the buckle cover is being held at ¼" (6 mm) from the buckle, slide the buckle cover down to clear the buckle cover tabs (tabs) from buckle (Figure 5).

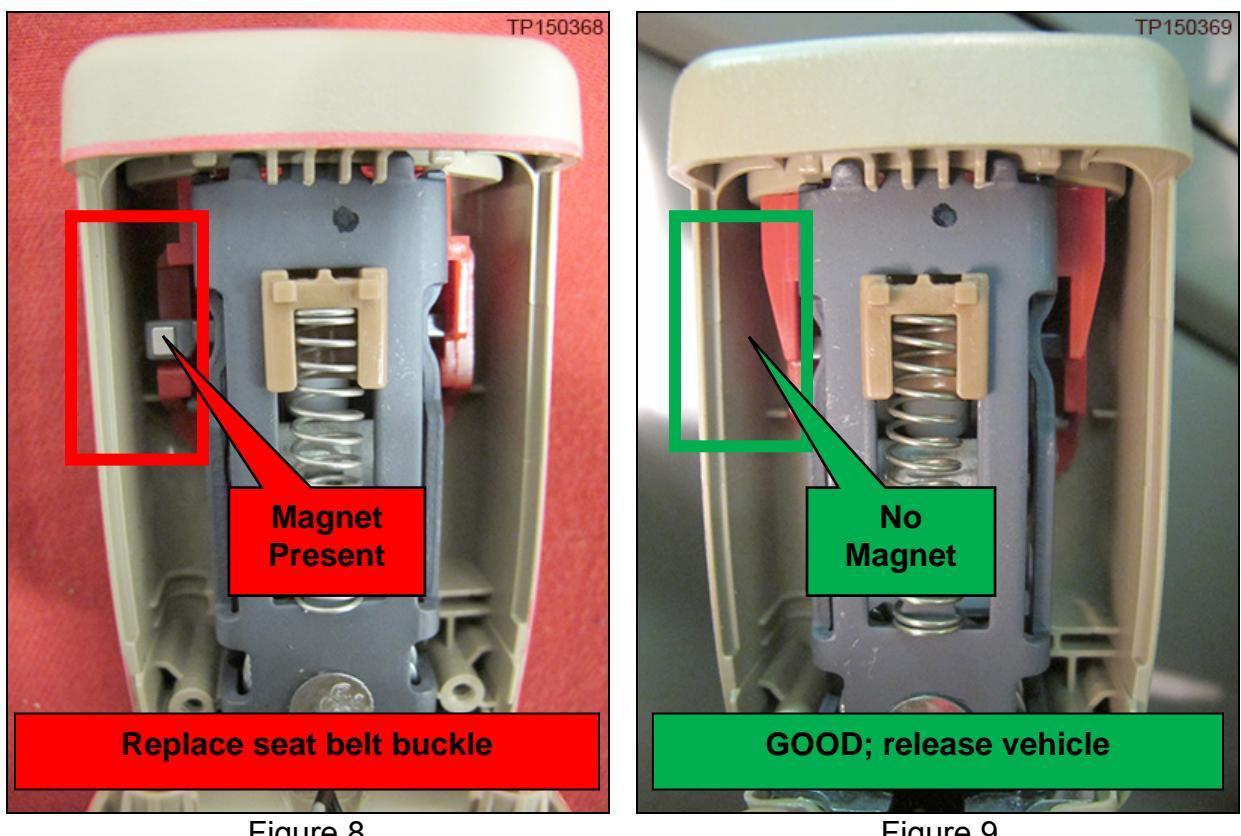
- 5. Inspect the seat belt buckle latch mechanism for the presence of a magnet.
 - See Figure 8 and Figure 9 below. •

- 6. Repeat the inspection (Steps 1-5) for the inspection of the second seat belt buckle.
- 7. If there is **NOT** a magnet present in either seat belt buckle mechanism:
 - a. Reassemble the vehicle.
 - b. Confirm the tongue latches and unlatches.
 - c. Submit warranty claim using PC3850 (see Claims Information), and release the vehicle.
- 8. If a magnet **IS** present in either of the front seat belt buckle mechanisms, as shown in Figure 8, replace the affected front seat belt buckle and confirm tongue latches and unlatches.
 - Refer to the 2015 Armada Electronic Service Manual (ESM), Section SB Seat Belts, for seat belt buckle replacement procedures.
