Recall Bulletin

PRODUCT SAFETY RECALL

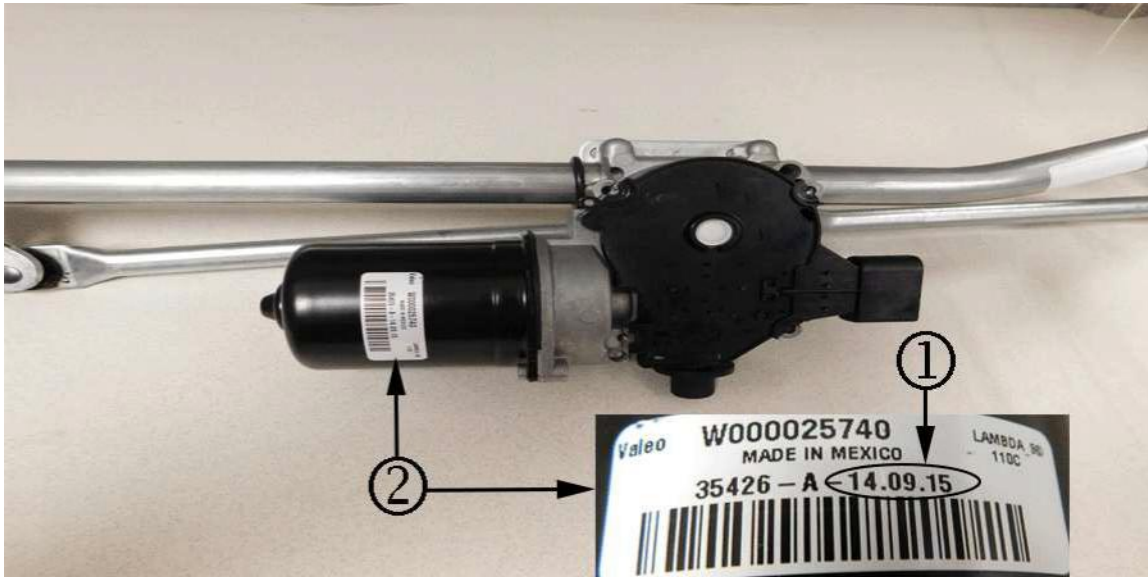
Note: The date formatting is DD-MM-YY.

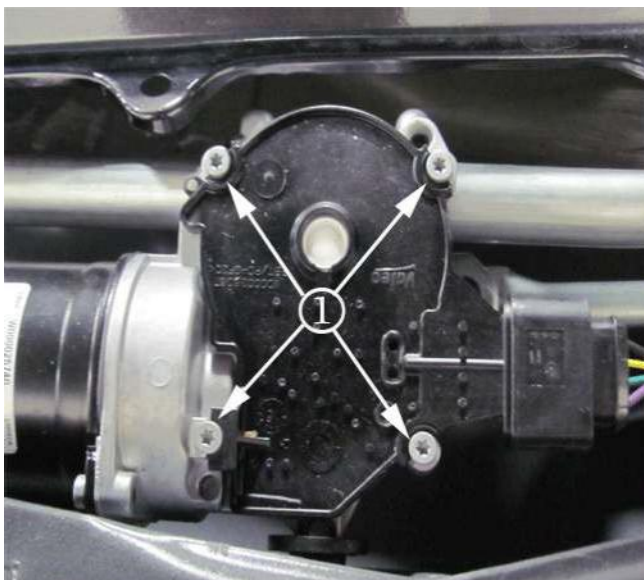
2. Verify the build date (1) printed on the label (2) of the windshield wiper motor.
 - If the build date is between 15-08-15 and 18-09-15, proceed to step 3.
 - If the build date is NOT between 15-08-15 and 18-09-15, no further action is required. Reattach the air inlet grille panel.
3. Disconnect the wiper motor electrical connection.
4. If required, remove dirt, debris or moisture from the wiper motor cover.

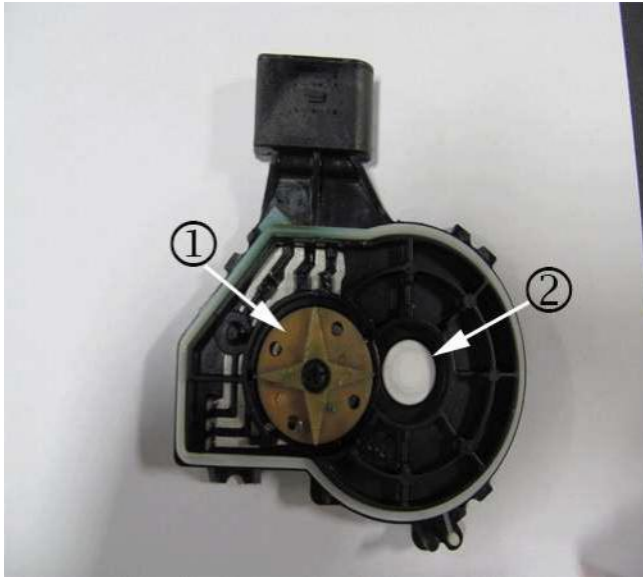
Caution: Damage may occur to the part if the sprocket is not aligned properly.

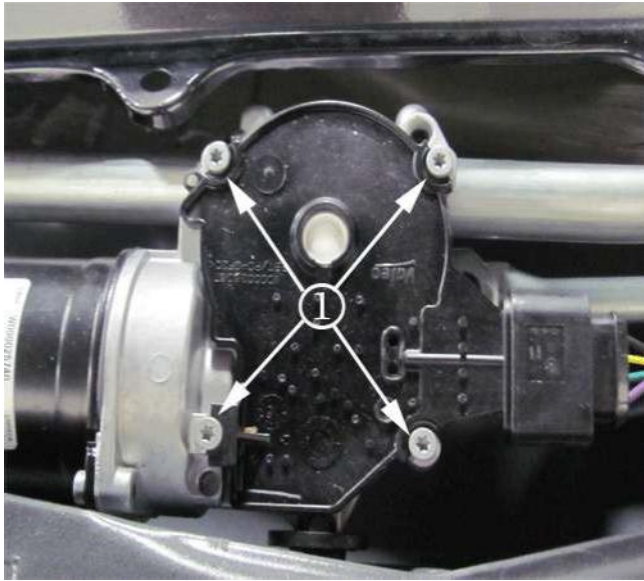
11. Tighten the 4 wiper motor fasteners (1) in a “X” pattern to 3.5 Nm (31 in lb). Verify the fasteners are bottomed out on the wiper motor casting.
12. Turn ON the ignition and verify wiper motor operation.
13. Turn OFF the ignition.
14. Install the air inlet grille panel. Refer to *Air Inlet Grille Panel Replacement* in SI.
15. Turn ON the ignition and verify wiper motor operation.
16. Turn OFF the ignition.
