TO: Mercedes-Benz Dealer Principals, General	FROM: Thomas Brunner, Department Manager,
Managers, Sales Managers, Service Managers, Parts	Vehicle Compliance and Analysis, Engineering
Managers	Services
RE: Recall Campaign 2016110008 MY 2017 Model 207 (E-Class Coupe/Cabriolet) Underbody Panel	DATE: December 8, 2016

Recall Campaign Bulletin

Campaign No. 2016110008, December 2016

SUBJECT: Model 207, Model Year 2017 Check Underbody Panel, Replace if Necessary

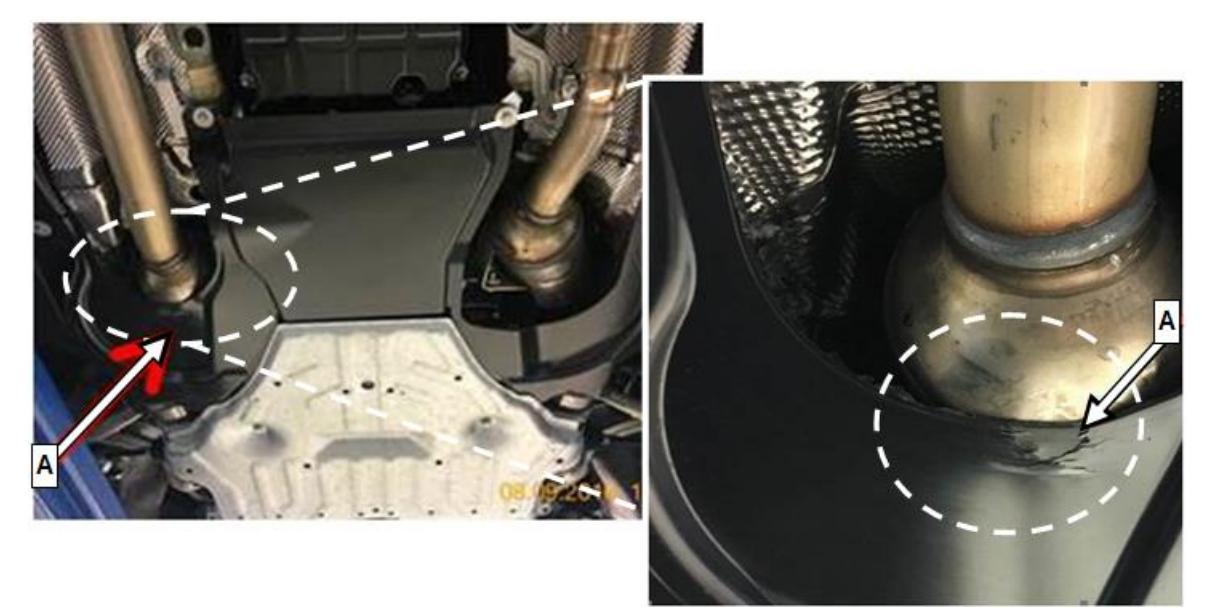
Figure 1 (NOT OK)

Daimler AG ('DAG'), the manufacturer of Mercedes-Benz vehicles, has determined that certain E-Class Coupe/Cabriolet vehicles (model 207 platform) may have been equipped with an underbody panel that contains a recess that may not provide sufficient clearance between the left catalyst and the panel. Under certain operating conditions (e.g. full load), the temperatures at the catalyst could melt the panel and possibly result in ignition. An authorized Mercedes-Benz dealer will check the underbody panel, and replace if necessary

1. Check if the underbody panel (A, Figure 1) makes contact with the catalytic converter.

The opening for the catalytic converter may not have been cut out completely.

- If the underbody panel does **NOT** make contact with catalytic converter **(OK)**: Procedure is complete.
- If the underbody panel **does** make contact with catalytic converter (**NOT OK**): Proceed to step 2.

2. Replace underbody panel, refer to WIS: AR61.20-P-1105EW.
