Michael A. Berardi Director Service Engineering Operations Ford Customer Service Division Ford Motor Company P. O. Box 1904 Dearborn, Michigan 48121

December 13, 2017

SUBJECT: Safety Recall 17S09 – Supplement #1 Certain 2013-2014 Fusion, 2013-2015 Transit Connect, 2014 Escape, and 2014-2015 Fiesta ST Vehicles Equipped with a 1.6L EcoBoost Engine Coolant Level Sensor System Installation

REF: Safety Recall 17S09 Dated March 28, 2017

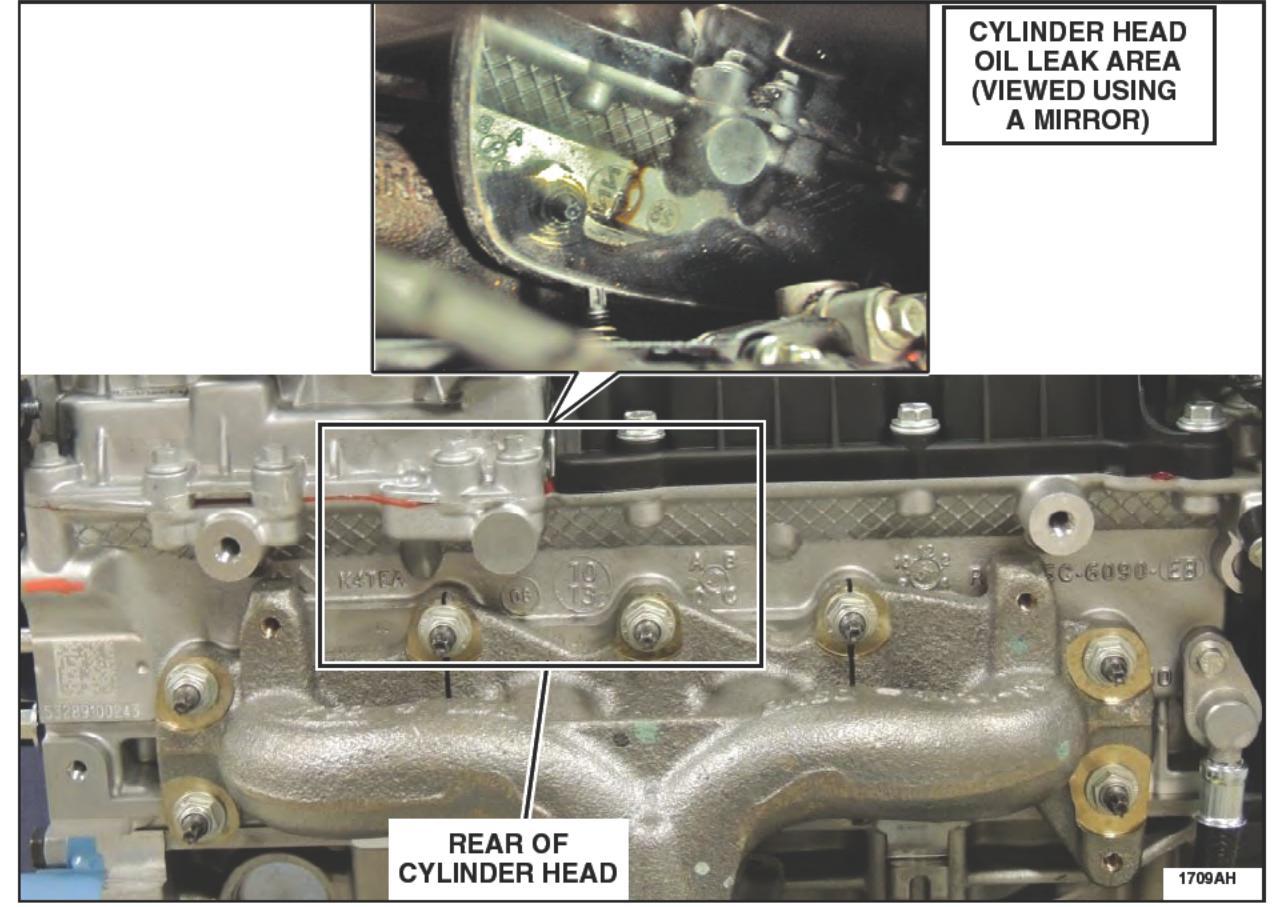
FIGURE B1

- 5. Check the engine oil level to ensure it is within normal range, note if it is overfilled. Visually check for engine oil leaks at the rear surface of the cylinder head, above exhaust manifold, that may be the result of a crack in the cylinder head. See Figure B1.
 - If an oil leak is detected at the rear surface of the cylinder head, replace the complete cylinder head assembly before proceeding.
- NOTE: The turbocharger coolant tubes and exhaust manifold heat shield are removed for clarity.

7. Note any concerns identified and repairs made on the Inspection / Check Sheet.

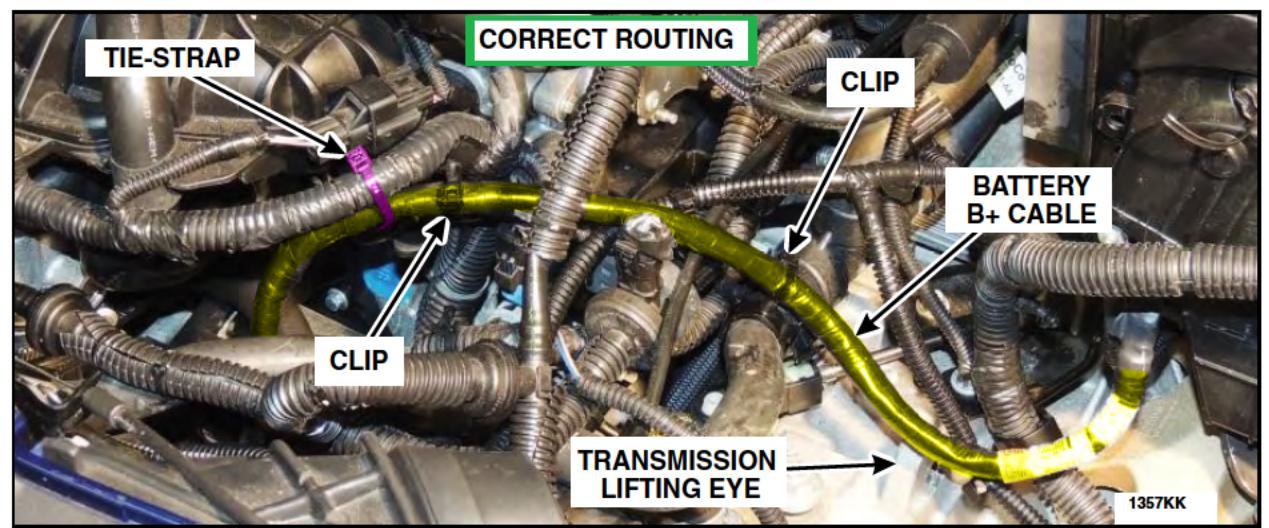
FIGURE K1

- 1. Inspect the battery B+ terminal cable for improper routing and/or any signs of wire and insulation damage. See Figures K1 and K2.
 - If the battery cable is damaged, replace it prior to proceeding.
 - A <u>properly routed</u> cable can be identified by having the cable routed from the generator across the front of the engine and with the cable secured to the main engine wiring harness with a tiestrap near the forward left side of the intake manifold. See Figure K1.
 - An <u>improperly routed</u> cable can be identified by the cable being routed forward of the engine near the radiator, and is not attached to the main engine wiring harness with a tie-strap. See Figure K2.
