### Release Date: November 2018 Revision: 00

Condition
 It has been determined that a defect, which relates to motor vehicle safety, exists in all 2006 model year Saab 9-2X vehicles that are not currently registered and, have never been registered, in Alabama, California, Florida, Georgia, Hawaii, Louisiana, Mississippi, South Carolina, Texas, Guam, Puerto Rico, Saipan, U.S. Samoa or U.S. Virgin Islands. In these vehicles, the front passenger air bag inflator module may experience an alteration over time, which could lead to overaggressive combustion in the event of an air bag deployment. This condition could create excessive internal pressure when the air bag is deployed, which could result in the body of the inflator rupturing upon deployment. In the event of an inflator rupture, metal fragments could pass through the air bag cushion material, which may result in injury or death to vehicle occupants.
 Correction

15046 Front Passenger Air Bag Inflator

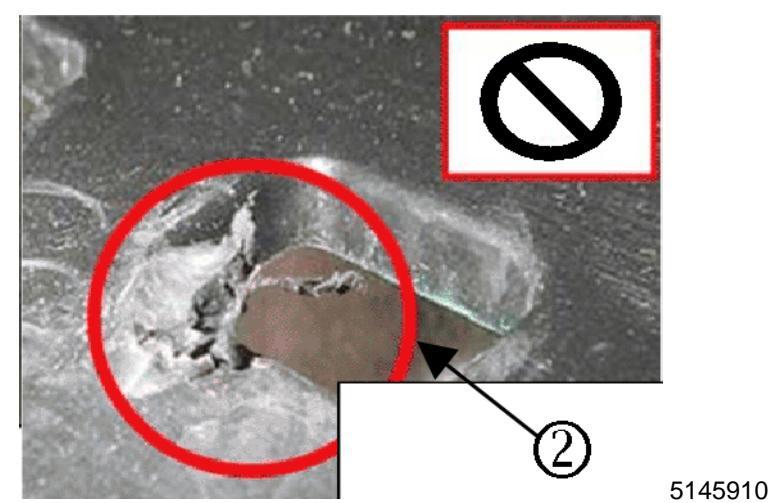
• Inspect the claw openings on the outside and inside of the cover for damage. If any found to look like the (2) the cover must be replaced.
