Safety Recall **Code: 47N3**

Subject	Brake Lines		
Release Date	March 9, 2017		
Criteria Repair	Criteria 01: Repair available March 9, 2017		
Availability information	Criteria 01 and 02: Repair available March 15, 2017		
Affected Vehicles	U.S.A. & CANADA: 2017 MY Volkswagen Passat		
	Check Campaigns/Actions screen in Elsa on the day of repair to verify that a VIN qualifies for repair under this action. Elsa is the <u>only</u> valid campaign inquiry & verification source.		
	 ✓ Campaign status must show "open." 		
	 If Elsa shows other open action(s), inform your customer so that the work can also be completed at the same time the vehicle is in the workshop for this campaign. 		
Problem Description	Affected vehicles may slowly leak brake fluid. After an extended period of time, the brake fluid low warning light may illuminate. If a customer does not heed the warning, brake power may diminish on the affected brake circuit. Reduced braking power may lead to extended stopping distance and could contribute to a rear end crash.

Corrective Action	Replace brake lines on affected vehicles.		
Parts Information	Special Services Parts: 5C1614726A & 5C1614723 Parts will be allocated prior to

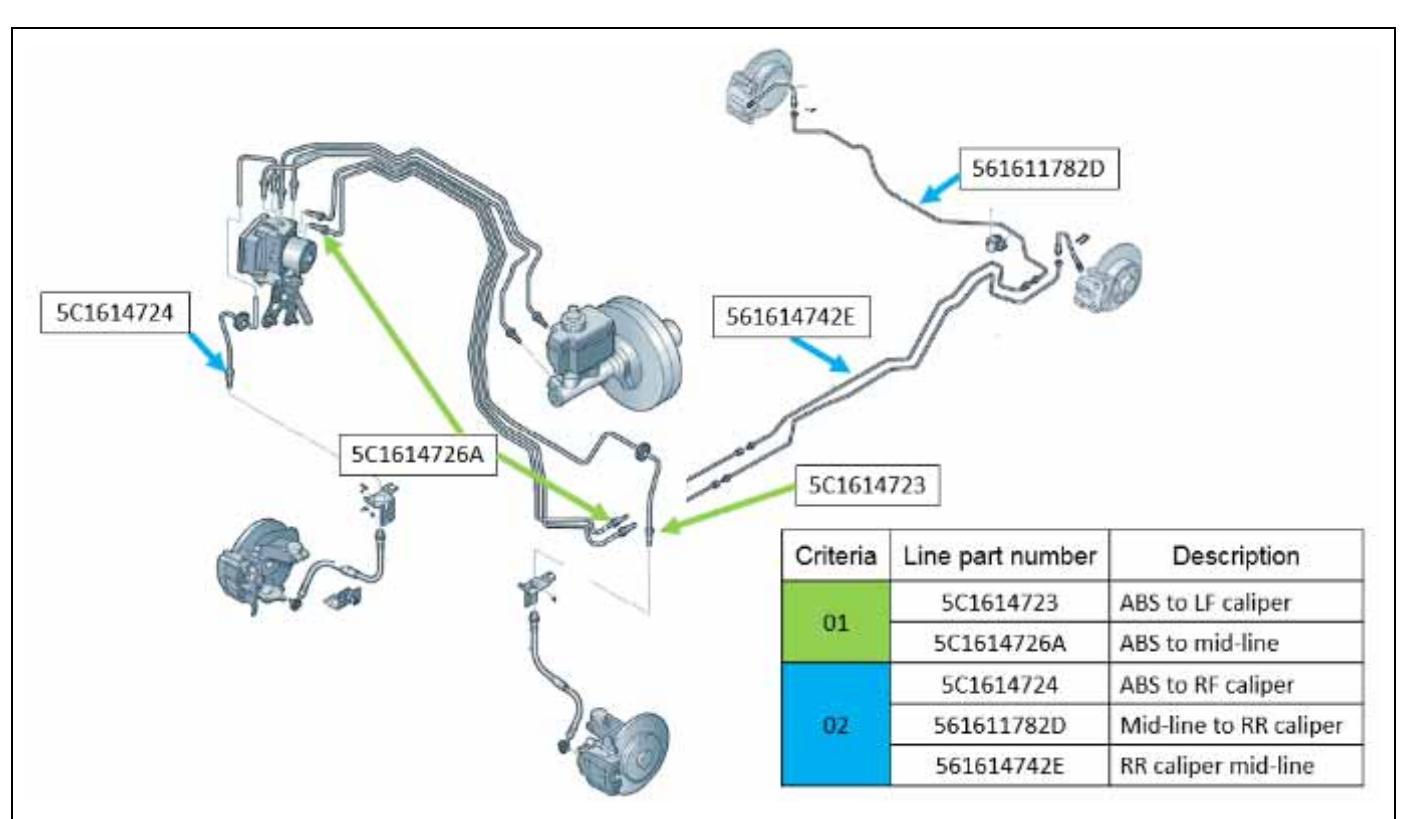
- Vehicles will either have only criteria 01, or have both criteria 01 and 02 open.
- Use the illustration above as a reference to identify which brake line is to be replaced.
