# Safety Recall Code: 80C6

Subject	Auxiliary Heater & Software		
Release Date	November 28, 2017		
Affected Vehicles	U.S.A. & CANADA: Certain 2013-2016 MY Audi A5 Cabriolet, A4 Sedan, A4 allroad, Q5 and A5 Coupe		
	Check Campaigns/Actions screen in Elsa on the day of repair to verify that a VIN qualifies for repair under this action. Elsa is the <u>only</u> valid campaign inquiry & verification source.		
	<ul> <li>✓ Campaign status must show "open."</li> <li>✓ If Elsa shows other open action(s), inform your customer so that the work can also be completed at the same time the vehicle is in the workshop for this campaign.</li> </ul>		
Problem Description	<b>n</b> The electrical connector of the auxiliary heater is susceptible to contact corrosion, which may cause the auxiliary heater to fail and/or cause the wires to overheat and melt. Melting wires may lead to an open circuit, but can also lead to overheating which can result in a fire.

### Subject: Safety Recall 80C6 – Auxiliary Heater and Software Certain 2013-2016 Model Year Audi A5 Cabriolet, A4 Sedan, allroad, Q5 and A5 Coupe

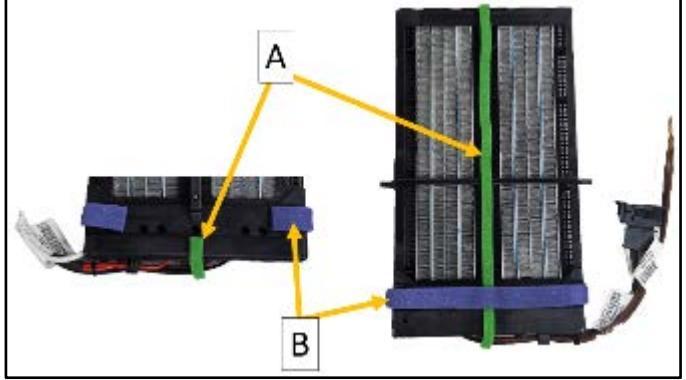
Remove the Auxiliary Heater Heating Element -Z35- <A> from the A/C unit in direction of <arrows>.

- Install foam seals <A> and <B> as shown onto the new Auxiliary Heater Heating Element -Z35-.
- Install seal <A> first.
