Dealer Service Instructions for:

October 2018

## Safety Recall U99 / NHTSA 18V-635 Coolant Hose

#### 2018 - 2019 (GU) Alfa Romeo Stelvio Quadrifoglio

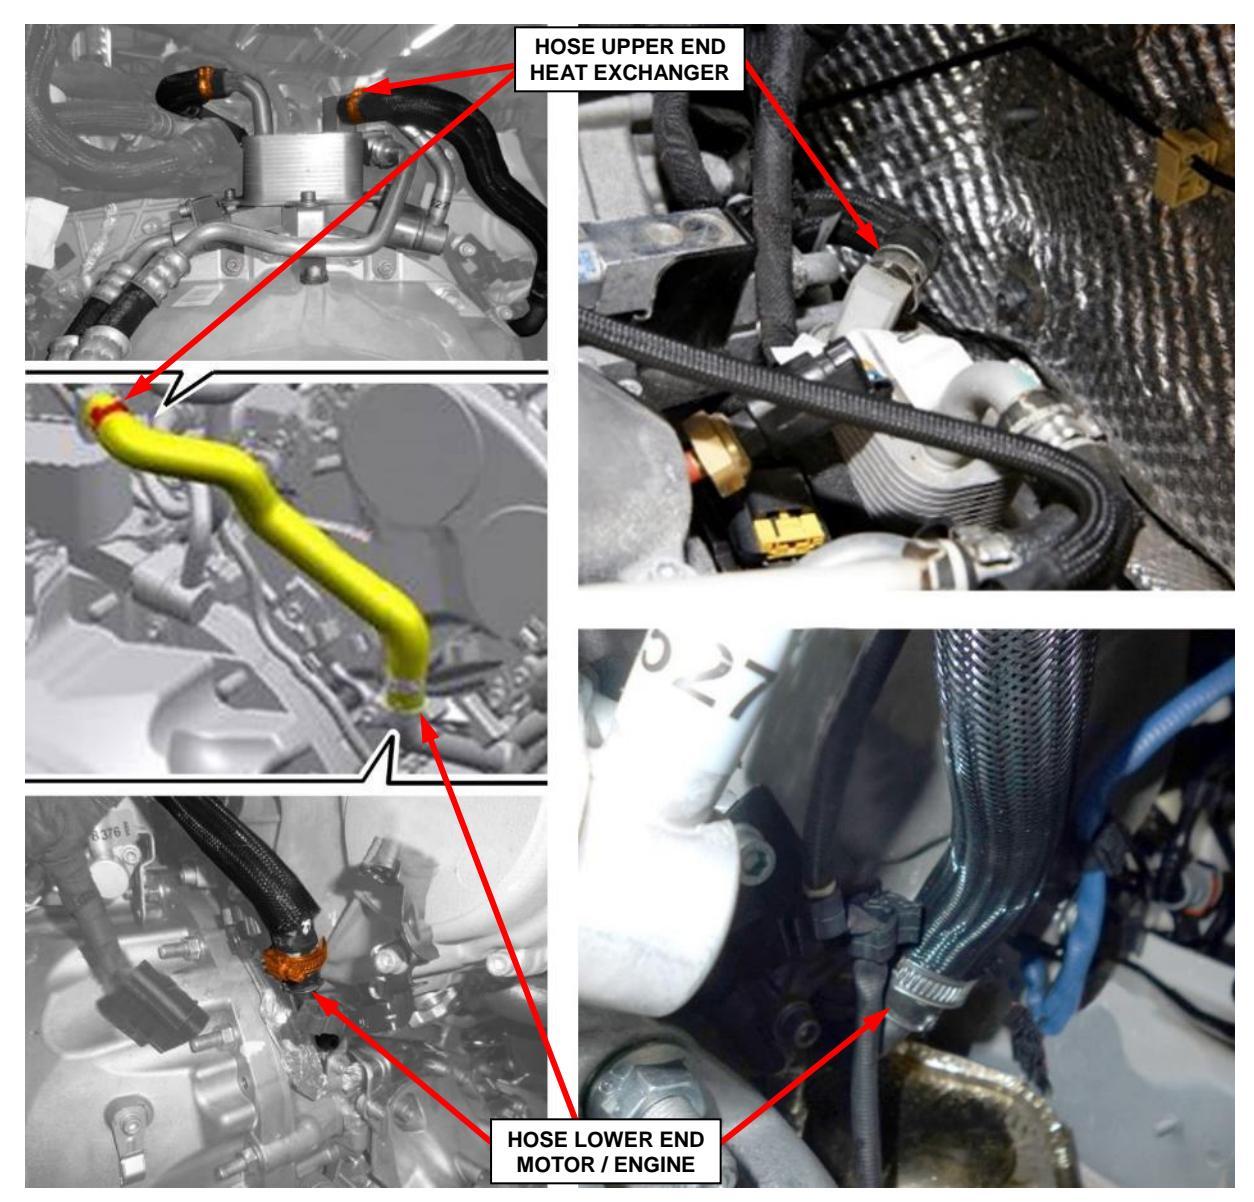
Figure 23 – Engine Coolant Hose

The engine cooling hose on about 660 of the above vehicles may have been manufactured with an inadequate inner webbing material, which may allow coolant to leak. Engine cooling hose leakage may result in a loss of coolant causing the engine to overheat. An overheated engine may result in a loss of motive power. Loss of motive power can cause vehicle crash without prior warning.

Replace the engine coolant hose between the engine crankcase to automatic transmission oil heat exchanger on the right side of the engine.

- 49. Remove and discard the clamps from both ends of the engine coolant hose between the engine water supply pipe to automatic transmission oil heat exchanger on the right side of the engine (Figure 23).
- 50. Remove and discard the engine coolant hose (Figure 23).
