Safety Recall Code: 69S8

Subject	Driver Frontal Airbag Inflator (Takata)
Release Date	December 10, 2021
Revision Summary	USA ONLY
	Added Rental Car/Loaner program claiming instructions
	Added Appendix for Rental Car/Loaner program FAQs
Affected Vehicles	U.S.A. & Canada: Certain 2017 MY Audi R8 Spyder and Audi R8 Coupe and Certain 2016- 2017 MY Audi TT Roadster and Audi TT Coupe
	Check Campaigns/Actions screen in Elsa on the day of repair to verify that a VIN qualifies for repair under this action. Elsa is the <u>only</u> valid campaign inquiry & verification source.
	✓ Campaign status must show "open."
	 If Elsa shows other open action(s), inform your customer so that the work can also be completed at the same time the vehicle is in the workshop for this campaign.
Problem Description	The driver airbag may explode in a crash with airbag deployment. Sharp metal fragments can hit people and cause serious injury or death.
Corrective Action	Replace the driver frontal airbag.

Subject: Safety Recall 69S8 – Driver Frontal Airbag Inflator (Takata) Certain 2017 Model Year Audi R8 Spyder and Audi R8 Coupe and Certain 2016-2017 Model Year Audi TT Roadster and Audi TT Coupe

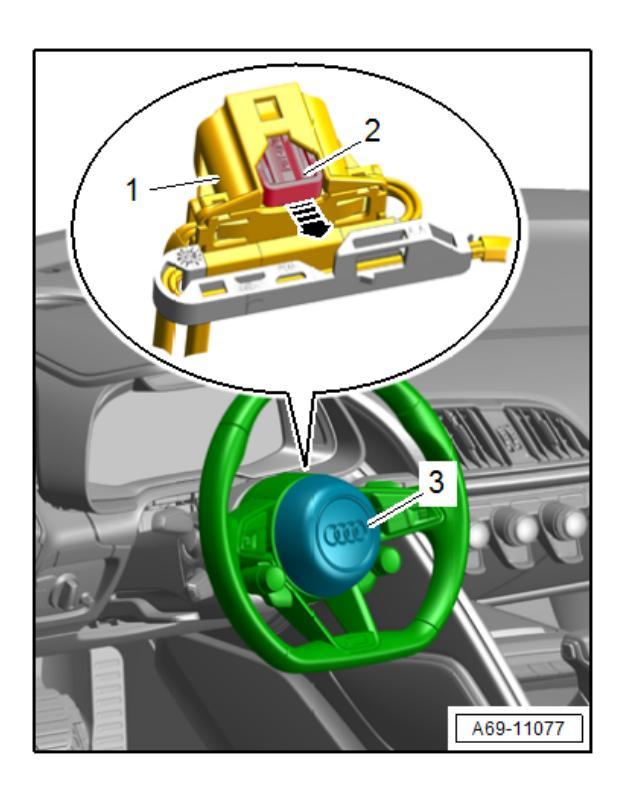
- The driver frontal airbag inflator could potentially rupture (due to propellant degradation occurring after longterm exposure to absolute high humidity and temperature cycling). In the event of an inflator rupture, in very rare cases metal fragments could pass through the airbag cushion material, which may result in serious injury or death.
- All Takata recalls should be performed before any other work is performed on the vehicle.

Replace driver frontal airbag <3>.
