June 7, 2019

Safety Recall: 2016-19 ILX Driveshaft Inspection

AFFECTED VEHICLES

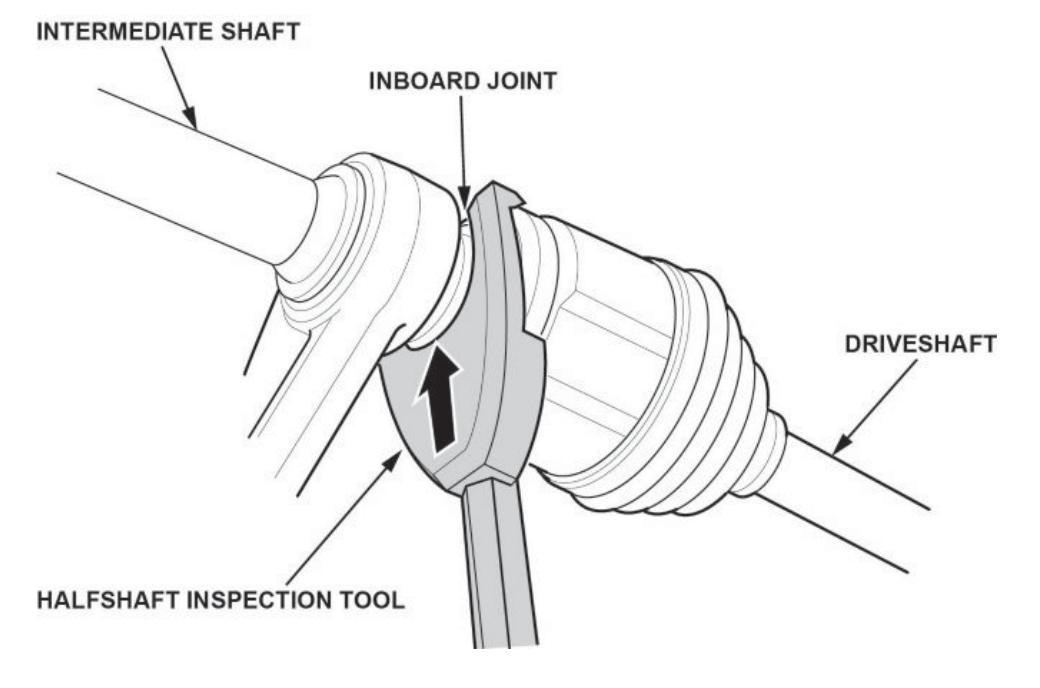
6. Place the open face against the inboard joint of the driveshaft. Make sure the curved edge of the tool is flush with the inboard joint as shown.
