Dealer Service Instructions for:

Safety Recall V63 / NHTSA 19V-449 Acceleration Sensors

2019 (KL) Jeep® Cherokee

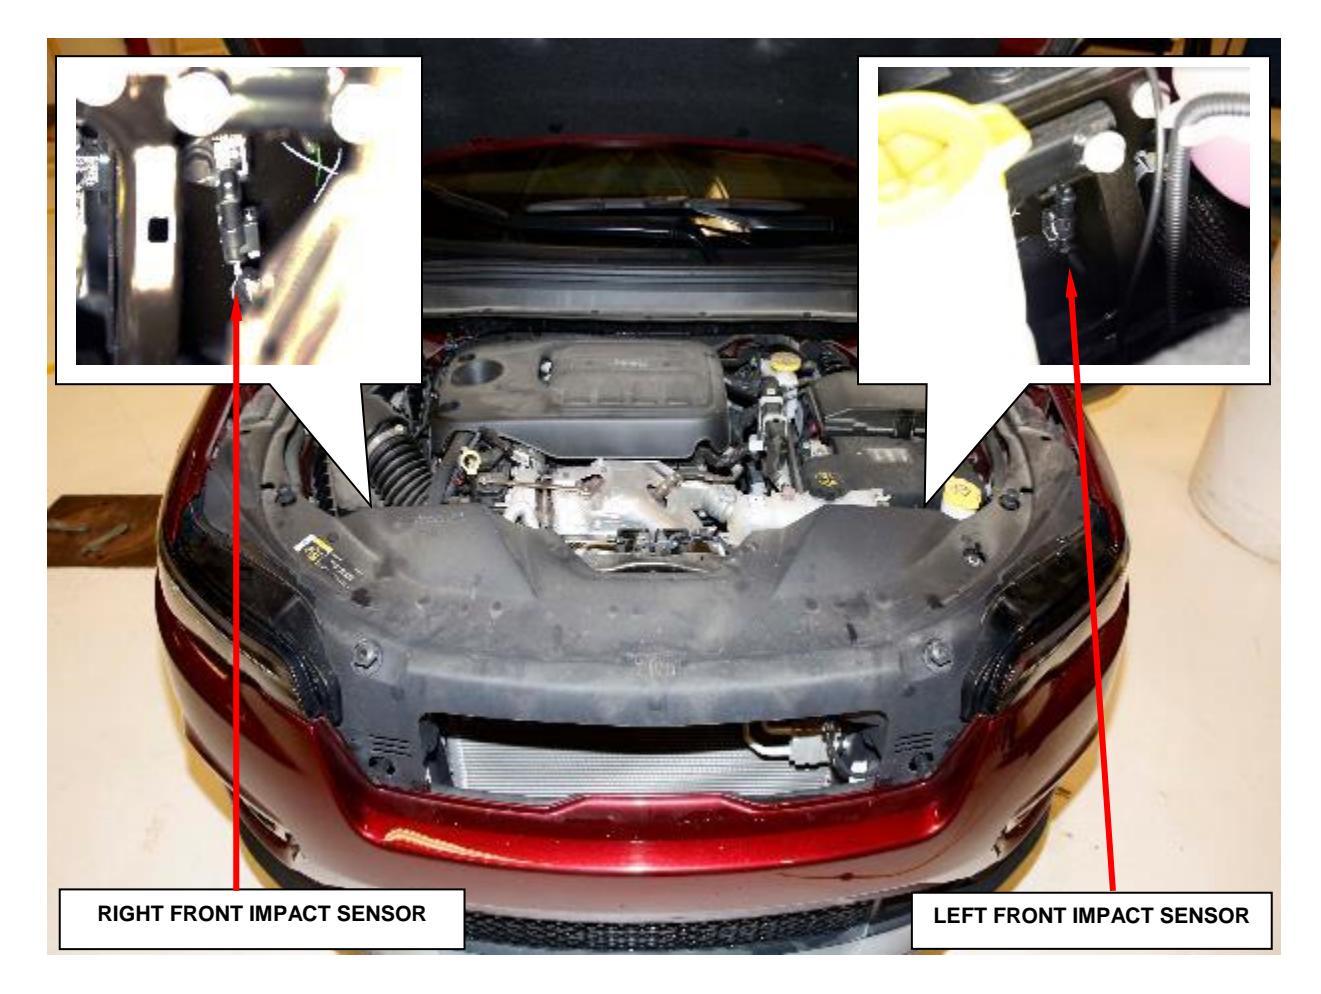
Figure 3 – Front Impact Sensors

The Occupant Restraint Controller (ORC) on about 41,100 of the above vehicles may lose communication between one or more of the acceleration sensors. This may result in a diminished capability of the air bag system to properly detect certain crash events which may result in degraded inflator outputs, late air bag deployment, or a failure to deploy. If an acceleration sensor loses communication with the ORC, the air bag warning lamp will illuminate in the instrument panel indicating a malfunction in the occupant restraint system. If this warning is not heeded, this condition may increase the risk of injury to vehicle occupants in the event of a crash.

- 4. Locate the front impact sensors mounted on the engine compartment side of the Front End Module (FEM) carrier, below the upper radiator cross member and just outboard of the cooling module (Figure 3).
- 5. Disconnect the FEM wire harness connectors from both right and left front impact sensors.
- 6. Remove the bolts that secure the sensors to the back of the FEM carrier.
- 7. Gently pry the sensor away from the FEM carrier far enough to disengage the latch feature of the locator pin on the back of the sensor from the locator hole in the FEM carrier.
- 8. Remove and **DISCARD** the front impact sensors from the vehicle.

- 9. Position the **NEW** right and left front impact sensors to the back of the Front End Module (FEM) carrier just outboard of the cooling module.
- 10. Be certain to engage the locating pin integral to the back of the sensor into the locating hole in the FEM carrier.
- 11. Install the bolts that secure the **NEW** right and left sensors. Tighten the bolts to $9 \text{ N} \cdot \text{m}$ (80 in. lbs.).
- 12. Connect the FEM wire harness connectors to the impact sensors.

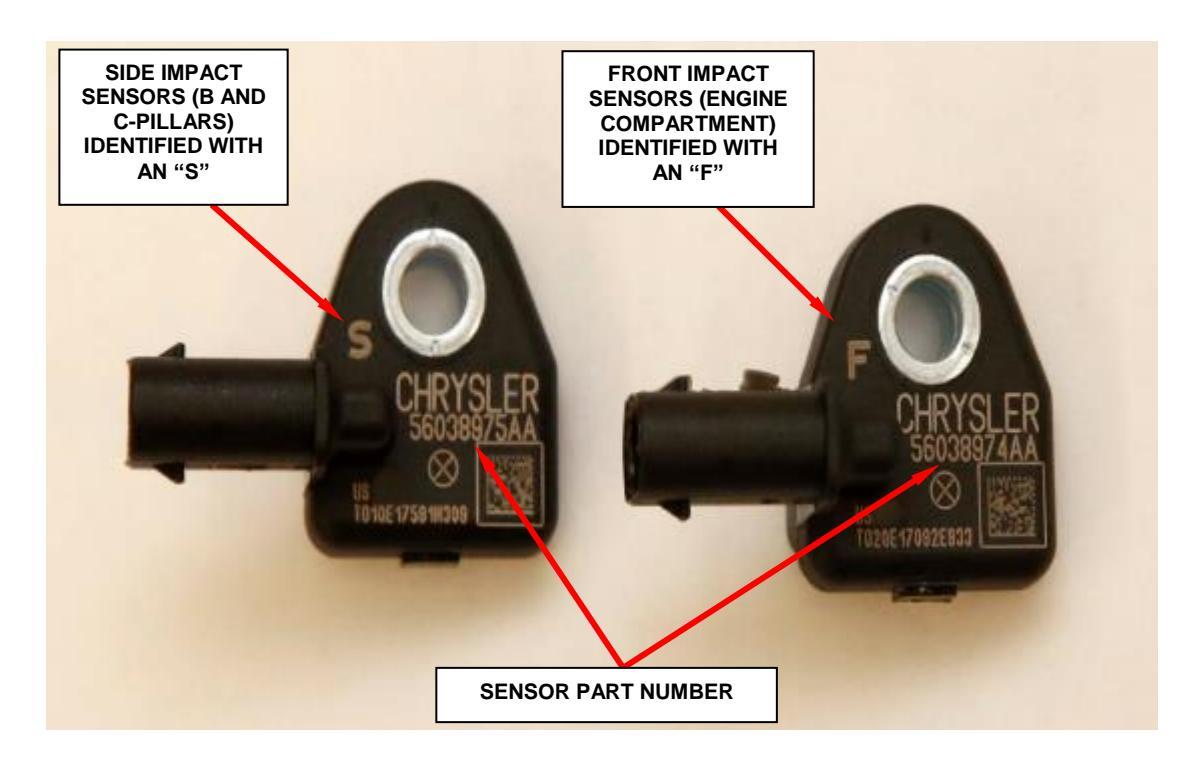
Figure 4 – Impact Sensor Identification

NOTE: The front and the side impact sensors are NOT interchangeable. Front impact sensors are identified with the letter F. Side impact sensors are identified with the letter S (Figure 4)
