Recall Campaign Bulletin

Campaign No. 2021050004, May, 2021

SUBJECT: Model 907 Sprinter, Model Year 2019 Update Incorrect VIN

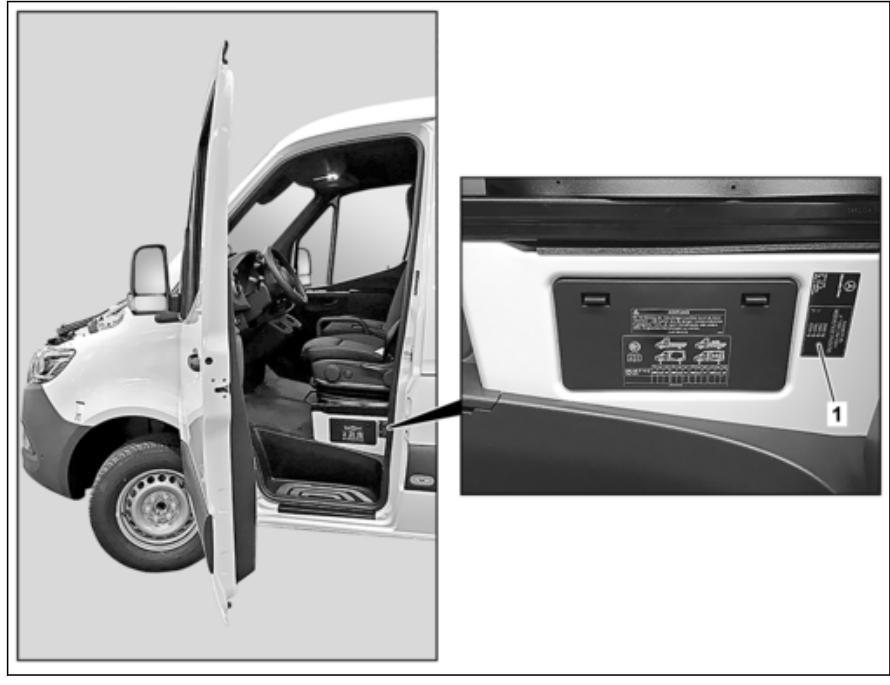
D60.00-A054-06

1 Information label

Cleaner	BR00.45-Z-1025-04A
3	Replace information label (2).	Bonding surface must be absolutely dry and free of dust and grease.	
		This prevents any adhesion problems.	
		Incorrect vehicle identification number:	
		WDZPF0ED6KT016360 Correct vehicle identification	
		number: W1Z40FHYXKT016360	
		i Aid of helper required.	
		Cleaner	BR00.45-Z-1025-04A

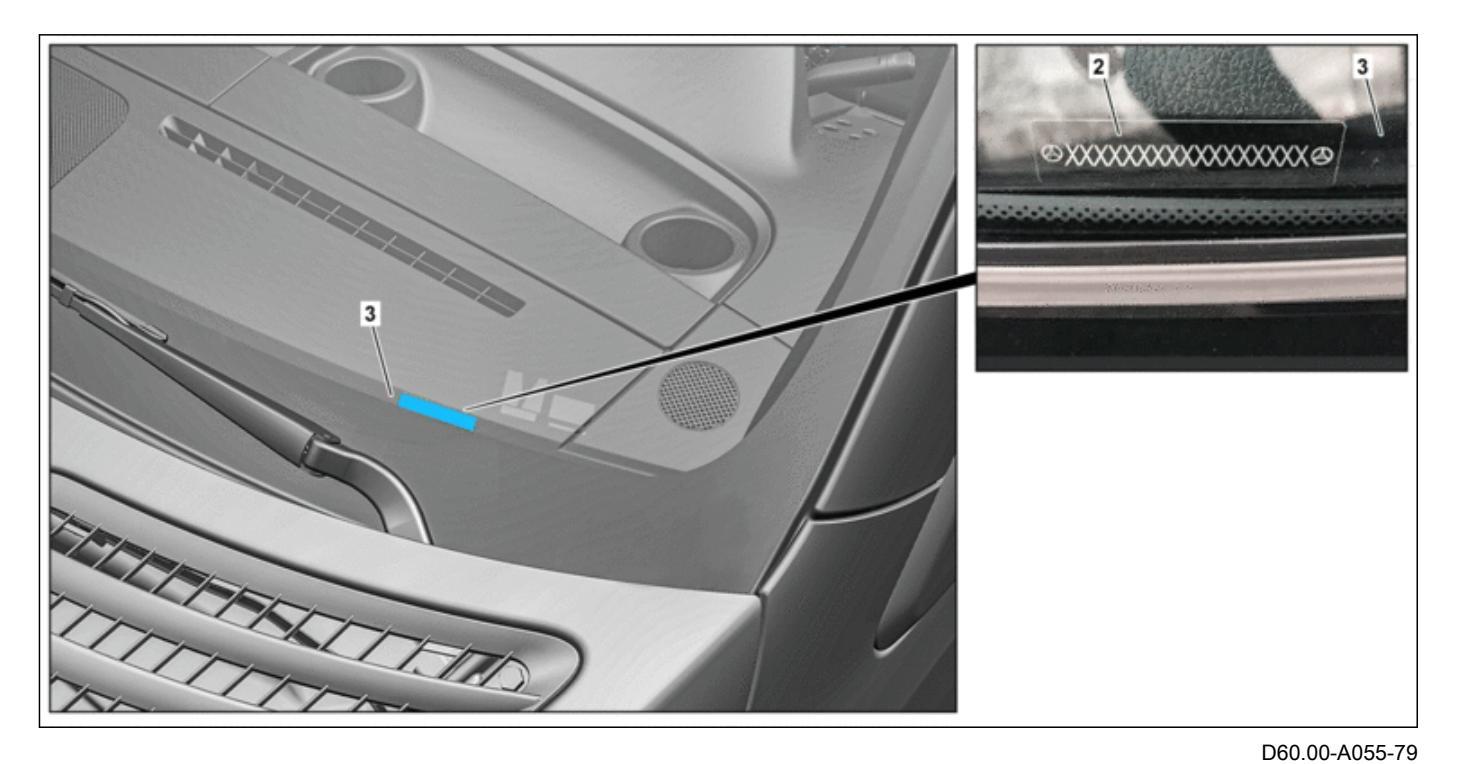
2 Information label

3 Instrument panel

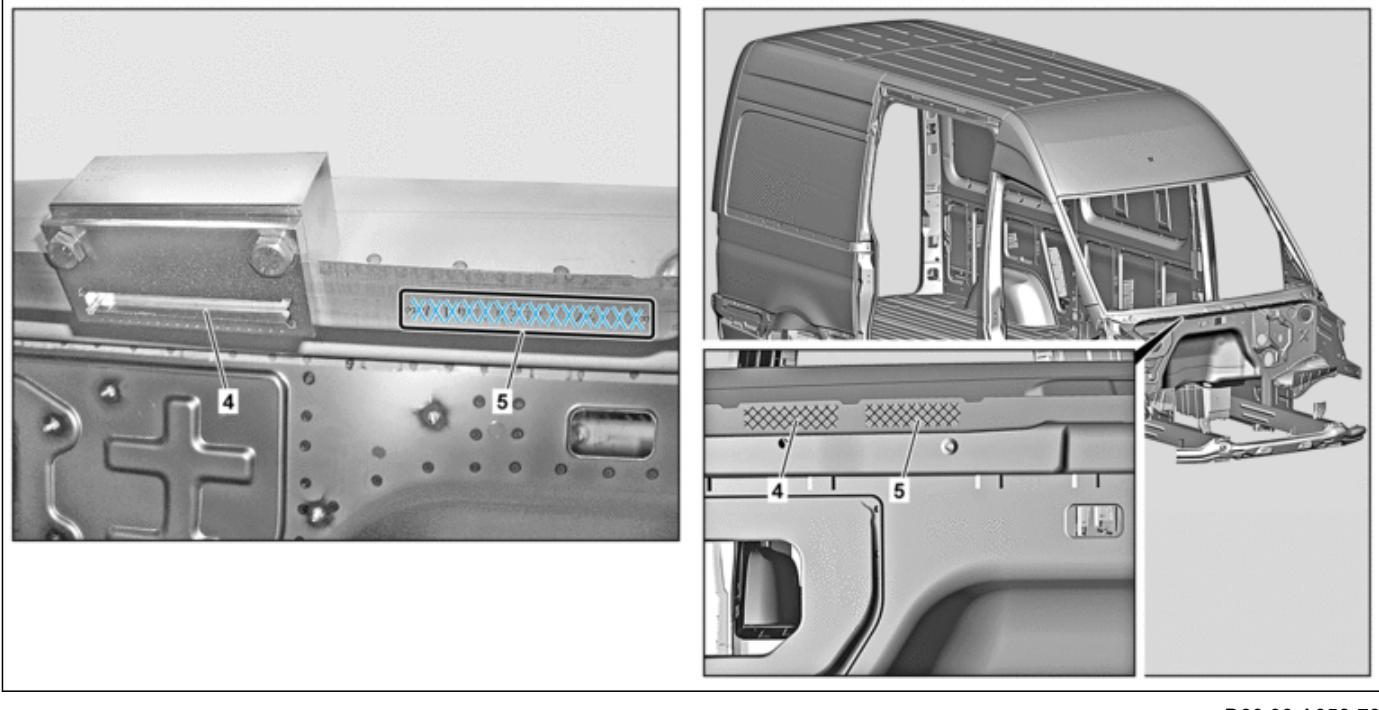
D60.00-A056-79 Standard field for vehicle identification number

4 Reserve field for vehicle identification number

5

X	Remove		
4	Remove ventilation box.		
₩ AR			AR83.10-D-0010TS
5	Remove engine compartment seal in area of reserve field (4).		
	Punch in VIN		
6	Stamp correct vehicle identification number into reserve field (4).		
₩AR		 i Cross out incorrect vehicle identification number in standard field (5). i Incorrect vehicle identification number: 	AR60.00-D-0800TS
		WDZPF0ED6KT016360 Correct vehicle identification number:	
		W1Z40FHYXKT016360	
		Stamping guide	906 589 10 63 00
		Star marking punch	000 589 02 39 00
		S Letter marking punch	000 589 00 39 00
		S Letter marking punch	000 589 03 39 00
		S Die stamp numbers	000 589 01 39 00
<u> </u>	Risk of explosion caused by paint vapors igniting. Risk of poisoning caused by inhaling paint vapors.	No smoking! No open fire! Use respiratory protection, protective clothing, gloves, safety glasses and protective skin cream. Ensure that the area is well ventilated.	AS98.00-Z-0002-01A
