06.2021
 RVXX2102
 01
 1(4)

Proprietary Hubcap Insufficient Retention VAH, VHD, VNL, and VNR

## **RECALL INFORMATION**

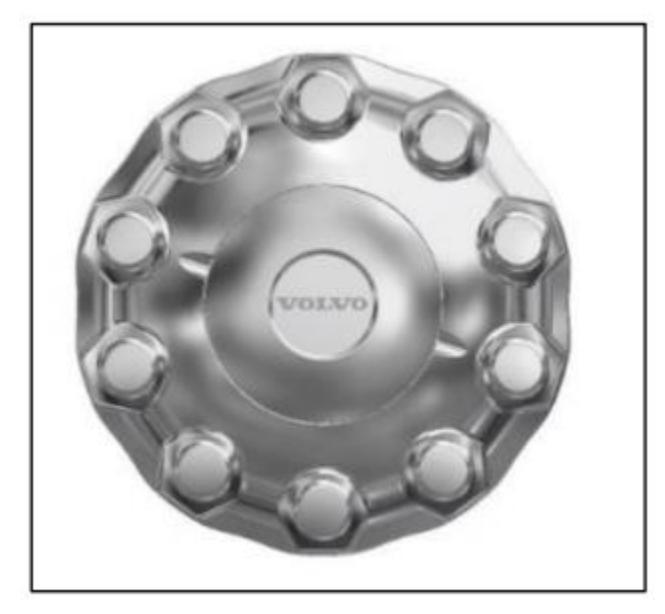
Volvo Proprietary Hubcap wheel cover shown below

Volvo has determined that some proprietary hubcap wheel covers, lack the spring retention force required to retain the hubcap to the wheel. These wheel covers could become separated from the vehicle while in motion, If the hubcap cover comes off, it can result in a hazard to other road users and potentially result in an injury.

- 1. Secure truck for service.
- 2. Remove all proprietary hubcap wheel covers.
- 3. Destroy the removed proprietary hubcap wheel covers so they cannot be reused.
- 4. Recycle the destroyed proprietary hubcap wheel covers in accordance with state and local regulations.
- 5. Release the truck to service.
