SAFETY NOTICE

VSR-TSB-037 NHTSA Campaign Number: 22V-376

Vehicle Safety Recall - Technical Service Bulletin PROMPT ACTION REQUIRED

Attention:	McNeilus Product Owner
Subject:	Bridgemaster Fender Tube for mounting Bridgemaster tag axle fenders
Models Affected:	Bridgemaster Rear Discharge Mixer (93)
Model Years:	2021-2022
Date:	July 2022

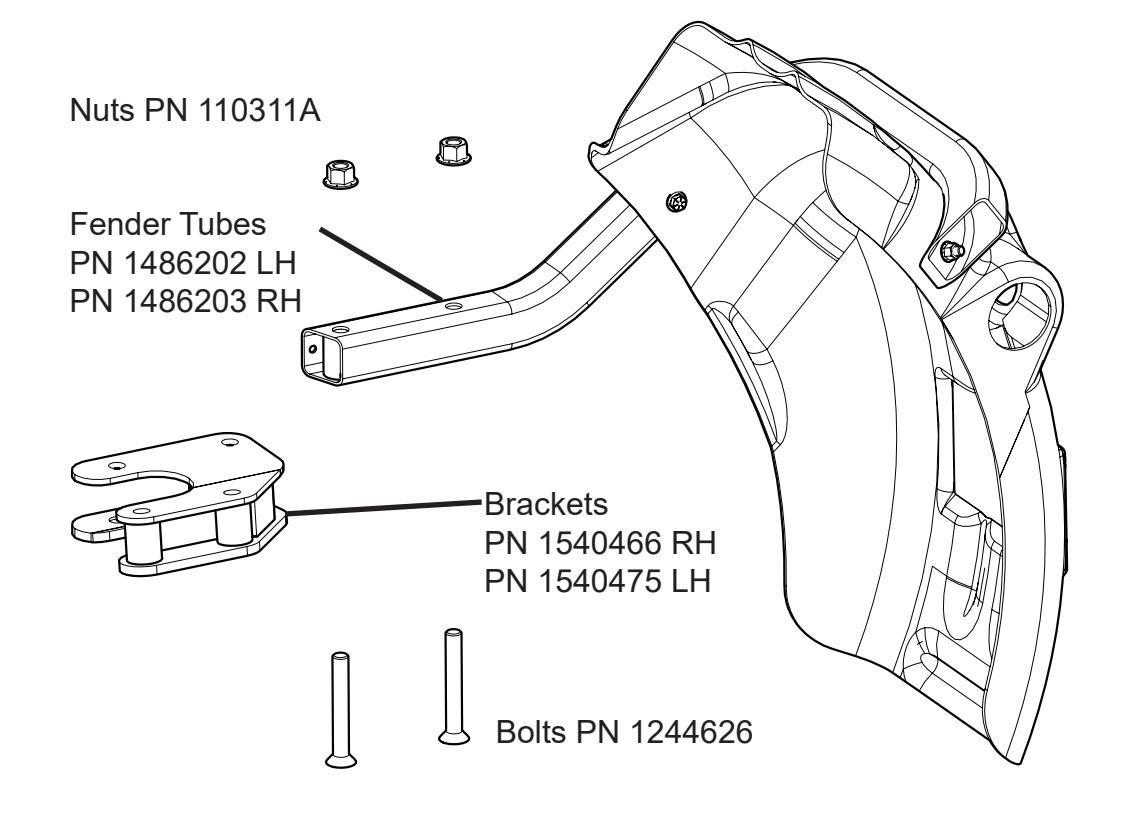
Figure 1

Parts image and descriptions (Figure 1)
