VOLUNTARY RECALL CAMPAIGN

NTB23-046A

VOLUNTARY SAFETY RECALL CAMPAIGN 2023 ROGUE; REAR SEAT BELT ANCHOR

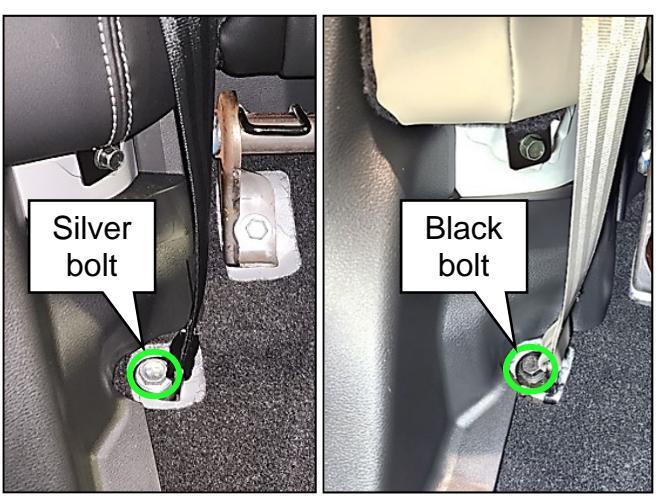
Figure 1

- 2. Locate and inspect BOTH outboard lower rear seat belt anchor bolts (Figure 1 and Figure 2).
 - For ALL bolts that are <u>SILVER</u> with an 18mm head, complete steps 3-25 on pages 4-10 for installing the rear seat belt warning label and replacing the lower rear seat belt anchor bolt washer.
 - For ALL bolts that are <u>BLACK</u> with a 14mm head, DO NOT install a rear seat belt warning label or replace the washer for that seat belt.
