TITLE: 2023 NINJA[®] ZX[™]-4RR KRT EDITION ALTERNATOR ROTOR BOLT INSPECTION

RECALL

IMPORTANT SAFETY RECALL NHTSA RECALL NO. 23V-515

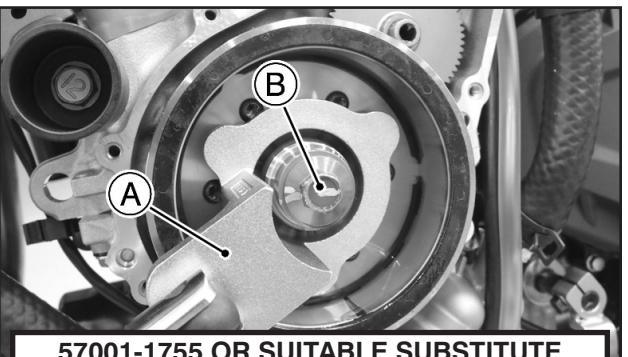
57001-1755 OR SUITABLE SUBSTITUTE

- Hold the alternator rotor steady with rotor holder [A] (57001-1755 or any of the substitute holders listed on page 3 of this bulletin).
- Remove and retain the rotor bolt [B] and washer.

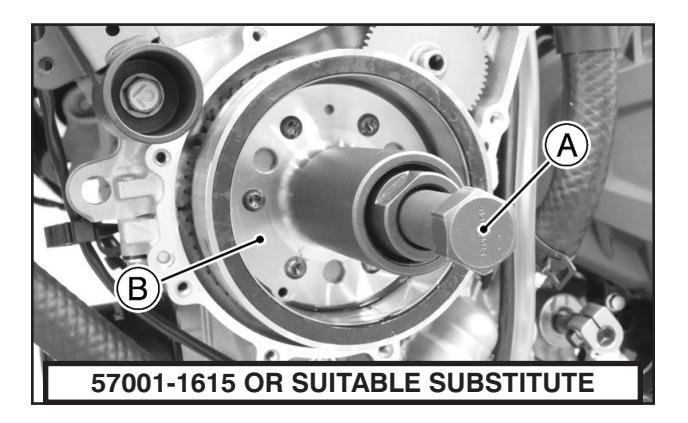
- Check the torque required to remove the alternator rotor by using the smaller, 35mm end of flywheel puller [A] (57001-1615 or suitable M35 x 1.5 aftermarket puller) and a torque wrench set to 89 in lb (1.0 kgf·m, 10 N·m).
 - \star If the rotor is not pulled off with less than 10 N·m (1.0 kgf·m, 89in·lb) of drawing torque, it is installed correctly. Proceed to the Installation Procedure section on page 9.
 - ★ If the rotor is pulled off with under 10 N·m (1.0 kaf·m. 89in·lb) of drawing torque. proceed to the Repair Procedure section on page 7 below.
