### Reference: 76A / NHTSA 23V-545

Jee	Rem	dy available for	
	2022	2023 Wagoneer/Grand Wagoneer	
Revision	Edition	Detail	Template Version 1.0

# SAFETY RECALL North America Upper B-Pillar Trim

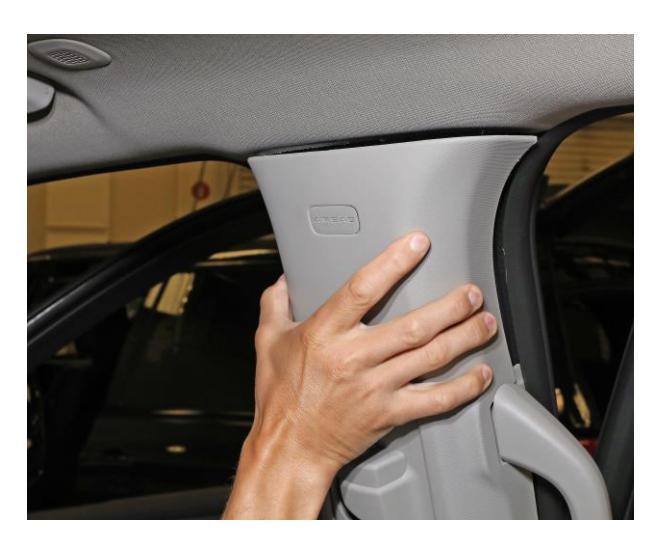
Figure 1 – Check Upper B-Pillar Trim Fit

The upper B-pillar trim on about 47,980 of the above vehicles may not be fully seated. Vehicles with the upper B-pillar trim not fully seated may have a compromised side airbag inflatable curtain ("SABIC") deployment. A compromised deployment of the

- 1. Inspect the upper B-pillar trim for proper fit to the pillar and that it is firmly attached. Grasp the top edge of the panel and tug on it to see if the upper clip is fully seated. Check both sides of the vehicle. (Figure 1). If there is a gap, or the panel is loose, try reattaching the panel by pressing it firmly in the area of the small AIRBAG screw cover.
- 2. Does the trim fit properly, or did it snap into place?
  - Yes: There is no issue. Return the vehicle to the customer.
  - No: Replace the upper B-Pillar trim panel. Proceed to Step 3.

Inspect and, if necessary, reseat or replace all loose or broken upper B-pillar interior trim pieces.
