#### **TECHNICAL INSTRUCTIONS**

#### 23TA14

# Loss of Motive Power

# CERTAIN 2023 MODEL YEAR GR SUPRA

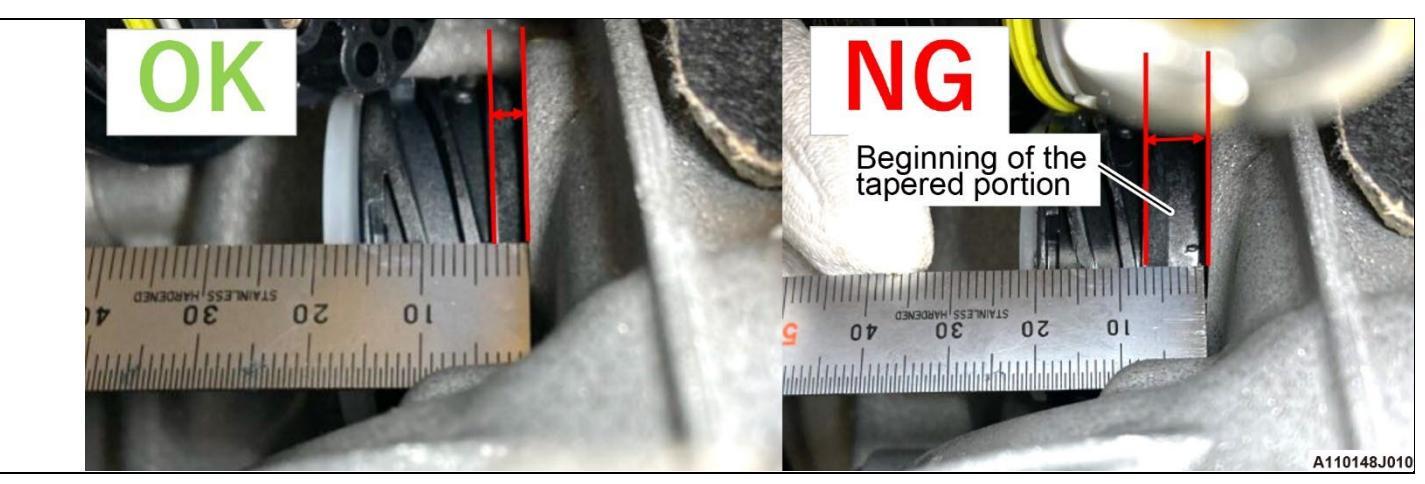
iv) When installing the sealing sleeve to the transmission case, securely install it by pushing it until it reaches the beginning of the tapered portion.

If the sealing sleeve is not securely installed as shown in the **NG** illustration, improper connector connection may result, leading to an ECU communication error.
